**CONCORDE NOISE-INDUCED BUILDING VIBRATIONS FOR
SULLY PLANTATION
CHANTILLY, VIRGINIA**

Staff-Langley Research Center

June 1976

SUMMARY

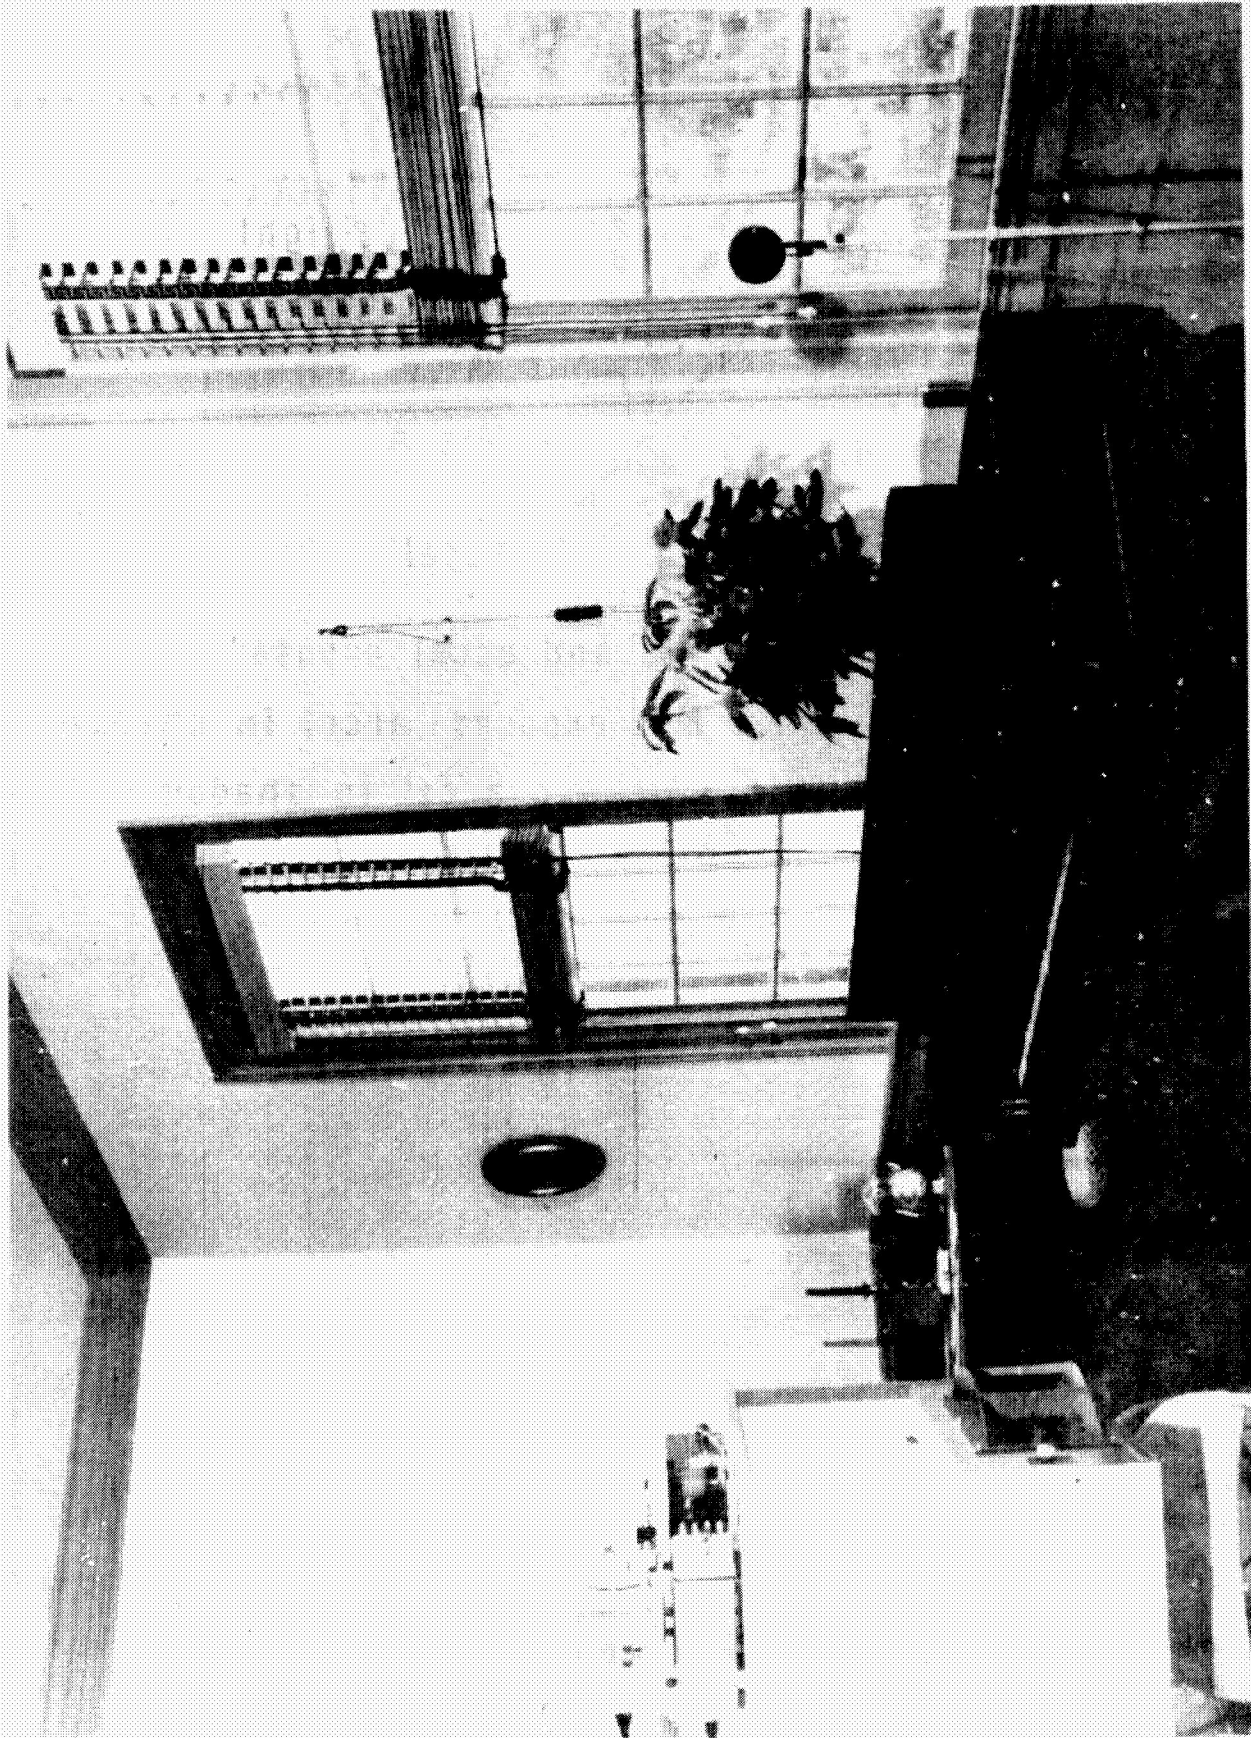
Figure 15.- Acoustic calibration

To provide a controlled acoustic input into each of the rooms, an Altec Model 9844A, playback/monitor speaker system having a frequency response extending from approximately 50 Hz to 15 kHz was used as the transducer. The speaker system contains two 12 inch (30.48 cm) speakers and a high-frequency horn. USASI shaped noise spectra at several acoustic levels (as monitored on a hand-held sound level meter) were impressed on the wall from approximately 6 feet (1.83 meters) away and data recordings made. Some sine wave testing was also performed. Figure 15 shows this system in the parlor (north room) essentially as it was positioned for the calibration tests.

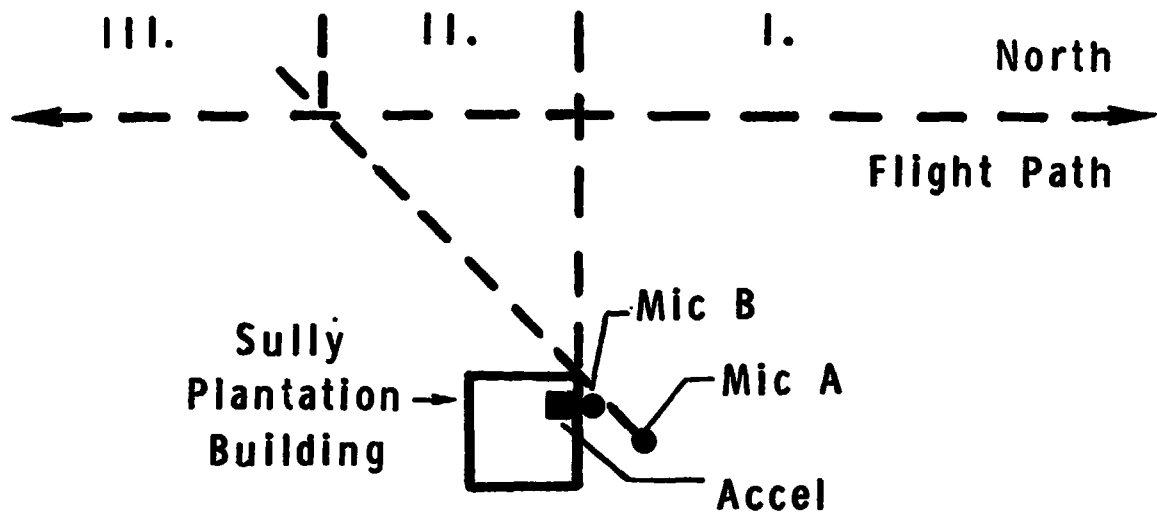
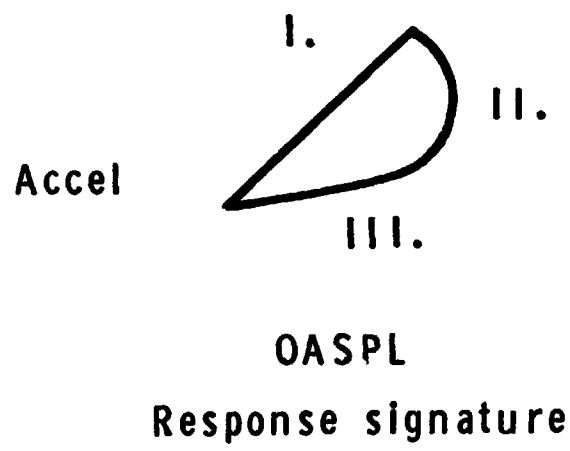
- I. Mic and accel exposed
- II. Mic exposed; accel in shadow
- III. Mic and accel in shadow

Figure 16.- Propagation path geometry for north wall of aircraft flight path.

Before presenting the results of this study, a comment on the observed "hysteresis loop" (figure 12, for example) is in order. This unexpected result is believed to be due to diffraction effects as a result of building, microphone, and flight path geometry as illustrated in the plan view sketch of figure 16. The top sketch shows schematically the flight path relative to the Sully Plantation building and instrument locations. The flight path can be broken down into three regions as indicated to provide the acoustic loading patterns designated as regions I, II, and III. It can be seen that when the aircraft is in region II, the microphone A and accelerometer are loaded differently and that the response indicated in the bottom sketch would be expected. This hypothesis was confirmed by conducting some special tests using an additional microphone (shown as microphone B in sketch of figure 16) near the Sully north wall. The response signature as illustrated in the figure was obtained with the microphone A location; whereas a straight line relationship

was obtained for microphone B location. Based on this information, only the data from the top line of the response signatures (region I) and referenced to microphone A position are presented in this report. It should be noted that microphone A was located in the free field to enable direct comparisons with other noise measurements or noise data bases.

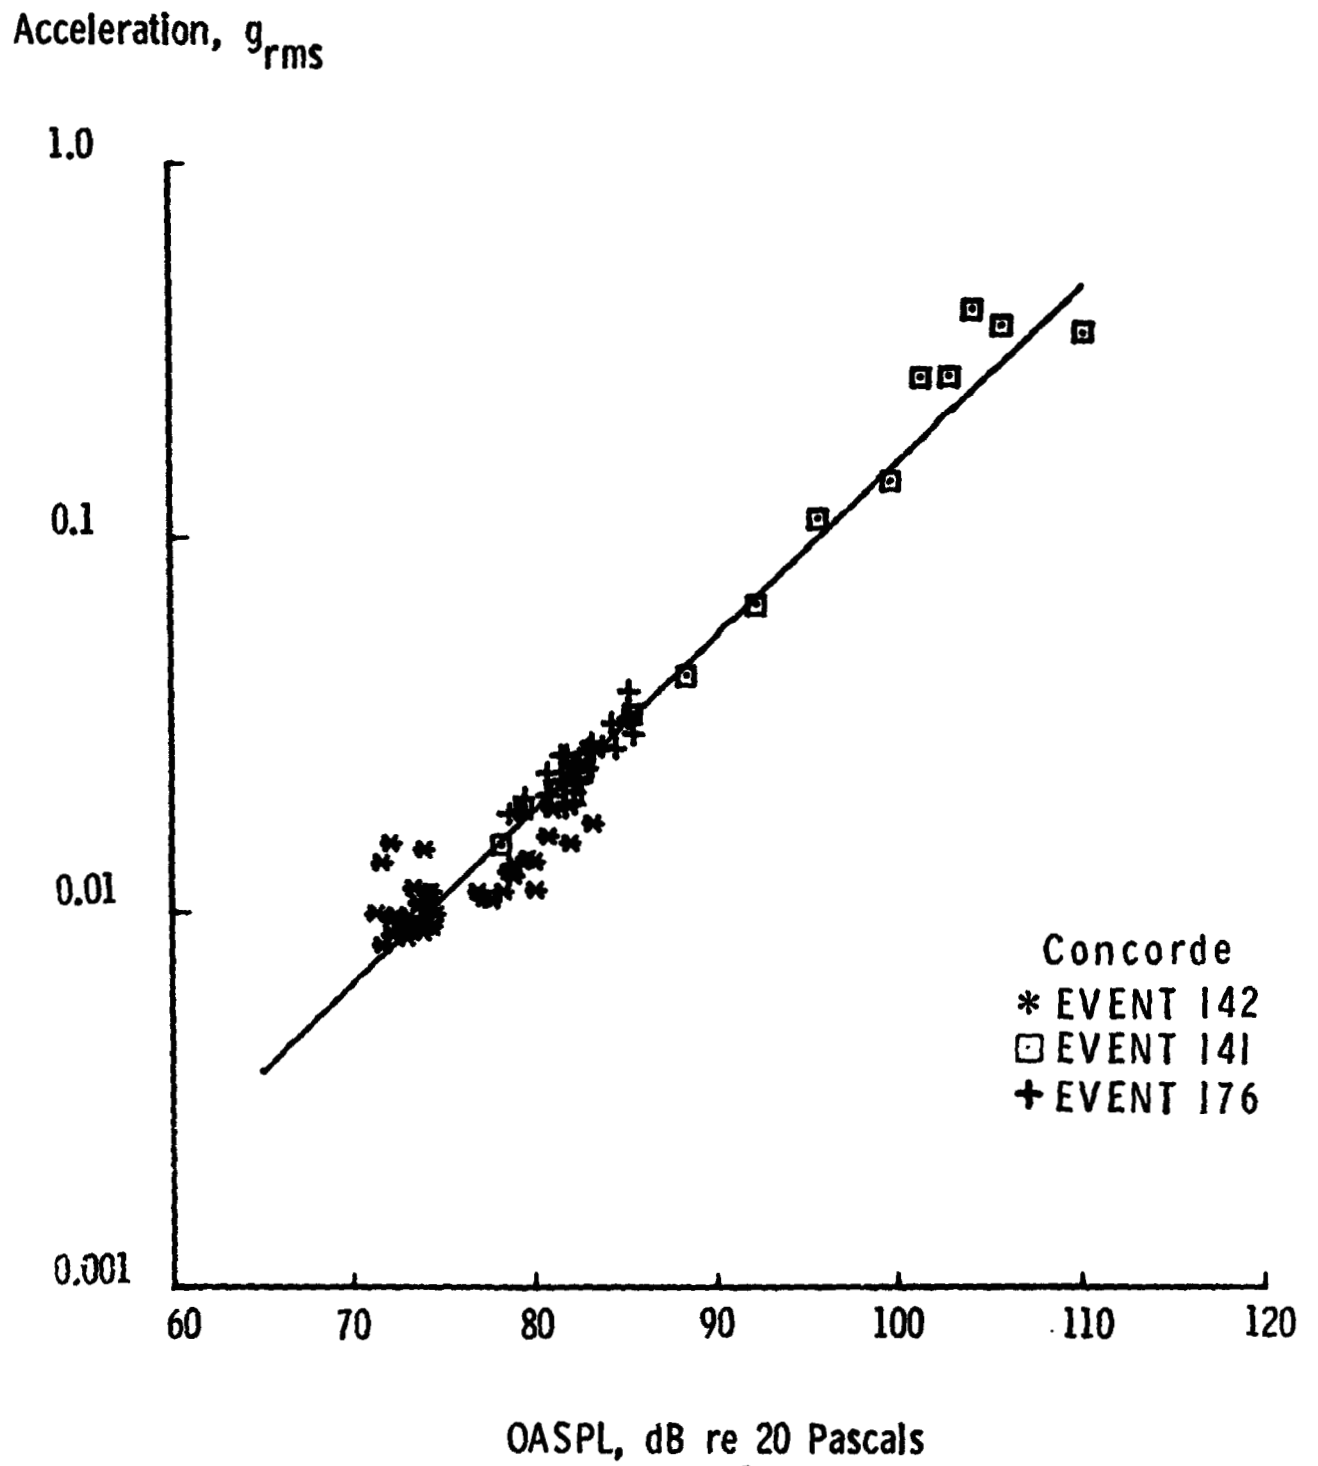
Figure 17.- North window vibration response for Concorde takeoff.

Sample vibratory response data and associated outdoor noise levels are presented in graphical form (figs. 17 through 22) to provide the functional relationships or "signatures" between vibratory response and aircraft noise. Also, the maximum vibration levels recorded are presented in tabular form (tables 2 through 4) to enable comparisons between Concorde and other aircraft and nonaircraft noise sources.

Review of all measurements indicate that the maximum vibratory response occurred on the window located in the north wall. The window response was greater for takeoff operations than landing operations. Consequently, the vibratory response signatures presented in this report are limited to the response of the north window for takeoff operations. Figure 17 represents data for three Concorde takeoff operations from different runways (Runway 19L, 19R, and 1L, respectively). The data are observed to cluster about a single line (least squares fit) and indeed show a linear relationship between response and noise level. This linear relationship is particularly significant in that it not only gives the absolute response of the aircraft as recorded but enables extrapolation to other runway cases, flyover distances, or other house locations assuming the availability of a noise data base. Also, the linear relationship and relatively small scatter band indicates that detailed spectral information may not be required which greatly simplifies the data gathering process.

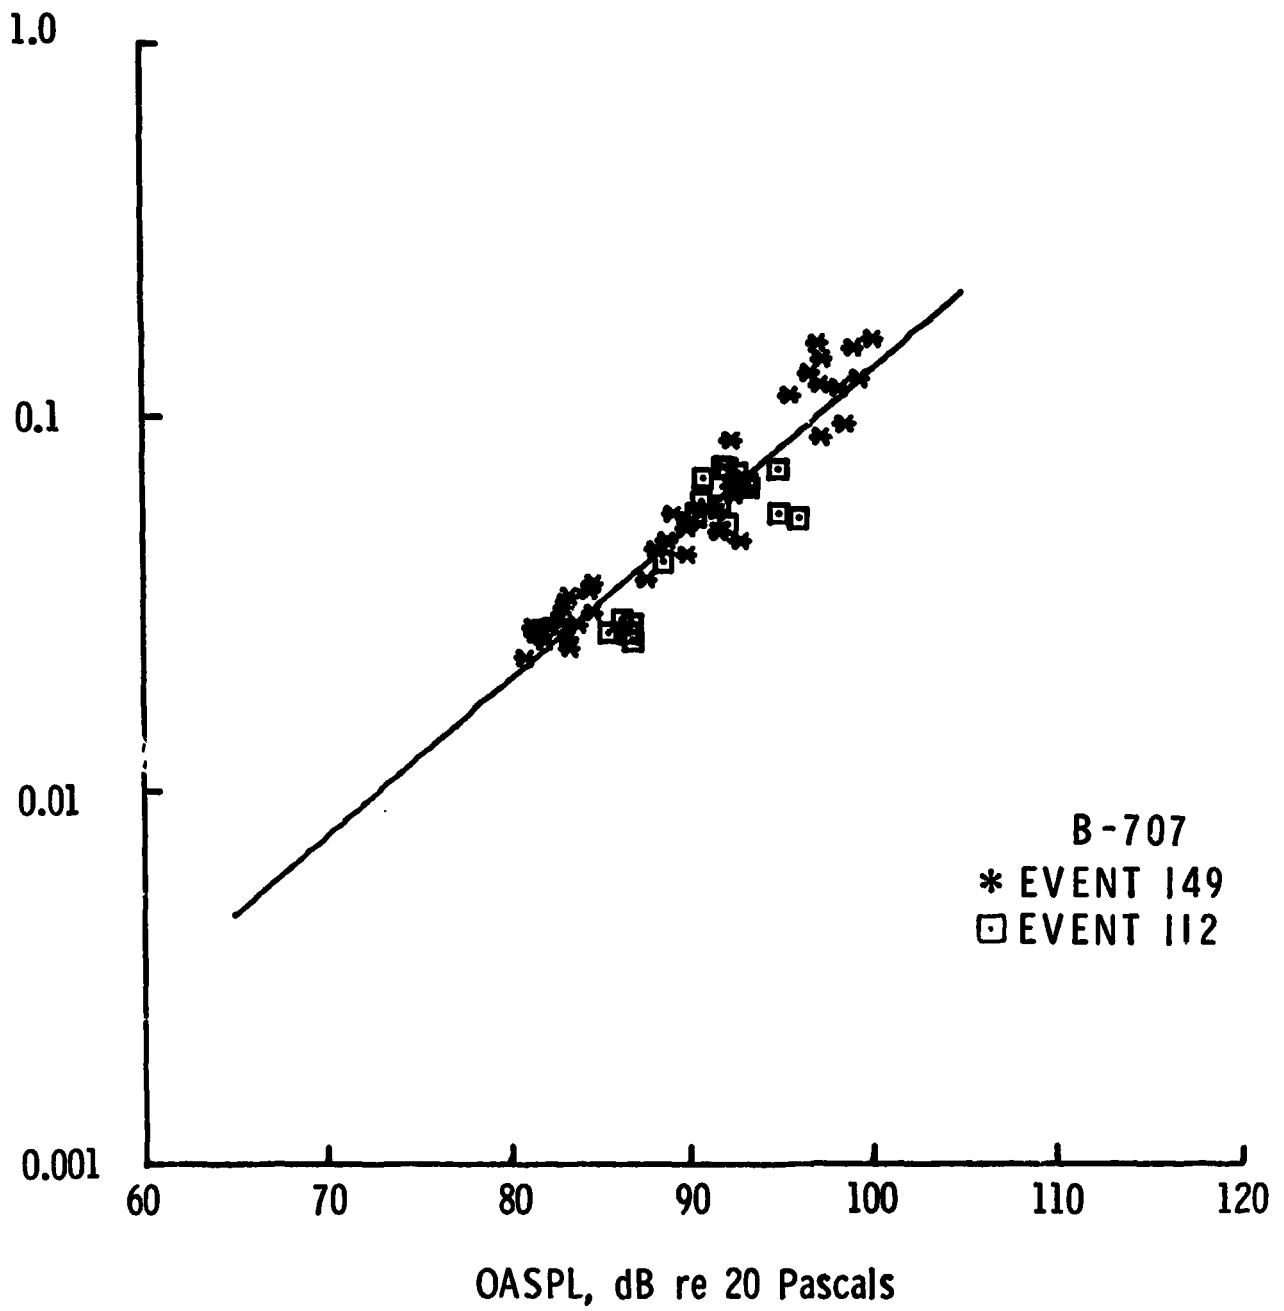
Figure 19.- North window vibration response for B-707 takeoff.

Inspections of the plots from the other aircraft takeoff operations shown in figures 18 through 22 indicate similar linear relationships and, in fact, it is noted that approximately the same slopes are obtained for all the aircraft. This result suggests that the window response is dependent upon pressure amplitude but may be independent of spectral content for the aircraft tested. Thus, the hypothesis (ref. 4) that Concorde induced building response will be greater due to the low frequency content of the Concorde spectrum may be questionable.
