**EXPERIMENTAL AND THEORETICAL INVESTIGATION OF FATIGUE  
LIFE IN REUSABLE ROCKET THRUST CHAMBERS**

by Ned P. Hannum, Harold J. Kasper, and Albert J. Pavli  
Lewis Research Center  
Cleveland, Ohio 44135

TECHNICAL PAPER to be presented at  
the Twelfth Propulsion Conference  
sponsored by the American Institute of Aero-  
nautics and Astronautics and the Society of Automotive  
Engineers  
Palo Alto, California, July 26-28, 1976

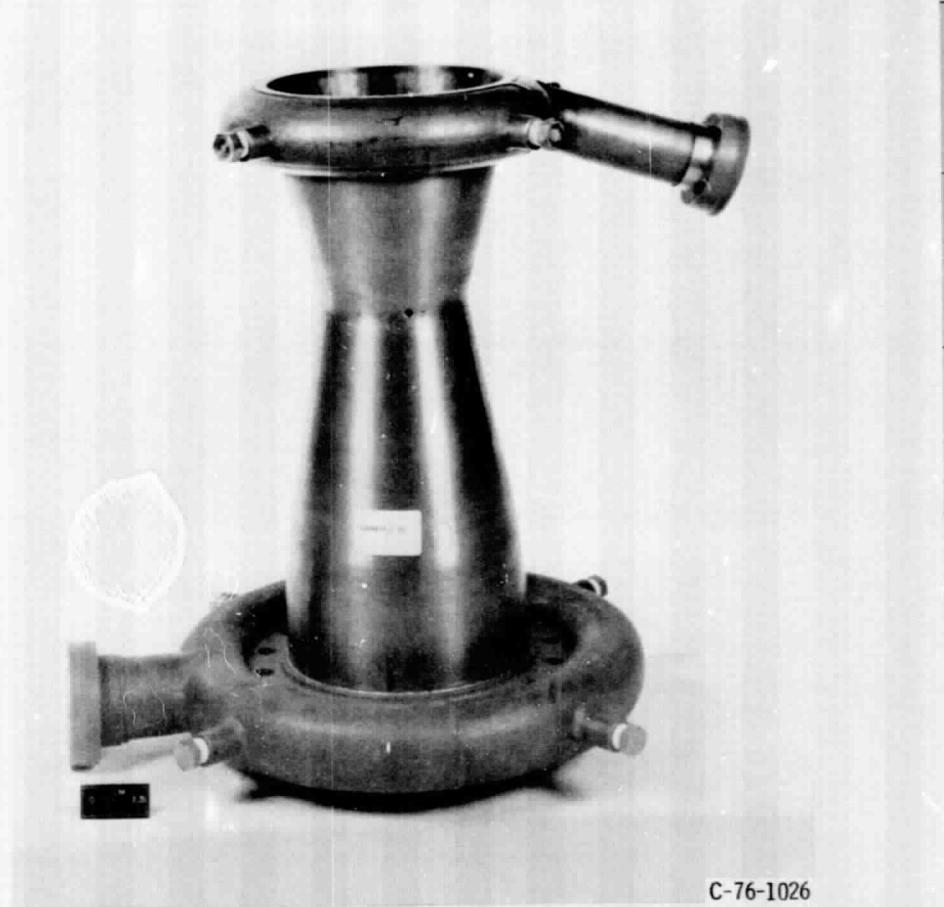
(f) COMPLETED FATIGUE CHAMBER (CONTOUR A).  
Figure 3. - Concluded.

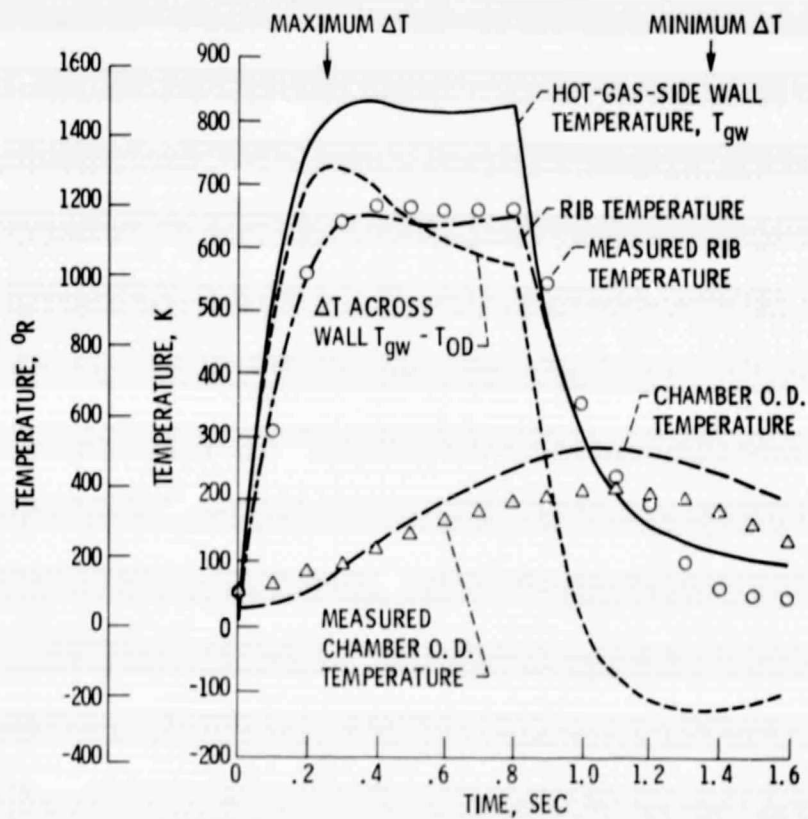
Figure 8. - Typical matching of thermal analysis to experimental data.

When this was done for the design conditions of 4.14-MN/m<sup>2</sup> (600-psia) chamber pressure and 0.91-kg/sec (2.0-lb/sec) coolant flow rate, the hot-gas-side wall temperature was determined to be 828 K (1490° R) instead of the design value of 811 K (1460° R). The difficulty with using an analytical program for a priori temperature prediction, however, is in properly describing the hot-gas-side and coolant-side boundary conditions during the rapid transients. The maximum temperature difference between the hot-gas-side wall and the chamber O.D. occurred during the transients for the cycle used in the present work. Therefore, it was necessary to empirically determine the boundary conditions during the transients in order to force the analytical prediction to match the experimental data. A typical comparison of the analytical temperatures with experimental data is shown in Figure 8. The experimental data, which are represented by the circles, are the rib temperatures measured in the throat plane at a point 1.27 mm (0.050 in.) from the hot-gas-side wall. The triangles represent experimental temperatures measured at the chamber O.D. in the same axial plane. The curves associated with these points are the loci of the analytical temperatures for those locations. Analytical temperature for the hot-gas-side wall is represented by the curve labeled as such, and the temperature difference between the hot-gas-side wall and the chamber O.D. is shown by the  $\Delta T$  curve. The maximum temperature difference occurs at 0.27 sec into the cycle and the minimum temperature difference occurs at 1.34 sec into the cycle for the case shown.

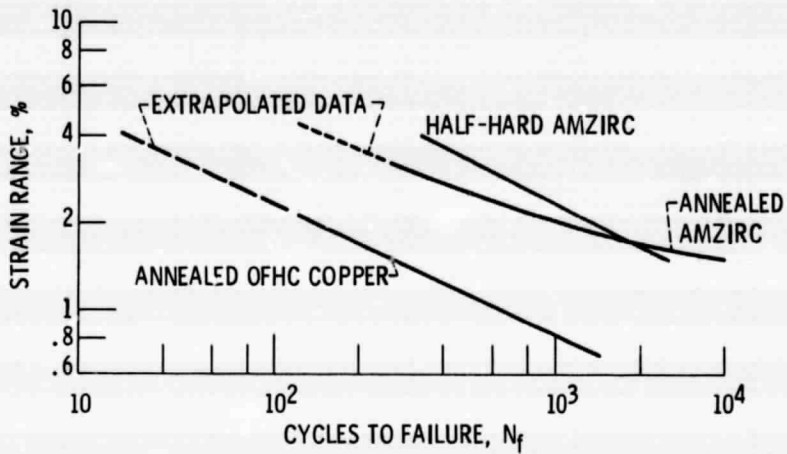
Figure 13. - Typical low-cycle fatigue life of annealed OFHC copper, annealed Amzirc, and half-hard Amzirc.  $\dot{\epsilon} = 0.002 \text{ sec}^{-1}$ ; 538 K (1460° R).

The maximum strain ranges were used, along with the life curves of Figure 13, to establish the minimum expected life of the chambers. This assumed that the engine failed when a crack appeared in the critical element. However, since all elements below the coolant channel had large strain ranges and a throughcrack had been defined as the criterion for failure, it seemed reasonable to average the strains in this area and to predict life based on this average.

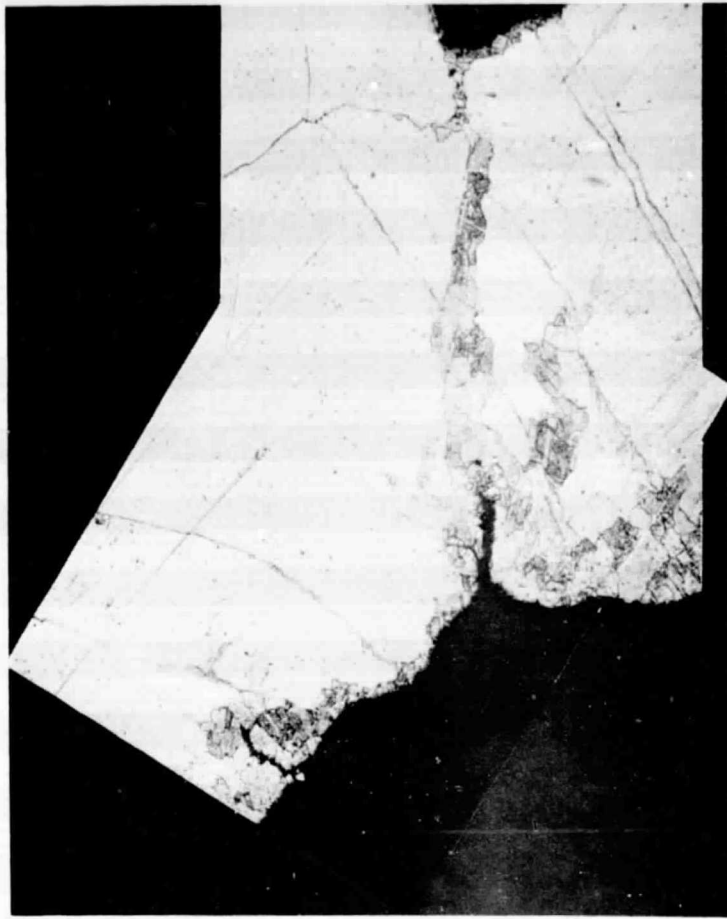
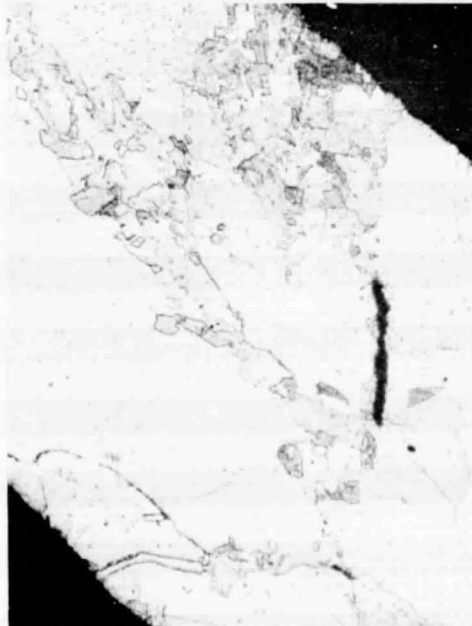
Figure 17. - Enlarged (X150) cross-sectional photograph showing recrystallization and cracking of grain boundaries with an OFHC copper chamber.

7. With OFHC copper combustion chamber liners, some recrystallization of grains at the hot-gas-side surface occurred and was accompanied by surface cracking.

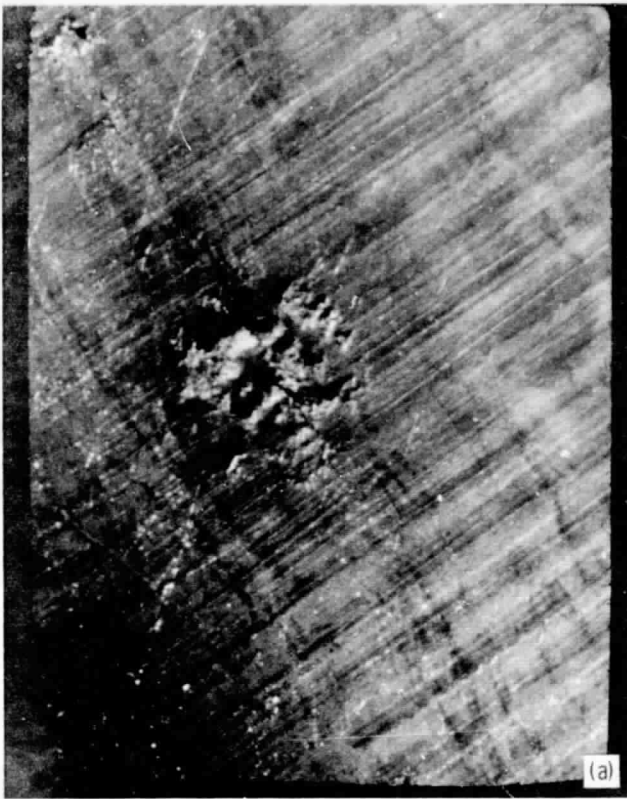
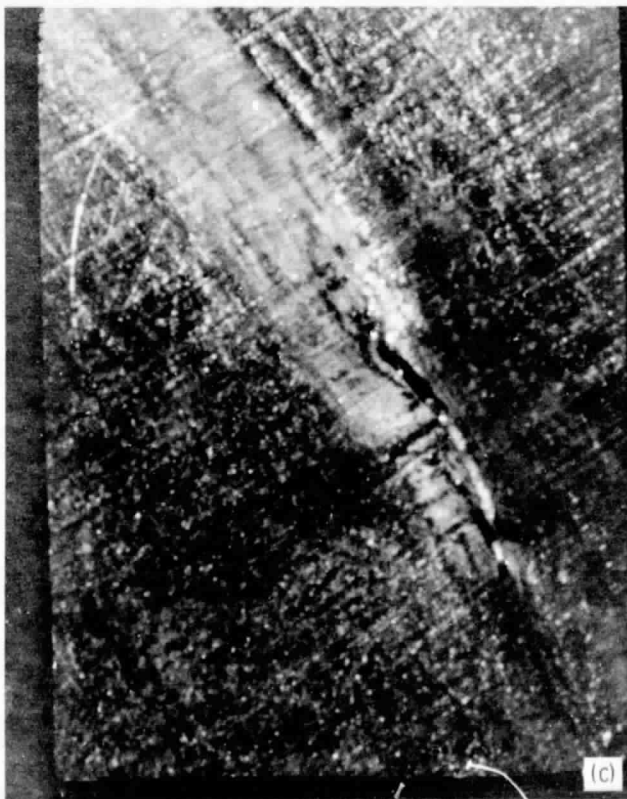
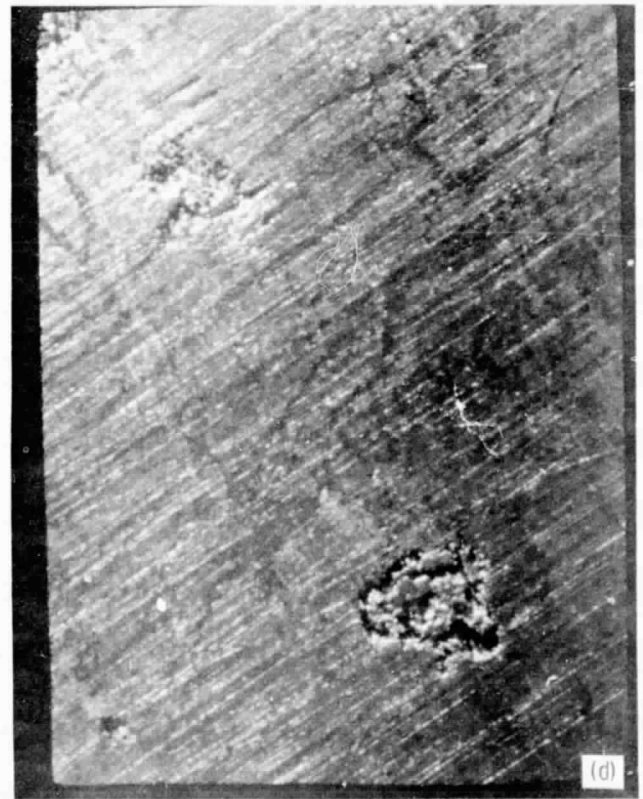
Following cyclic testing, surface pits were observed on the hot-gas sides of the Amzirc chamber liners. These visible pits were located randomly over the surface of both the annealed and half-hard Amzirc chambers. Nothing similar was observed with the OFHC copper chambers. Macrophotographs of representative pitted areas of a half-hard Amzirc chamber are shown in Figure 18. The pits were 200 to 400  $\mu\text{m}$  in diameter.

electron dispersion analysis showed that the material around the pits had a high zirconium content. It was concluded that the zirconium had not been dispersed uniformly throughout the material and consequently its strengthening potential had not been fully utilized. Furthermore, surface cracking was observed in the pitted areas, as shown in Figures 18(a) and (d), which indicated that the pits were possible locations of stress concentration. Similar investigation of the samples used to obtain the life data in reference 8 showed that the zirconium was uniformly distributed as fine precipitation-strengthening particles rather than as randomly distributed agglomerations of zirconium. This observation confirmed that the test specimen material was not identical to the chamber material with respect to its microstructure. Therefore, the fatigue life curves used to predict the chamber lives were not applicable to these chambers.

Figure 18. - Enlarged (X15) photographs of surface pits.

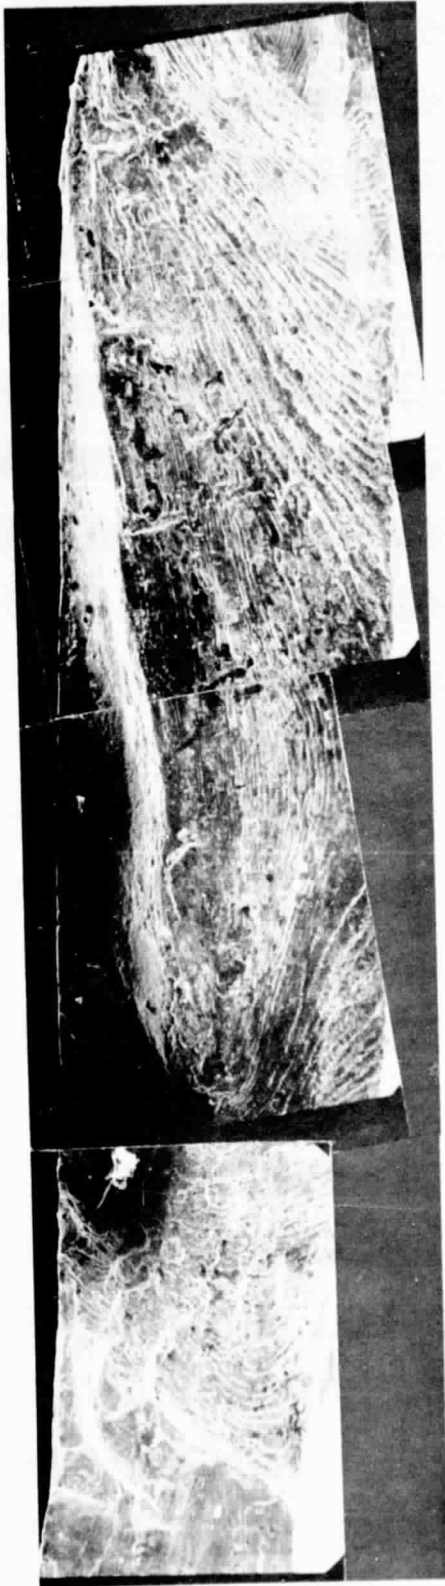
A scanning electron micrograph of an Amzirc chamber (chamber S/N 120) fracture surface is shown in Figure 19. The hot-gas-side surface is at the top of the figure. This micrograph clearly shows the existence of fatigue striations in the vicinity of the crack, which confirms the assumption that the Amzirc chambers probably failed in a fatigue failure mode. Also shown at the top center of the micrograph is the crack initiation site. This flaw had a measured length of 1300  $\mu\text{m}$  (0.050 in.) and a depth of 250  $\mu\text{m}$  (0.010 in.), which is approximately one-third of the channel wall thickness. It was speculated that this flaw was present prior to testing and that it was a result of a zirconium-rich grain boundary inclusion. The striations show that the flaw grew in depth with each cycle until it reached the coolant side of the liner wall in approximately 35 cycles. Once it reached this point the crack grew longitudinally until it became large enough to produce a detectable failure.

Figure 19. - Scanning electron microscope photograph of fracture surface. Chamber S/N 120.
