Title: The application of LANDSAT data from collection platforms and LANDSAT IMAGERY for Fire Management, Everglades National Park, Florida.

LANDSAT TYPE I PROGRESS REPORT

a. TITLE: THE APPLICATION OF LANDSAT DATA FROM COLLECTION PLATFORMS AND LANDSAT IMAGERY FOR FIRE MANAGEMENT, EVERGLADES NATIONAL PARK, FLORIDA.

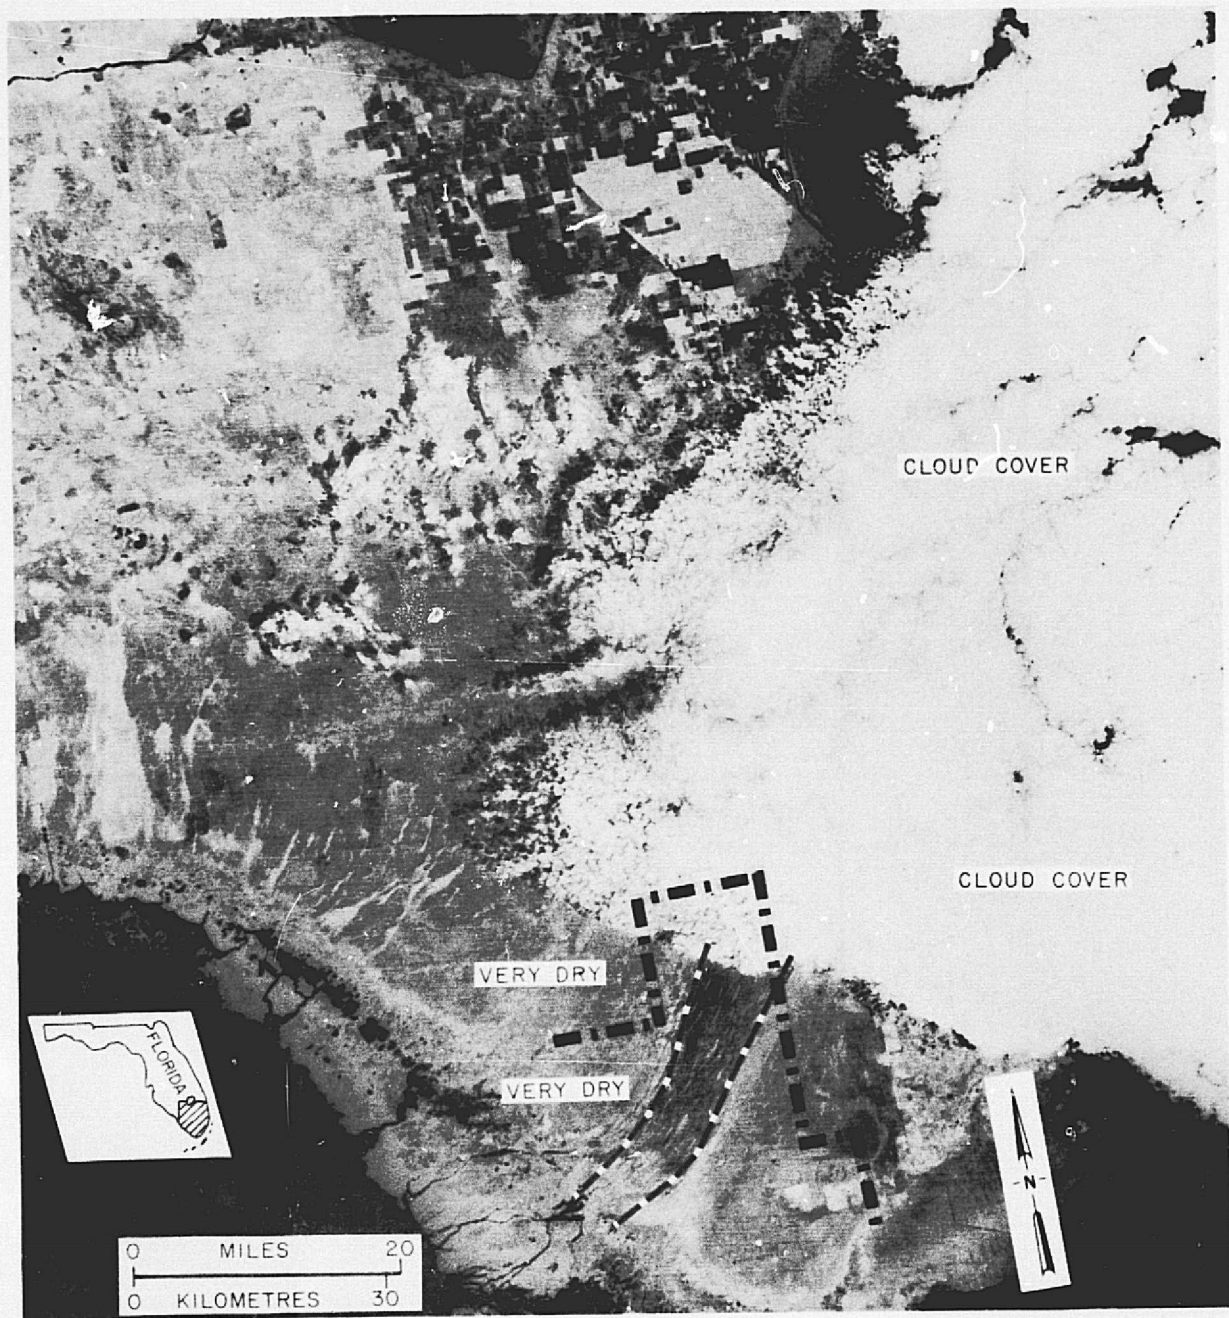
Figure 5.--Landsat Imagery - 1584-15184-7, February 27, 1974. Dark areas indicate water distribution. S-12-A (figure 3) has not been open for one year. The area west of Shark River Slough is dry and the slough has diminished in width. Fires broke out along the west Park boundary six weeks after this image was taken (figure 7).
