# EVALUATION OF MATERIALS AND DESIGN MODIFICATIONS FOR AIRCRAFT BRAKES

T.L. Ho, F.E. Kennedy, and M.B. Peterson

TRIBOLOGY LABORATORY  
DEPARTMENT OF MECHANICAL ENGINEERING,  
AERONAUTICAL ENGINEERING & MECHANICS  
RENSSELAER POLYTECHNIC INSTITUTE  
TROY, NEW YORK 12181

January 1975

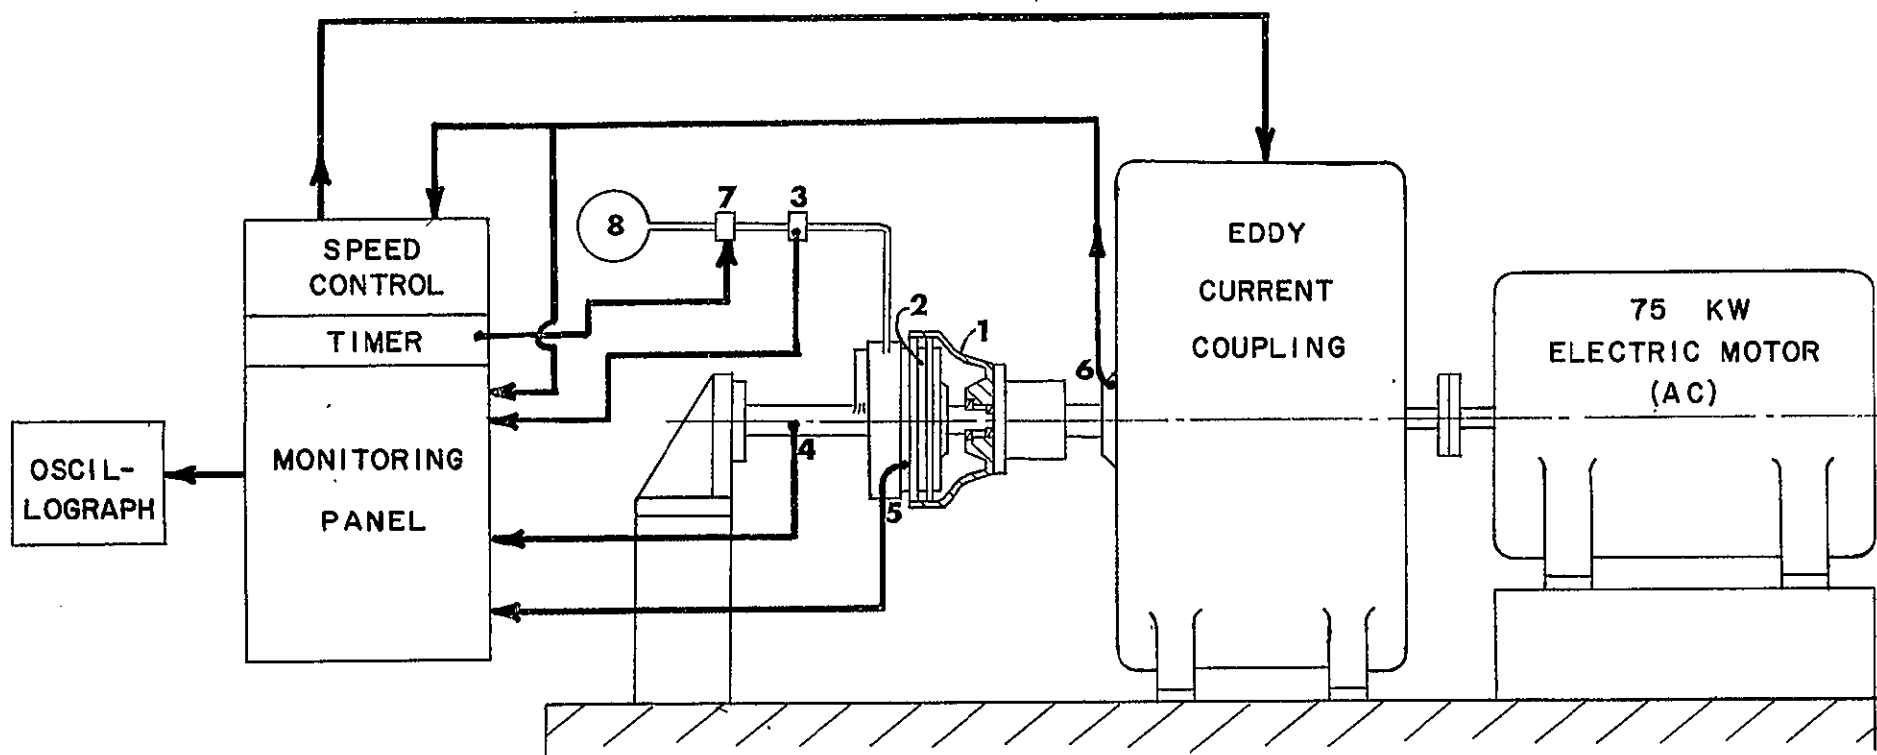
- 1 - WHEEL HALF
- 2 - DISC BRAKE
- 3 - PRESSURE TRANSDUCER
- 4 - STRAIN GAGE TORQUEMETER
- 5 - THERMOCOUPLES
- 6 - TACHOMETER
- 7 - SOLENOID VALVE
- 8 - REGULATED COMPRESSED AIR SUPPLY

Figure 3 Schematic Diagram of Test Equipment

A schematic diagram showing the test equipment is included as Figure 3.

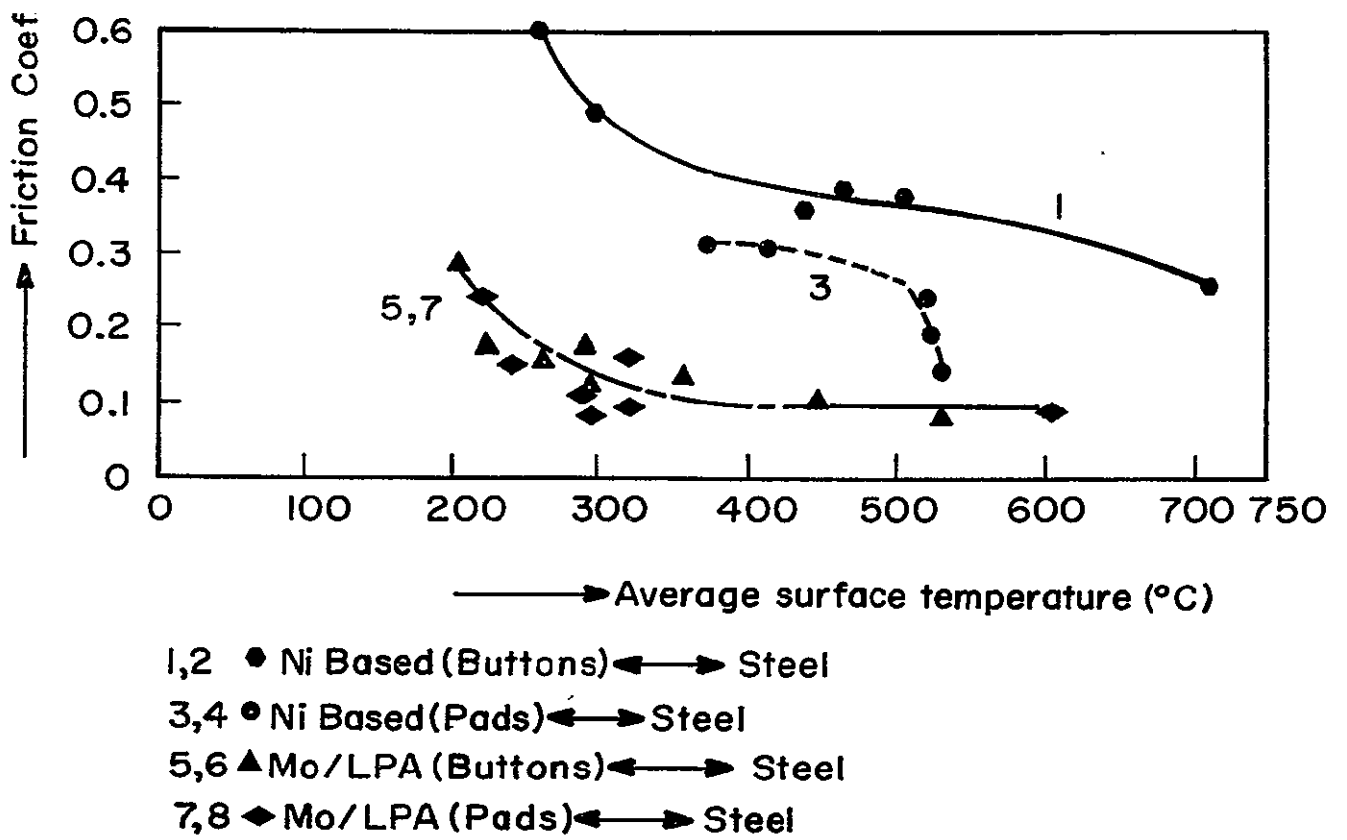
Similar curves are shown in Figure 14 where the wear is plotted versus the average surface temperature measured in brake material near the sliding interface. It is felt that the steel jacket used with the pads is important to support the brake material which is usually porous and fragile. The nickel-based material with a high percentage of graphite has soft and easily sheared off edges. This results in the significant increase in wear for the button brake C compared with the data of the pad brake F. The Mo/LPA material is stronger so it is less susceptible to edge cracking.

Friction. In Figure 14, a comparison of the friction-temperature performance is also shown for the four brakes (Brakes C, D, F, and G). It is seen that brakes D and G have approximately the same friction-temperature relation. The friction coefficient drops from 0.3 to 0.1 when the temperature increases from 200 to 300°C, then it stays level at 0.1 up to 600°C (Curves 5 and 7). However, the friction-temperature curve for brake C (Curve 1) decreases gradually from 0.6 to 0.25 as the temperature increases from 250 to 700°C. It stays quite higher than that for brake F (Curve 3) which shows the drop of friction coefficient from 0.3 to 0.14 at temperatures of 520°C. It is felt that the oxide film is more easily removed on the sliding surface of the button configuration. It is the way in which the metal contact still dominates the sliding of brake C at higher temperatures and results in high friction and high wear.

Figure 14 Effect of Average Surface Temperature on Friction and Wear for Brakes C, D, F, and G

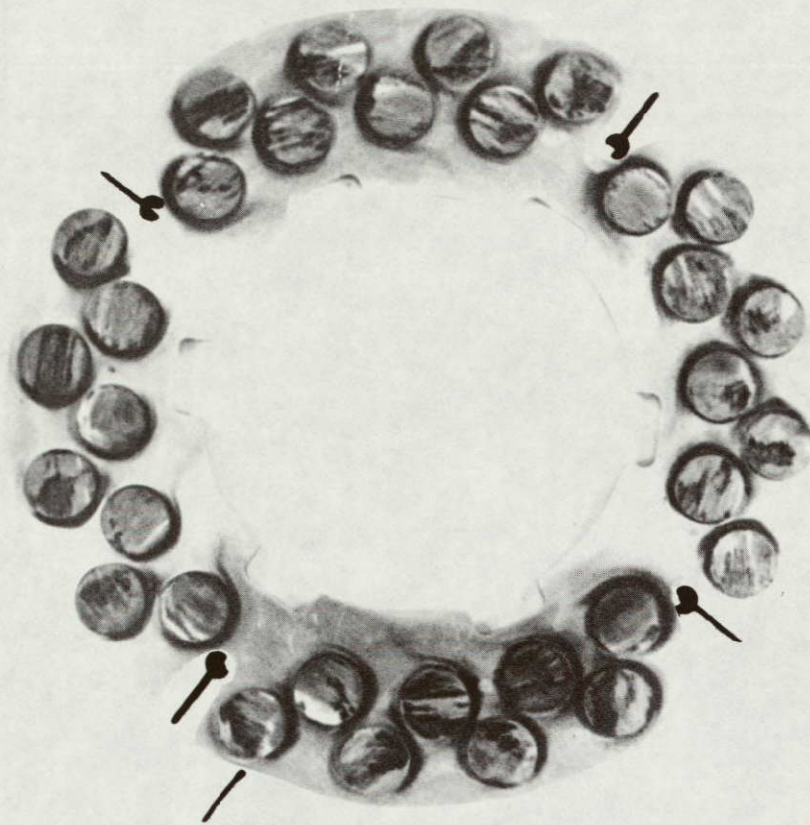
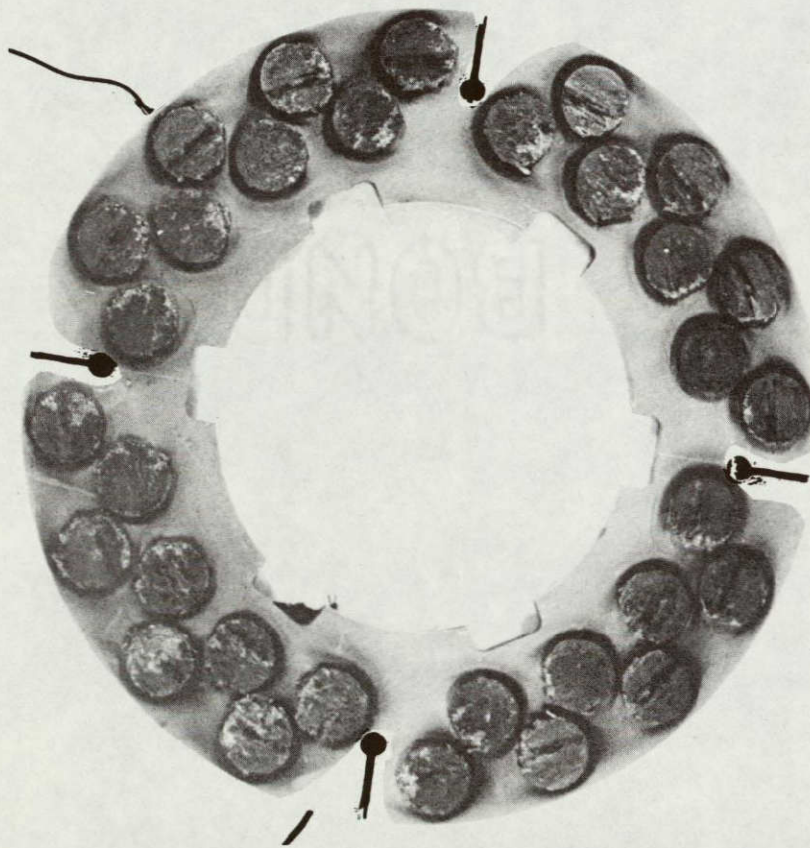
In Figure 15, two photographs show the rubbed surface conditions of the stators, one with Mo/LPA buttons and the other with nickel-based buttons, at the conclusion of all evaluation tests. There is a lot of damage at the rear edges of the nickel-based buttons due to the low strength of the nickel-based material. It is seen that it did not happen for the Mo/LPA buttons.

Figure 15 Photographs Showing the Rubbed Surface Conditions of Stators, One with Mo/LPA Buttons and the Other with Nickel-Based Buttons after all Evaluation Tests

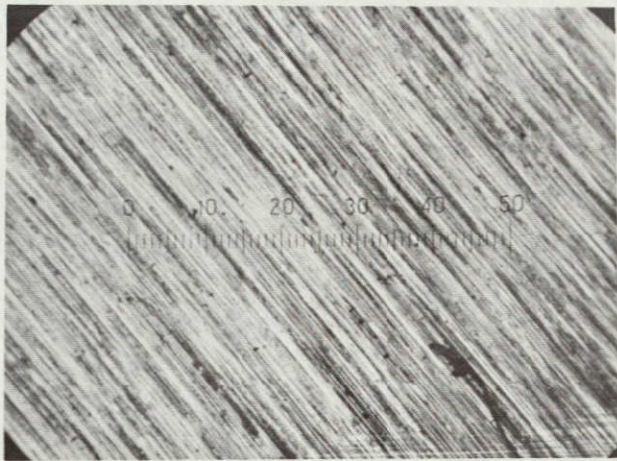
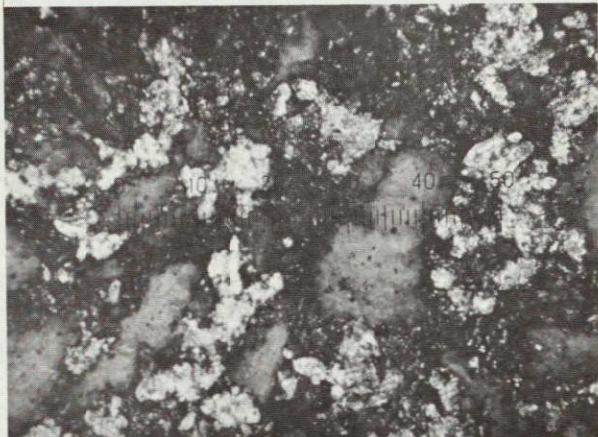
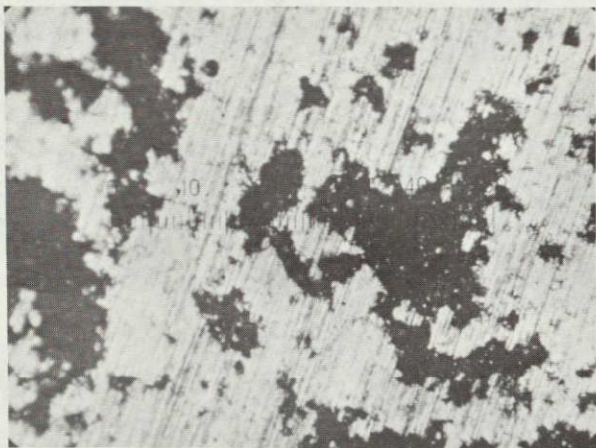
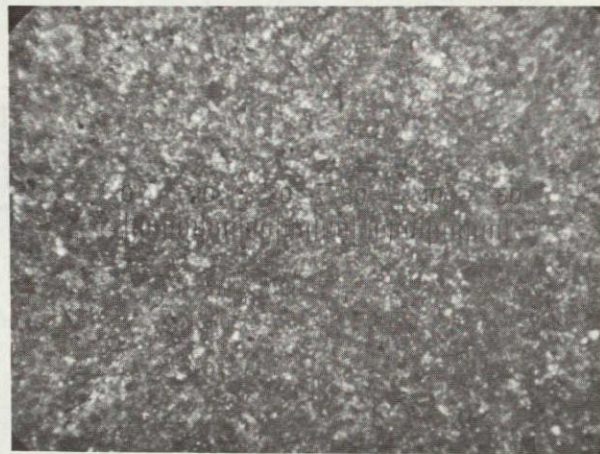
The photomicrographs in Figure 16 illustrate the surface conditions of the steel and four lining materials before the evaluation test.

Figure 16 Typical Photomicrographs (50 X) Showing the Surface Conditions of the Steel and Four Lining Materials before the Testing

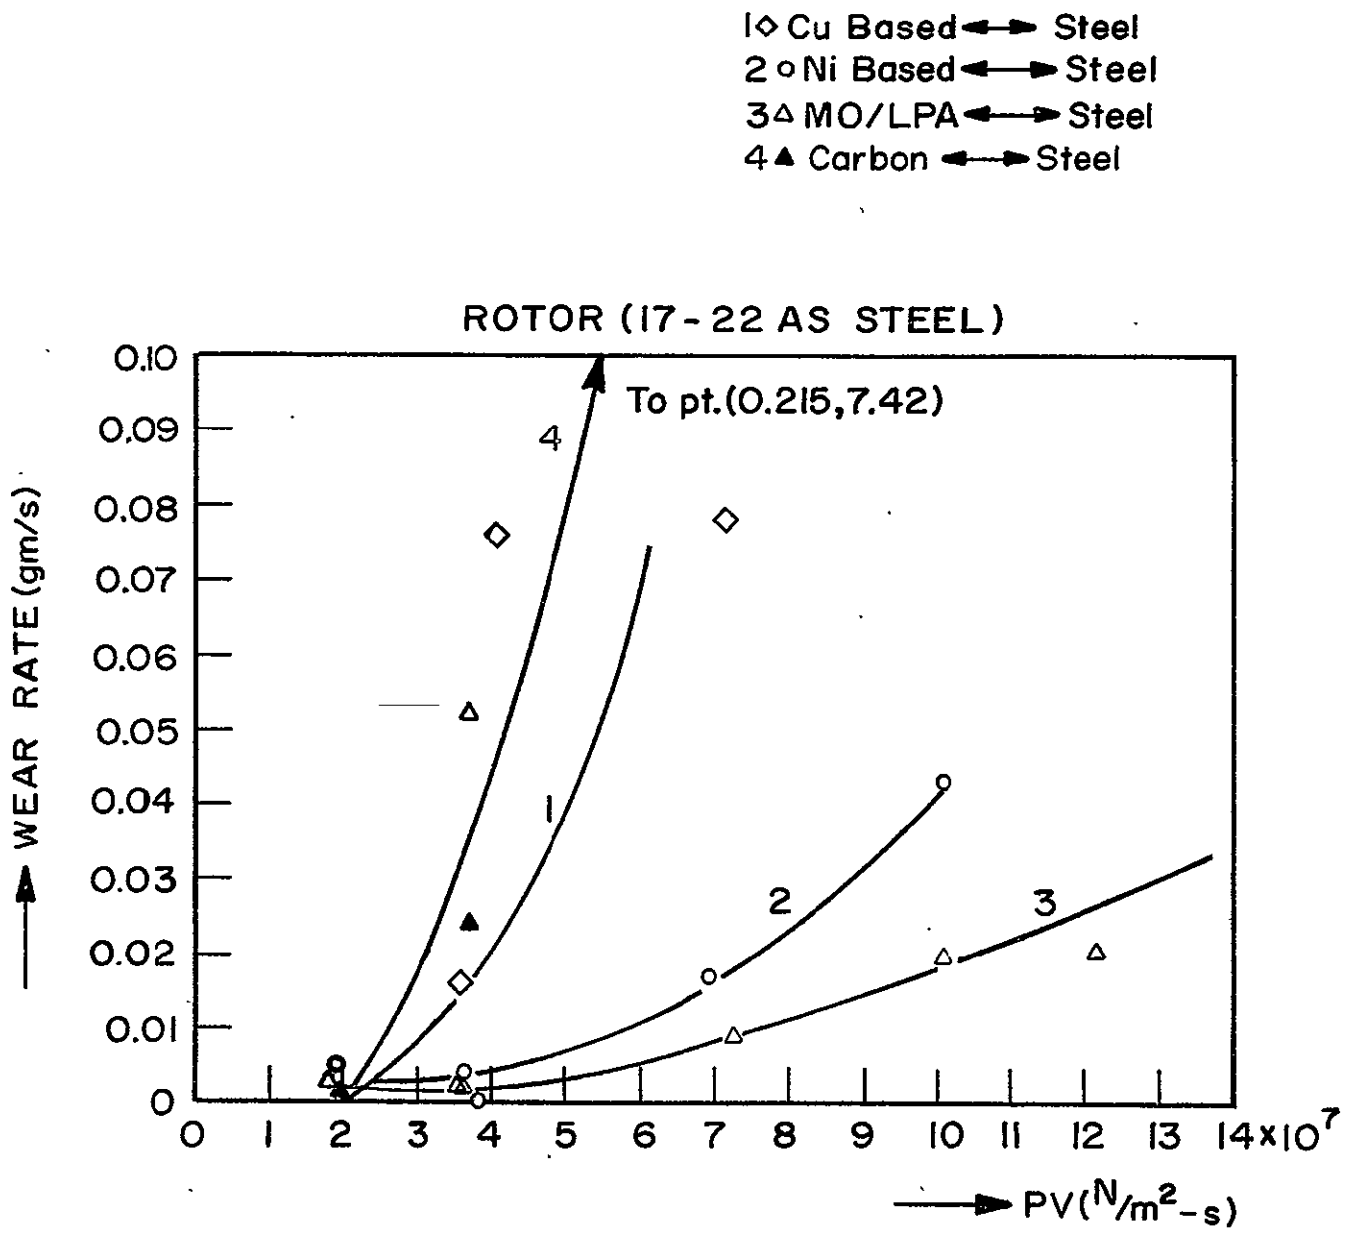
Figure 20 The Effect of PV Factor on the Wear Rate of Steel Disk

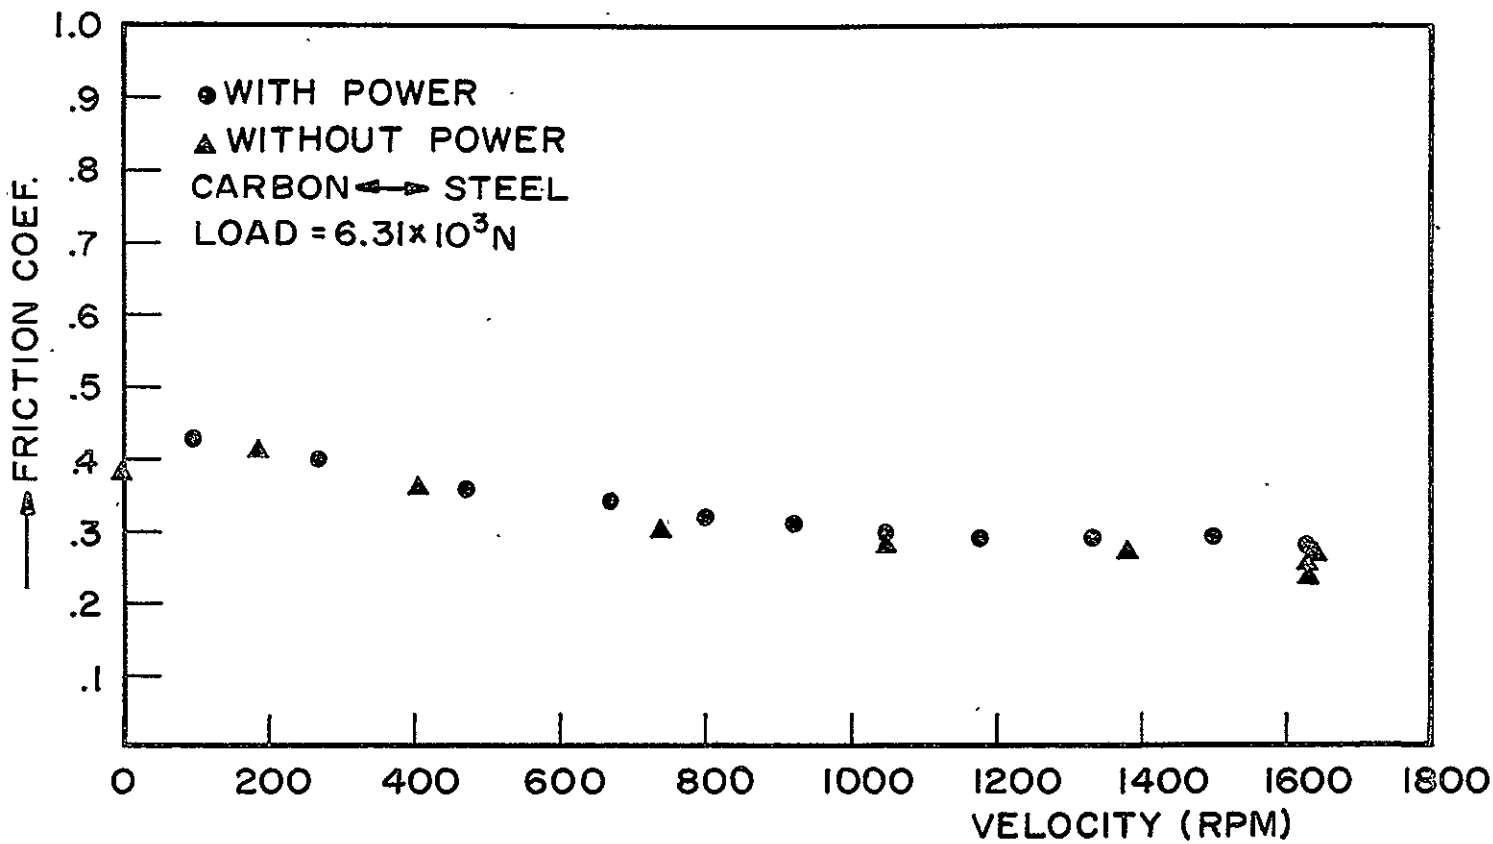
Figure 25 The Effect of Velocity on the Friction Behavior of the Carbon Material

The friction of carbon against steel stays relatively constant around 0.3 for both loading conditions ( $3.24$  or  $6.31 \times 10^3$  N) in the speed range over 800 rpm (Figure 25). It increases when the speed is reduced from 800 rpm to around 200 rpm. Finally the friction drops when the speed is near zero value.

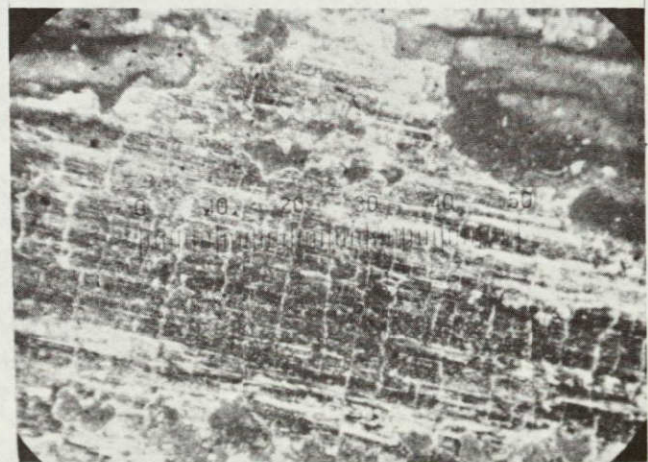
Figure 29 Typical Photomicrographs (50 X) Showing Both Rubbed Surface Conditions in Three Zones of Different Radii for the Nickel-Based Material and Steel Disk after all Evaluation Tests

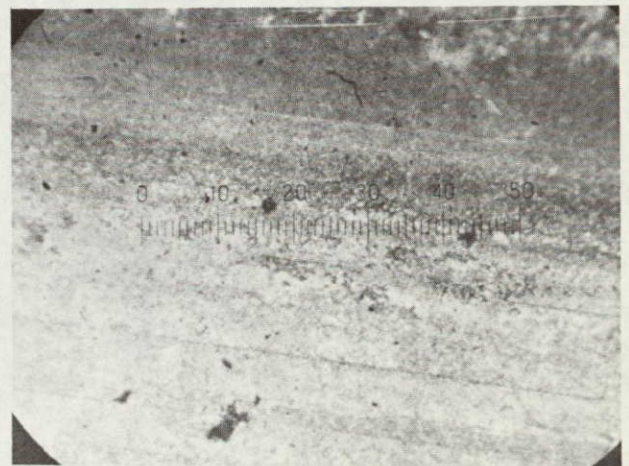
In Figure 31 there are six typical photomicrographs ( $50 \times$ ) showing a comparison between both rubbed surface conditions in three different slide zones for Mo/LPA 100 and steel disk after all evaluation tests. Only light contact occurred as shown in the outer radius portion. There is no damage on the lining material. On the steel disk the rubbing tracks indicated that the sliding between steel cups and steel disk dominated in this zone. However, the isolated surface films were built up in the middle radius portion with lots of worn areas in between; serious oxidation was found. In the inner radius portion the steel transfer dominated. It is felt that both surfaces are covered with similar structures of the same material which was heavily oxidized at high temperatures. Though the lining material did get worn off in the middle radius zone, the steel transfer was so severe that the total weight of stators increased through the braking under extremely high energy conditions.

Figure 31 Typical Photomicrographs (50 ×) Showing Both Rubbed Surface Conditions in Three Zones of Different Radii for the Mo-Based Material and the Steel Disk after all Evaluation Tests

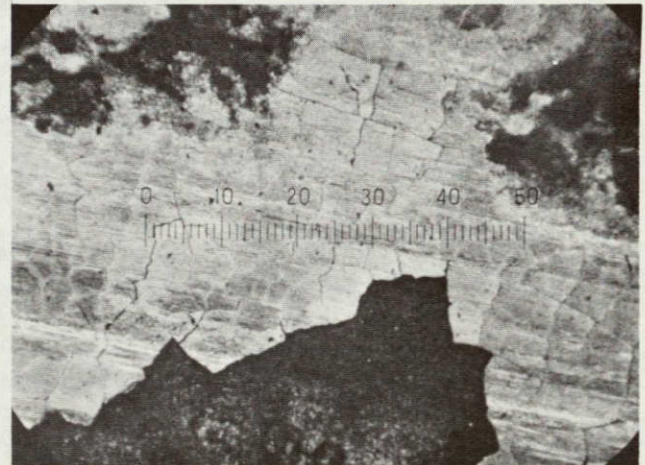
Figure 33 Typical Photomicrographs (50 X) Showing Both Rubbed Surface Conditions in Three Zones of Different Radii for the Carbon Material and the Steel Disk after all Evaluation Tests
