SDSU-RSI-75-11

AERIAL THERMAL SCANNER DATA FOR MONITORING ROOFTOP TEMPERATURES

Remote Sensing Institute
South Dakota State University
Brookings, South Dakota 57006

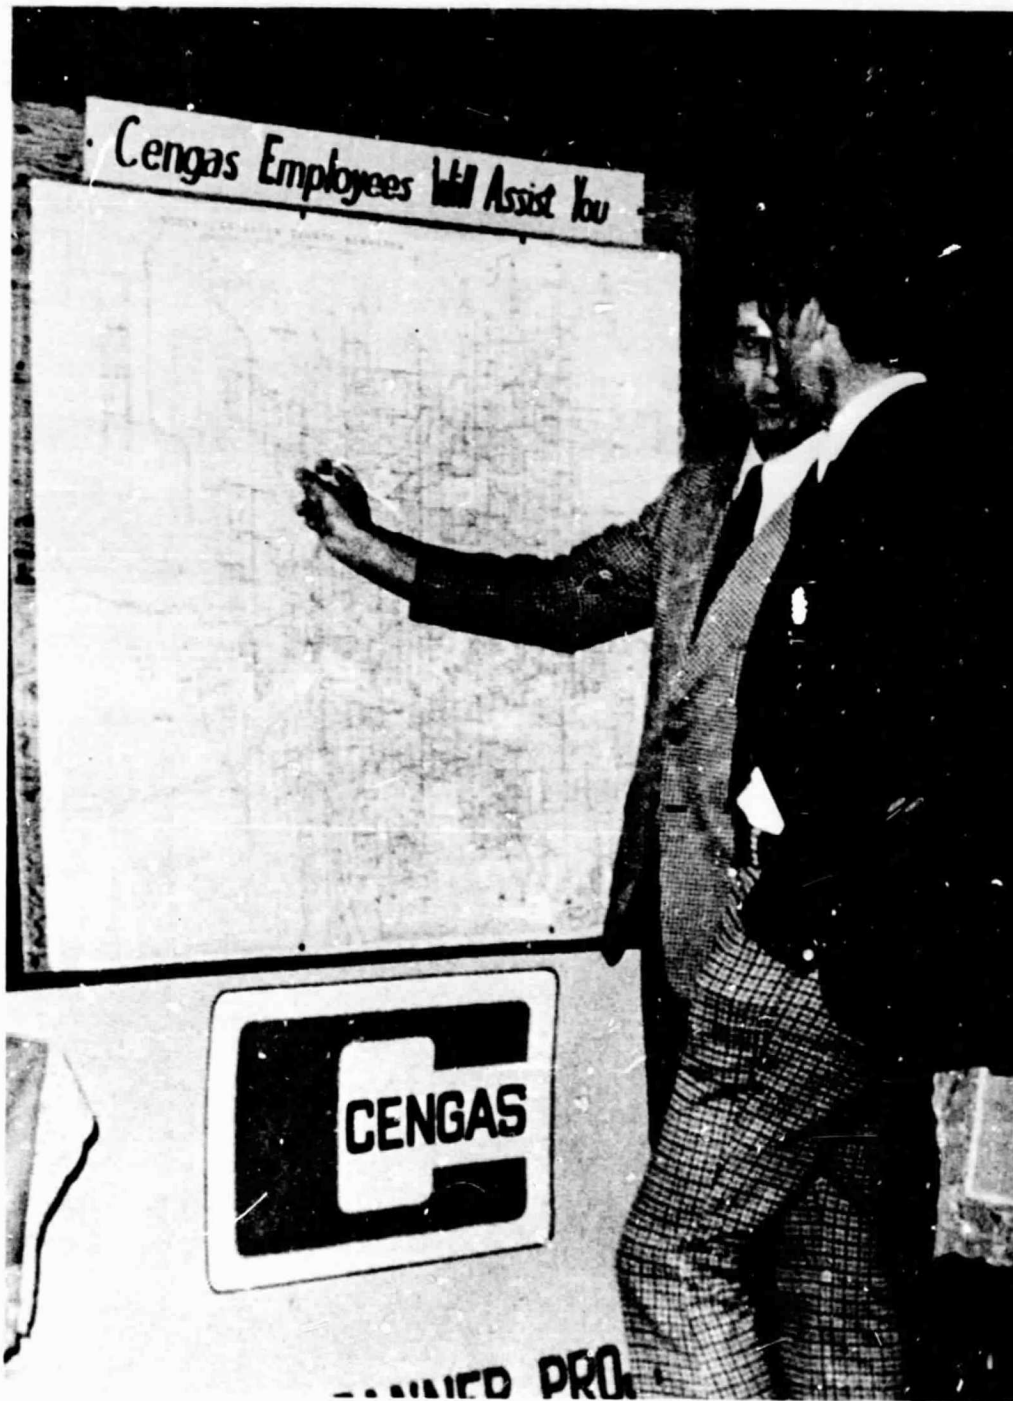
Figure 3. Location map used by CENGAS interpreters to locate thermogram print of customer building.

Thermal scanner data were recorded on magnetic tape and laboratory processed to a 70mm continuous film base format. Laboratory analysis, including level slicing of data, produced optimum contrast in gray levels for a majority of the residential roofs. The film data prepared by RSI were printed for CENGAS by the University of Nebraska Remote Sensing Center on black and white photographic paper. The CENGAS division offices catalogued the prints as to flight line number and the flight maps were used for rapid accession to the proper thermogram print.
