NASA TM X- 62,486

**MECHANICAL TEST IN-SITU FRACTURE DEVICE FOR
AUGER ELECTRON SPECTROSCOPY**

R. Dale Moorhead

**Ames Research Center
Moffett Field, Calif. 94035**

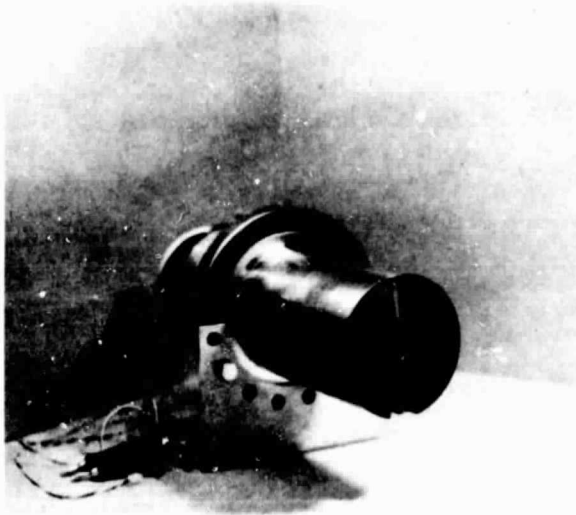
Figure 1.— (a) Fracture device partially disassembled. The large cylinder is the load frame. The extra (unattached) clevis with the pin is used for the DCB type of specimen. (b) Fully assembled with a DCB specimen in the loaded position. (c) General view of Auger spectrometer with fracture attachment installed.

This finally took the shape of a cylinder which is seen detached and sitting upright in Fig. 1(a). The cylinder is machined from high-grade steel and is bored to a size just large enough to permit it to slip over the bellows sleeve of the vacuum assembly and come to rest against the inside surface of the vacuum flange, as shown in Fig. 1(b). Slots and openings machined into the closed end of the cylinder at various locations and directions are for loading and alignment of the specimen. The specimen is gripped by dowel pins pressed into holes in the specimen ends. Figure 2 is a cutaway view of the apparatus as it appears with a tensile specimen in the loaded position. The free end of the specimen is fed into the apparatus through the horizontal and vertical slots in the bottom half of the load-frame cylinder and springs up to be caught by the yoke attached to the bellows and screw. For DCB specimens, the yoke shown attached in Figs. 1(a) and 2 is replaced by a clevis type with a fixed pin shown unattached in Fig. 1(a). The DCB specimen is manipulated into the assembly in such a way that the "hook" side of the specimen is caught by the clevis pin. A DCB is shown in the loaded position in Fig. 1(b).
