HYDROGEOLOGICAL INVESTIGATIONS IN THE PAMPA OF ARGENTINA

Dr. Dieter BANNERT

Bundesanstalt für Bodenforschung (Federal Geological Survey)

November 1974

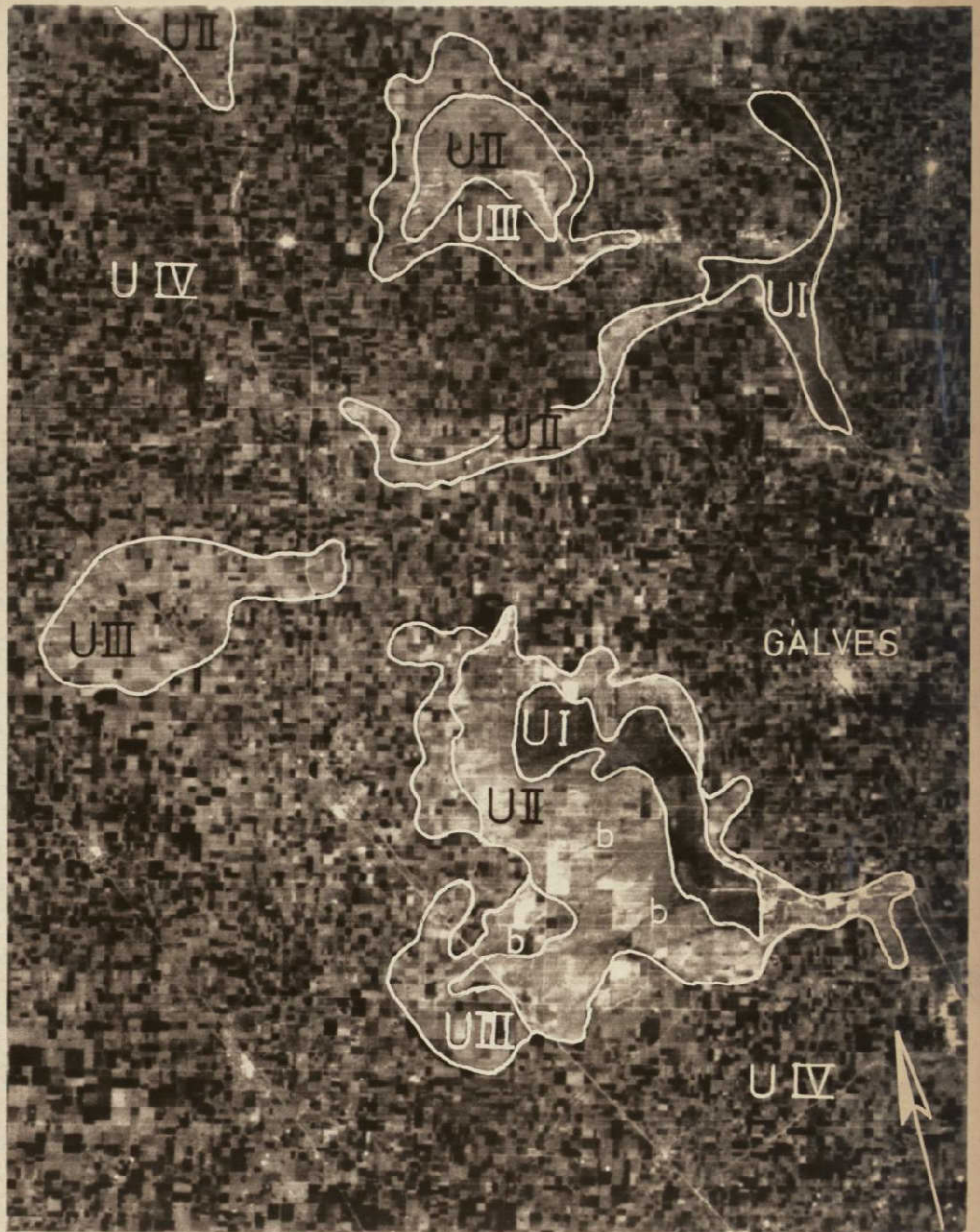
Fig.: 2

Areas of differing ground water salinity 75km SW of Santa Fé

UI - UIV show different salinity of ground water
b = Bajos

Unit I (UI)

Image indication: Very dark areas caused by high soil moisture, sparsely cultivated; e.g.: Borders of the Rio Paraná affluents and lowlands in the North of lagoon Mar Chiquita. (See also: Terraces of the Rio Paraná, LT and UT, in Fig. 5.)

Hydrogeological conditions: Depth to ground water less than 0,5 m; high ground water salinity.

Image indication: Light areas with indistinct field pattern, e.g.: Surroundings of Rio Paraná affluents.

Hydrogeological conditions: Depth to ground water up to about 5 m; high ground water salinity.

Image indication: Light areas with distinct field pattern.

Hydrogeological conditions: Depth to ground water up to about 10 m, medium salinity of ground water.

Image Indication: Dark areas with distinct field pattern.

Depth to ground water more than 10 m. Medium to low
salinity of ground water.

Regions with different grey tones on the imagery represent different types and density of vegetation. This is closely related to the depth to ground water. Generally, ground water mineralisation and the salt content in the soil, increases due to the influence of evapotranspiration with decreasing depth to ground water. High ground water salinity and soil salinity lead to unfavourable growth conditions for plants with high chlorophyll content. These regions appear dark in channel 7 and light in channel 5 (fig. 2).

The identification of different units was carried out using channel 5 images which provided the best contrast for this type of interpretation (fig. 2).

Because of similar phenology, irrigated farmland (fig. 6, unit A₁) cannot be distinguished from non irrigated farmland of UIV (fig. 2).

"Bajo" is an Argentinian term to describe elongated flat depressions with little or no surface drainage. In space imagery they appear as sharply defined strips (b in fig. 2). They run more or less straight in an ENE-WSW direction, are between 100 and 200 m wide and are spaced at relatively even distances of approximately 2 km apart.

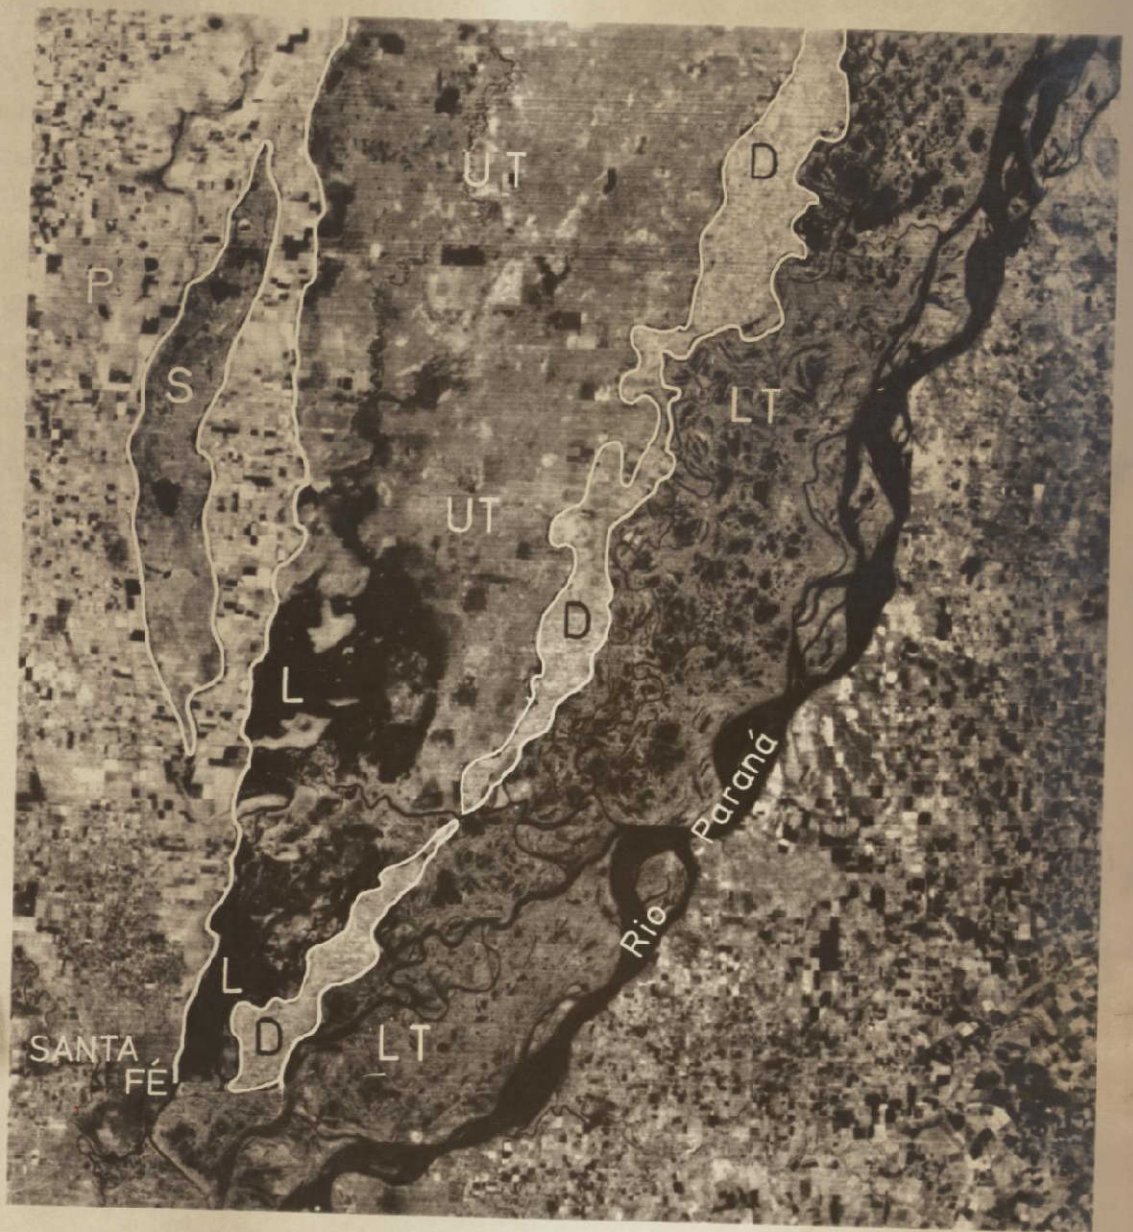
Fig.: 5

Rio Paraná, NE of Santa Fé

- LT Lower Terrace
- UT Upper Terrace
- D Dunes (Upper Terrace)
- S Swamp
- P Pampa Plain
- L Lagoon

On the Eastern edge of the mainly dark colored upper terrace of the Rio Paraná is situated a sand dune field that appears as a white stripe in the imagery (fig. 5).

The depth to ground water in the terrace bed extends to about 1 m, in the sand dunes up to 5 m. The salt content of the ground water differs considerably. In the sand dunes, ground water with a salt content of about 0.3 g/l was found, whereas in the remaining terrace area the salt content exceeds in some cases 6 g/l.

The East of the imaged area is dominated by the Rio Paraná and its terraces. The upper and lower terrace can be distinctly delineated (fig. 5, UT and LT). The lower terrace appears darker than the upper terrace due to a more intense soil moisture. The terraces are partly covered by open waters and meandering streams. Dark grey patches on the image stretching from North to South, to the West of the upper terrace, could be identified as swamp (S in fig. 5). Probably they represent the location of another older terrace.

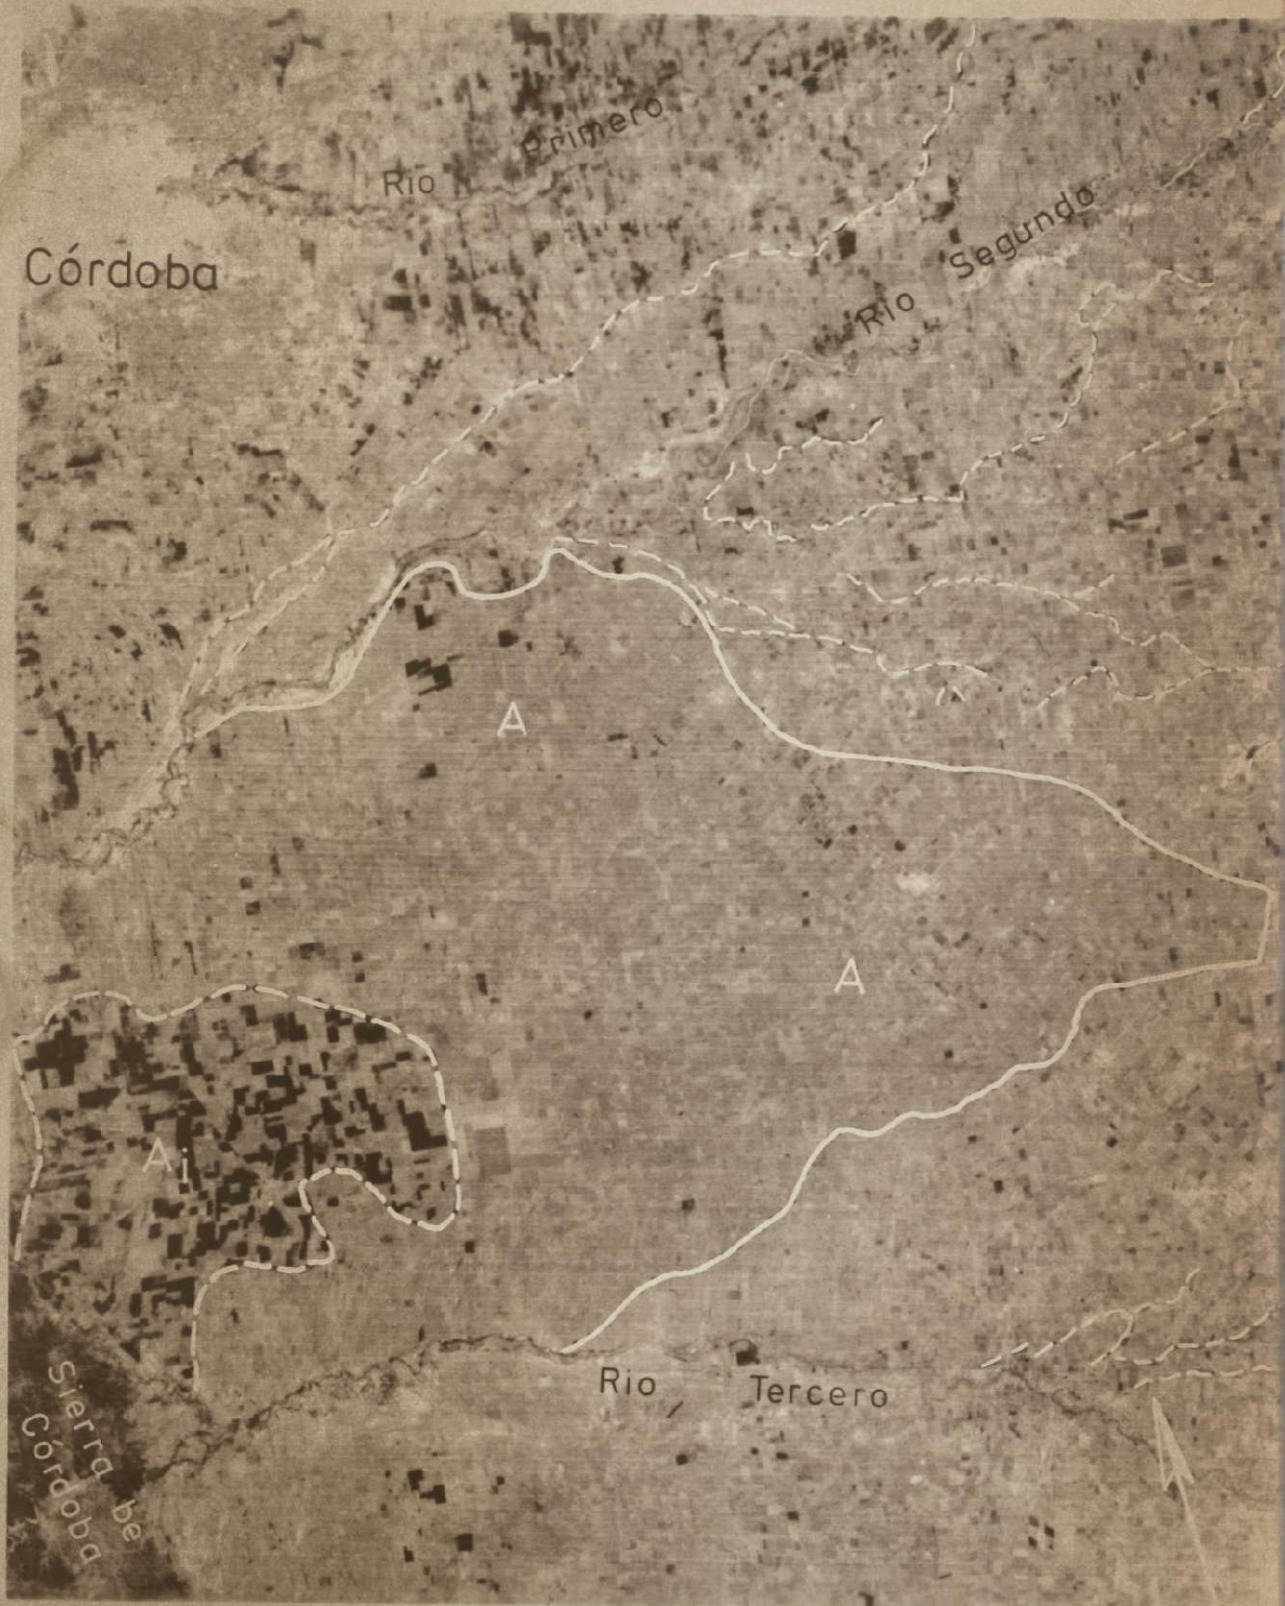
Fig.: 6

Region SE of Córdoba

ERTS-1, 1040-13 332-5

Old River Beds
- A Region without drainage pattern
- Ai Irrigated part of region A

At the moment of imaging both the Rio Primero and the Rio Segundo contained water but only in their upper courses. On the other hand the Rio Tercero contained water throughout its length as shown in the imaged scene of fig. 6. In channel 7 the water filled sections appear dark grey whereas the dry lower courses appear light grey (fig. 6). The sides of the rivers show dry beds of ancient rivers appearing as light grey stripes.
