NASA TM X-3252

**THE EFFECTS OF ENVIRONMENTAL EXPOSURE
ON REUSABLE SURFACE INSULATION
FOR SPACE SHUTTLE**

Philip O. Ransone

J. D. Morrison

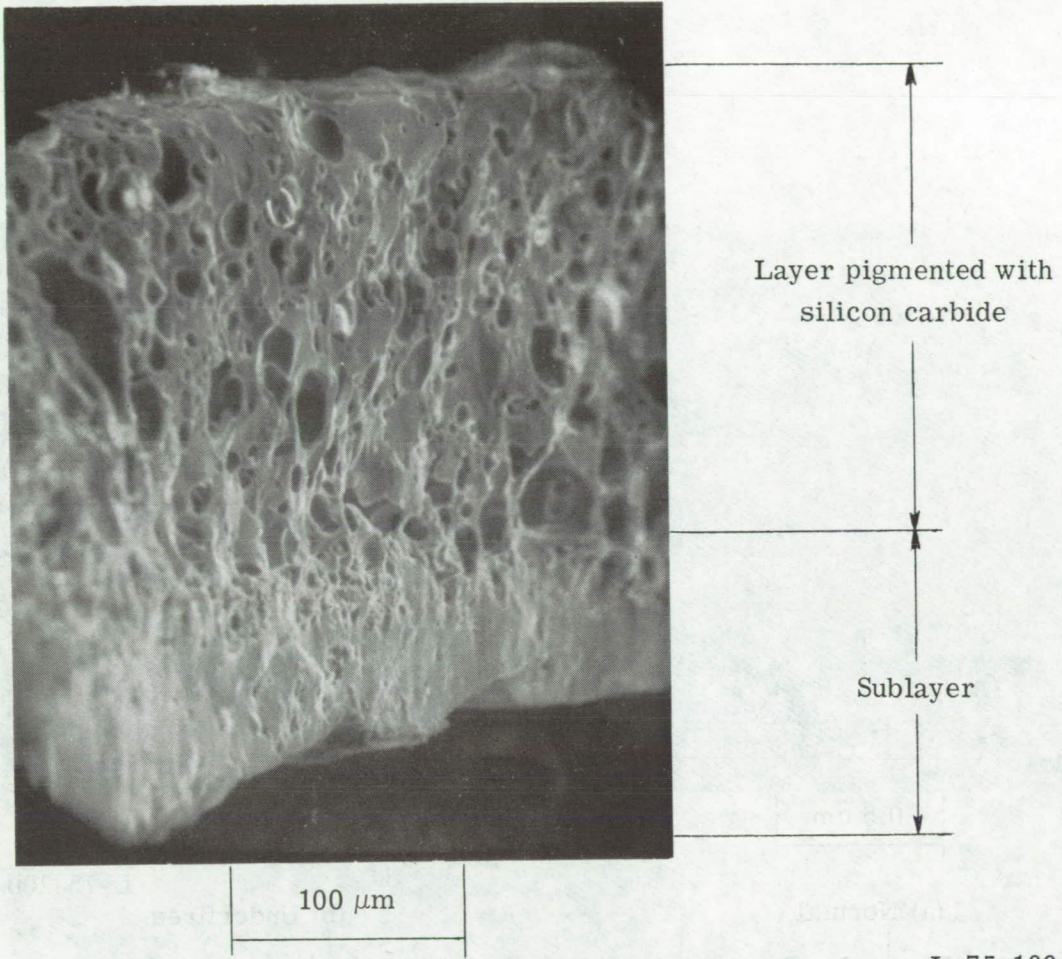
L-75-199

Figure 1.- Fractograph of LI-0042 coating.

The material tested in this investigation was silica RSI LI-0942, supplied by Lockheed Missiles and Space Company. LI-0942 consists of LI-0900 silica tiles with a LI-0042 coating. The coating is a silicate glass formulation containing a silicon carbide emittance pigment in the outer layer. The thickness of the coating is nominally 0.4 mm. The pigmented layer has a significant bubble structure, reportedly resulting from evolution of gases from oxidation of the silicon carbide during the initial firing process. A cross section of the coating is shown in figure 1.

The exact eruption mechanism is not known; however, it could involve one or more of the following possibilities. The outer layer of the LI-0042 coating is very porous as shown in the coating cross section of figure 1. There could be sudden steam pressure generated from water entrapped in the pores of the coating. The resulting localized pressure could conceivably blow out coating fragments during portions of the temperature cycle when the temperature of the coating is lower than its softening point. The coating was apparently too refractory because in some cases it appeared to be underfired. In fact, coating fragments were expelled from the surfaces with considerable force only during the early or late stages of temperature cycles when temperatures were low. A significant number of eruption failures did not extend through the sublayer of the coating. This is a good indication that the origin of failure was in the coating and cannot be associated with steam pressure originating in the insulation beneath.

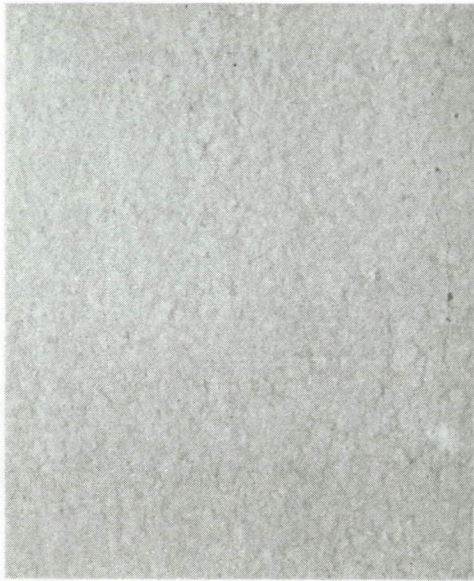
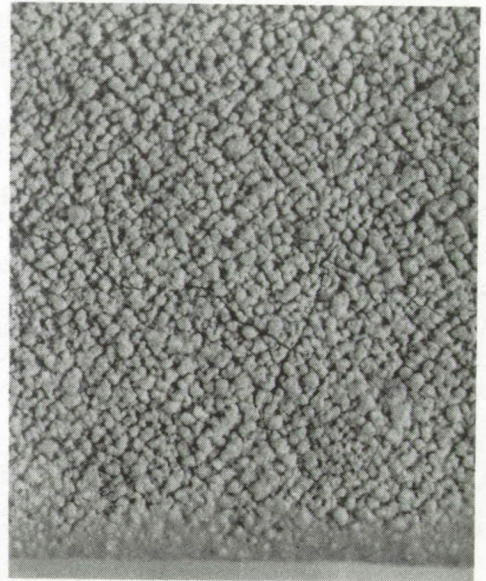
L-75-200

(a) Normal.

(b) Underfired.

Figure 2.- Comparison of a normal coating surface and an underfired coating surface.

Coated surfaces on some of the furnished tiles appeared to be underfired in that they were not well glazed. An example of these surfaces is shown in figure 2 with the surface in figure 2(a) considered normal and the surface in figure 2(b) showing little evidence of

having melted and flowed. The underfired coatings were observed only on the smaller of the two tile sizes supplied.

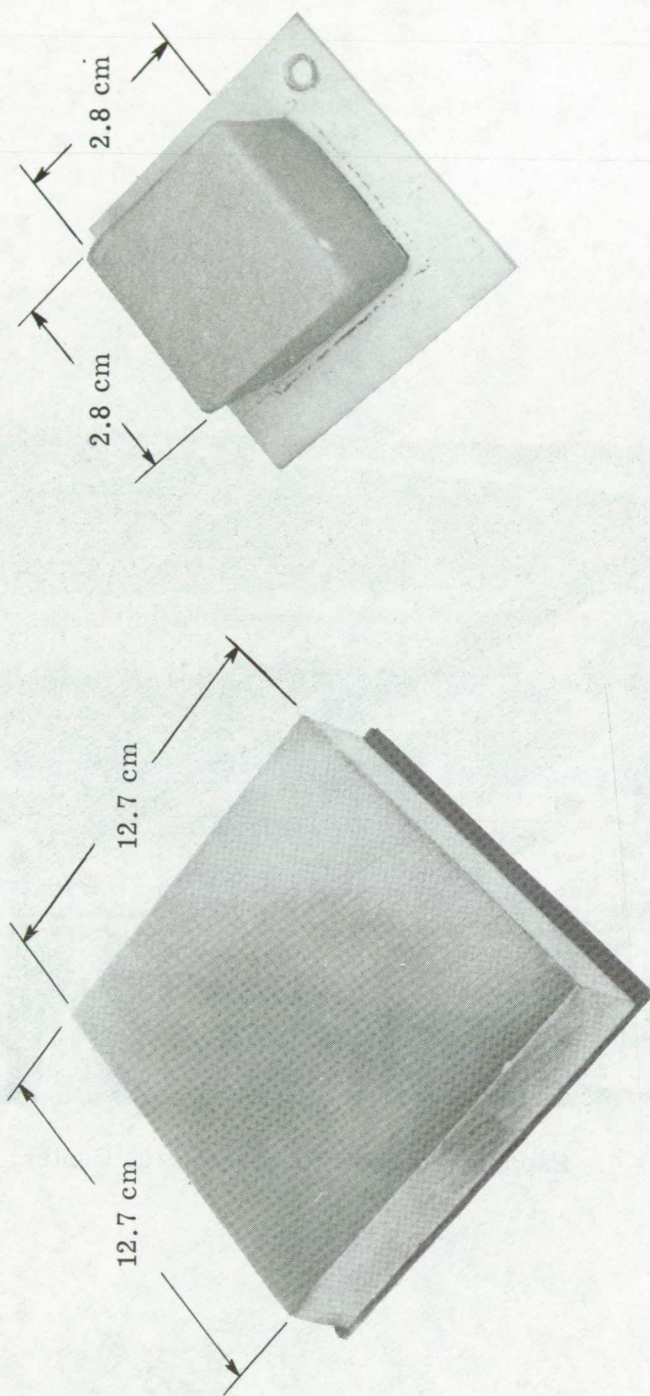
L-75-201

Figure 3.- Specimen configuration.

Two sizes of specimens with coating on five sides (fig. 3) were tested. The nominal dimensions of the specimens were 2.8 by 2.8 by 2.5 cm and 12.7 by 12.7 by 2.5 cm. A silicone adhesive was used to bond the small specimens to aluminum mounting pads and the large specimens to bakelite pads. Two of the small specimens were instrumented with Pt/Pt-0.13Rh thermocouples for use as temperature control samples in the radiant heating tests. The large specimens were not instrumented.

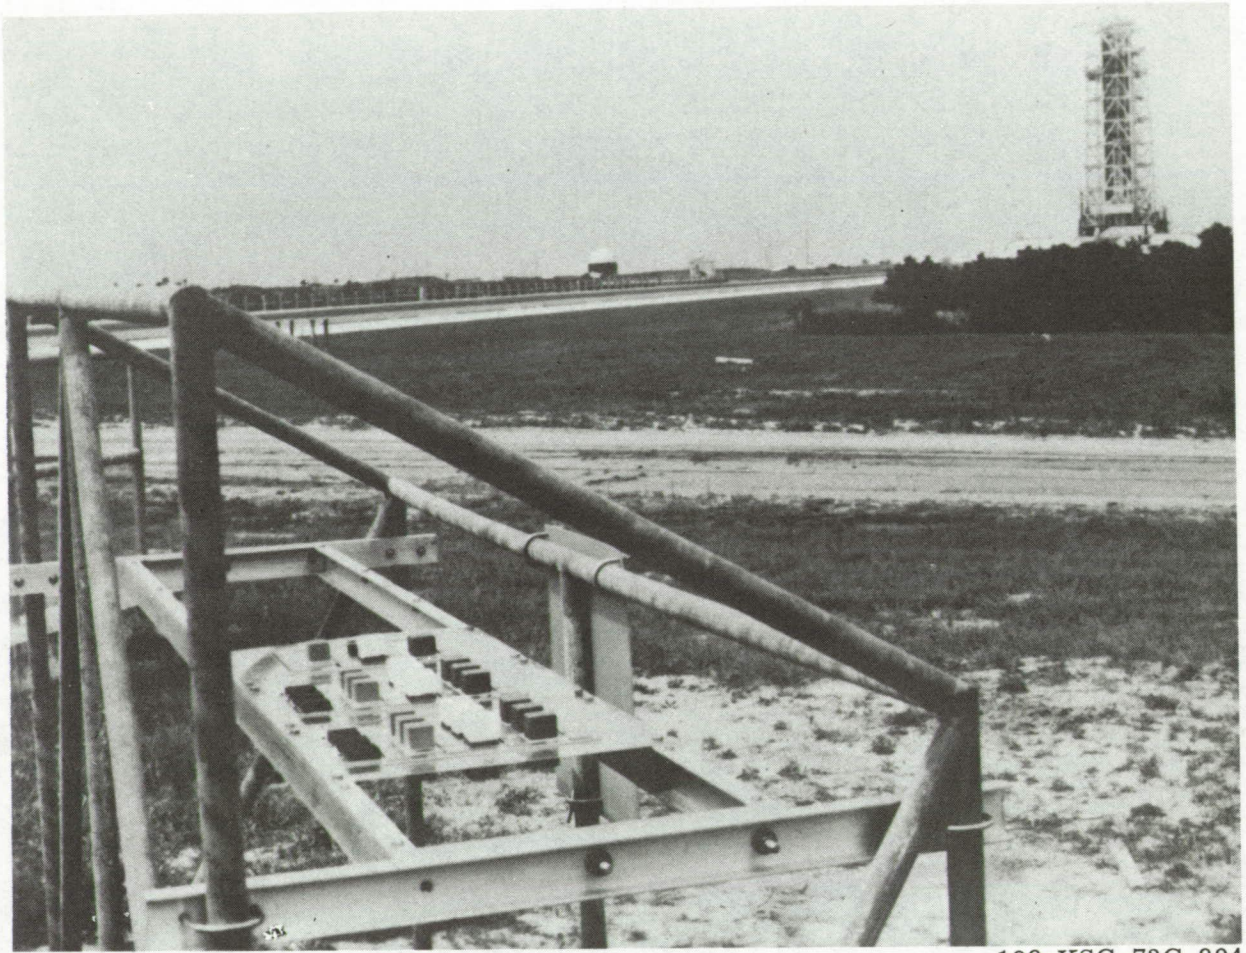
108-KSC-73C-894

Figure 4.- Exposure rack at Kennedy Space Center.

Atmospheric exposures.- Twenty small specimens were attached to four aluminum holder plates with an equal number of specimens on each side of each plate. The plates were horizontally affixed to the exposure rack so that half the specimens would be shielded from rain and settling dust. Figure 4 shows the exposure rack with some of the specimens in place. The LI-0942 specimens are in the second row from the left. The other specimens shown are of other materials which were also being evaluated after KSC exposures, but which are of no current interest and are not considered in this report. Launch Complex 39B is seen in the background to the north. Specimens were arranged in 1-, 2-, and 4-week exposure groups on separate plates to facilitate handling. Specimen identification and exposure details for the LI-0942 specimens only are shown in table I.

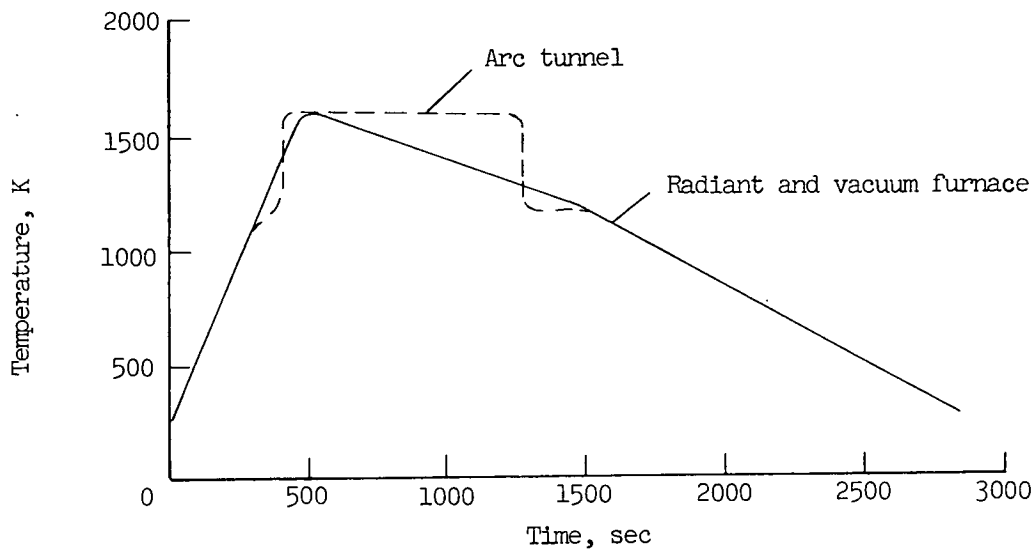
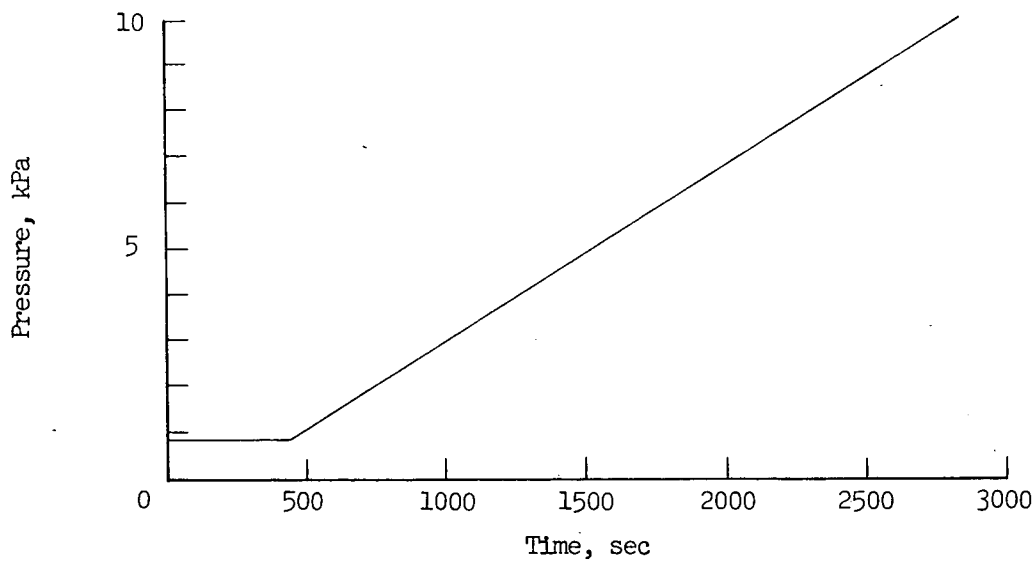
(a) Temperature profile.

(b) Pressure profile (for vacuum furnace test only).

Figure 5.- Surface temperature and pressure profiles for a space shuttle reentry simulation.

These specimens are listed in table II with other laboratory test specimens. Figure 5 presents surface temperature and pressure profiles for a space shuttle reentry simulation. The radiant heat cycle used resulted in the surface temperature profile shown by the solid line in figure 5(a). This profile is representative of the temperature history during reentry for the space shuttle lower wing and fuselage surfaces.

Heating tests.- The artificially contaminated specimens and an equal number of clean specimens were exposed to 12 consecutive cycles of the temperature profile shown in figure 5(a) by using the three heating methods described. The small specimens were exposed to radiant and vacuum furnace heating cycles while the large specimens were heated in an arc tunnel. Specimens and exposure details are listed in table II.

For the vacuum furnace test, a vertical muffle-tube furnace depicted by the sketch in figure 8 was used. This apparatus was designed so that the temperature profile of figure 5(a) could be closely approximated by manually moving the specimen into and out of the furnace hot zone at a predetermined rate. At the same time, the pressure could be manually controlled to approximate the reentry pressure profile shown in figure 5(b). This was done by evacuating the muffle tube and then bleeding in air against the vacuum system at a preselected rate.

The holder could be positioned in the stream or off to the side by remote control. The tunnel conditions (table III) required to obtain the maximum surface temperature of figure 5(a) were established with the specimen out of the stream. While out of the stream, the specimen was preheated to 1273 K by use of an auxiliary radiant heater which was programmed to follow the temperature rise rate specified by figure 5(a). A calibration specimen placed near the test specimen and instrumented with a thermocouple was used to control the radiant heater. When a surface temperature reached 1273 K, the specimen was moved into the arc-jet stream. While in the stream, the specimen surface temperature was monitored with a radiation pyrometer which senses radiation in the range 2.0 to 2.6 μm . An emittance value of 0.65 was used to compute the temperature. After 800 seconds in the stream, the specimen was removed and allowed to cool according to the temperature profile of figure 5(a) by using the radiant heater to maintain the cooling rate. The deviation from the desired temperature profile for a given cycle is indicated by the dash-line curve in figure 5(a).

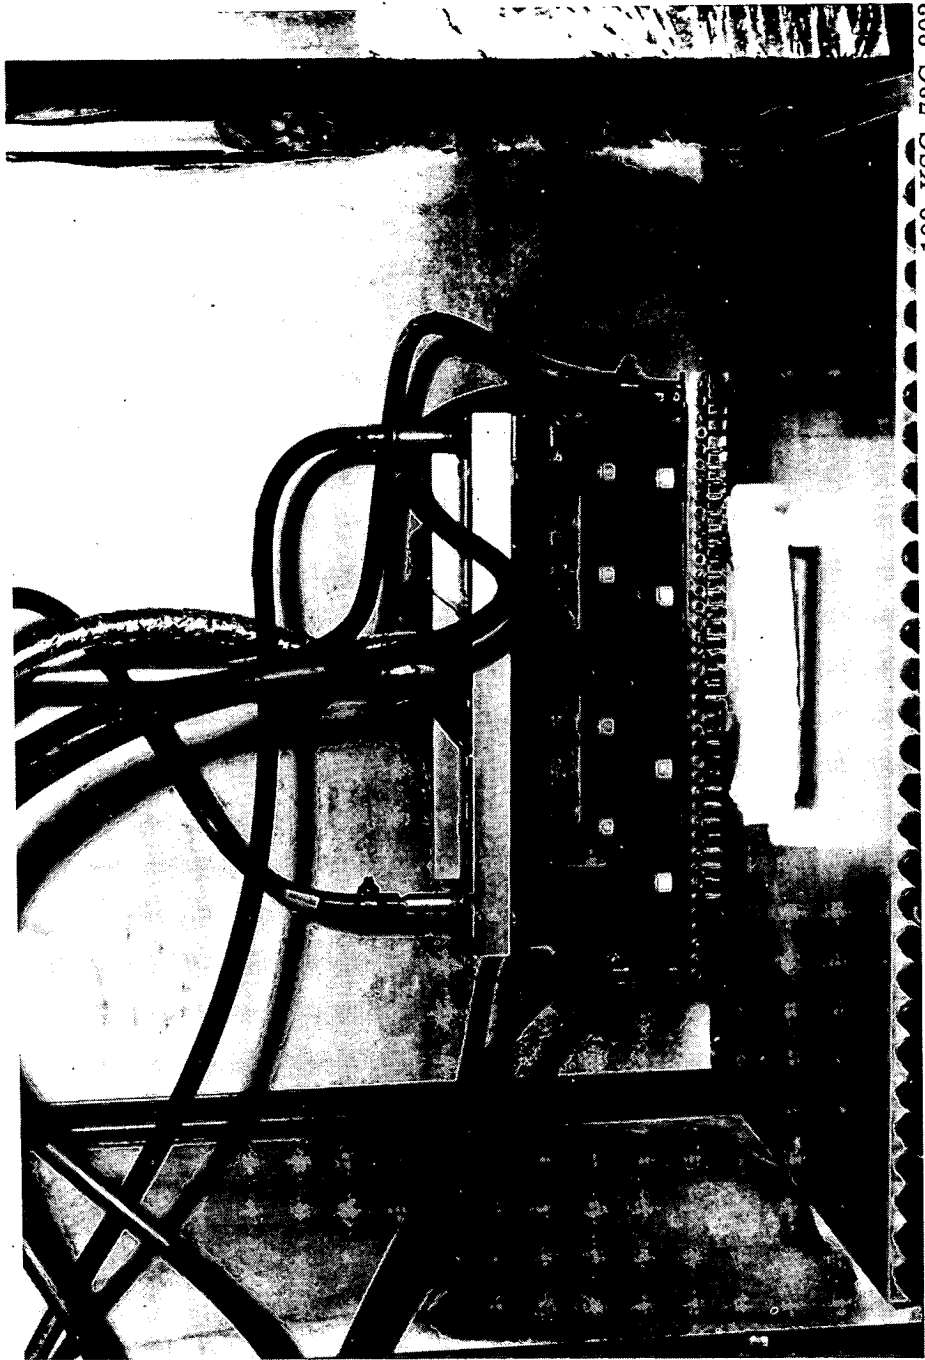
108-KSC-73C-892

Figure 6.- Radiant heating apparatus used for heating tests on launch-site and laboratory specimens.

The heat source used was a radiant heater consisting of a 25- by 38-cm array of infrared quartz tube lamps (fig. 6). Up to seven specimens, including a control sample, could be heated simultaneously to a uniform surface temperature. The control sample thermocouple was connected to a feedback control system and programmer to regulate power to the lamps. Specimens were positioned under the lamps on a water-cooled aluminum plate. The RTV bonds between the tiles and pads were shielded from radiation by using a mask made from a commercial alumina-silica insulative felt.

The radiant heating procedure was identical to that previously described for heating specimens after launch-site exposures. An identical heating apparatus was used (fig. 6).

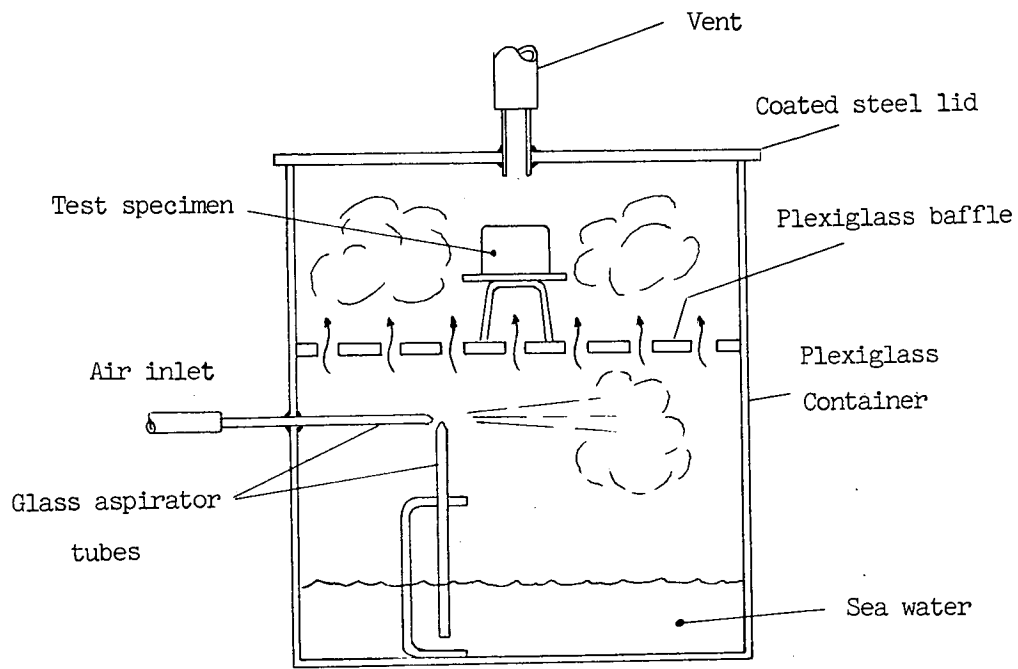
Figure 7.- Salt fog apparatus used to artificially contaminate laboratory specimens.

Artificial contamination.- One large and four small specimens were contaminated with measured amounts of sea salt by means of exposure to a sea-water fog for 1 hour. The fog apparatus used for the exposures is depicted in figure 7. The sea water was taken from the Atlantic Ocean 50 miles off the Virginia Coast. The weight of salt deposited on each specimen was arbitrarily chosen as 0.124 mg/cm^2 . This was found to be the weight of salt deposited per hour on a 2.54- by 2.54-cm glass slide placed in the apparatus with the selected operating conditions.

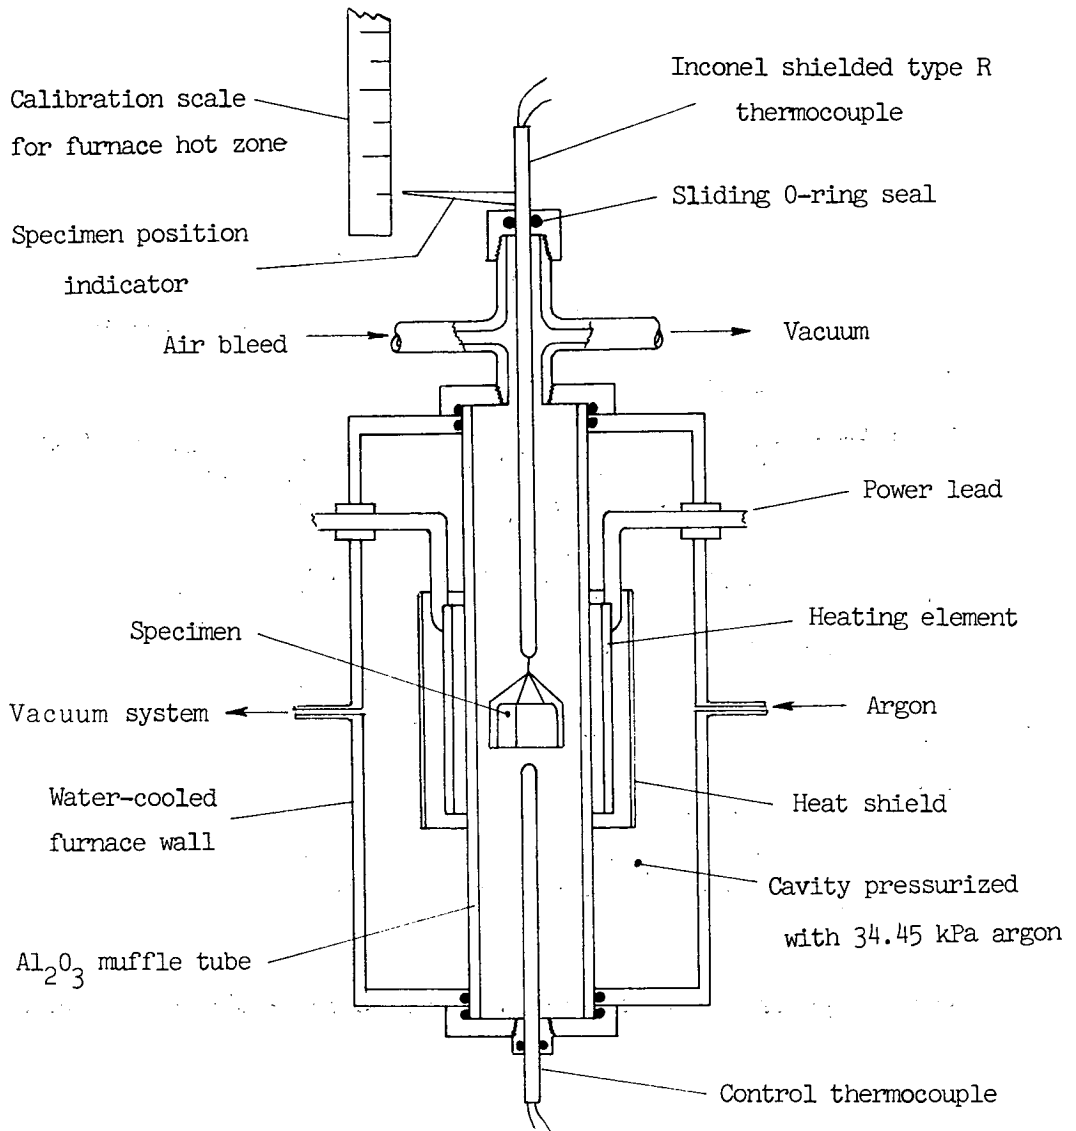
Figure 8.- Vacuum furnace and test setup used for pressure profile heating of laboratory specimens.

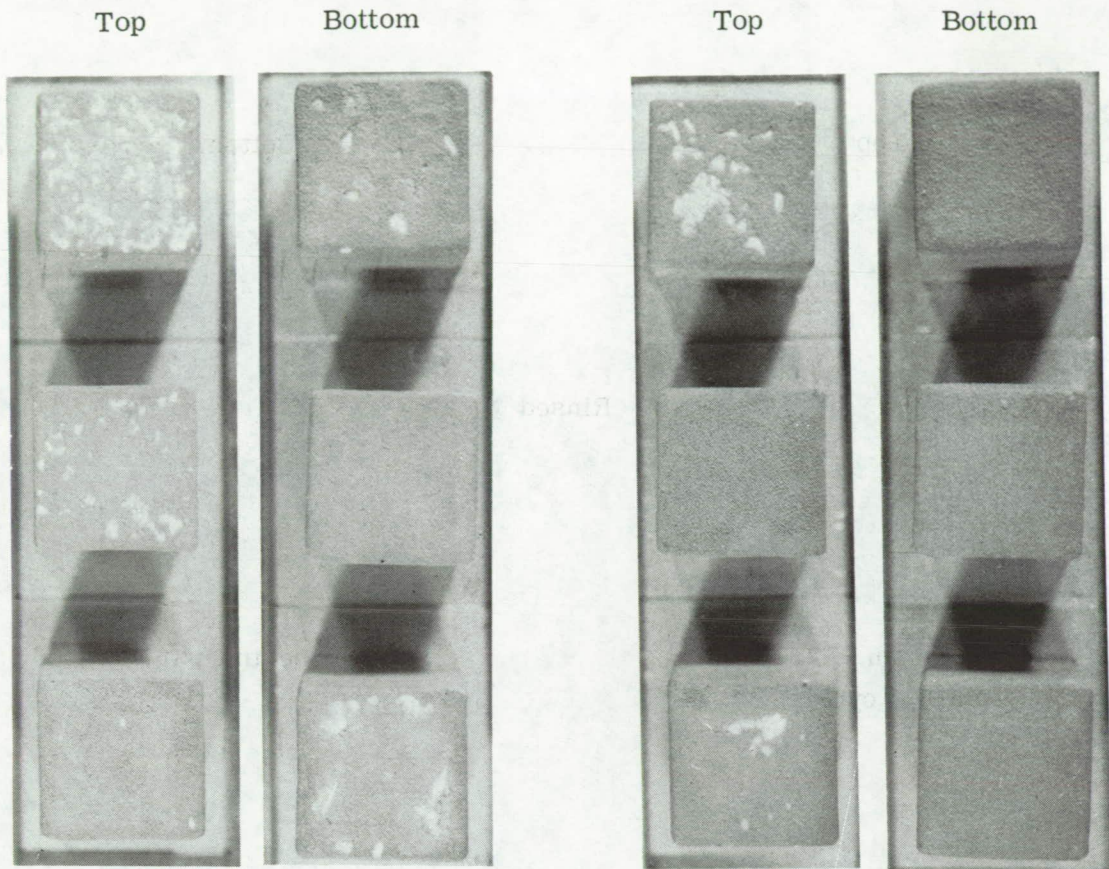
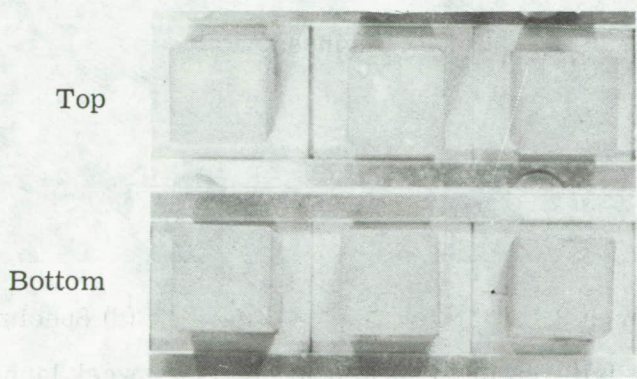
(a) 2-week exposure; rinsed;
5 heating cycles.

(b) 2-week exposure; not rinsed;
5 heating cycles.

(c) 1-week exposure; not rinsed;
10 heating cycles.

L-75-204
Figure 9.- Eruption failures in LI-0042 coating.

Eruption failures. - Eruption failures occurred during the second through fifth temperature cycles and affected at least half of the total number of specimens. About 40 percent of all specimens tested were damaged by eruption to the extent that they had to be retired after five atmospheric exposure and temperature cycles (table I). No significant devitrification was detected in the retired specimens. Figure 9 shows photographs of the 2-week and 1-week specimens after 5 and 10 temperature cycles, respectively. These photographs show that top specimens degraded more than bottom while specimens rinsed with tapwater degraded more than unrinsed specimens. These visual observations and preliminary examination of weight change data suggest that water played an important role in the eruption mechanism.

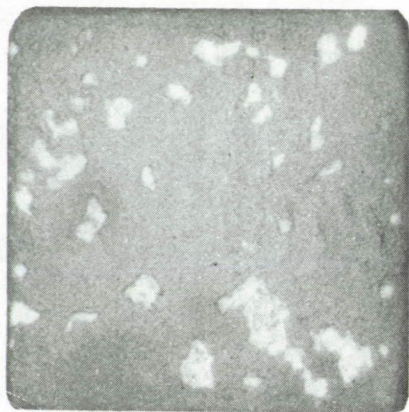
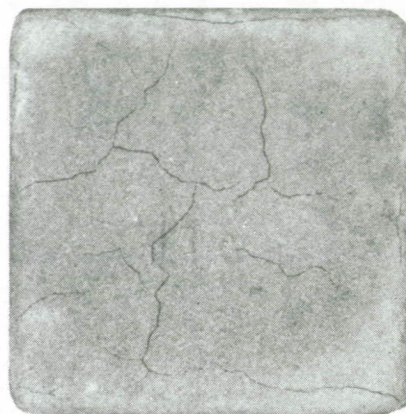
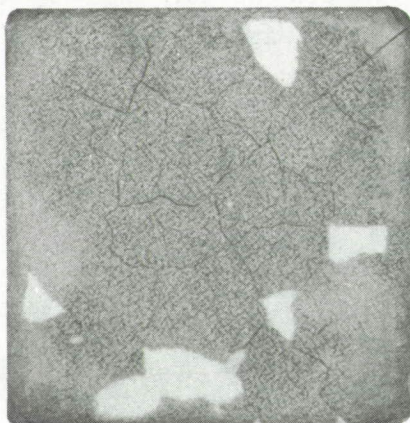
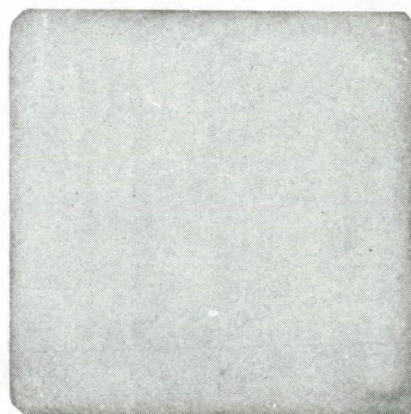
(a) Specimen 15 (retired after 5 cycles).

(c) Specimen 16.

(b) Specimen 9.

(d) Specimen 10.

Figure 10.- Cracking failures in LI-0042 coating. Two-week launch-site exposures; 18 heating cycles (table I). L-75-205

Cracking failures. - Figure 10 shows photographs of three launch-site test specimens after eighteen 2-week exposures and temperature cycles and one specimen after five cycles. Cracks were first visually detected on specimens 9 and 16 after the 15th cycle. Degradation proceeded rapidly during the next three cycles and final results are seen in figure 10. It is assumed that the cracks were not present before the 15th cycle because of the rapid degradation witnessed from the apparent onset of cracking through the 18th cycle. Specimen 10 survived the 18 cycles without cracking and specimen 15 was retired after 5 cycles because of eruption damage.

Devitrification. - The specimens shown in figures 10 and 11 were analyzed for devitrification. The spalled areas on the lower right or 4th quadrant surface of specimen 9 resulted from crumbling of the coating, while other damaged areas resulted from eruption failures that did not extend through the sublayer of coating. The coatings of specimens 9 and 16 were found to be very friable when they were removed from specimens for X-ray diffraction analysis. Analysis revealed that these coatings contained about 85 percent by weight cristobalite which would account for the extreme friability of the coating. (Friability is characteristic of devitrified glass bodies.) Specimen 10 did not show an appreciable amount of cristobalite after 18 cycles. As indicated previously, this was the only specimen of its group which did not crack after 18 cycles and was the only one of its group which was not exposed to water impingement. Specimen 5 which was exposed to water impingement, qualitatively indicated a high cristobalite content (probably 80 to 90 percent).

Slight sagging of the test faces on all specimens shown in figures 10 and 11 was noted. This sagging was not attributed to devitrification of the coatings but rather to shrinkage of the underlying insulation. Sagging was evident on nearly all specimens, clean or contaminated, after 12 to 15 cycles.

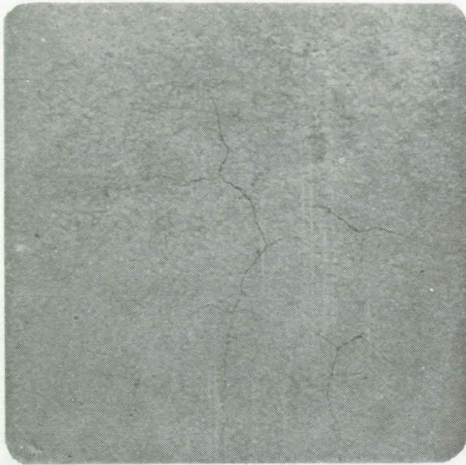
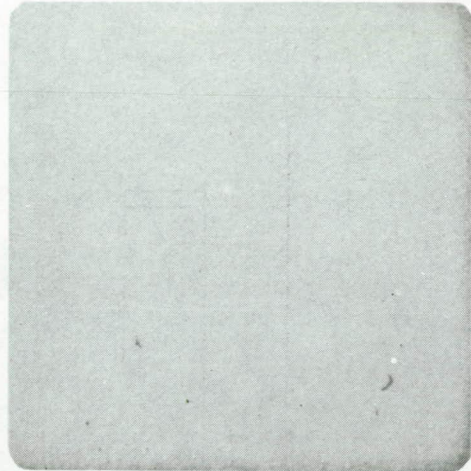
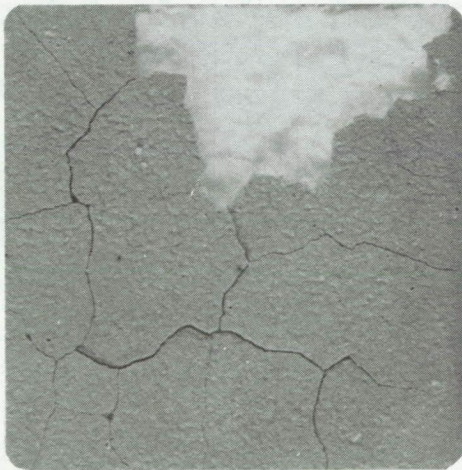
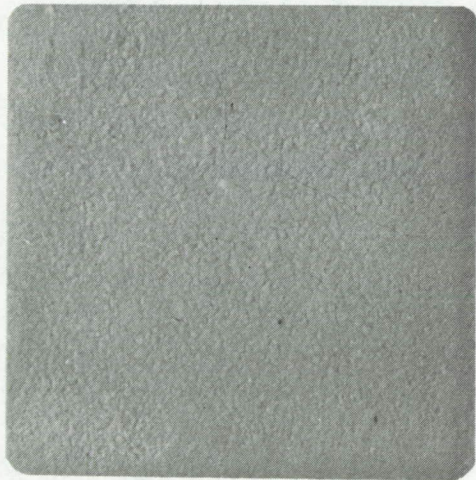
L-75-206

Figure 11.- Cracking failures in LI-0042 coating. One-week launch-site exposures; 38 heating cycles (table I).

Figure 11 shows two launch-site specimens after twenty-nine and thirty-eight 1-week exposures and temperature cycles. Comparison of these specimens with the 2-week exposure group of figure 10 shows that cracking commenced after approximately the same total atmospheric exposure time (30 weeks) even though the 1-week exposure group had experienced about twice as many temperature cycles. Therefore, figures 10 and 11 show that cracking depends on time exposed to environment rather than number of cycles. They also show that specimens exposed to water impingement (i.e., specimens on top side) suffered the most degradation by eruption failure and/or macrocracking.

On the other hand, specimen 6 which was not exposed to water impingement, qualitatively indicated much less cristobalite.

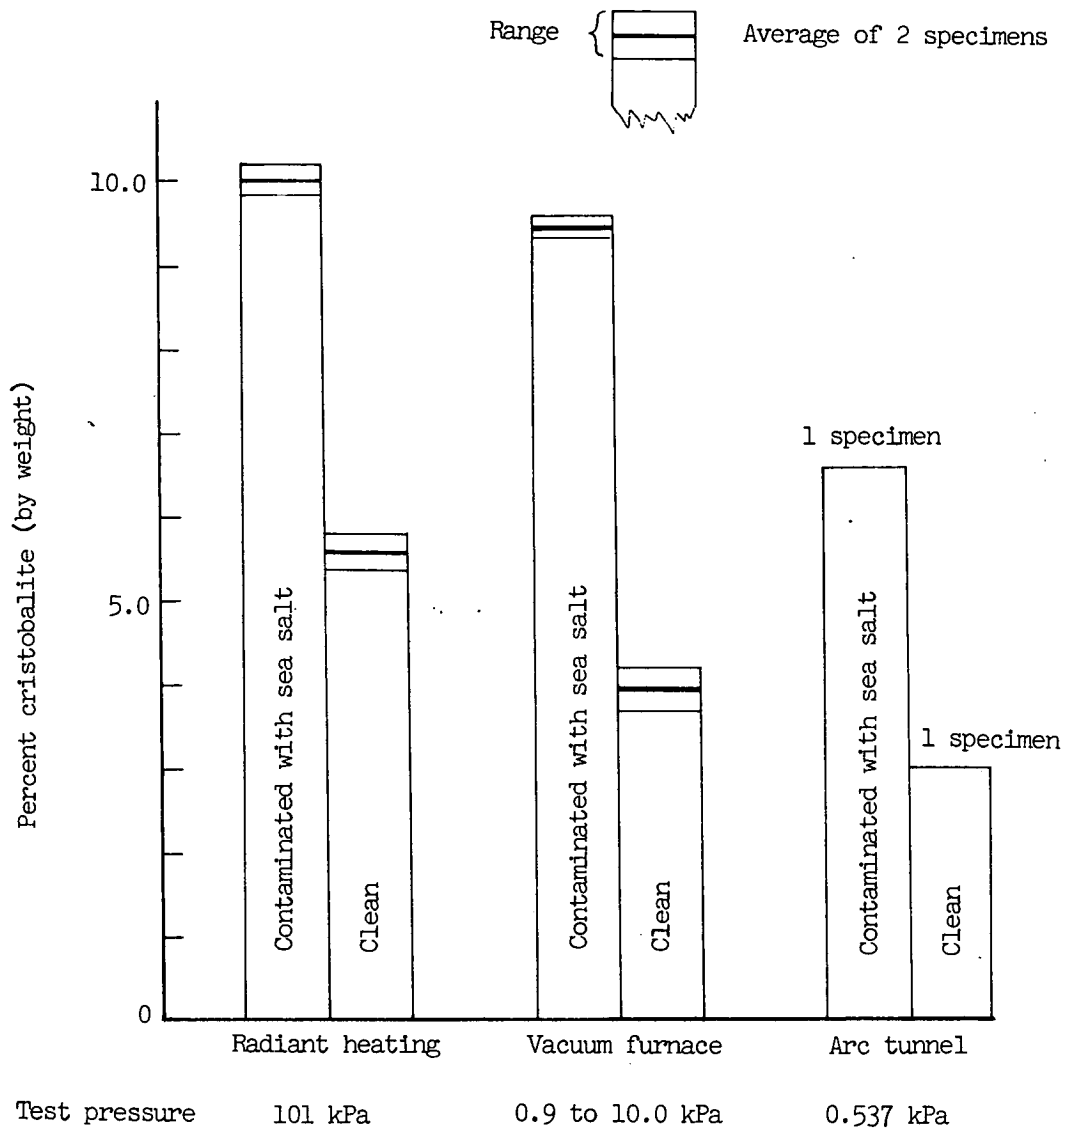
Figure 12.- Percent cristobalite in LI-0042 coating after 12 temperature cycles in three different heating atmospheres (contaminated before first cycle only).

In the heating tests where different test atmospheres were used, artificially contaminated specimens showed significantly more cristobalite than uncontaminated specimens after 12 test cycles. (See fig. 12.) In all cases, water was removed from the specimens before the tests were begun. Cracking did not occur, nor would it be expected to occur, since the percentage of cristobalite found was still relatively low and the number of cycles was small. From figure 12 it can be seen that the air pressure in the heating atmosphere had little effect on devitrification and certainly what effect it did have was relatively small when compared to the effect of contamination with sea salt. The contaminated arc-tunnel specimen probably produced less cristobalite than the others as a result of the low test

pressure which may have permitted significant vaporization of the salt contaminants. Also the test for this specimen was in flowing air and the specimen was contaminated only once before receiving the 12 heating cycles. All these factors would result in a more rapid depletion of available contaminant.
