**NASA TECHNICAL
MEMORANDUM**

NASA TM X-3269

**ACCELERATED LIFE TEST OF SPUTTERING
AND ANODE DEPOSIT SPALLING IN
A SMALL MERCURY ION THRUSTER**

John L. Power

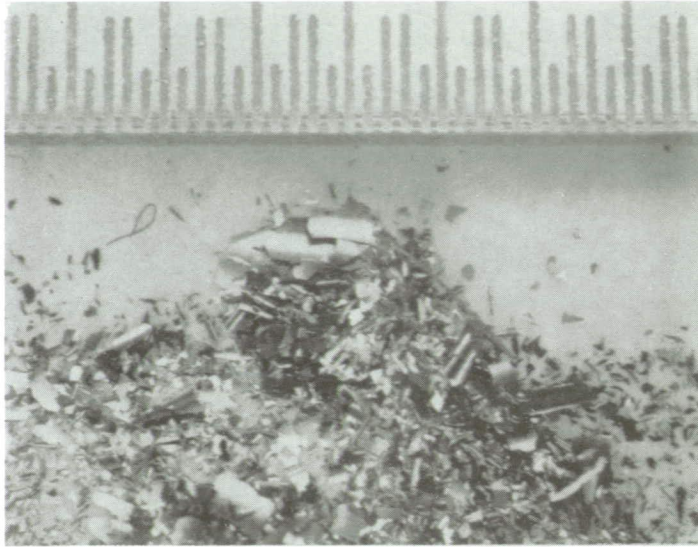
Figure 18. - Portion of loose flakes and material collected from thruster discharge chamber after test. Smallest divisions on ruler, each 0.254 millimeter (0.01 in.).

The curled condition of the flakes retrieved from the discharge chamber following the accelerated life test (fig. 18) suggests that residual forces, present in the coating when the thruster was shut down, were responsible for the spalling of the coating from the smooth anode surfaces and the generation of the observed flakes. Such forces could easily arise from a mismatch in the thermal expansion coefficients of the coating and the substrate, but other driving forces for the spalling from the smooth anode surfaces cannot be ruled out. It is clear, however, from the striking contrast between the coating adhesion to the smooth and the grit-blasted anode surfaces that the roughness of the anode surface has an effect on the coating adhesive forces considerably larger than the magnitude of the spalling forces present, at least for the anode coatings obtained and the thruster conditions prevailing in this work.

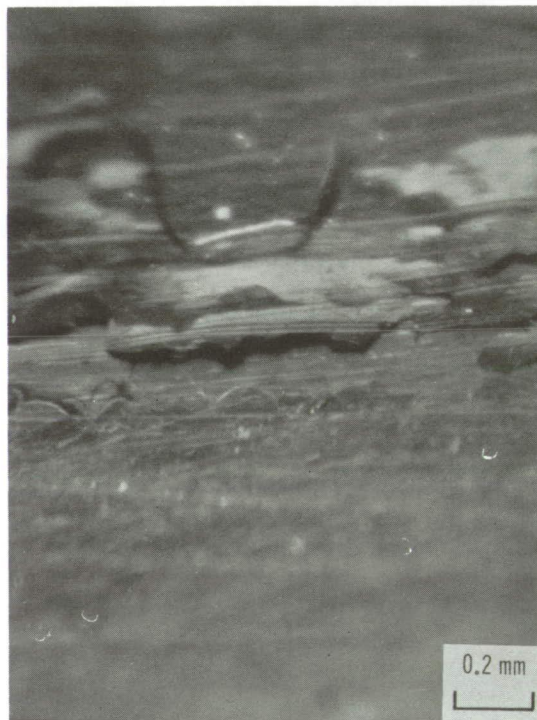
Figure 23. - Photomicrograph of deposits near upstream end of thruster body interior surface after test.

Sputtered material also was visibly deposited on the thruster body interior over all of the unshielded area extending both upstream and downstream from the anode edges. This material did not show much tendency to spall, perhaps because it was unevenly distributed. The thickest deposits, which appeared rather lumpy, were concentrated in a narrow ring located even with the upstream edge of the anode. These deposits may be seen in figure 22. Such deposits also had been observed in the SIT-5 erosion tests (ref. 2). On microscopic examination, the thickest of these deposits did show raised broken edges and the potential for spalling as small flakes (fig. 23).

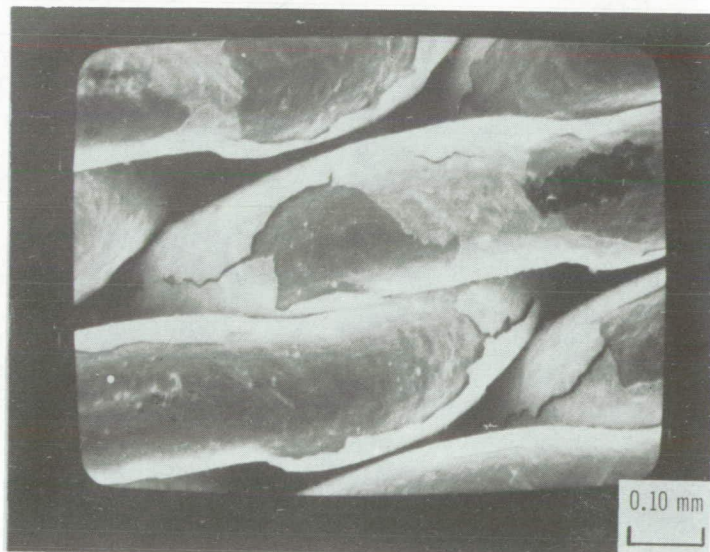
Figure 29. - Electron micrograph of stainless-steel screen anode insert (after test), showing spalled coating areas and cracks.

The coarse screen anode insert showed no macroscopic spalling after the test. Examination of the screen insert with both optical and scanning electron microscopes revealed, however, that in a large number of cases the coating on the exposed screen wires was cracked along the crest of the wires, for a maximum length of one mesh unit. As seen in figure 29, many small flakes of less than one mesh unit length (0.50 mm) spalled or broke off from the edges of these cracks.
