NASA TECHNICAL MEMORANDUM

NASA TM X-58161  
April 1975

SKYLAB PARASOL MATERIAL EVALUATION

**Stephen Jacobs and  
Thomas J. Ballentine  
Lyndon B. Johnson Space Center  
Houston, Texas 77058**

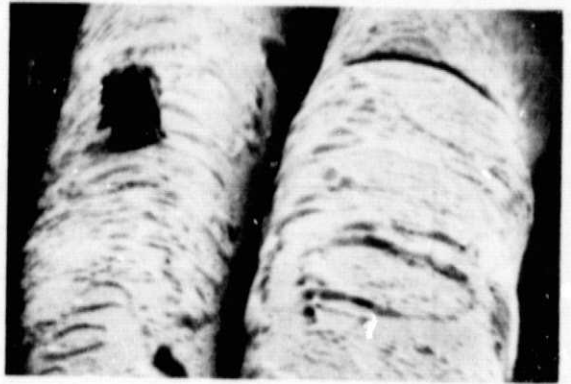
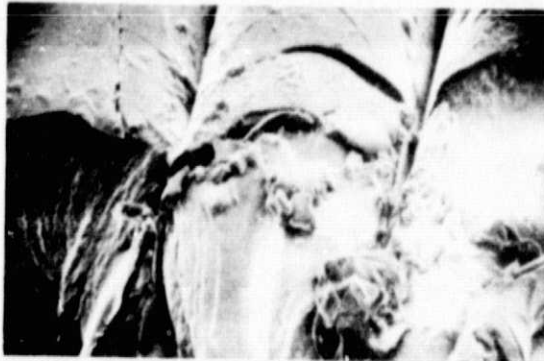
(a) At 5000 $\times$  magnification.

(b) At 2000 $\times$  magnification.

(c) At 2000 $\times$  magnification, cut.

Figure 10.- Scanning electron microscope photomicrographs of nylon ripstop material after 1260 equivalent solar hours exposure.

**Scanning electron microscopy.**- A scanning electron microscope (Cambridge Stereoscan S-4) was used at JSC to examine surface morphology of the nylon ripstop material as received, after 500 equivalent solar hours ultraviolet exposure, and after 1260 equivalent solar hours ultraviolet exposure. Typical photographs of these samples are shown in figures 8 to 10. The appearance of dark spots on the 500-hour specimen is accompanied by a slight surface roughening, and by the formation of a thin crust. Evidence of some embrittlement can be seen on the cut end of the 500-hour specimen. The 1260-hour specimen shows a marked increase in surface roughness, and the surface crust is well defined. Increased embrittlement is indicated by marked surface cracking near the cut region. No evidence of flaking or lack of crust adherence was observed at these exposure levels.

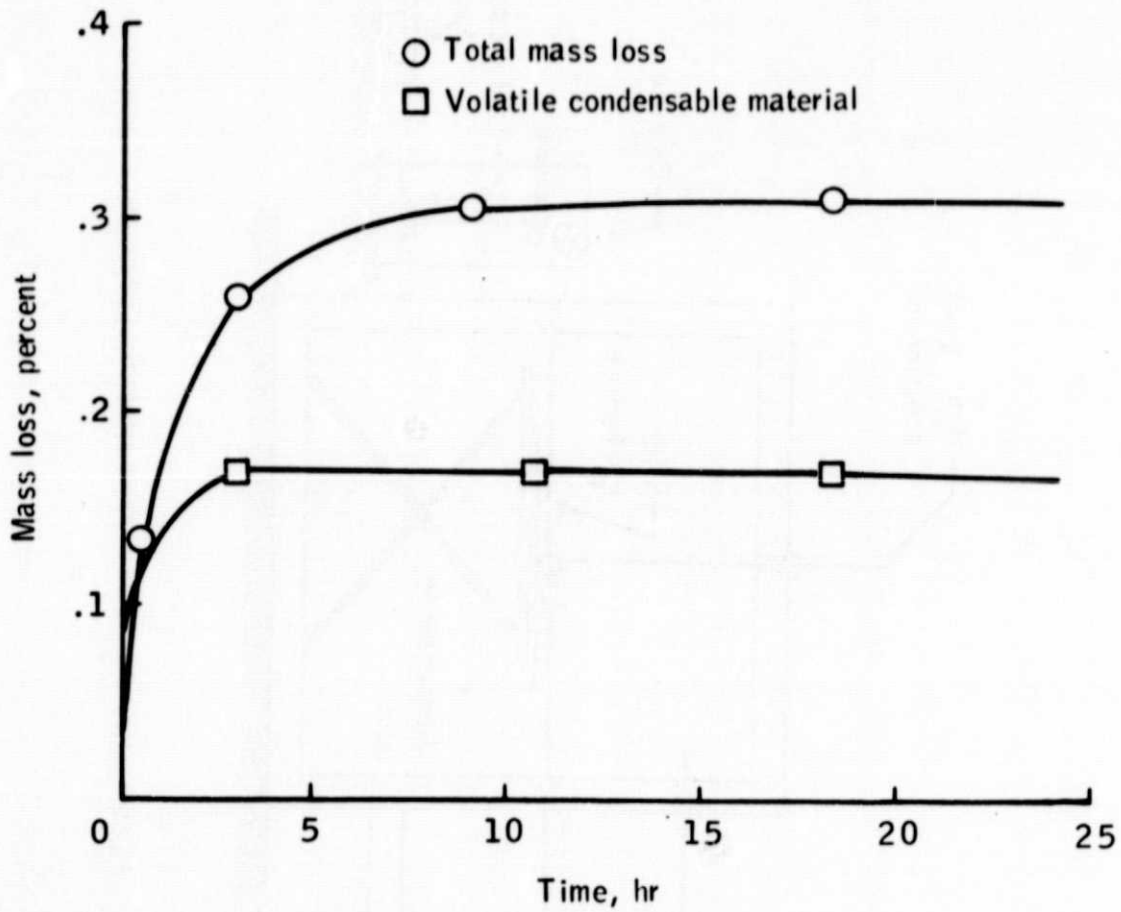
Figure 13.- Volatile condensable material determination of GT-76 at 399 K and  $1.33 \times 10^{-4}$  N/m<sup>2</sup>.

**Total mass loss and volatile condensable material:** An Ainsworth vacuum balance system was used for the evaluation of the outgassing characteristics of the parasol material. This system provides a continuous in situ measurement of mass loss. Figure 13 shows data on the total mass loss and the volatile condensable matter for the unexposed parasol material.

Total mass loss and volatile condensable material were measured for the parasol material. Total mass loss (0.3 percent) was within the requirements specified in NASA SP-R-0022 (less than 1 percent), and volatile condensable material was slightly greater than the requirement of 0.1 percent. Although the volatile condensable material in the parasol was slightly above specified values, the figure was not considered to be sufficiently high to interfere with the performance of the Skylab parasol.
