NASA TM X-72695

THE EFFECT OF CHINE TIRES ON NOSE GEAR WATER-SPRAY CHARACTERISTICS
OF A TWIN-ENGINE PROPJET AIRPLANE

Thomas J. Yager, Sandy M. Stubbs

NATIONAL AERONAUTICS AND SPACE ADMINISTRATION
LANGLEY RESEARCH CENTER, HAMPTON, VIRGINIA 23665

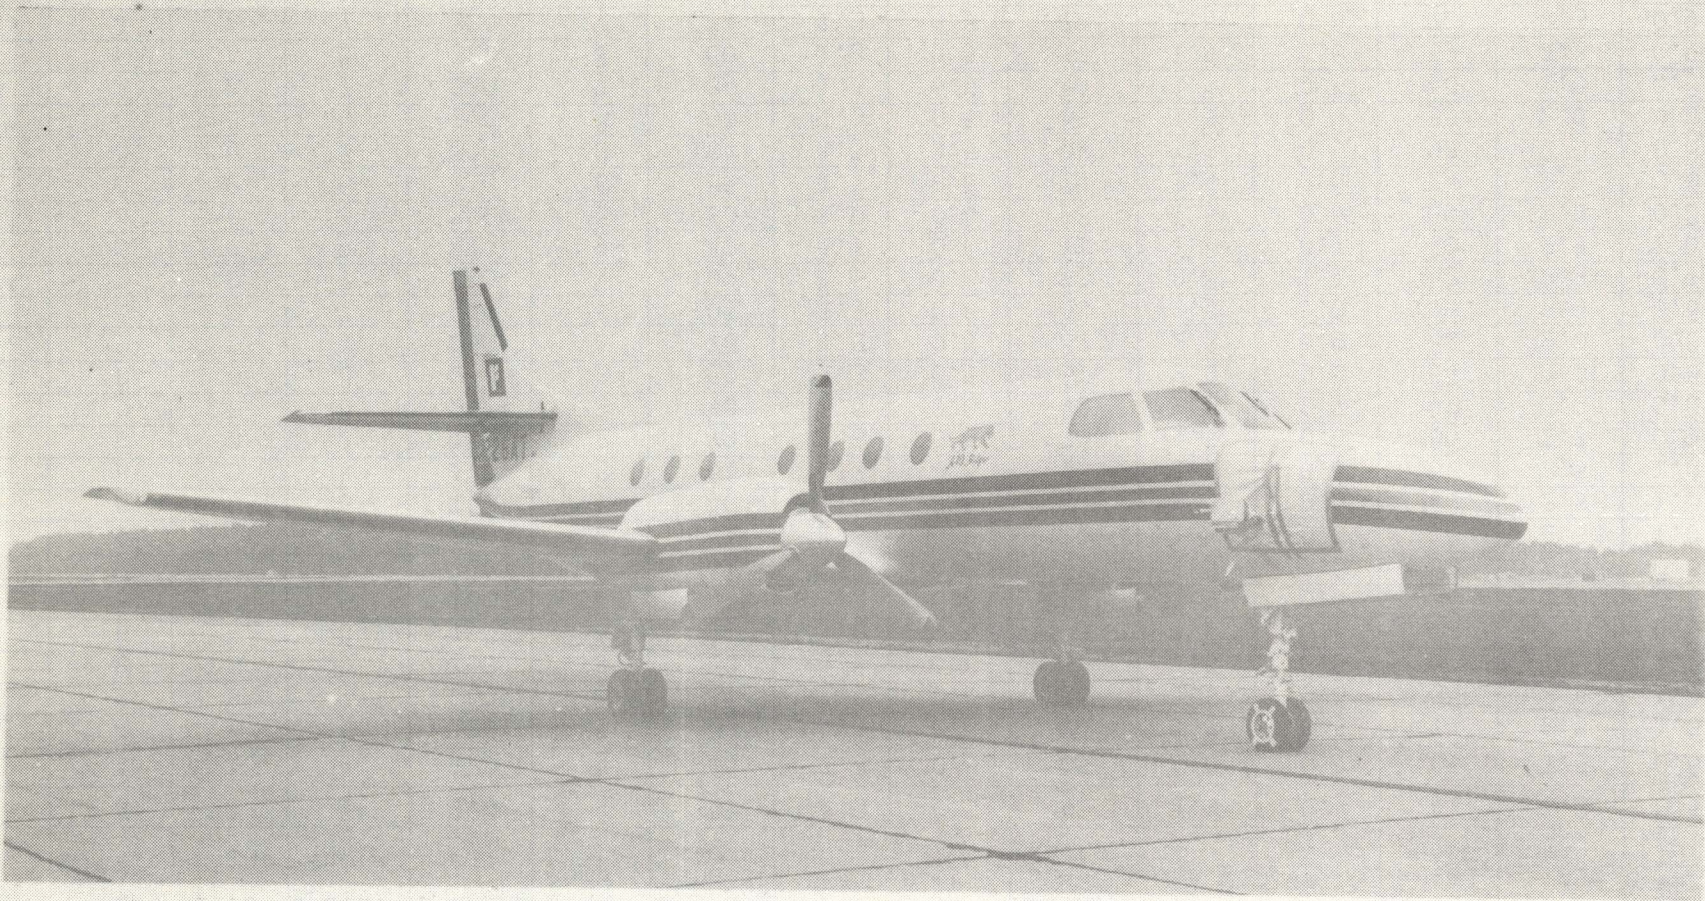
Figure 1.- Photograph of the test airplane.

The aircraft used in this investigation was a Merlin IV executive twin-engine propjet manufactured by Swearingen Aviation Corp. A photograph of the test airplane is presented in figure 1 and sketches which provide geometric details are presented in figure 2. The airplane has a dual nose gear which on slush-covered runways has been observed under certain conditions to introduce spray into the engine air intake located above the propeller hub and into the oil cooler inlet located below and slightly aft of the hub. The location of these intakes relative to the nose gear is noted in figure 2(b). Also noted is the mean location of the wing leading edge between the engine nacelle and the fuselage, as it is used later for identifying spray locations. For this investigation, the aircraft was lightly loaded and its mass was estimated to be 3855 kg (8500 lbf). At this mass, the static loading on the nose gear was approximately 4.45 kN (1000 lbf).

The forward baggage compartment doors were removed from the test aircraft to provide space for mounting a motion picture camera, visible in figure 1. This camera provided a near head-on view of the spray in the vicinity of

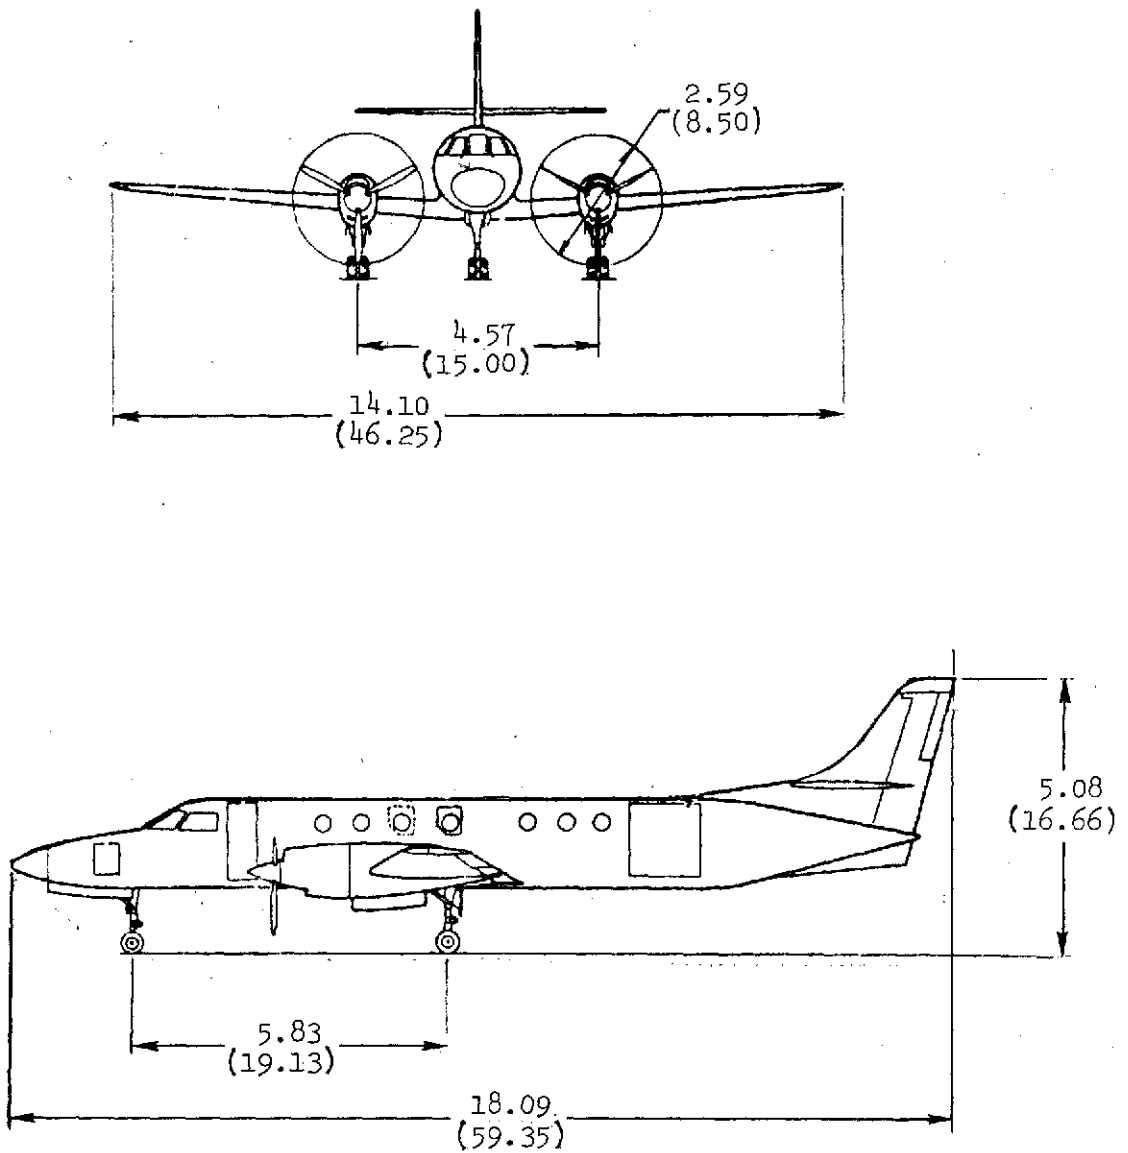
(a) General arrangement.

Figure 2.- Geometric details of the test airplane.

(Dimensions are given in meters and parenthetically in feet.)

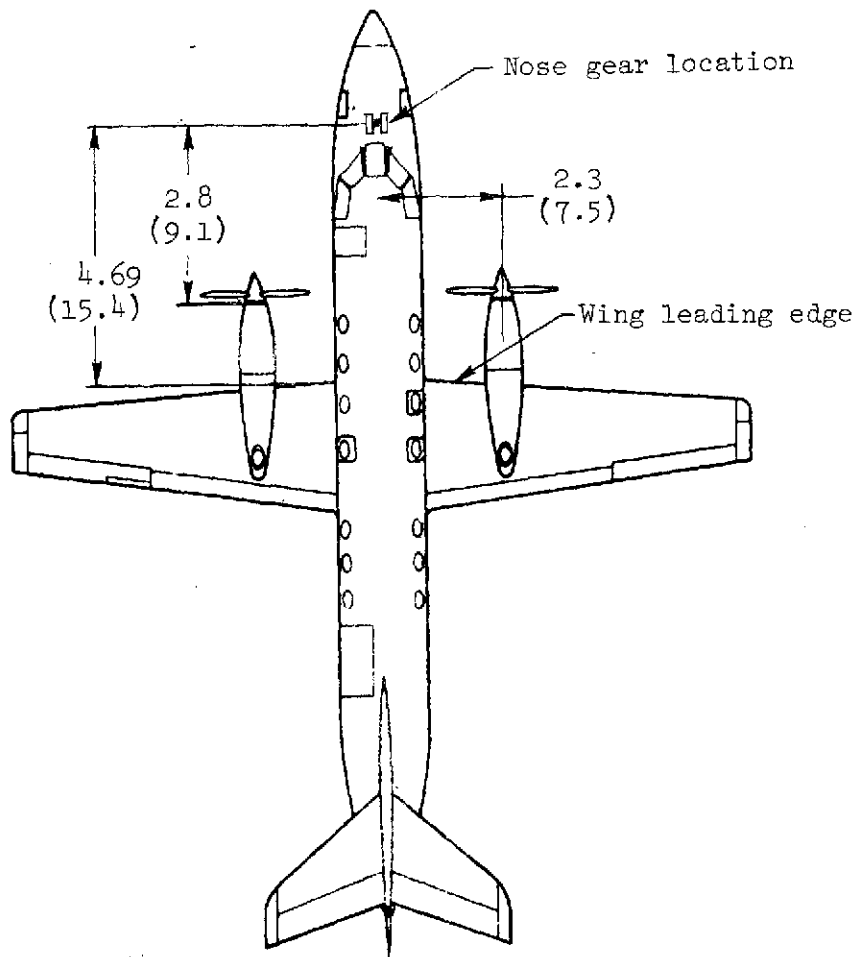
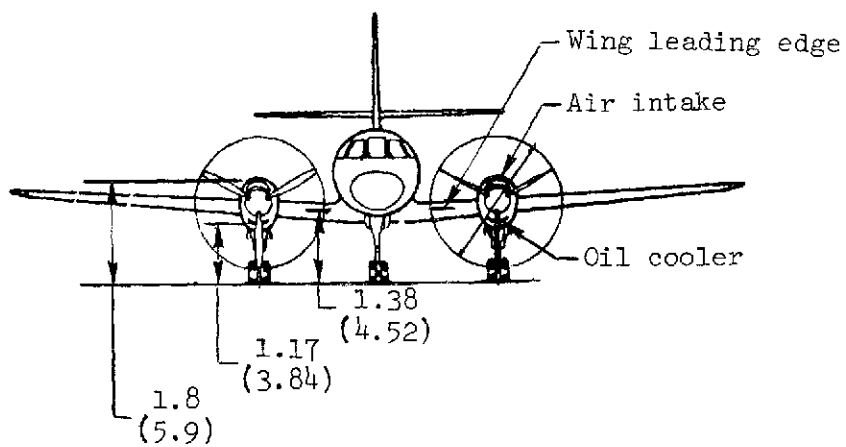
(b) Wing leading edge and air inlet locations.

Figure 2.- Concluded.

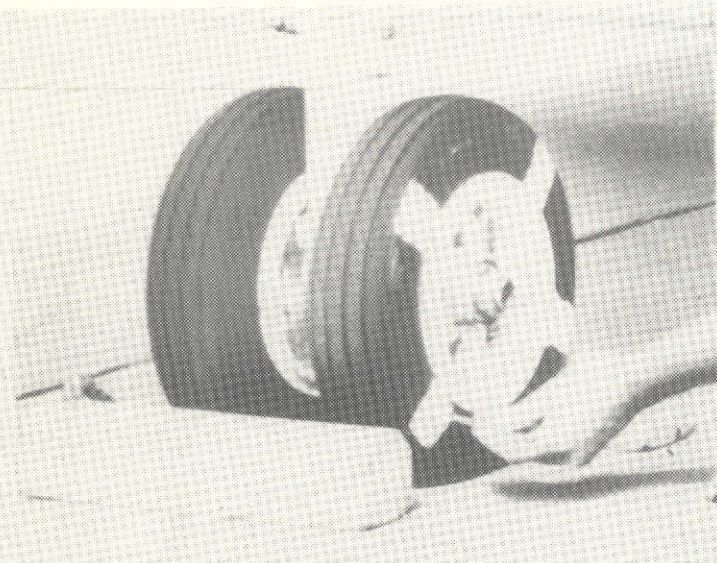
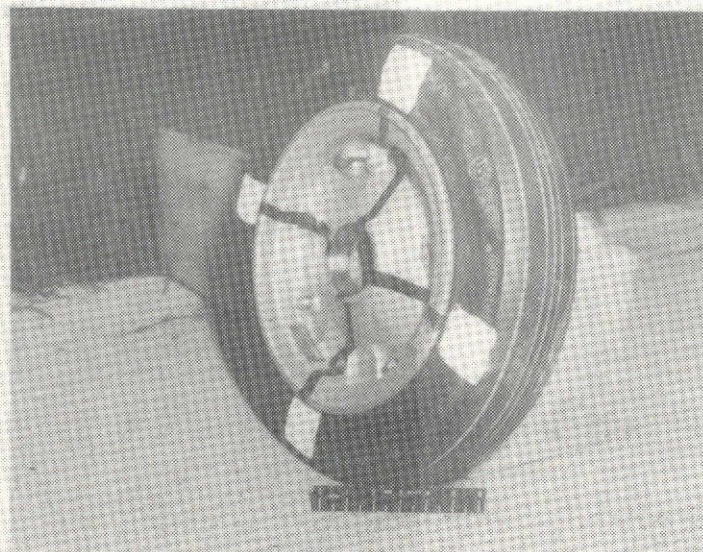
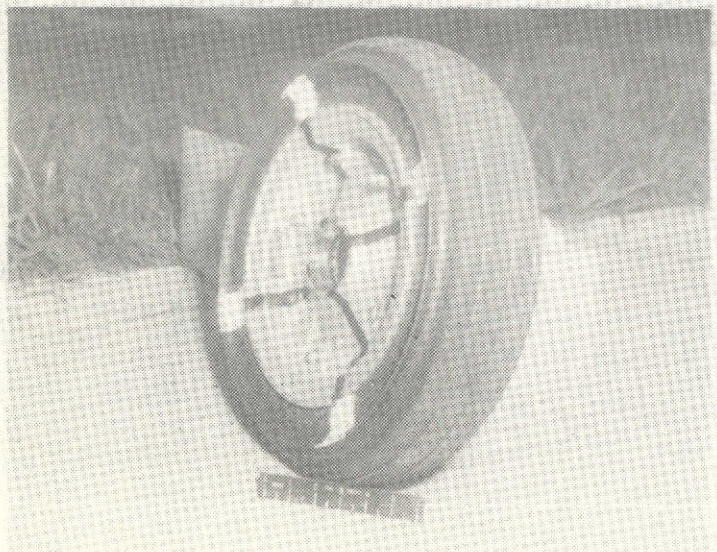
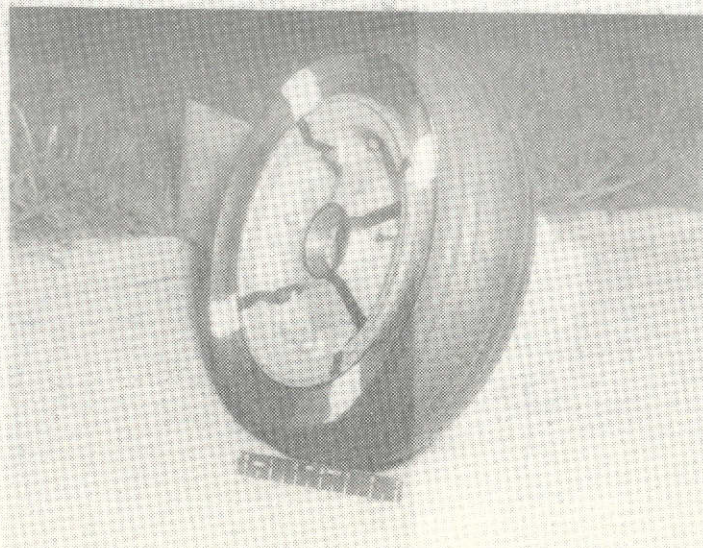
Tire A

Tire B

Tire C

Tire D

(a) Photographs of nose gear test tires.

Figure 3.- Details of nose gear test tires.

Photographs of the nose gear test tires are presented in figure 3(a) and cross-sectional schematics are presented in figure 3(b). Tire A, the standard tire currently in use on the test airplane, is a size 16 x 4.4 type VII aircraft tire. Unfortunately, a chine tire is not commercially available in this size; the nearest being a size 18 x 4.4 which, when fully inflated, is approximately 5.1 cm (2 in.) larger in diameter than the standard tire for this airplane. Two chine tires of this size but of different configuration were selected for testing in this study and designated as tires C and D. As shown in figure 3(b), the chine for tire C extended 1.37 cm (0.54 in.) beyond the sidewall at a radius 3.63 cm (1.43 in.) less than the undeflected tire radius. The chine for tire D protruded 1.32 cm (0.52 in.) beyond the sidewall at a radius 2.92 cm (1.15 in.) less than that of the undeflected tire. Thus, for equal load and inflation pressure, the chine of tire D was slightly closer to the runway surface than that of tire C.

Test tire B is a conventional tire of the same size as that of the two chine tires, and was included in the program to provide data for evaluating directly any possible merits for a chine tire. The standard size 16 x 4.4 tire (tire A) was tested at an inflation pressure of 550 kPa (80 psi) whereas the larger size tires were inflated to only 340 kPa (50 psi) - the pressure identified by the airplane manufacturer necessary to provide the same load factor on the aircraft structure. The tread pattern of the various test tires differed because tires with a uniform pattern were not available when the program was conducted. These tread differences, observable in figure 3, were considered to have an insignificant effect on the developed water spray patterns.

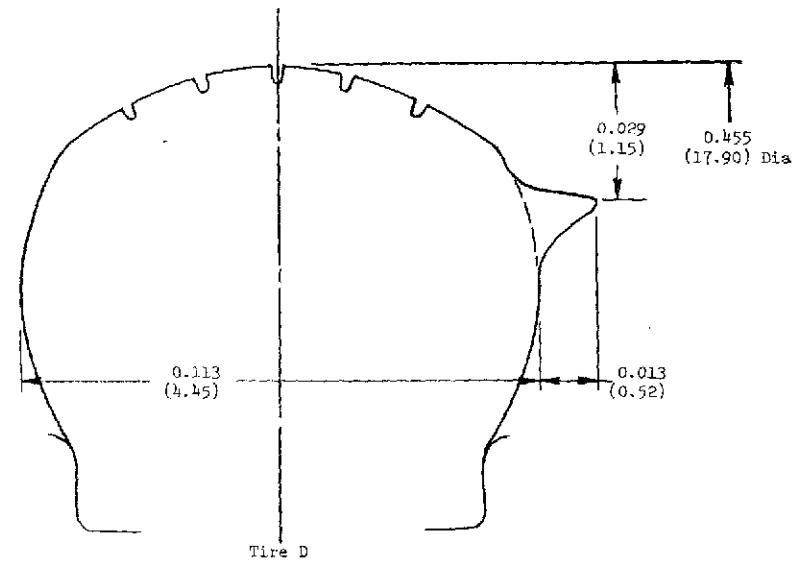
(b) Cross section details of test tires
(Dimensions are given in meters and parenthetically in inches.)

Figure 3.- Concluded

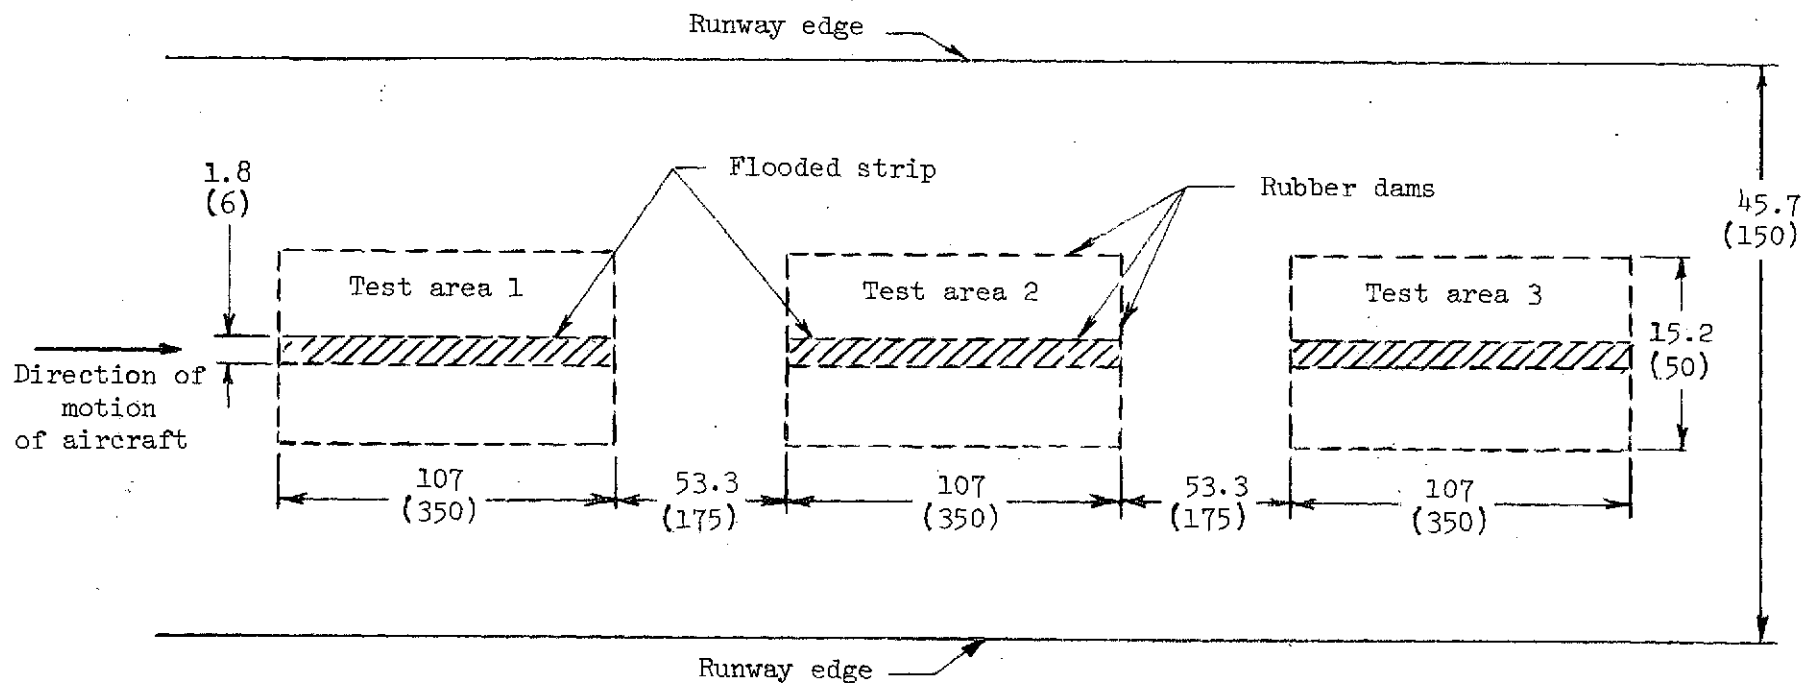
Figure 4.- Research runway test section layout for spray ingestion investigation.
 (Dimensions are given in meters and parenthetically in feet.)

The tests were conducted on the 2670m (8750 ft) Landing Research Runway at Wallops Flight Center because the unique, flat-surface test section of that runway provided a means for obtaining a uniform controlled water depth which was considered essential for describing the water spray patterns developed by the airplane during a test run. Figure 4 presents a geometric layout of the runway test section and shows the three areas which were flooded for testing. Each area consisted of a strip 1.8m (6 ft) wide to accommodate the nose gear and 107m (350 ft) long, bounded by dams and flooded to designated depths by means of fire department tank trucks as shown in figure 5. Test areas 1 and 2 were flooded to a nominal water depth of 1.27 cm (0.5 in.) and test area 3 was flooded to a depth of 2.54 cm (1 in.). Dams were also installed 7.6m (25 ft) either side of the centerline of each flooded test strip to retard the water dispersion across the entire 45.7 m (150 ft) runway width.

The surface of the runway in test areas 1 and 3 was smooth concrete whereas that of area 2 was equipped with transverse grooves 0.63 cm (1/4 in.) wide and deep, spaced 2.54 cm (1 in.) apart. Thus, areas 1 and 2, flooded to

the same nominal depth, provided the opportunity to evaluate what effects grooving might have on the nose wheel water spray characteristics during flooded runway operations.

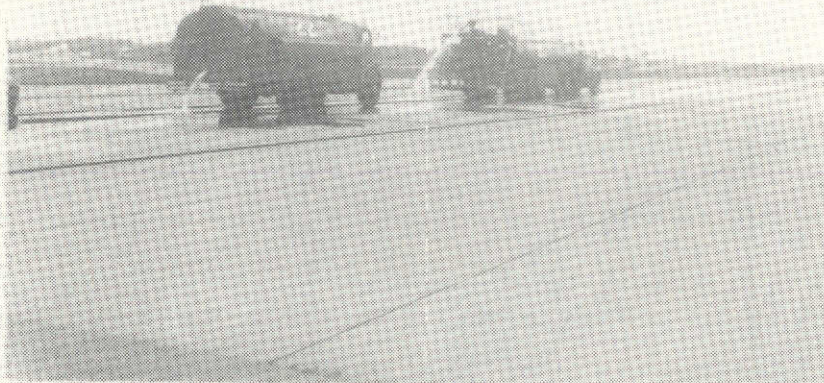
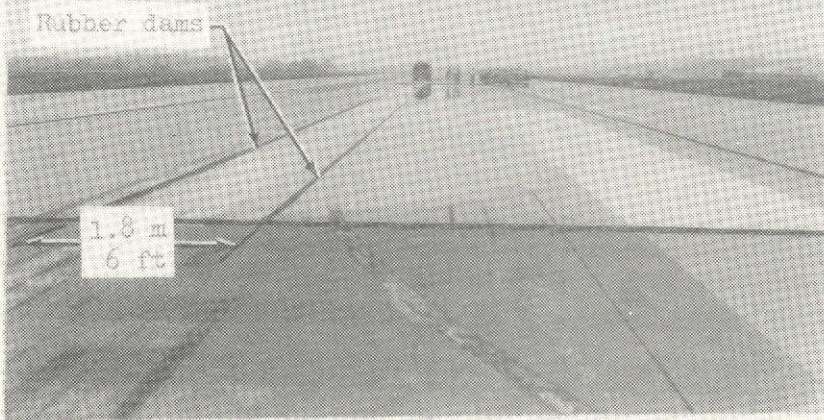
(a) Runway wetting procedure

(b) Wetted nose gear strip

Figure 5.- Photographs of test runway preparations.

The procedure for each test run began with the wetting process. After the tank trucks flooded the three 1.83 m (6 ft) wide test strips to approximately the desired depths (1.27 cm (0.5 in.) in areas 1 and 2; 2.54 cm (1 in.) in area 3), observers at each area recorded the average of many water-depth measurements and the runway was cleared. For each run, the pilot accelerated the airplane rapidly to the desired test speed and attempted to maintain that speed as the airplane traversed the three test areas with the nose gear centered in the flooded strips. Motion picture cameras were started prior to the airplane entering the first test area; other cameras were operated after the spray pattern had been developed in each test area. Following each run, the observer at each test area would again measure water depths and instruct

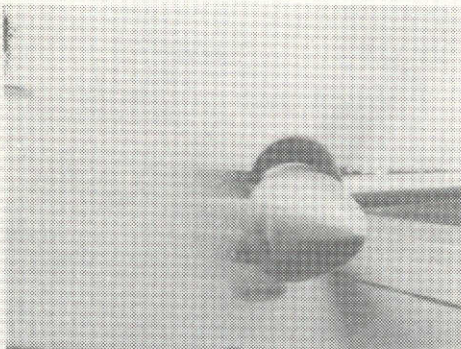
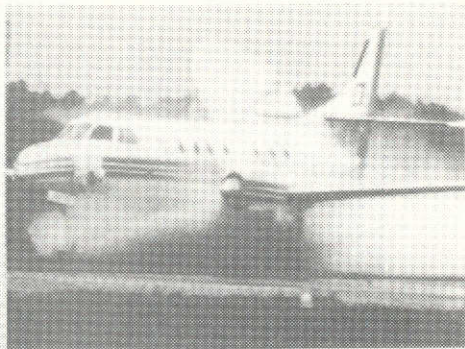
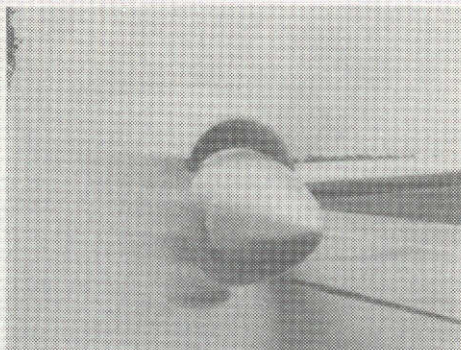
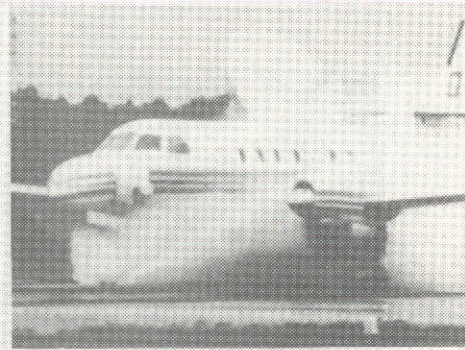
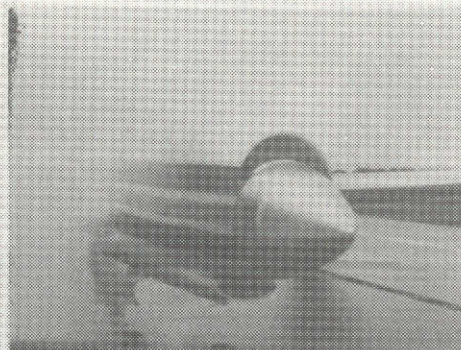
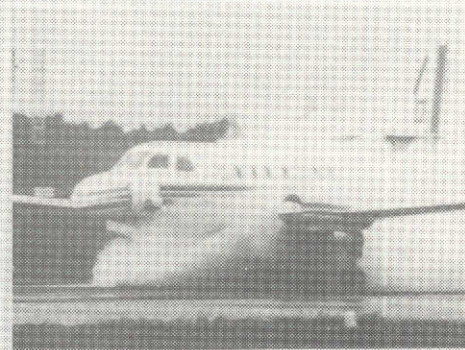
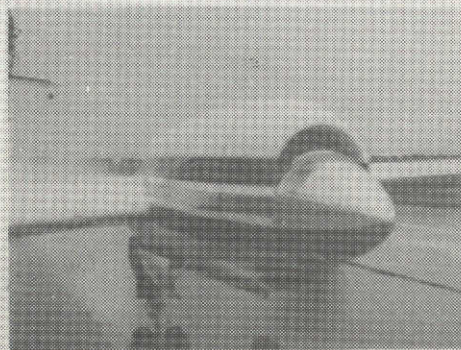
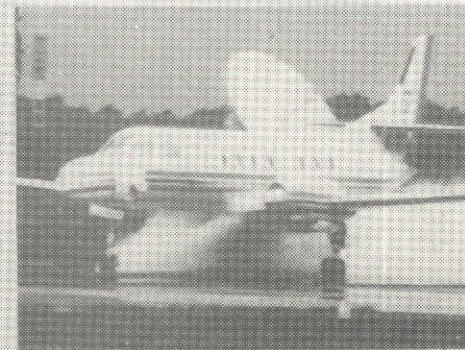
(a) Test Wire A: Nominal water depth = 8.79 cm (3.46 in.).

Figure 7.- Typical photographs chosen to show the effect of speed on spray characteristics.

The spray pattern of the conventional tire is highly dependent upon the aircraft ground speed as noted in figures 7(a) and 10. Below the critical hydroplaning speed (the hydroplaning speed V , in knots, is approximated by the equation, $V = \sqrt{p}$, where p is the tire inflation pressure in psi), a large portion of the spray appears to emanate from the side of the tire footprint, yet there is an apparent bow wave which throws spray ahead of and over the tire to the extent that the tire is typically hidden in spray mist (see figure 7(a)). Above the critical hydroplaning speed, no bow wave is evident, the tire is quite visible, and the spray is directed aft and to the side of the tire footprint.

As noted in figures 7 and 10, the core of the spray from the side of the tire does approach the engine nacelle at the low test speeds. This core appears to move inboard with increasing speed until, at super-hydroplaning speeds (80 knots calculated for tire A, 64 knots for tire B), the core is well inboard of the nacelle.

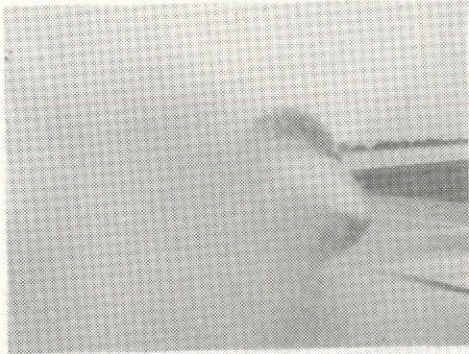
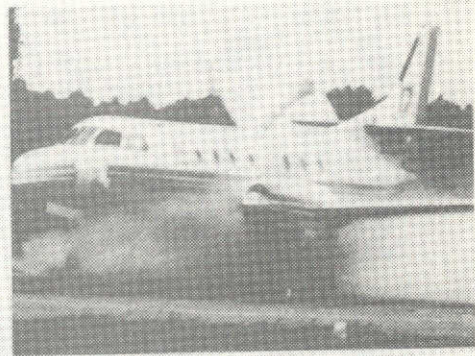
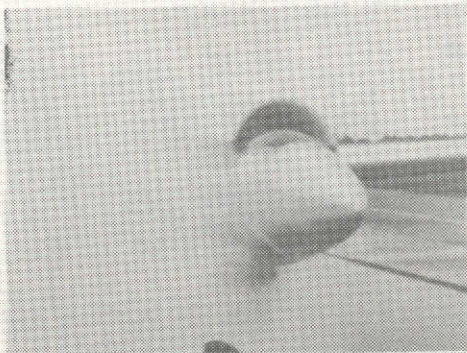
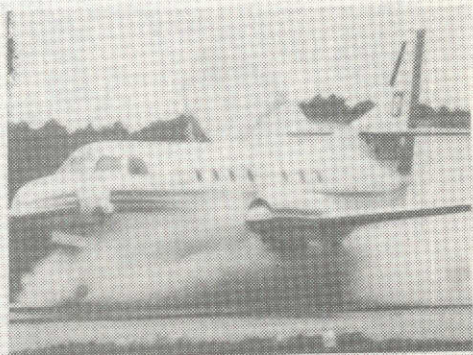
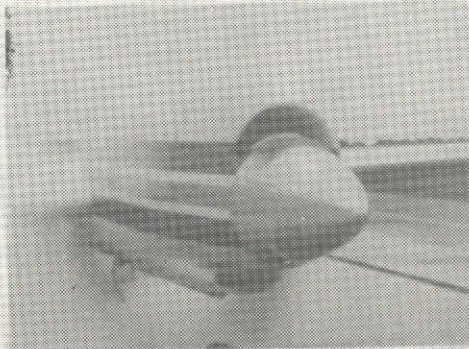
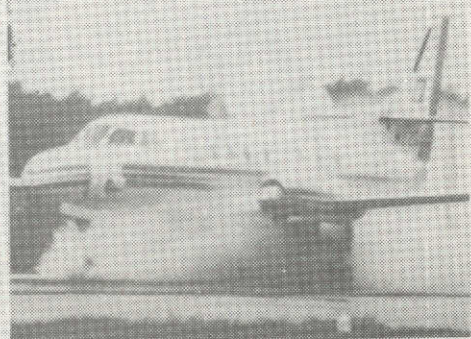
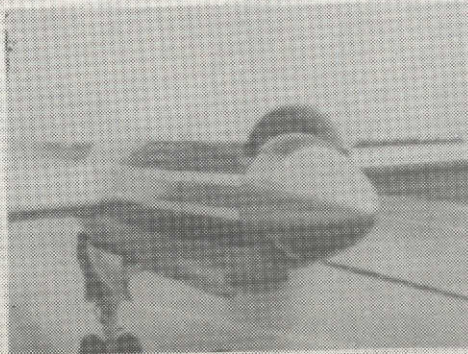
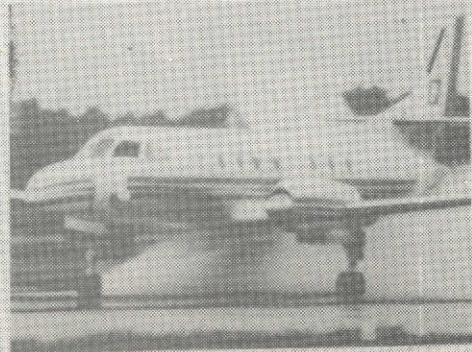
(6) Test Case 2. Neutral water depth = 2.0 cm (0.8 in.)

Figure 7.- Concluded

The spray pattern from the two test chine tires was quite similar to that from the conventional tires at speeds above the critical hydroplaning speed. The calculated hydroplaning speed for these tires (at an inflation pressure of 340 kPa (50 psi)) is 64 knots, but photographs in figure 7(b)

indicate that the critical hydroplaning speed is somewhere between 75 and 92 knots. This higher experimental hydroplaning speed for these tires is possibly due to carcass stiffness effects.

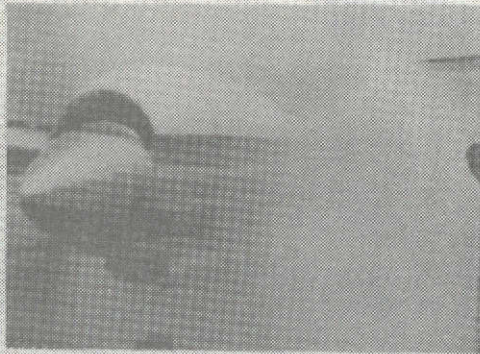
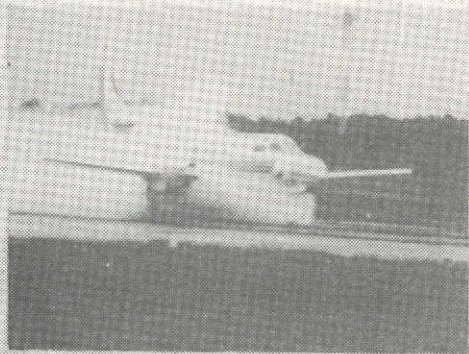
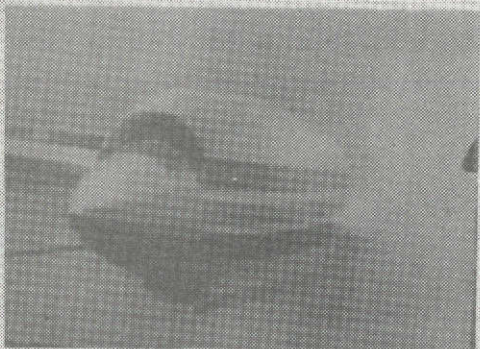
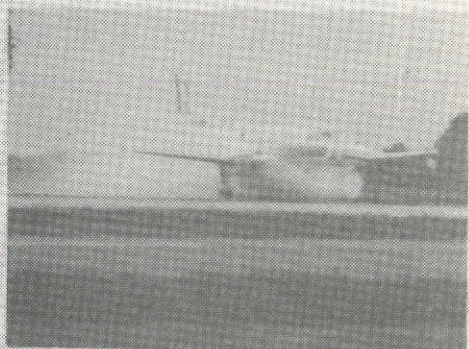
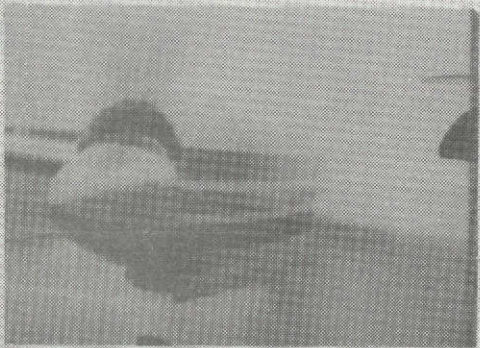
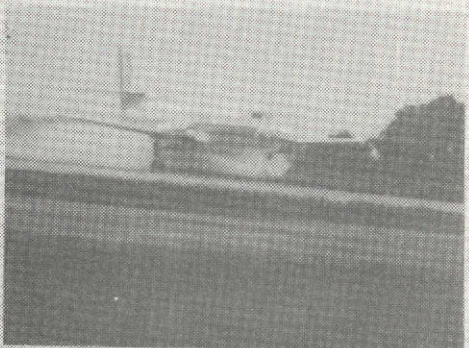
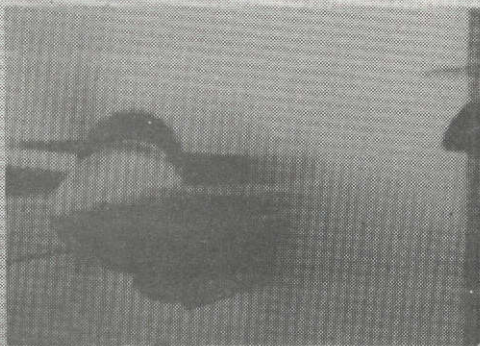
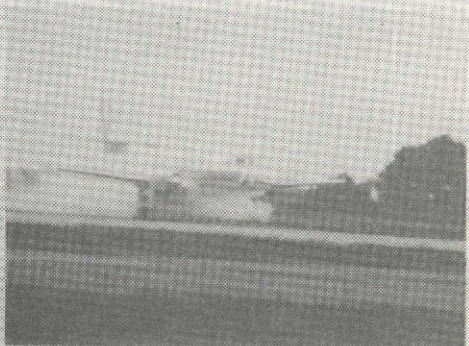
Figure 8 - Typical photographs chosen to show the spray characteristics associated with the four test wires. Nominal test speed = 60 kts; Nominal water depth = 4.54 cm (1.8 in.).

The results from this experimental program were derived primarily from a study of the photographic and television coverage employed during the course of each test. Figures 7, 8 and 9 are typical photographs presented to illustrate the effects of such test variables as aircraft ground speed, tire configuration, and surface water depth on the spray pattern produced by the nose gear during flooded runway operations. Figure 10 attempts to summarize all of the test data by defining the approximate grid location of the downwind water-spray core in the vertical plane which contains the wing leading edge. These core locations are based upon estimates made by observers reviewing the photographic and television coverage and hence are somewhat subjective. The spray patterns from the conventional and chine tires are discussed in the paragraphs which follow.

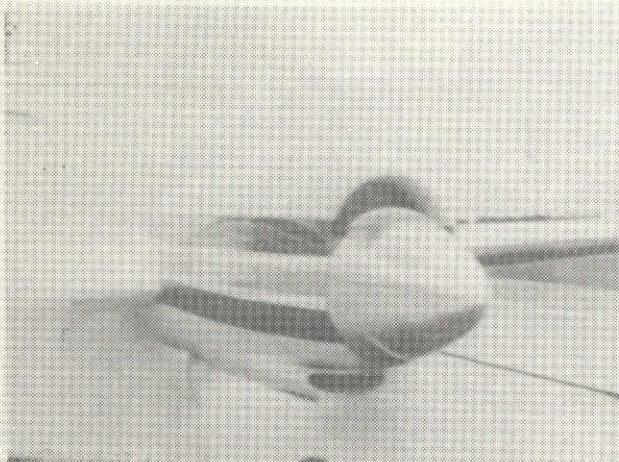
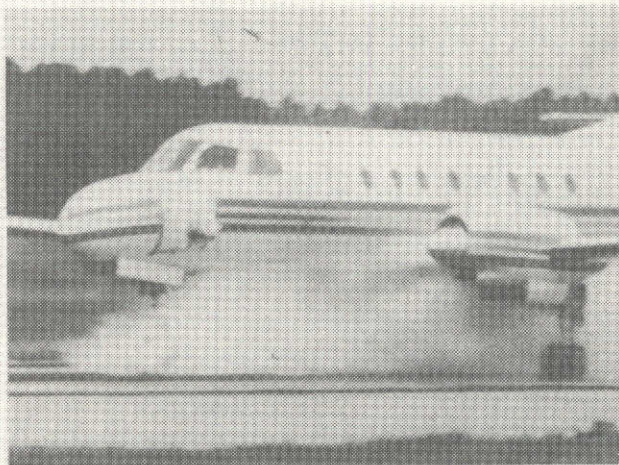
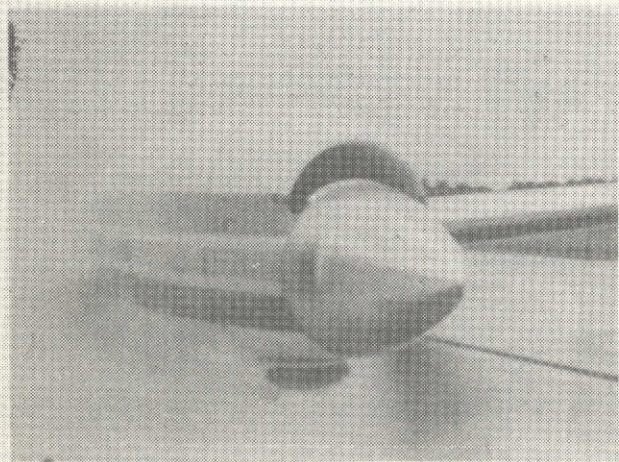
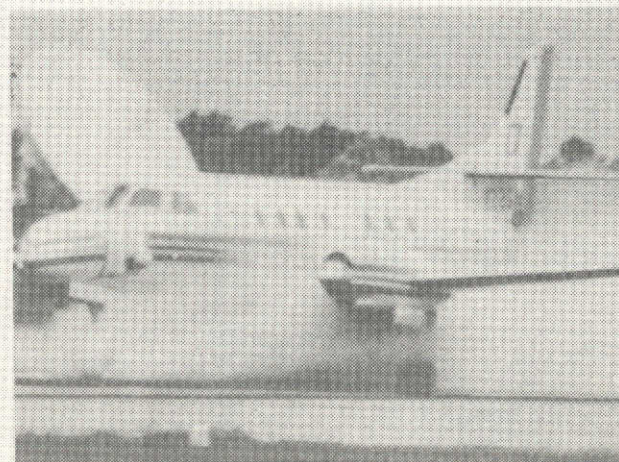
(a) Nominal water depth = 1.27 cm (0.5 in.)

(b) Nominal water depth = 2.54 cm (1.0 in.)

Figure 9.- Typical photographs chosen to show the effect of water depth on spray characteristics.

Run 14: Test time D; Speed = 64 kts.

As a rule of thumb, the water depth required on the surface to produce dynamic hydroplaning conditions must be equal to or greater than the groove depth in the tire thread. For the nose gear tires used in these tests, the average tread groove depth was approximately 0.4 cm (0.16 in.). Thus, the two nominal test water depths in this investigation (1.27 cm and 2.54 cm (0.5 in. and 1.0 in.)) were both well above the minimum depth required for hydroplaning. A comparison of the data for tire A in figure 10(a) with that in figure 10(c) indicates that the pattern of the spray and the approximate location of its core were essentially the same for the two flooded conditions, both below and above the hydroplaning speed. The photographic coverage did suggest, however, that the volume of water in the core of the spray was greater for the deeper depth.

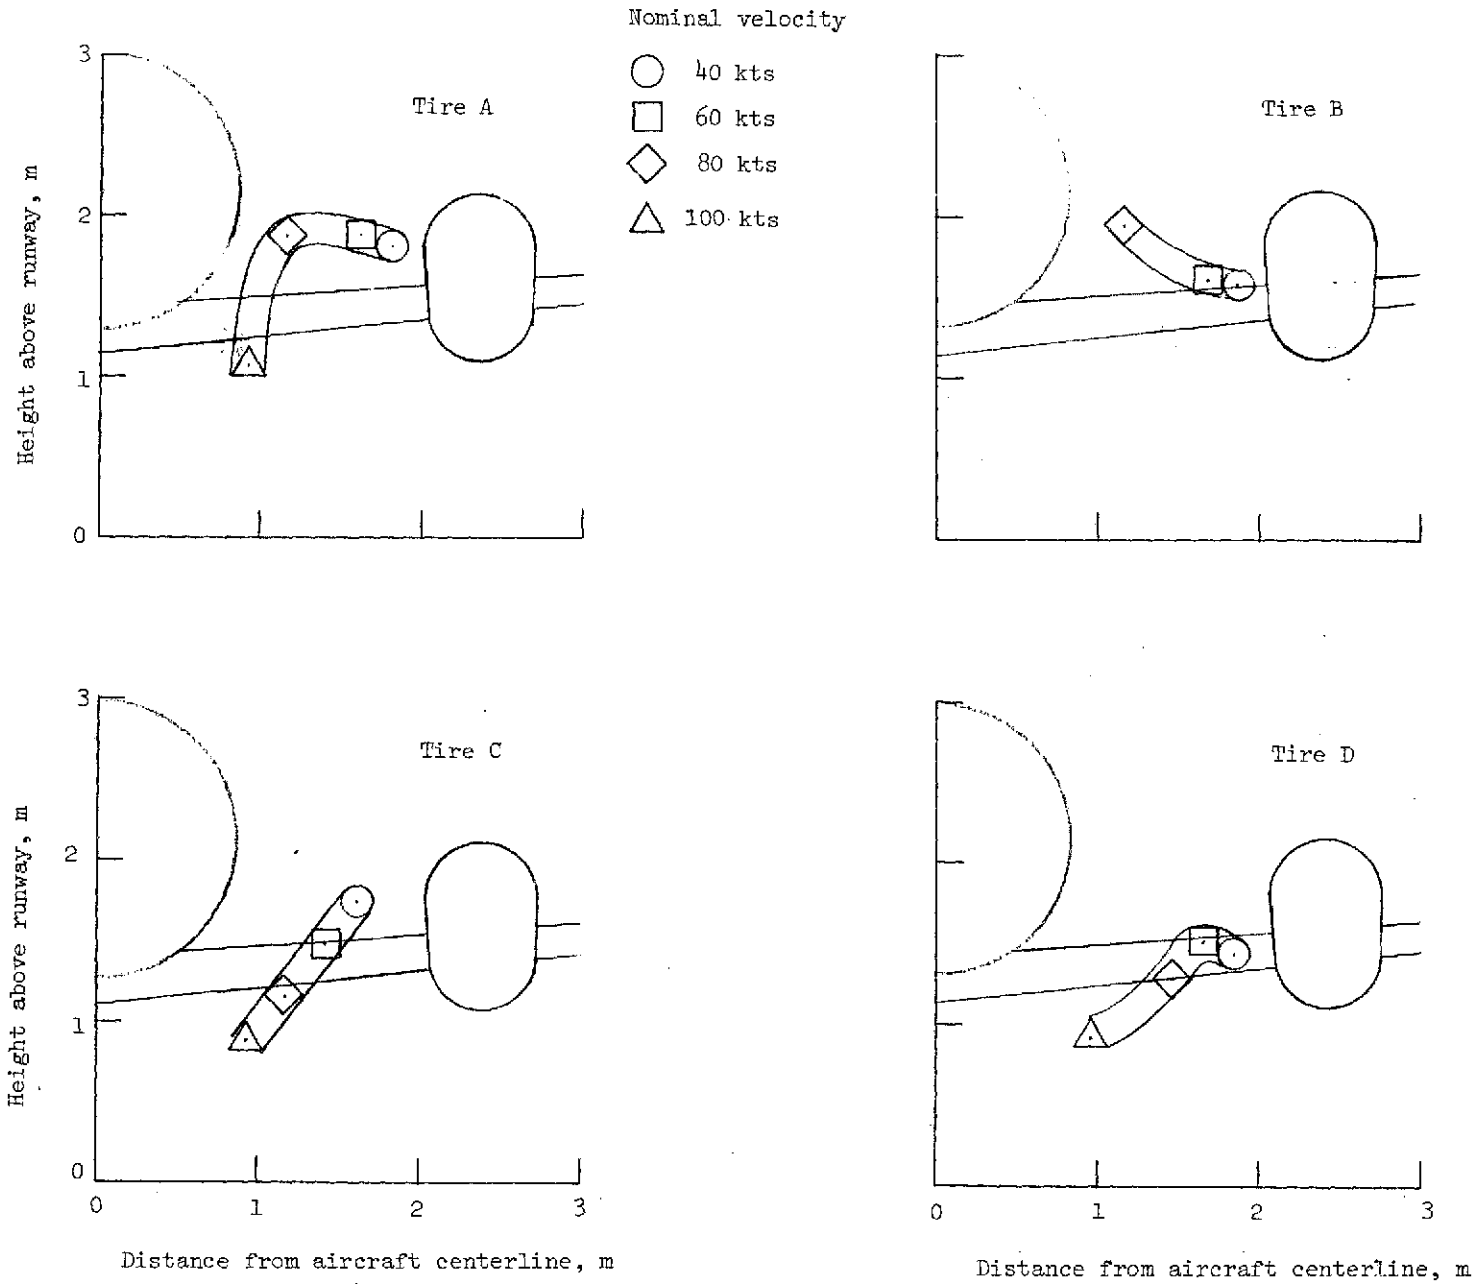
(a) Test area 1. Nominal water depth = 1.27 cm (0.5 in.)

Figure 10.- Location of spray core in the vertical plane of the wing leading edge.

The data for tire A in figure 10(a) and 10(b) also indicate that when the runway is flooded to the depths examined in this study, surface grooving has no effect on the spray pattern.

The spray pattern from the larger tire B is shown in figure 10 to be essentially the same as that of tire A although tire B appeared to throw more water above the wing. This slightly higher core location for tire B could possibly mean a potentially more hazardous spray problem. In neither case, however, was the spray ingestion problem experienced by this airplane on several occasions in the field, duplicated. Nevertheless, it is apparent from the observed data that perhaps under higher crosswinds which would require some aircraft yaw, a significant spray could be caused to enter the downwind air-and oil-cooler intakes of this airplane.

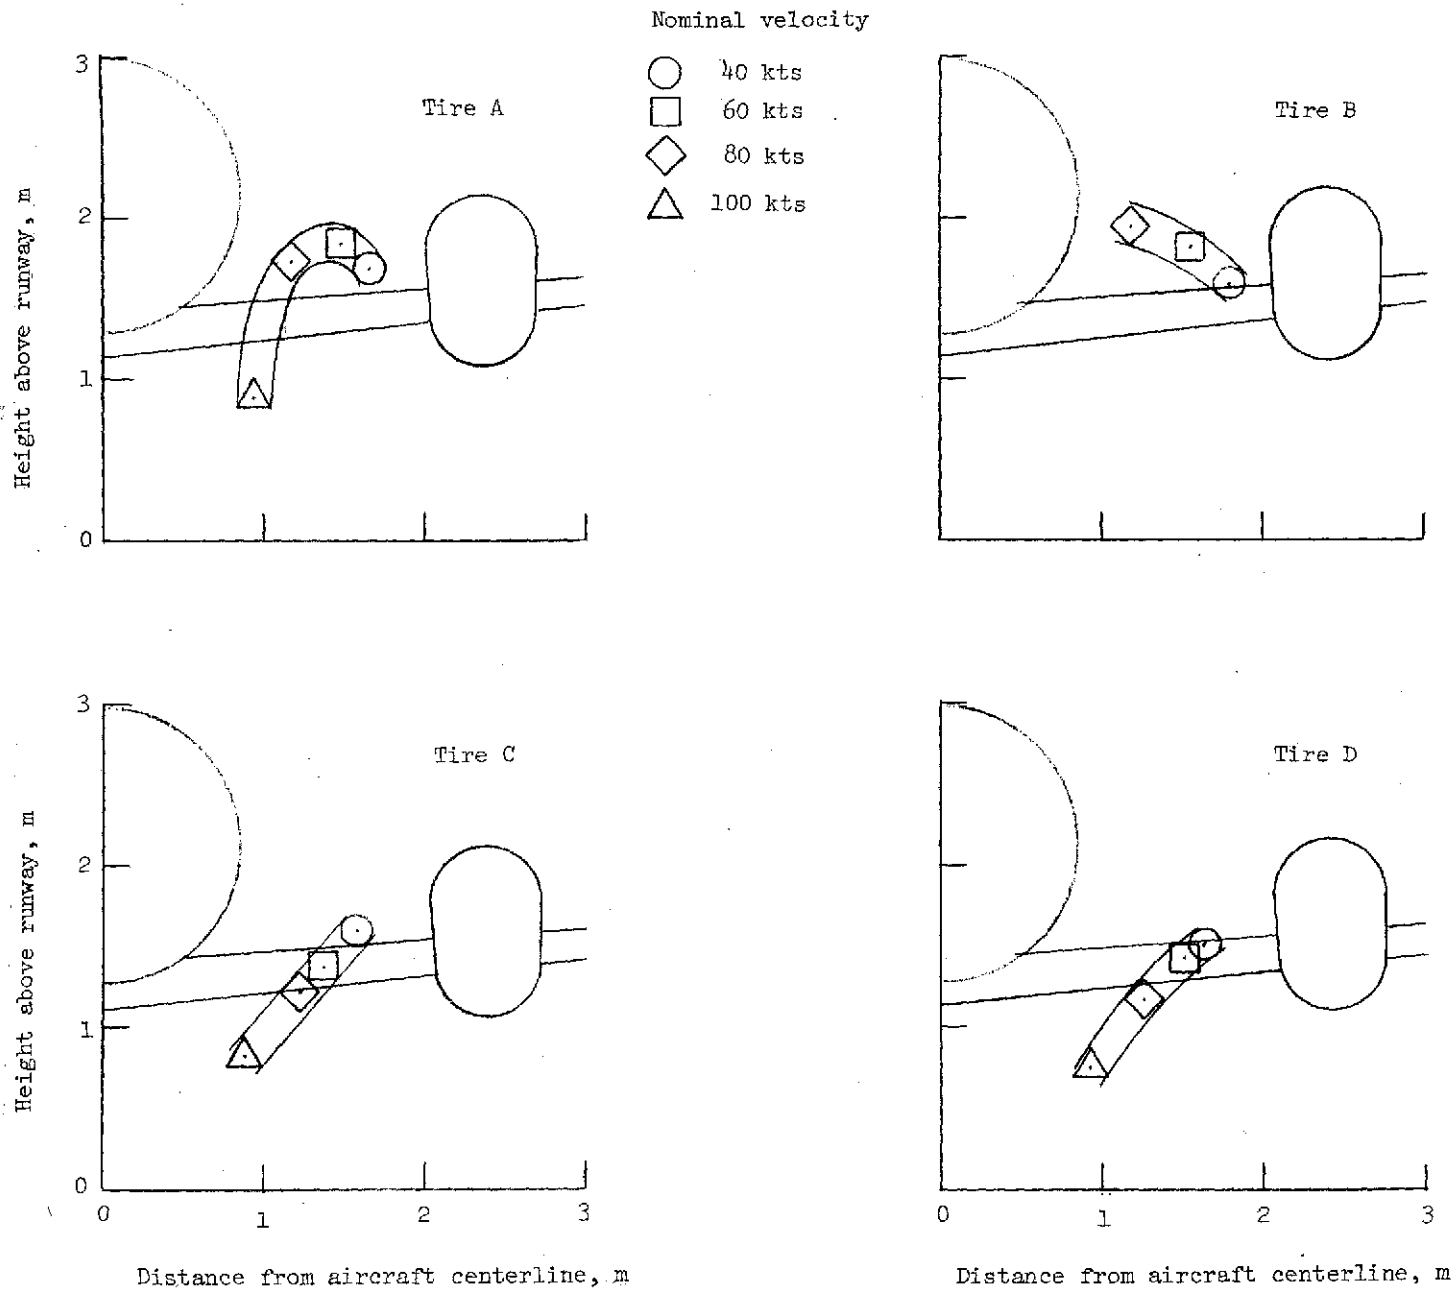
(b) Test area 2. Nominal water depth = 1.27 cm (0.5 in.)

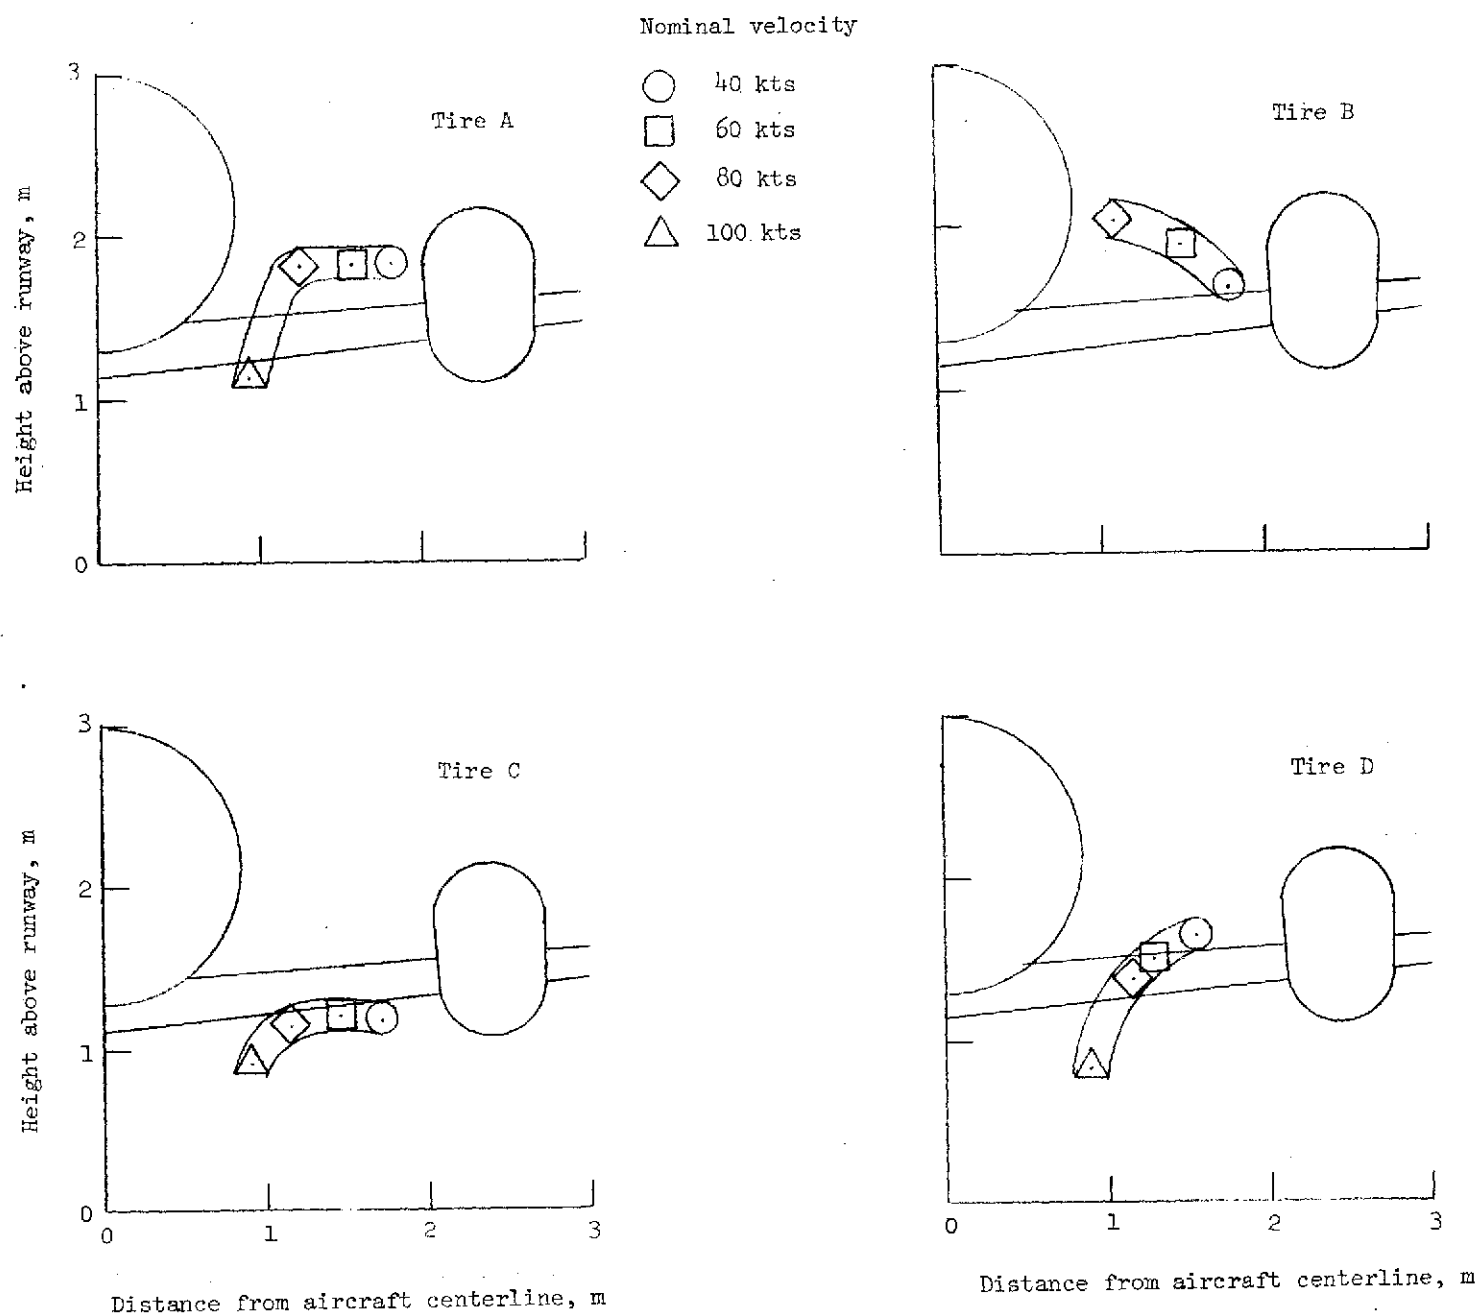
(c) Test area 3. Nominal water depth = 2.54 cm (1.0 in.)
