SPECIAL REPORT - THE USE OF SKYLAB AND ERTS IN A GEOHYDRO-
LOGICAL STUDY OF THE PALEOZOIC SECTION, WEST-CENTRAL
BIGHORN MOUNTAINS, WYOMING.

Barbara J. Tomes
Department of Geology
University of Wyoming
Laramie, Wyoming 82071

March, 1975

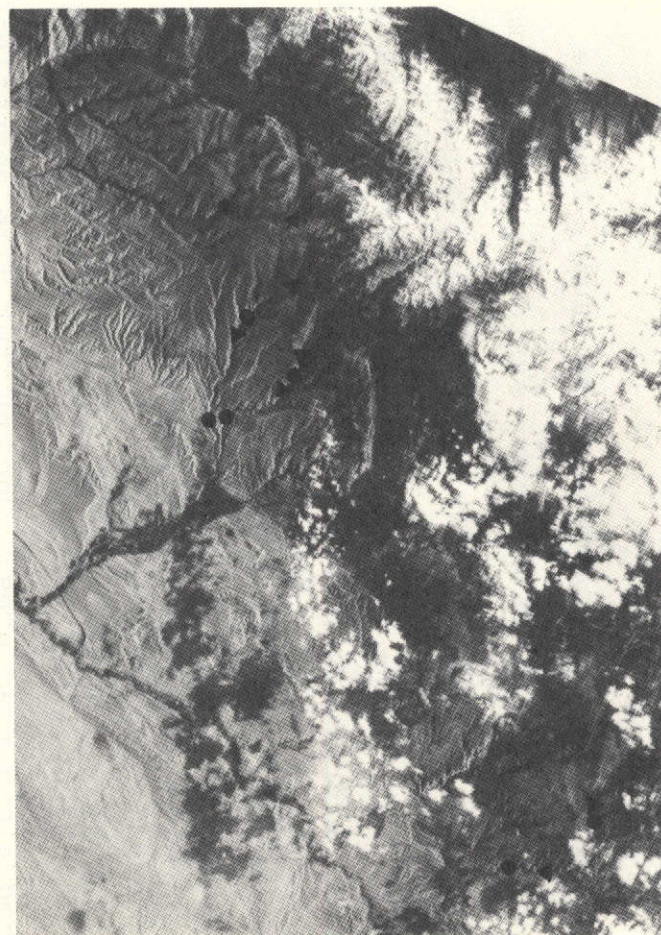
Figure 3a.

Skylab II Track 5 pass 10 S190-B photograph and ERTS-1 image 1409-17285-5 showing location of known sinks and springs on four creeks in the study area.

Paleozoic rocks cropping out in the study area include the Pennsylvanian Tensleep and Amsden formations, Mississippian Madison limestone, Ordovician Bighorn dolomite, and Cambrian Gros Ventre, Gallatin, and Flathead formations. Runoff flows from the Precambrian core of the Bighorn Mountains across the Paleozoic section and into the Bighorn Basin. Water normally carried in surface streams often sinks as it flows over the outcrops of the Bighorn dolomite, the first Paleozoic carbonate encountered in the downstream direction. Down-gradient, but up-section, a portion of the water lost to sinks reappears in springs. Known sinks and springs are located on Figures

3a and 3b. All the upstream sinks are found in the Bighorn dolomite. Springs downstream are usually found in the Madison limestone. In two cases the water sinks and rises twice in a single drainage.

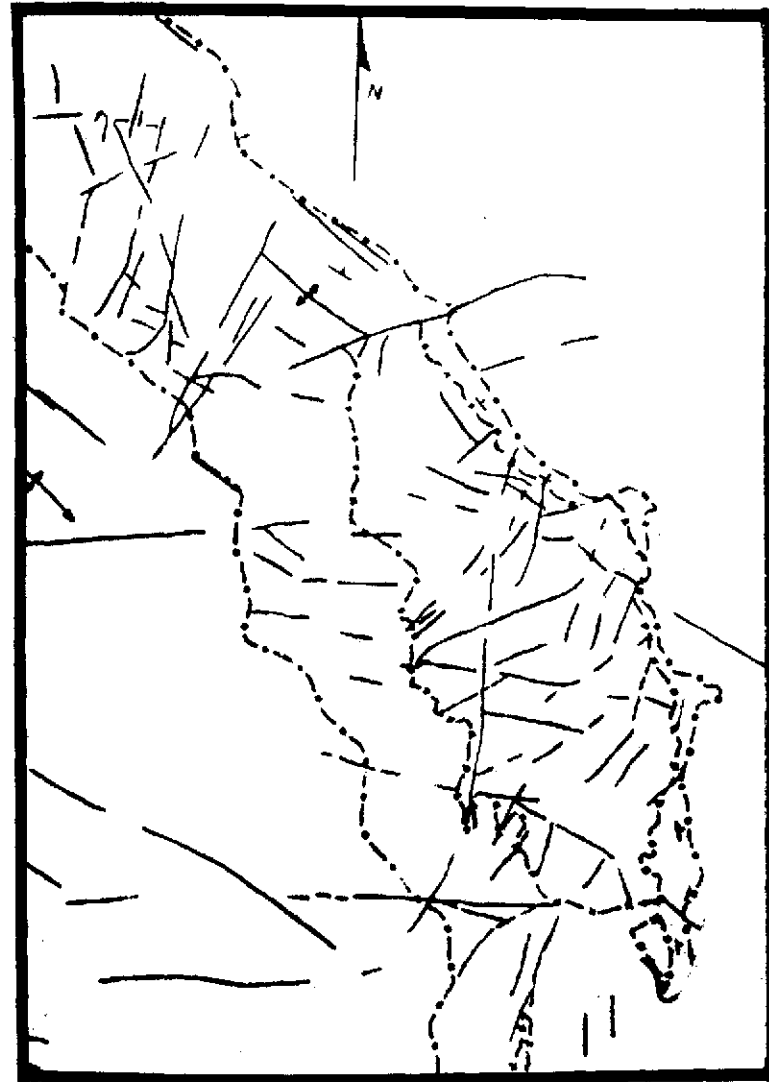
Photolineation maps of the Bighorn Mountains, compiled by Blackstone (1973) and Hoppin (1973).

Lineation maps of the study area have been prepared by Blackstone (1973, Figure 6a), Hoppin (1973), Hoppin and Jennings (1971, Figure 6b), and Earle (unpublished, Figure 6c). Each map is somewhat different and reflect different interpretations. Two photolinear maps were compiled by the author for this report using ERTS (Figure 7a) and Skylab (Figure 7b). For the purpose of this compilation a lineation is defined as any feature (large or small) that appears to have lateral continuity. Such features include aligned stream channels and structural lineaments. Care was taken to eliminate cultural-related lineations such as tree lines, clear cutting, and fence lines. Figure 7a is a representation of "major" lineations or very broad scale
