NASA CR-132611

FINAL REPORT  
FABRICATION AND TESTING OF  
PRESTRESSED COMPOSITE ROTOR BLADE  
SPAR SPECIMENS

Prepared Under Contract No. NAS1-11594

ARDE, INC.  
19 Industrial Avenue  
Mahwah, New Jersey 07430

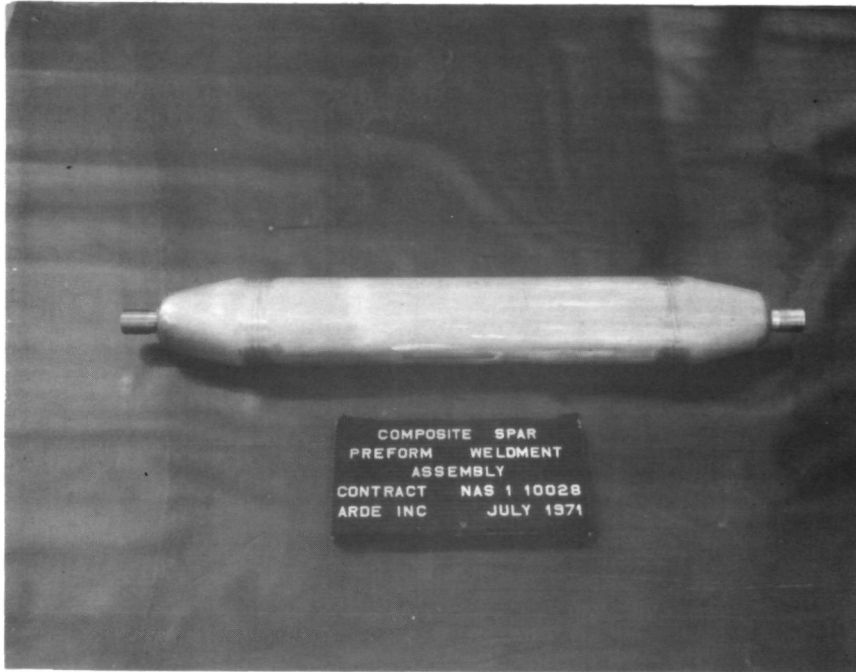
FIGURE 8

COMPLETED COMPOSITE SPAR PREFORM  
WELDMENT ASSEMBLY

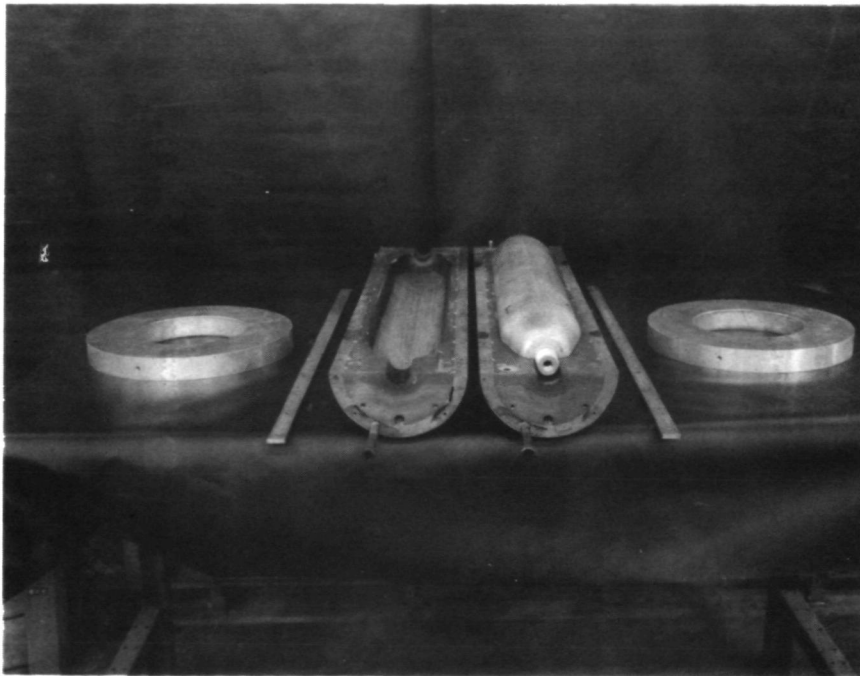
FIGURE 10

HYDROSTRETCH DIE

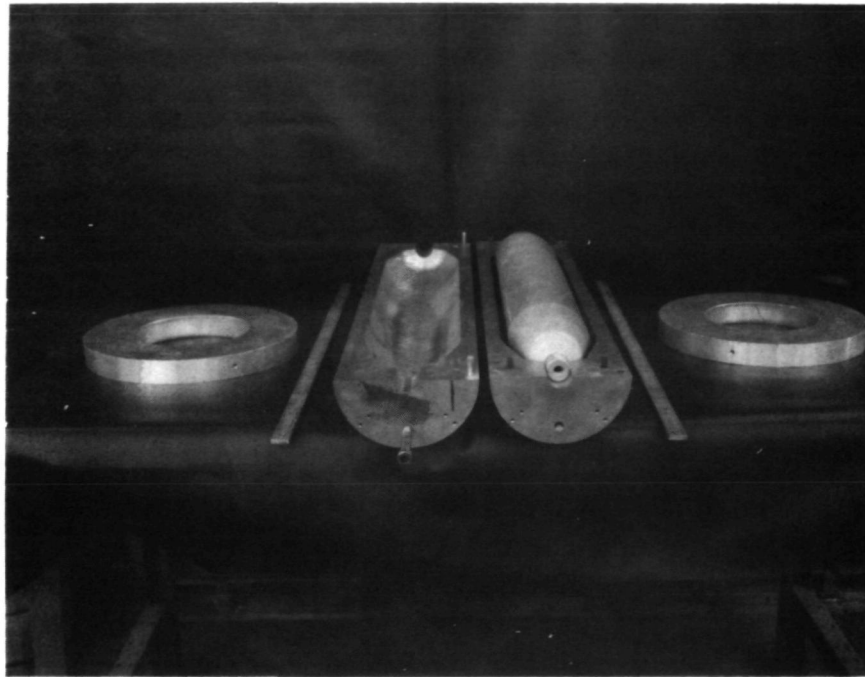
FIGURE 15

CRYOGENIC STRETCH DIE COMPONENTS

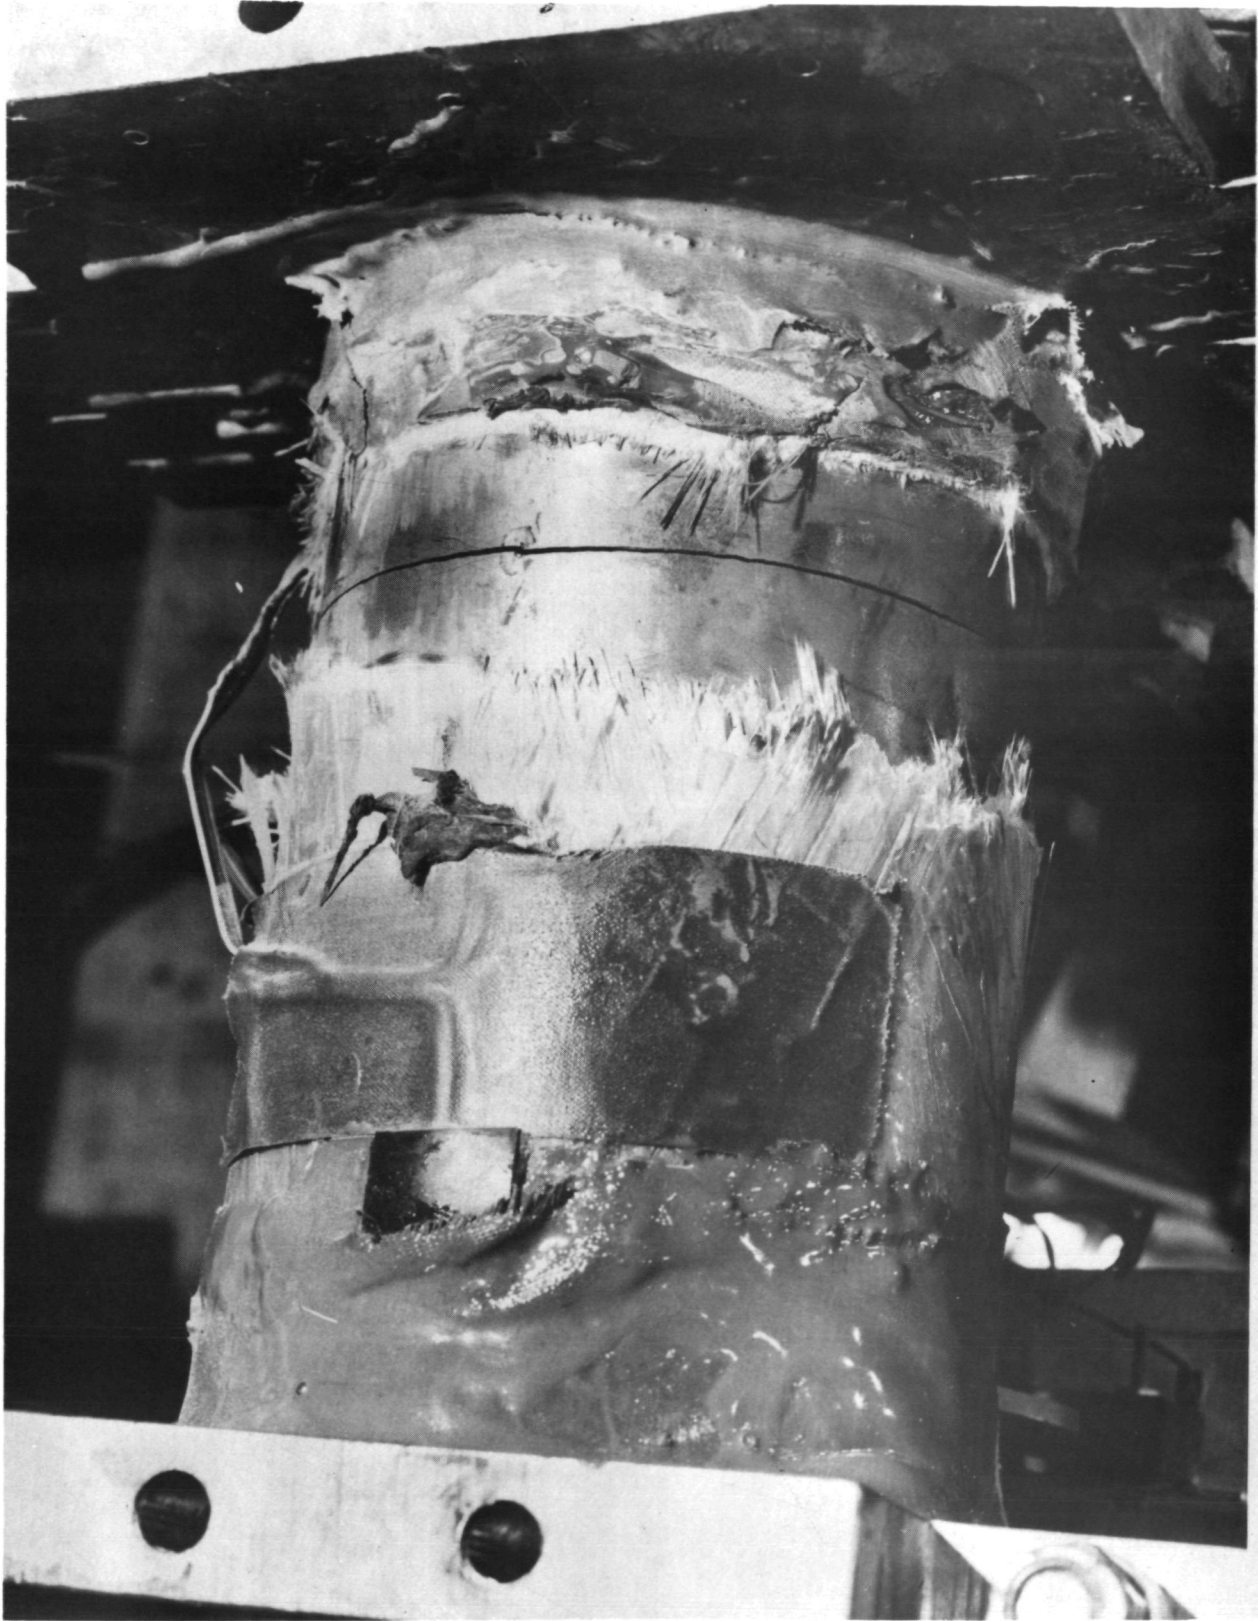
Figure 37

SPECIMEN #3 DURING CRACK PROGRESSION TEST
