NASA CR-2487

EVALUATION OF WET TANTALUM CAPACITORS  
AFTER EXPOSURE TO EXTENDED PERIODS  
OF RIPPLE CURRENT

Volume II

MARTIN MARIETTA AEROSPACE

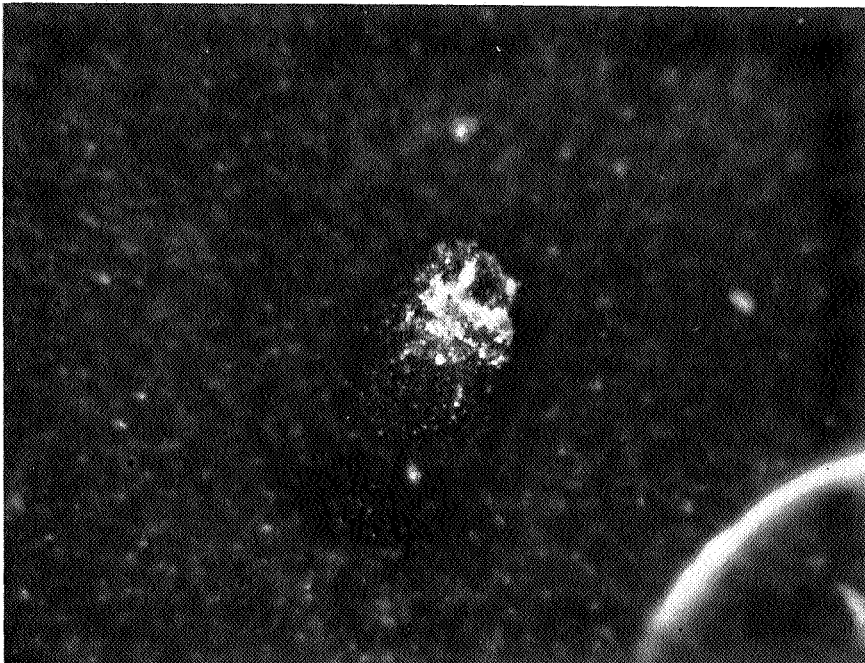
Photo #2  
Silver area on bottom of  
Anode S/N 51. -21  
300 hr. (70X)

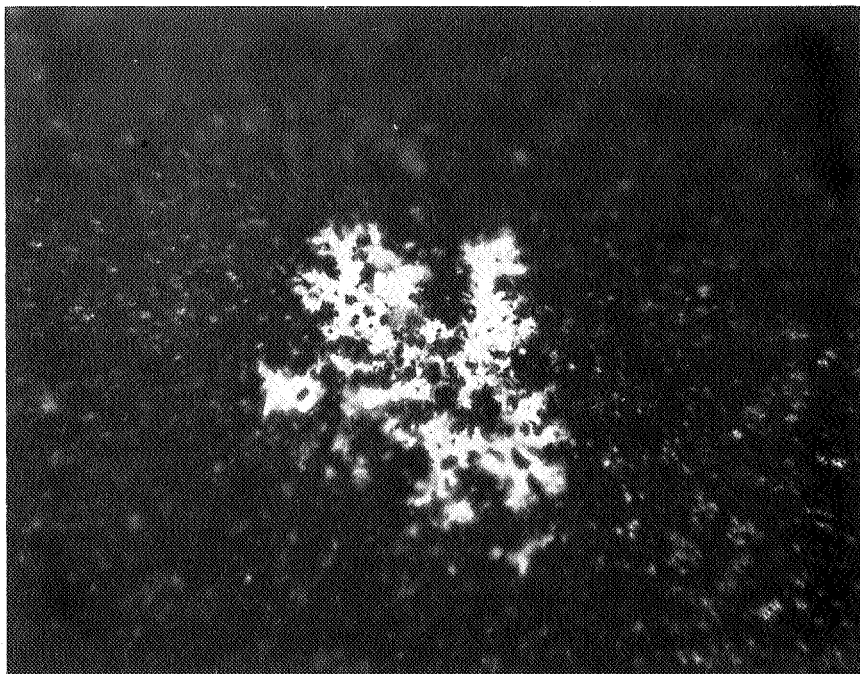
Photo #4

Silver flower on S/N 35.  
(280X)

These crystals were not  
identified, however, were  
composed of Ag<sub>2</sub>S.  
(100X)

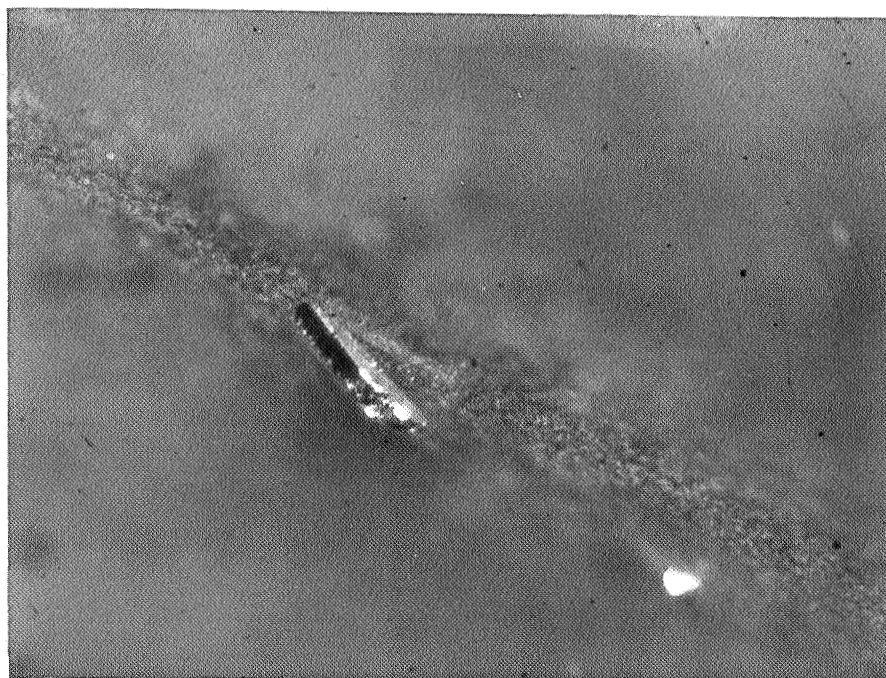
Photo #6

Magnified view on crystal  
from case of S/N 194.  
These crystals were not  
identified; however, were  
comprised of Ag-PT.  
(140X)

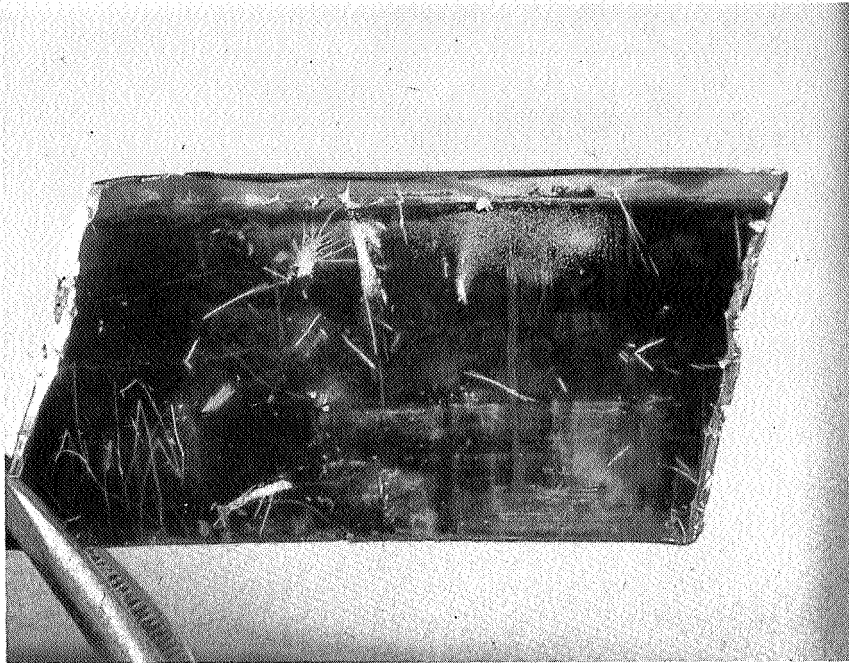
Photo #7

Typical inside of case  
which displayed the  
silver redeposition.  
S/N 78 -21.

The silver sprays and redeposition are probably related to ripple as it is believed that silver is in a dynamic exchange into and out of solution due to current flow at the case. When silver replates on the case it would easily tend to form around existing silver particles and lead to large redeposited areas. These redepositions have been previously reported along with large silver sulfate crystals<sup>1</sup>.
