1. Report No. NASA CR- 134735		2. Government Accession No.		3. Recipient's Catalog No.	
4. Title and Subtitle Coatings for Directional Eutectics				5. Report Date October, 1974

6. Performing Organization Code	
7. Author(s) E.J. Felten, T.E. Strangman and N.E. Ulion				8. Performing Organization Report No. PWA-5091	
9. Performing Organization Name and Address Pratt & Whitney Aircraft Division United Aircraft Corporation East Hartford, Connecticut				10. Work Unit No.

14. Sponsoring Agency Code	
15. Supplementary Notes Project Manager, John P. Merutka, NASA Lewis Research Center, Cleveland, Ohio					
16. Abstract Eleven coating systems based on MCrAlY overlay and diffusion aluminide prototypes were evaluated to determine their capability for protecting the γ/γ' - δ (gamma/gamma prime-delta) directionally solidified eutectic alloy (Ni-20Cb-6Cr-2.5Al) in gas turbine engine applications. Furnace oxidation and hot corrosion, Mach 0.37 burner-rig, tensile ductility, stress-rupture and thermomechanical fatigue tests were used to evaluate the coated γ/γ' - δ alloy. The diffusion aluminide coatings provided adequate oxidation resistance at 1144°K (1600°F) but offered very limited protectio

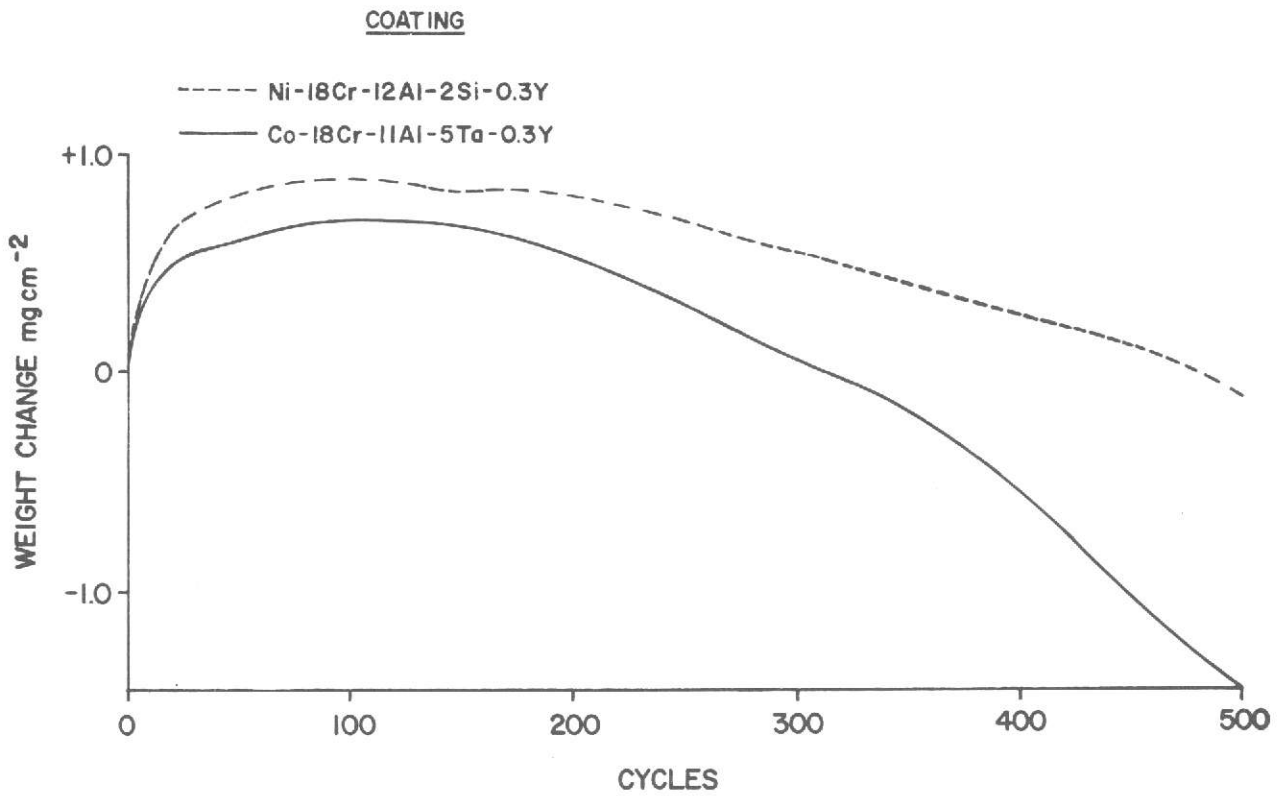
Figure 13 1366° K (2000°F) Cyclic Oxidation Behavior Of Plasma Spray Overlay Coated Eutectic Alloy Coupons.

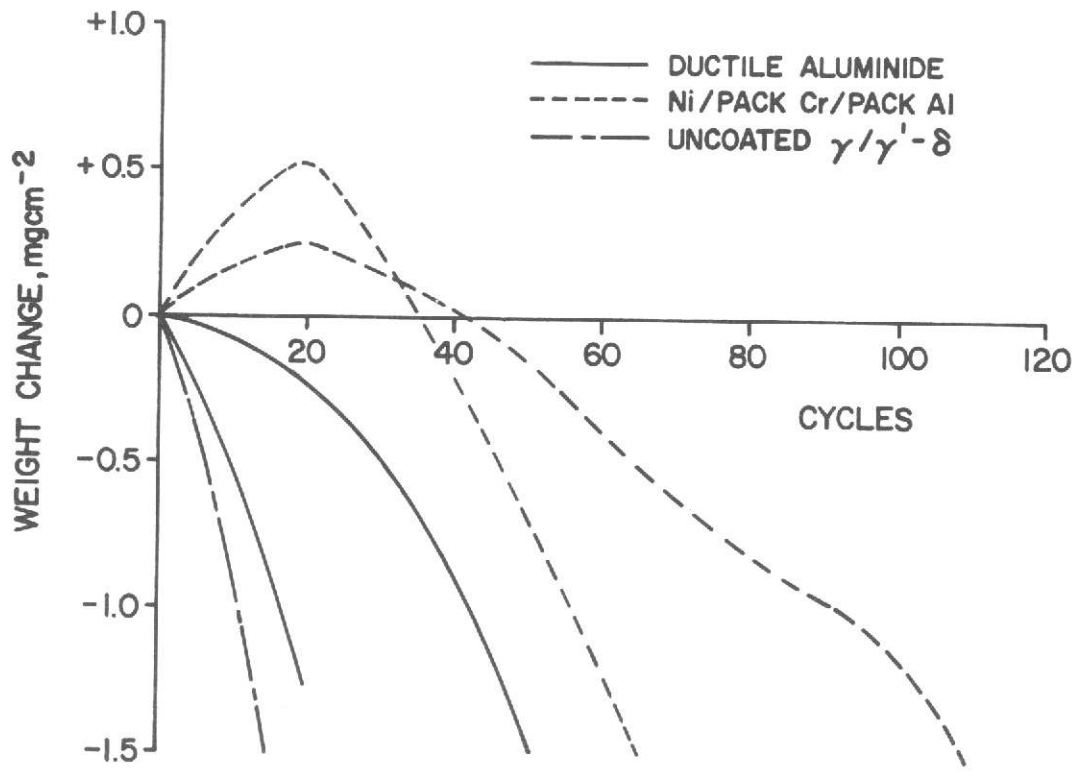
Figure 14 The 1366°K (2000°F) Cyclic Oxidation Behavior Of The γ/γ' - δ Eutectic Alloy, Uncoated And Coated With Two Diffusion Aluminide Coatings.

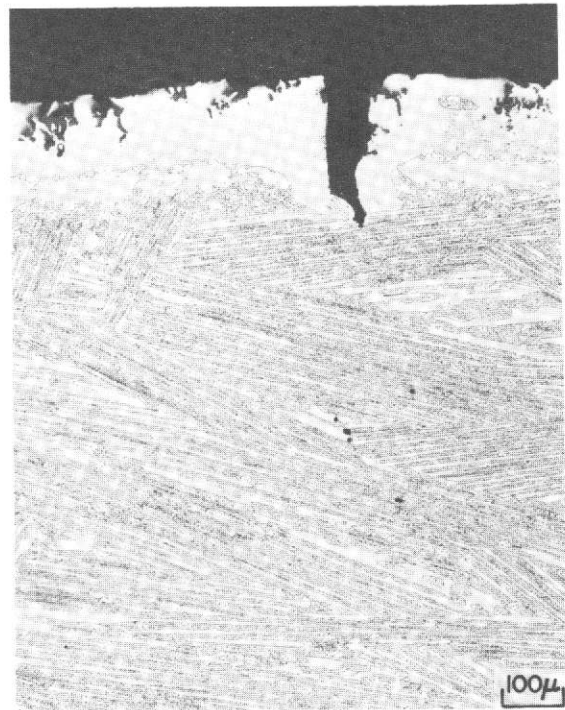
Figure 46 Surface Appearance of Thermal Fatigue Cracks in the Leading Surface of NiCrAlY/Al Coated $\gamma/\gamma' - \delta$ Erosion Bar (R-7406) After 89, 493 and 1016 Hours of Testing in the Burner Rig 1366° K (2000°F) Cyclic Oxidation Test. Post-Test Examination of This Region Shows Crack Propagation into the $\gamma/\gamma' - \delta$ Substrate.

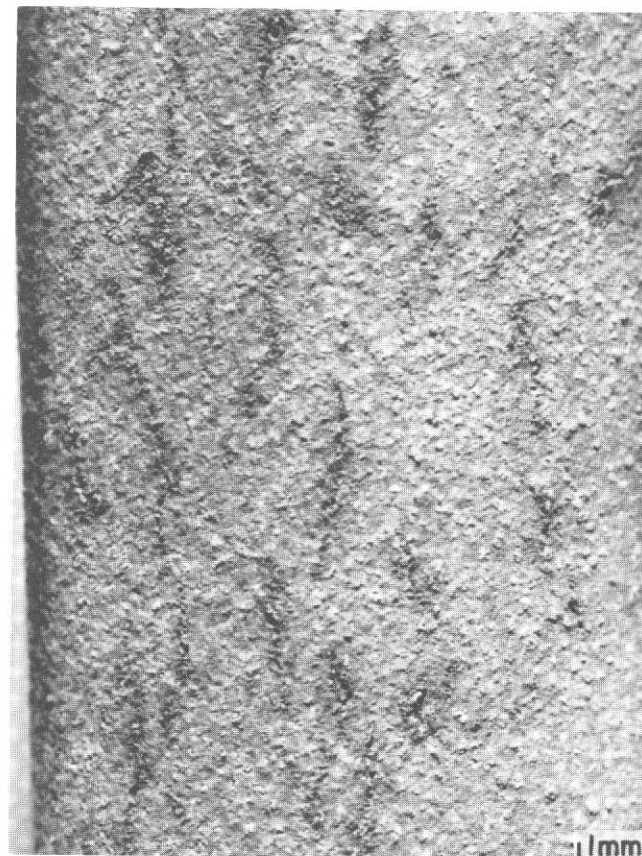
Figure 47 Surface Appearance of Thermal Fatigue Cracks in the Trailing Surface of NiCrAlY/Al Coated $\gamma/\gamma' - \delta$ Erosion Bar (R-7406) After 818 (Left) and 1016 Hours (Right) of Testing in the Burner Rig 1366°K (2000°F) Cyclic Oxidation Test. Cracks Appear to be Developing into Localized Oxidation Failures. Post-Test Metallographic Examination of this Area (Figure 48) Indicated that the Coating Cracks Propagated into the $\gamma/\gamma' - \delta$ Substrate.

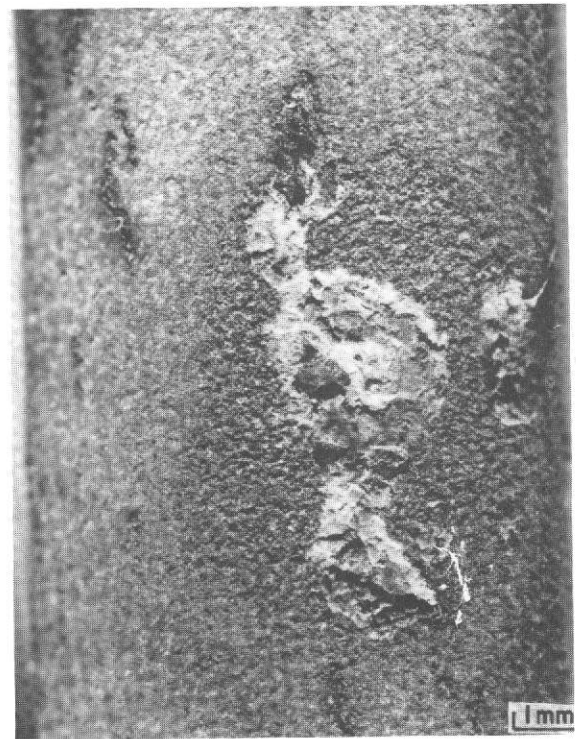
Figure 51 Surface Appearance of Thermal Fatigue Cracks in the Trailing Surface of NiCoCrAlY Coated $\gamma/\gamma' - \delta$ Erosion Bar (R-7409) After Indicated Time in the Burner Rig 1366°K (2000°F) Cyclic Oxidation Test. Localized Oxidation Failures of the Coating Were Initiated at the Thermal Fatigue Cracks.

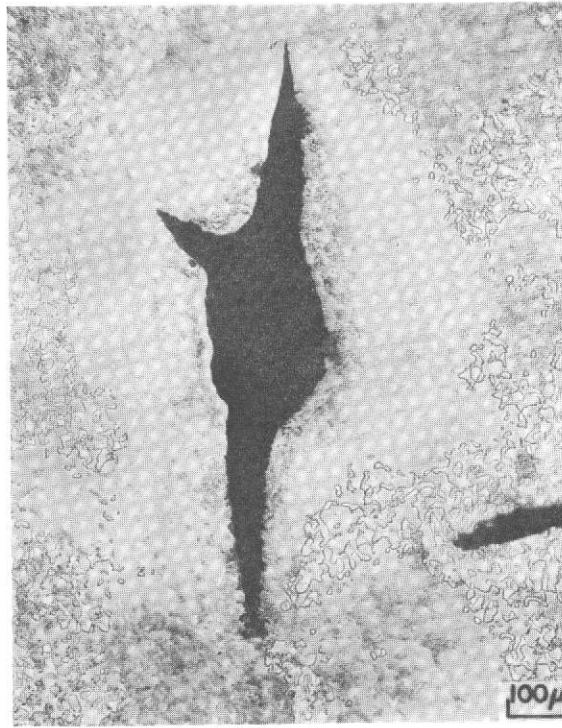
Figure 57 Surface Appearance (left) of the Largest Thermal Fatigue Crack (Which Initiated at a Coating Pit) in NiCrAlY/Pt Coated γ/γ' - δ Erosion Bar (R-7414) Which Was Evaluated for 1016 Hours in the Burner Rig 1366°K (2000°F) Cyclic Oxidation Test. Post-Test Planar (Center) and Cross Section (Right) Microstructures Indicate That the Coating is Locally depleted Adjacent to the Crack and That the Crack had not Propagated Through The Diffusion Affected Substrate Layer
