NASA CR-134657
BAC Report No. 8654-953005

FINAL REPORT APPENDIX

NONDESTRUCTIVE TESTS OF REGENERATIVE CHAMBERS

JUNE 1974

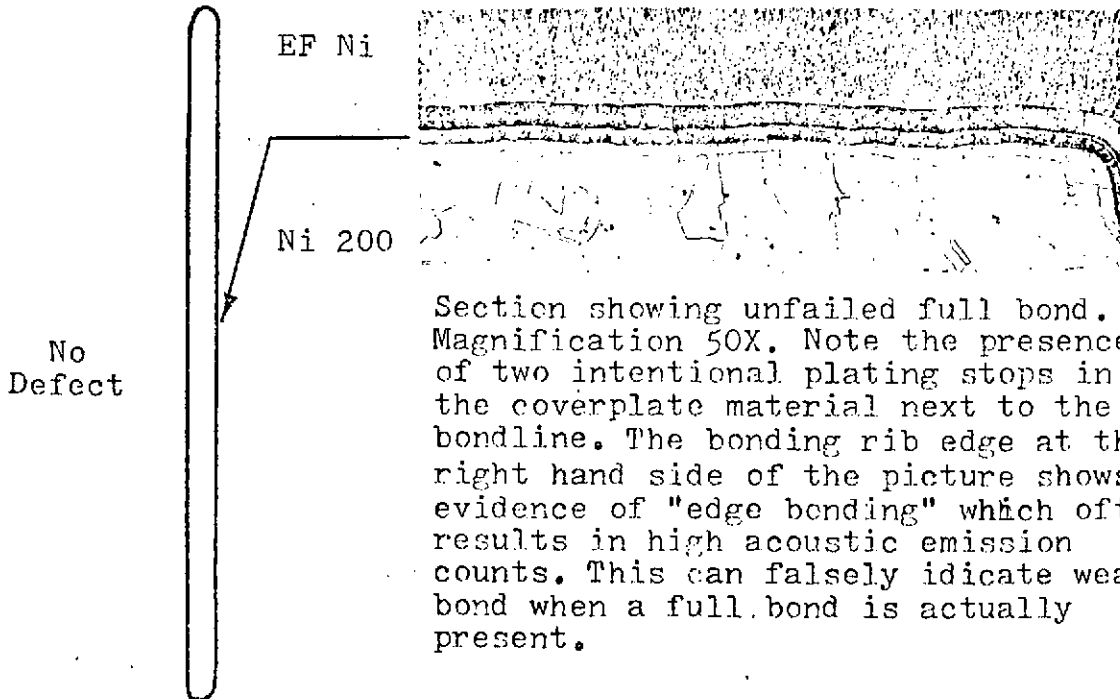
FIGURE A-1

Section showing unfailed full bond. Magnification 50X. Note the presence of two intentional plating stops in the coverplate material next to the bondline. The bonding rib edge at the right hand side of the picture shows evidence of "edge bonding" which often results in high acoustic emission counts. This can falsely indicate weak bond when a full bond is actually present.

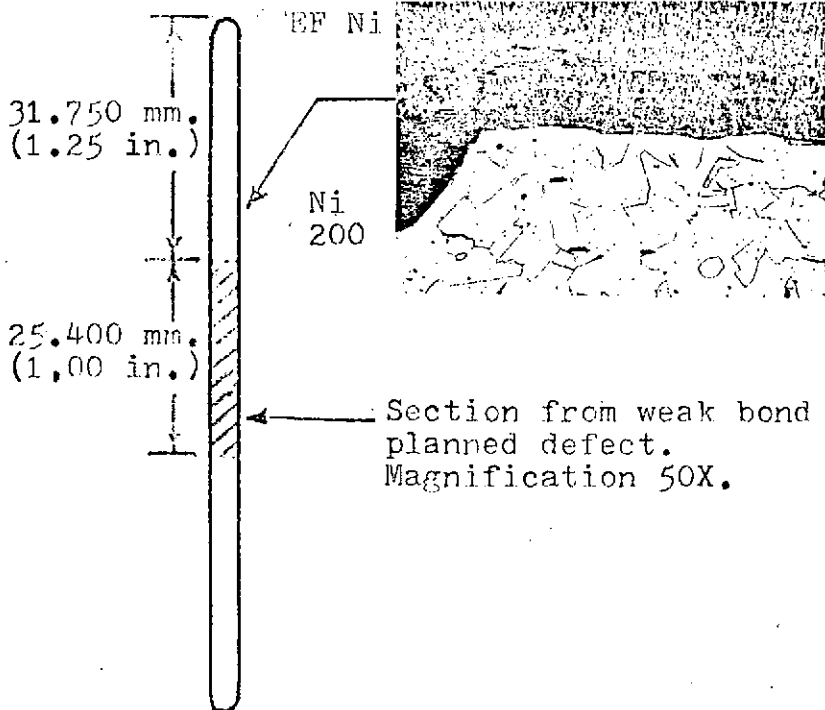
Full bond area. Note
initiation of bond
tearing. Magnification
50X.

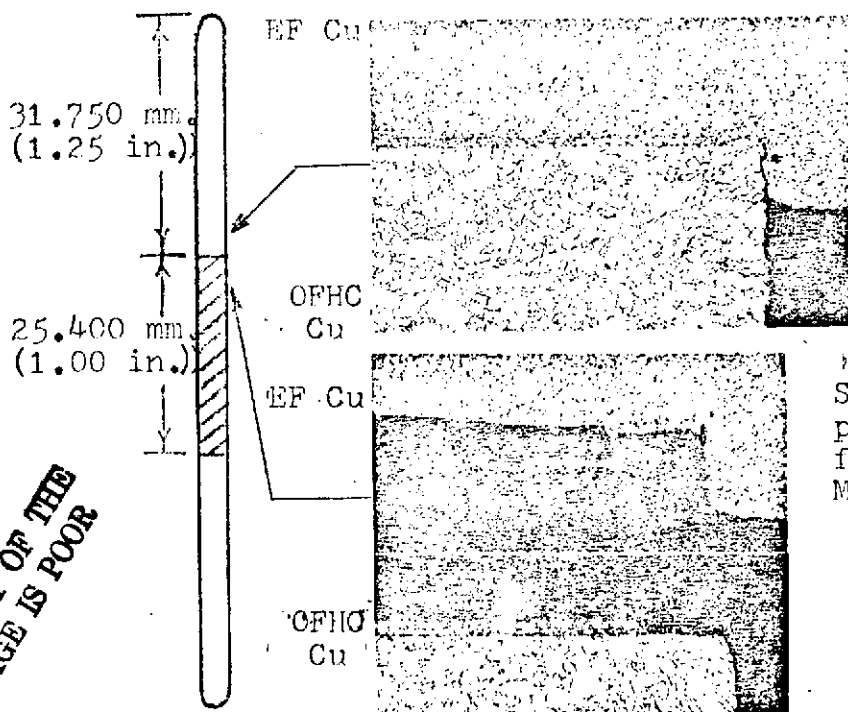
Full bond area of
land showing no
bond failure.
Magnification 50X.

Section of weak bond
planned defect. Bond
failure occurred.
Magnification 50X.

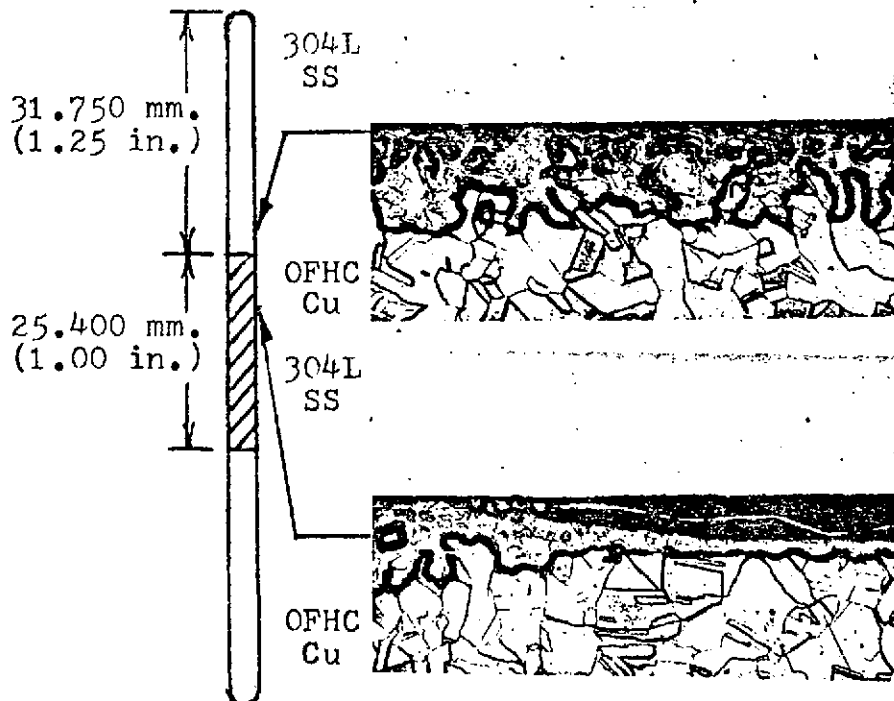
Section showing full bond adjacent to the planned weak bond. Magnification 50X.

Section from the planned weak bond area showing regions of poor braze wetting of the Stainless coverplate. Magnification 50X.

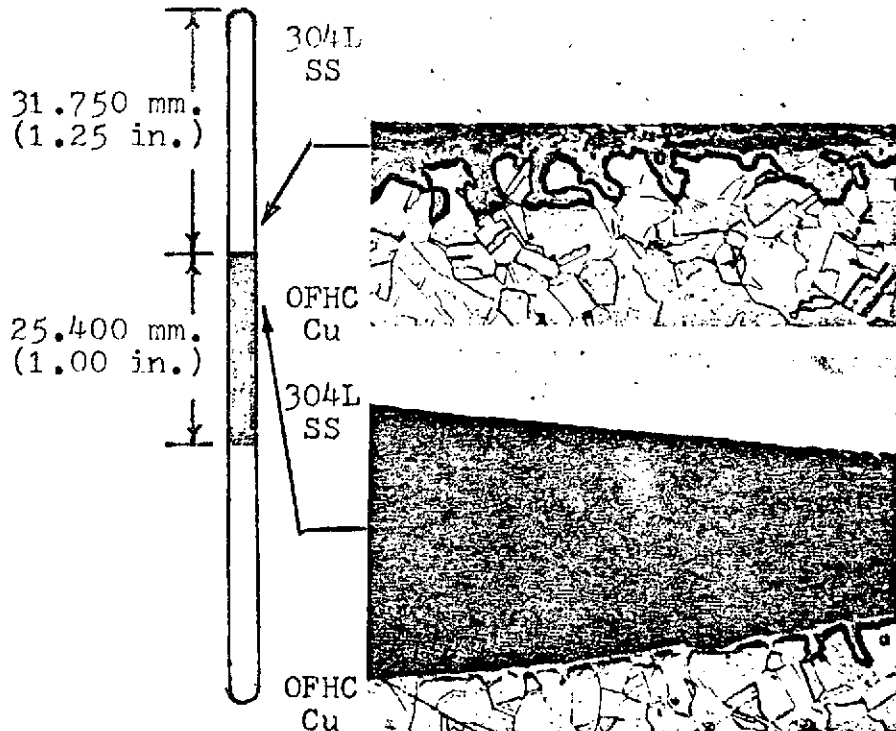
Section from full bond adjacent to the planned non-bond. Some braze failure was initiated. Magnification 50X.

Illustration of separation which occurred in the planned nonbond. Magnification 50X.

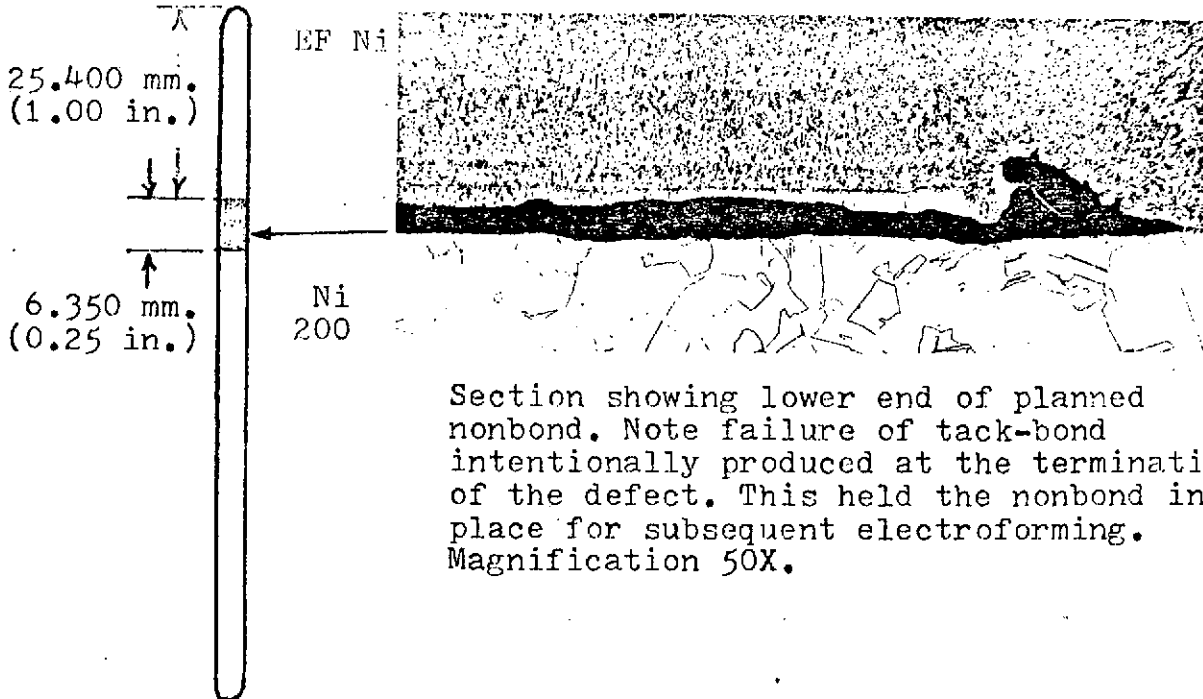
FIGURE C-4

Section showing lower end of planned nonbond. Note failure of tack-bond intentionally produced at the termination of the defect. This held the nonbond in place for subsequent electroforming. Magnification 50X.

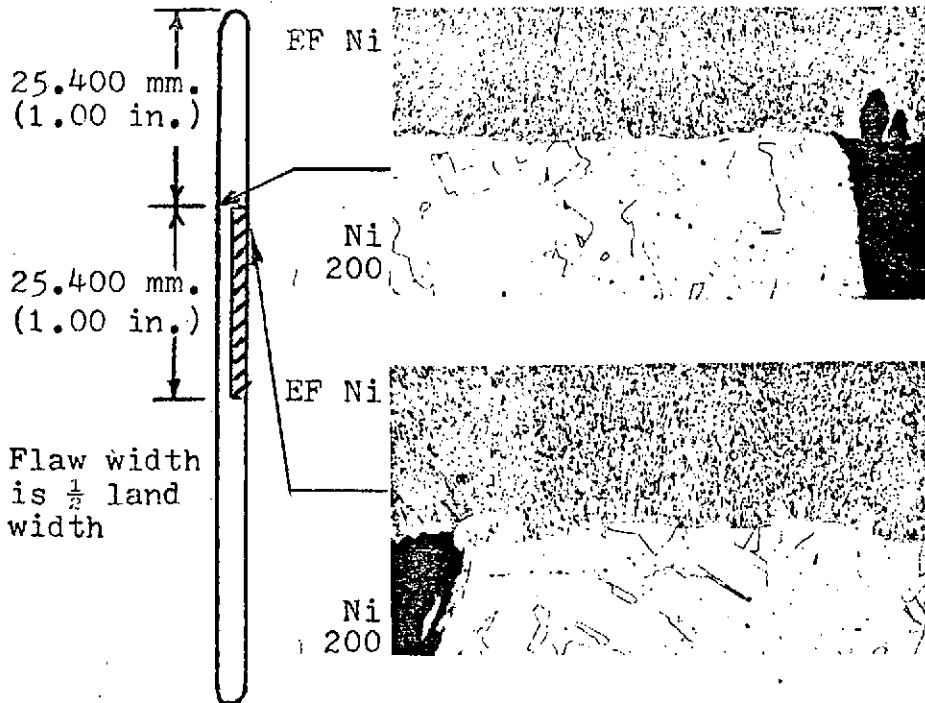
Full bond section.
Some failure was
initiated at land
edge. Magnification
50X.

Planned defect area.
No bond failure is
indicated. Some
intermittent failure
may have occurred.
Magnification 50X.

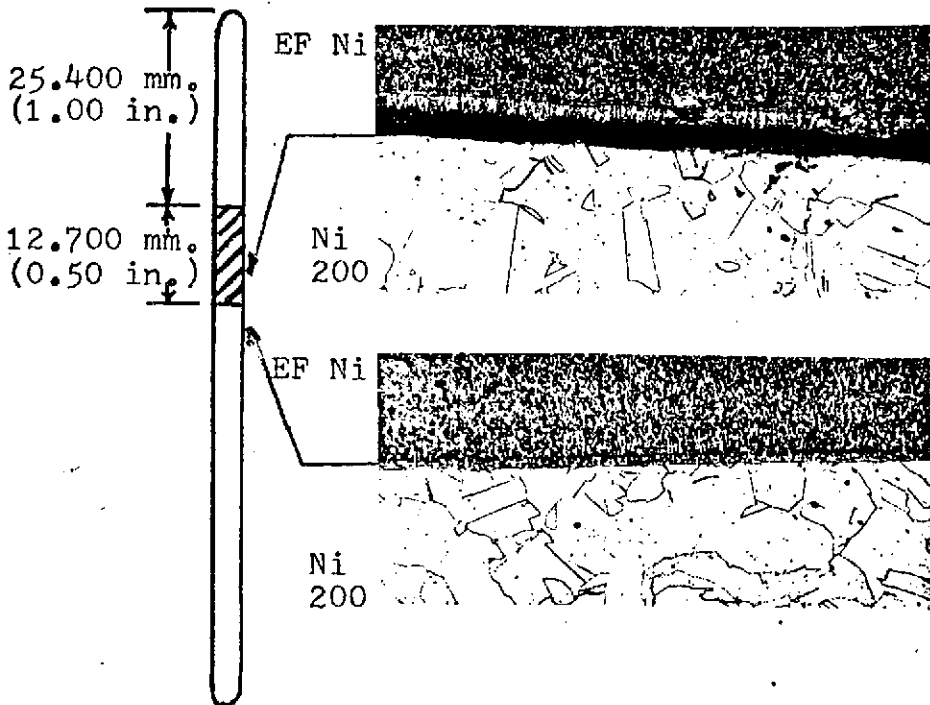
Section showing planned weak bond failure. Bond was quite weak as evident from the lack of significant metal disturbance. Magnification 50X.

Planned full bond region near the weak bond above. No failure evident. Magnification 50X.

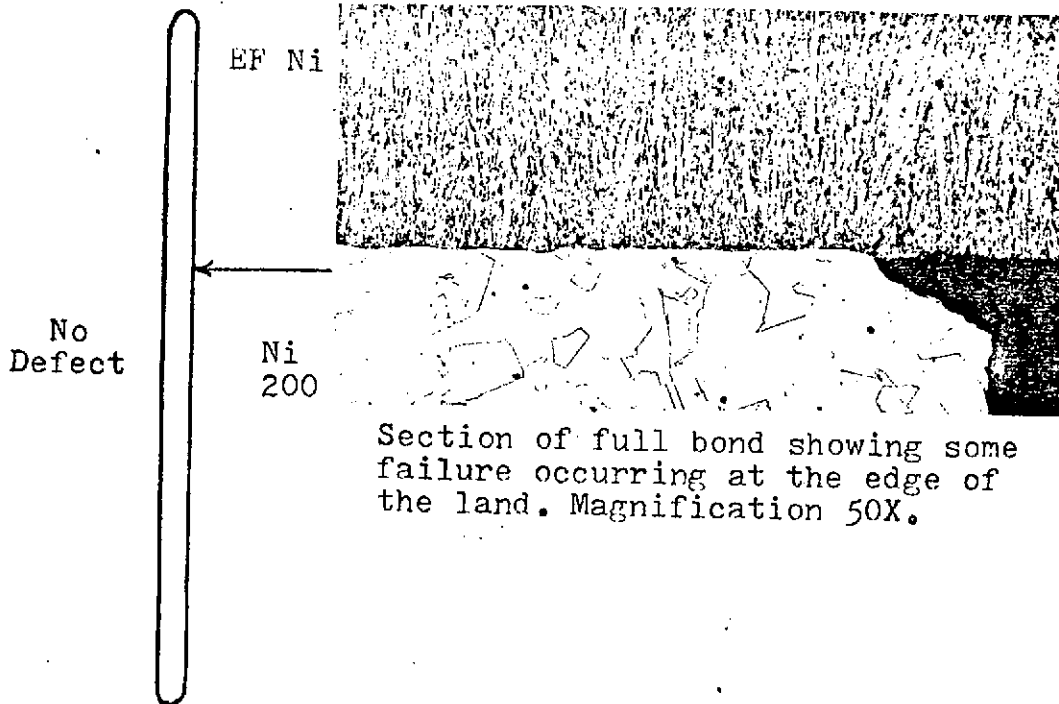
FIGURE C-12

Section of full bond showing some
failure occurring at the edge of
the land. Magnification 50X.

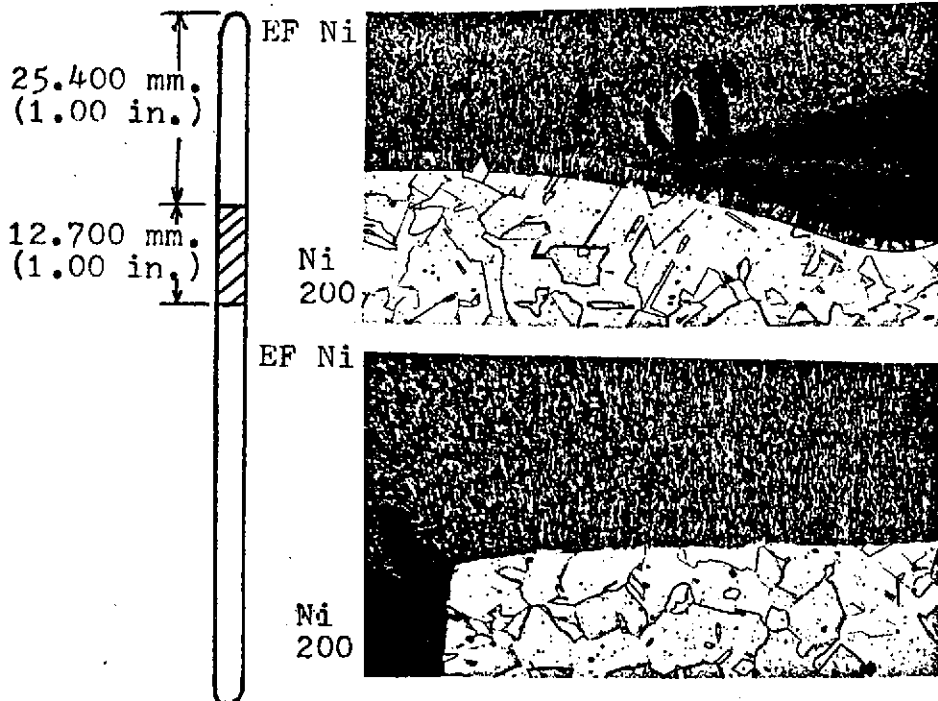
Section from the
planned weak bond
showing progress
of failure.
Magnification 50X.

Section of the
full bond from
Land 3 illustrat-
ing no bond fail-
ure, but some
tearing of the
thin coverplate
is evident.
Magnification 50X.

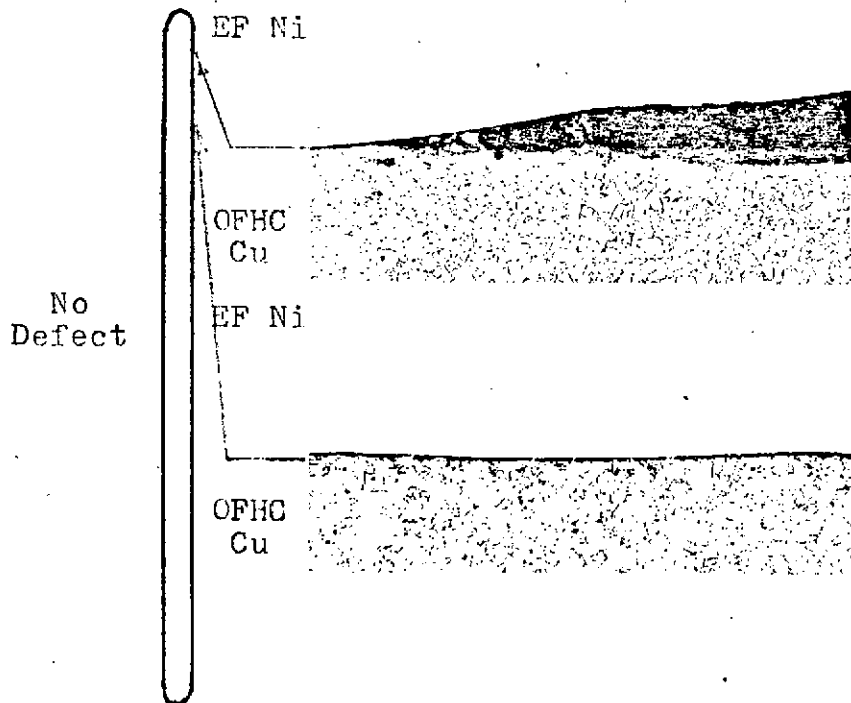
Area of planned full bond showing failure after destructive test. Magnification 50X.

Area of planned full bond next to failed region. No failure noted. Magnification 50X.

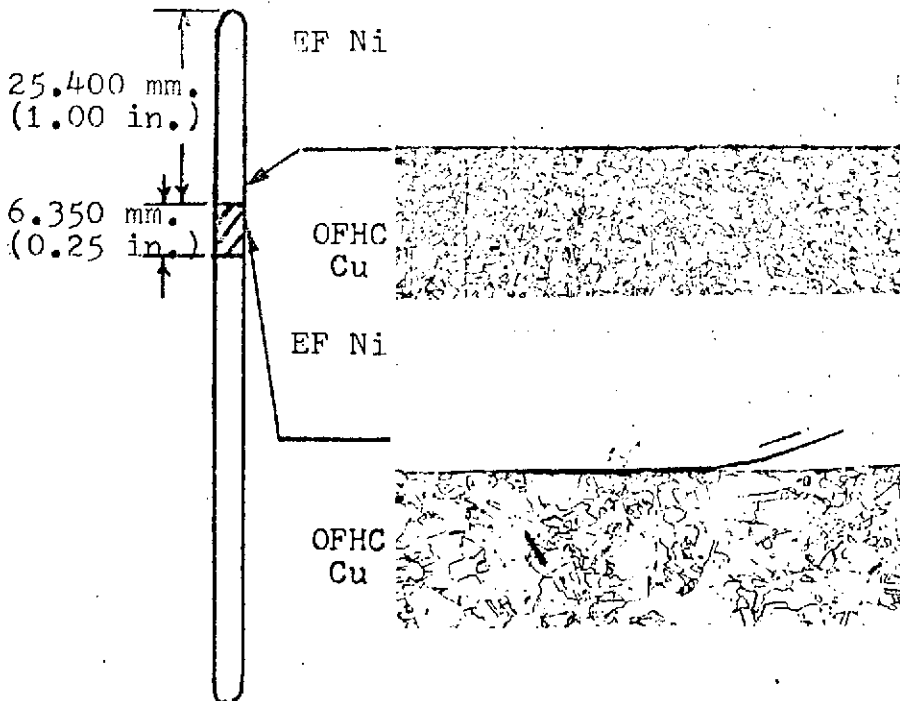
Section of full bond area adjacent to the planned weak bond. Magnification 50X.

Section of planned weak bond. Preparation of specimen removed most of the failure. Some traces remain. Magnification 50X.

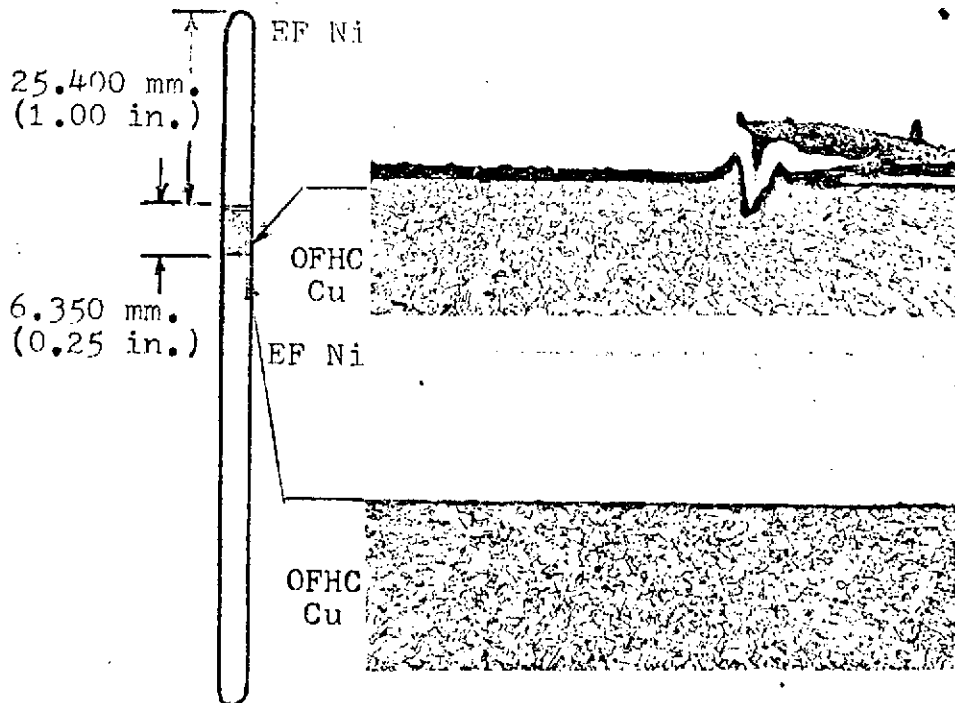
Section showing
termination of
nonbond as plan-
ned. Magnificat-
ion 50X.

Planned full bond
area adjacent to
the nonbond.
Magnification 50X.

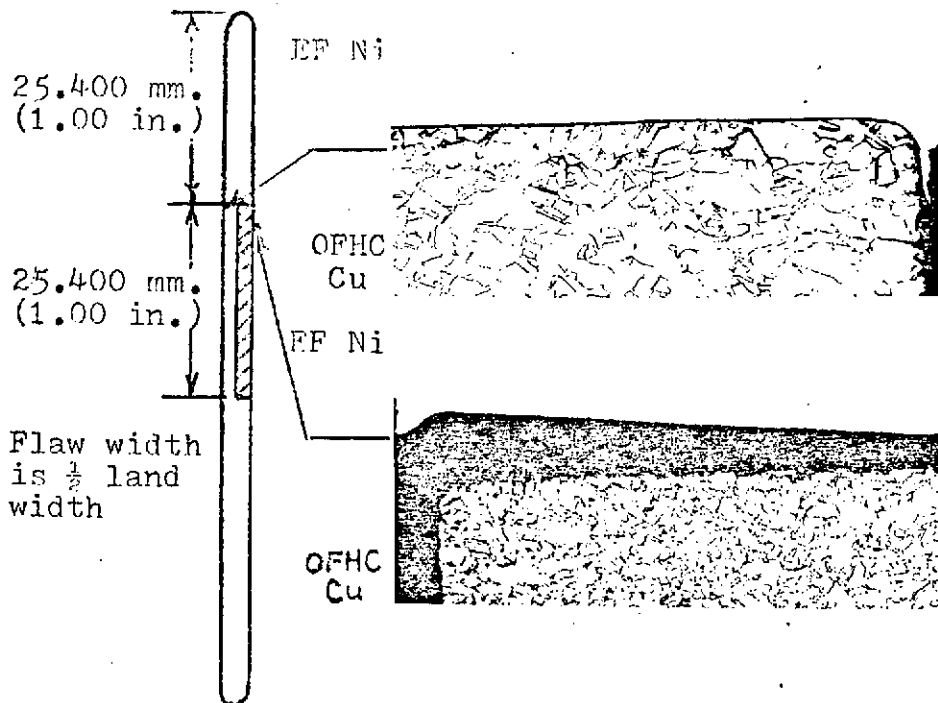
Full bond area next to planned weak bond. View appears reversed due to viewing direction. Magnification 50X.

Planned weak bond showing bond failure. Section appears reversed due to direction of viewing. Magnification 50X.

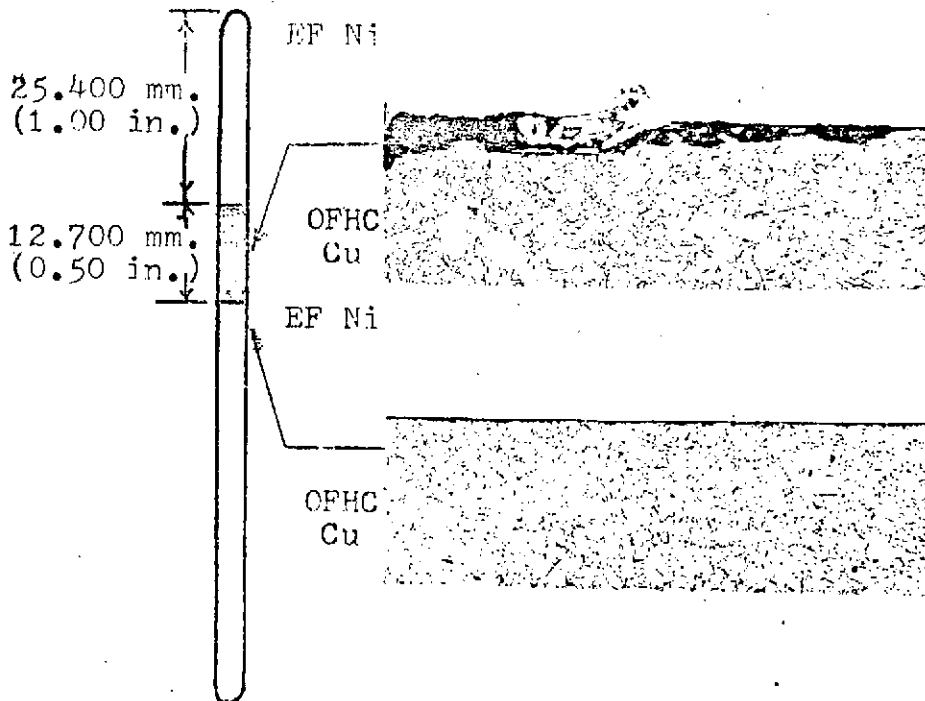
Section showing separation of the planned nonbond. Some full bond failed beyond the end of the nonbond. Magnification 50X.

Section of full bond from the middle land which exhibited no failure. Magnification 50X.

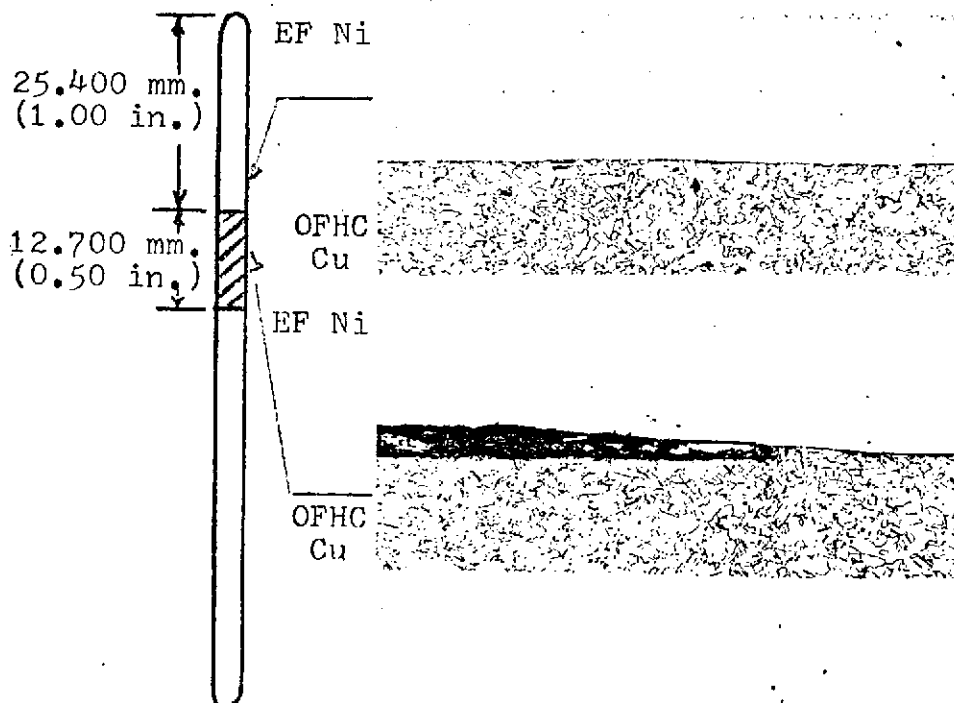
FIGURE C-30

Planned full bond
showing no fail-
ure after destruct-
ive test.
Magnification 50X.

Planned weak bond
which failed in
destructive test.
Magnification 50X.

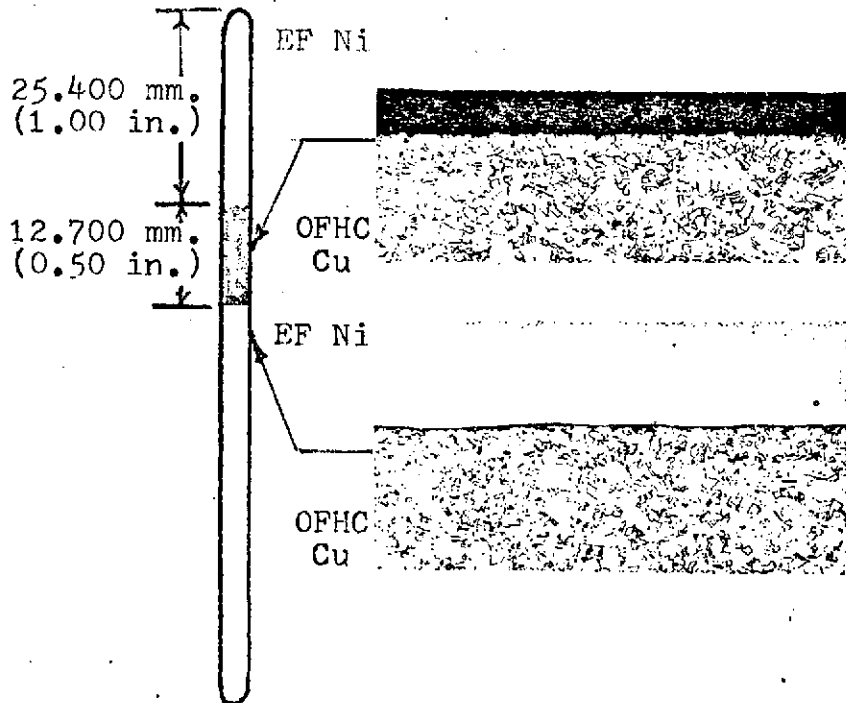
Section showing nonbond separation. Magnification 50X.

Section showing full bond adjacent to the planned nonbond. Magnification 50X.

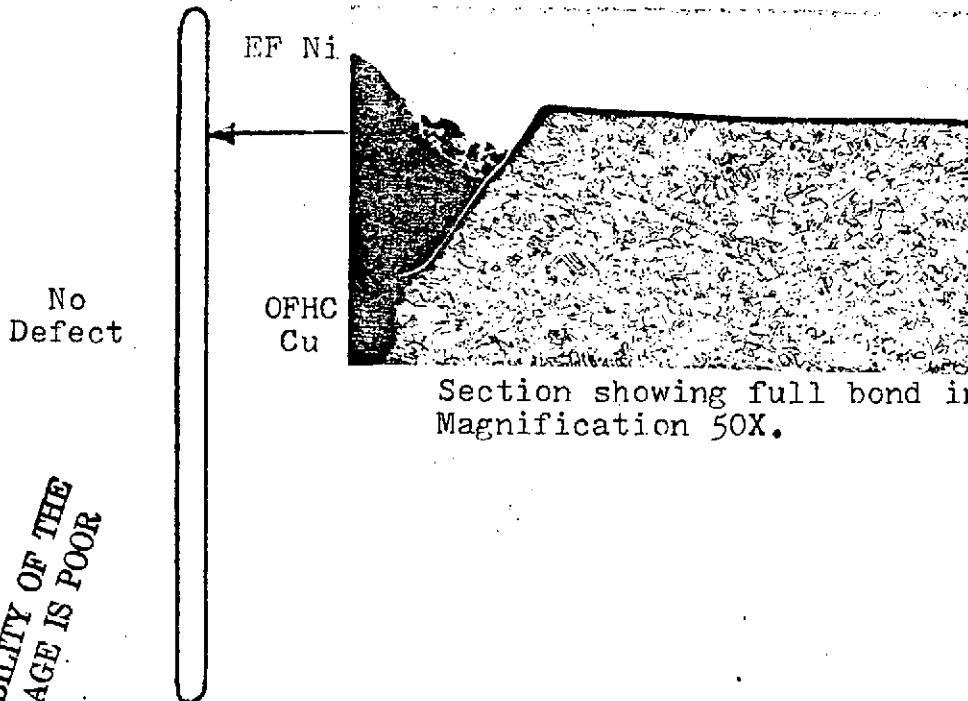
Section showing full bond intact.
Magnification 50X.

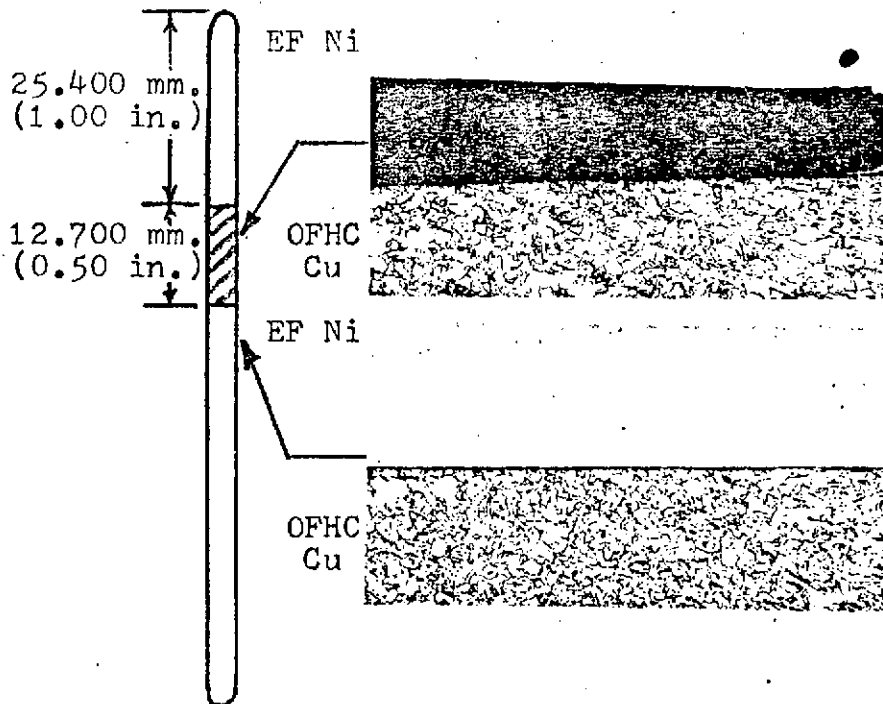
Section of planned weak bond showing separation after pressurization to destruction. Magnification 50X.

Section showing full bond from region just below the weak bond after destructive test. Magnification 50X.

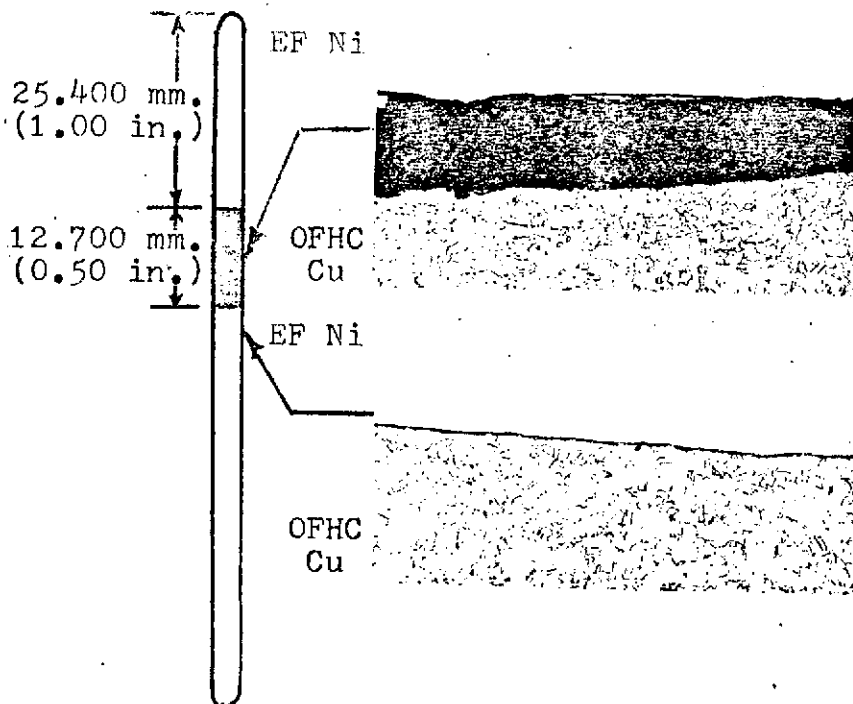
Section showing the planned nonbond separation after destructive test. Magnification 50X. Very slight metal disturbance indicates some "tack" bonding was present.

View of full bond area adjacent to the planned nonbond. Magnification 50X.

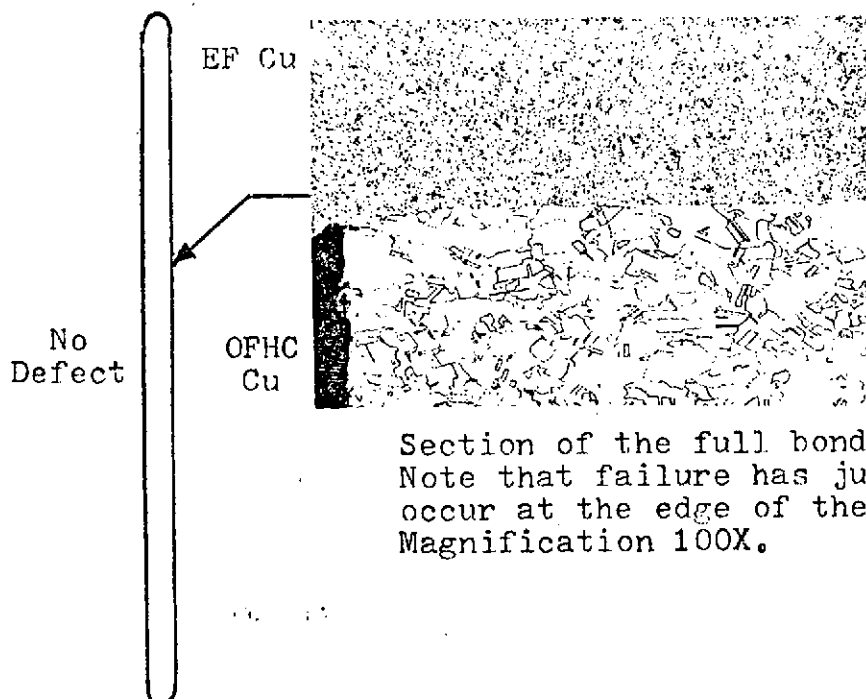
FIGURE C-37

Section of the full bond in Land 2.
Note that failure has just begun to
occur at the edge of the land.
Magnification 100X.

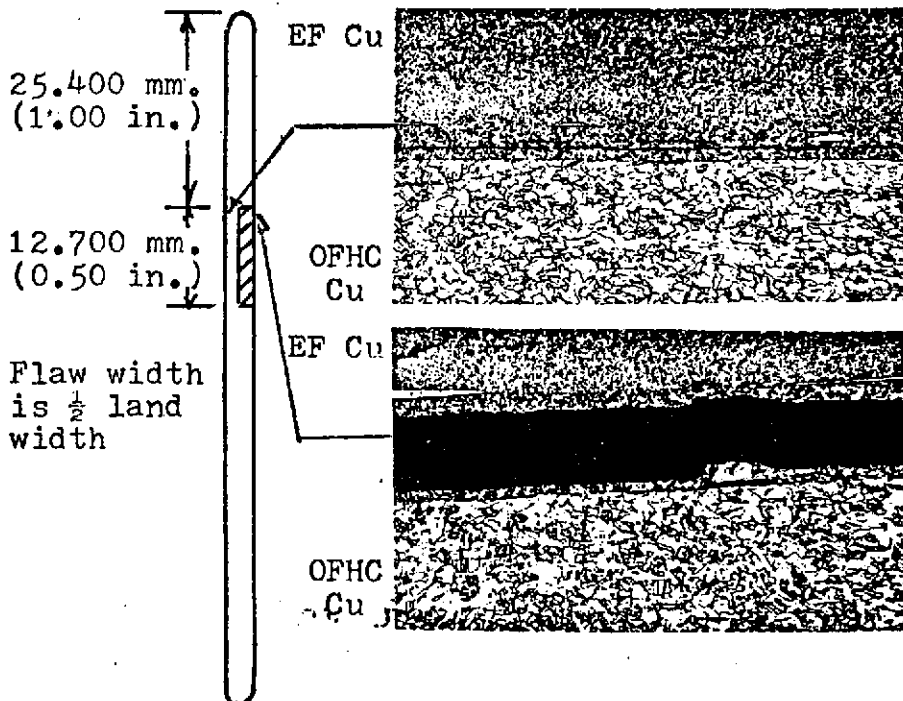
Section of planned full bond running parallel to the planned weak bond. Magnification 50X.

Section showing failure occurring in the planned weak bond area. Magnification 50X.

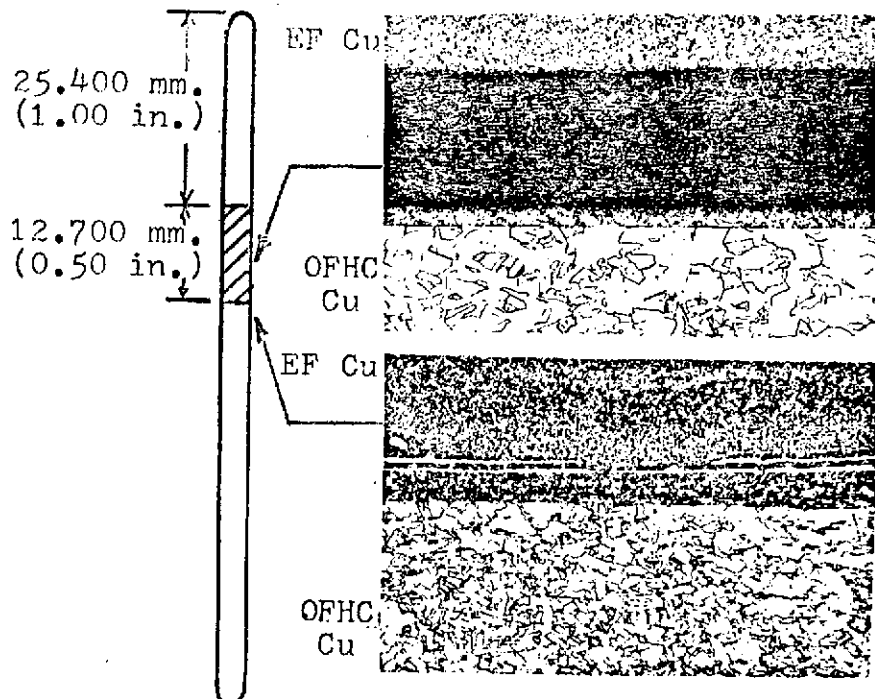
Section through the planned weak bond. Note separation as occurring between the initial copper deposit layer and subsequent build-up. Magnification 100X.

Section showing the full bond near the planned weak bond. Magnification 50X.

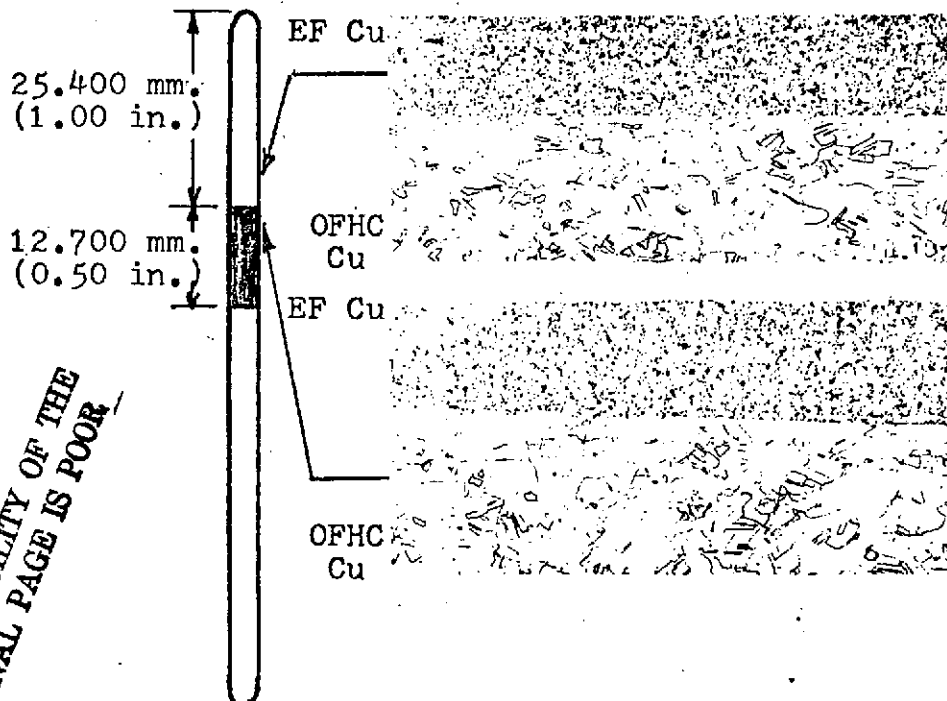
Section from the planned full bond area showing no failure after the destructive test. Magnification 100X.

Section from the planned nonbond. The bondline has the appearance of a full or weak bond and shows no evidence of failure. Magnification 100X.

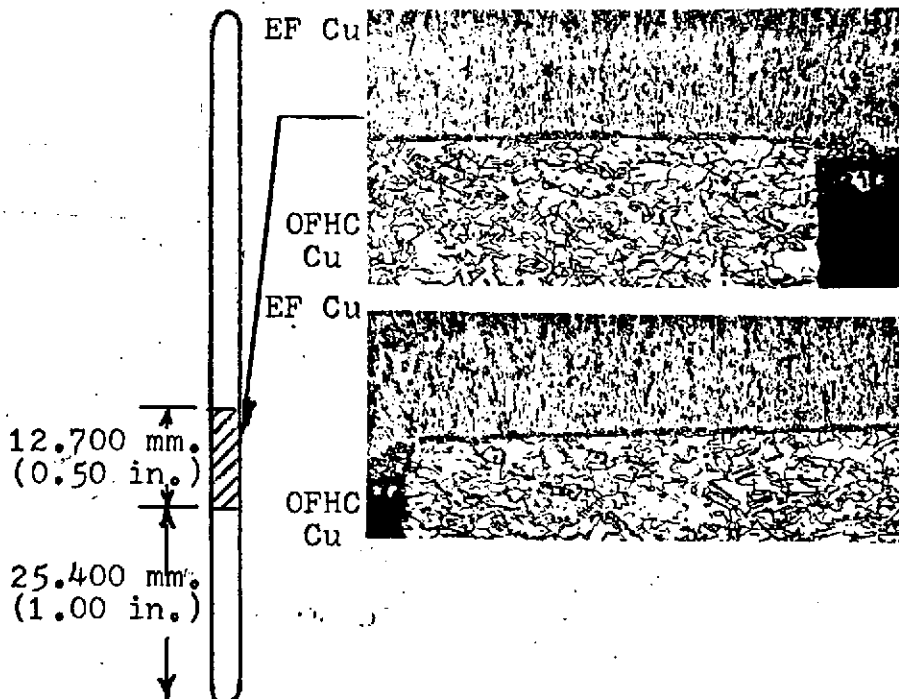
Section of the planned weak bond showing no failure. Coverplate failed at too low a pressure to fail bond. Magnification 50X.

Section of planned full bond on Land 3 adjacent to the Land 2 weak bond. Magnification 50X.

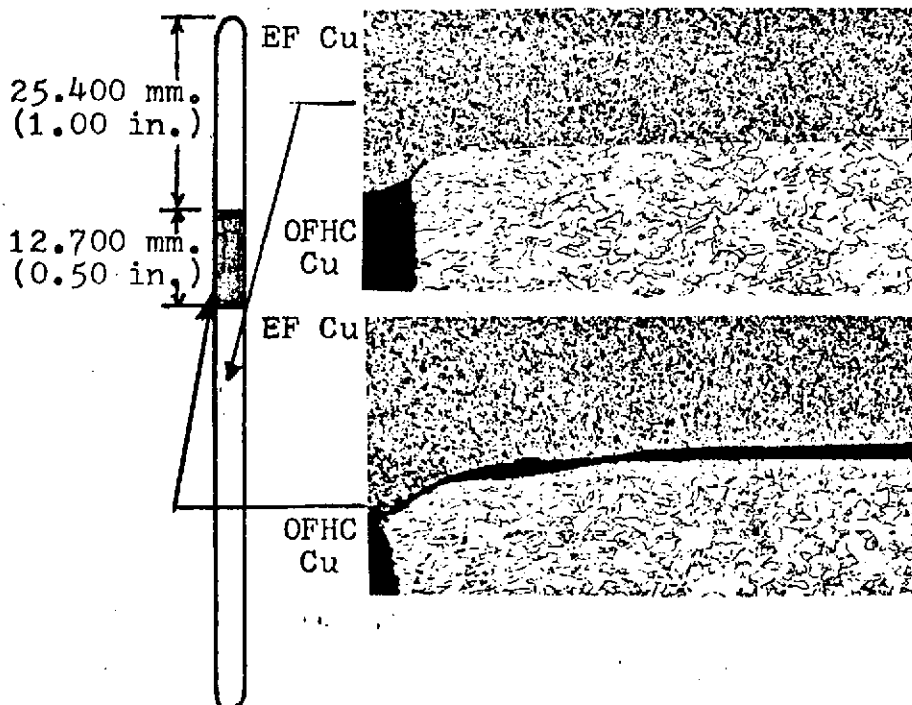
Full bond area next to planned nonbond. Note initiation of failure at land edge. Magnification 50X.

Separation of the planned nonbond; No metal disturbance was noted. Magnification 50X.

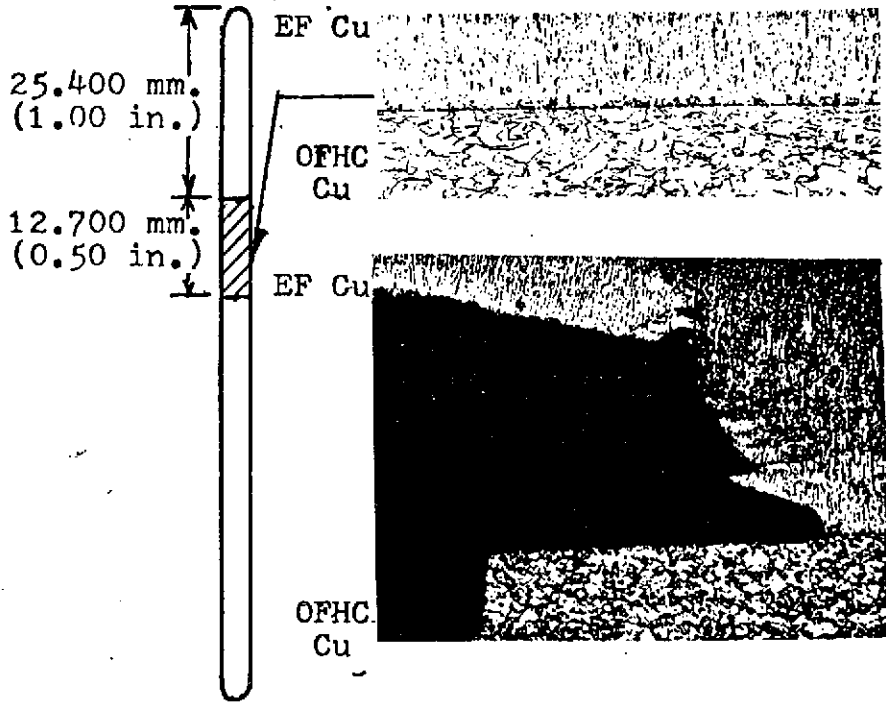
Section from planned weak bond indicates a full bond actually was obtained. No signs of failure are noted. Magnification 500X.

Panel failed in lower part of Land 1 and the manifold. Note failure occurred through an unplanned weak bond on one side of the land and tore through the copper coverplate. Magnification 32X.

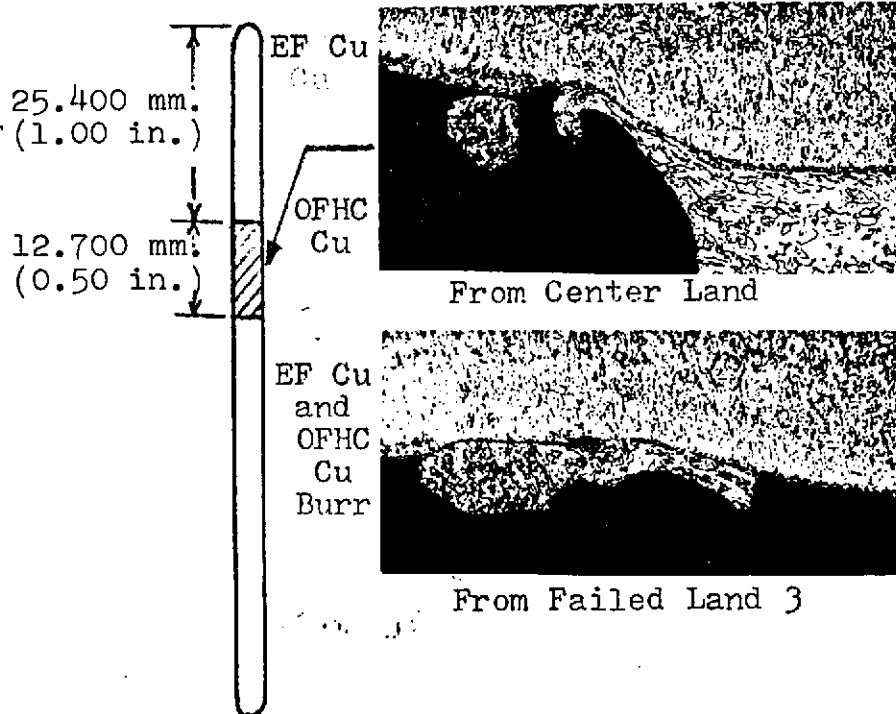
FIGURE C-50

Because of a large unplanned nonbond noted on the original panel, the baseplate was machined to remove the old cover. The baseplate had burrs from the machining which were not completely removed by pickling. When the new coverplate was fabricated, the burrs failed under pressure and gave the false conception of a weak bond. The planned weak bond did not fail nor show any evidence of failing. Magnification 50X.

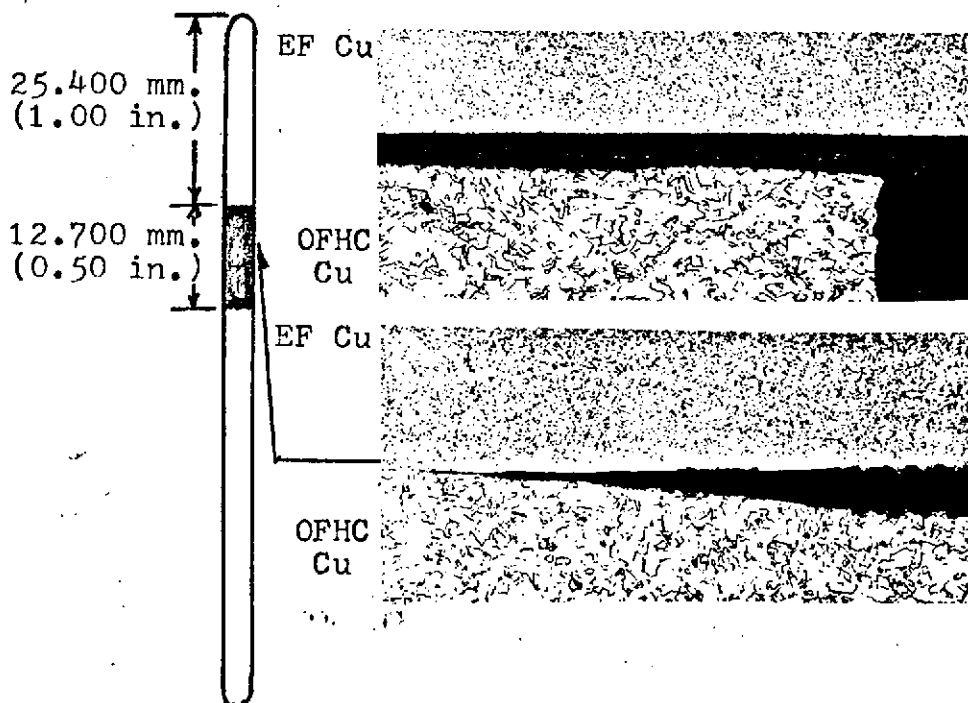
Section of an unplanned weak bond at the top manifold end of Land 3. Lack of metal disturbance indicates very weak bond. Magnification 50X.

Section of the planned nonbond. Metal disturbance indicates some tack bonding had occurred. Magnification 50X.

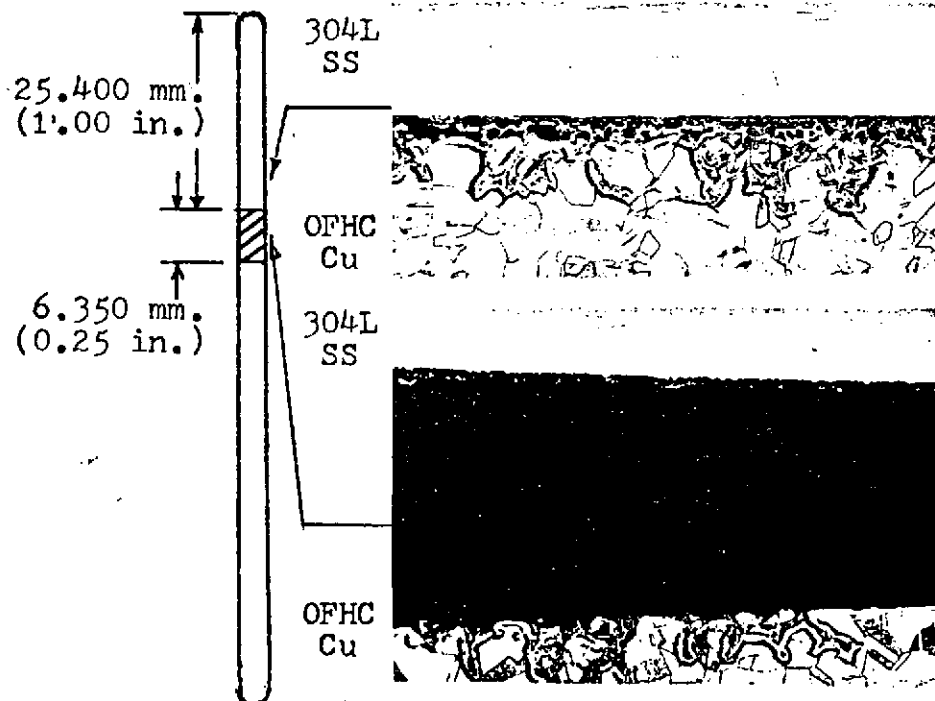
Full braze bond near the planned weak bond. Voids in braze indicate some metal failure in destructive test. Magnification 50X.

Complete bondline separation occurred in the planned weak bond. Braze layer appears to be "starved". Magnification 50X.

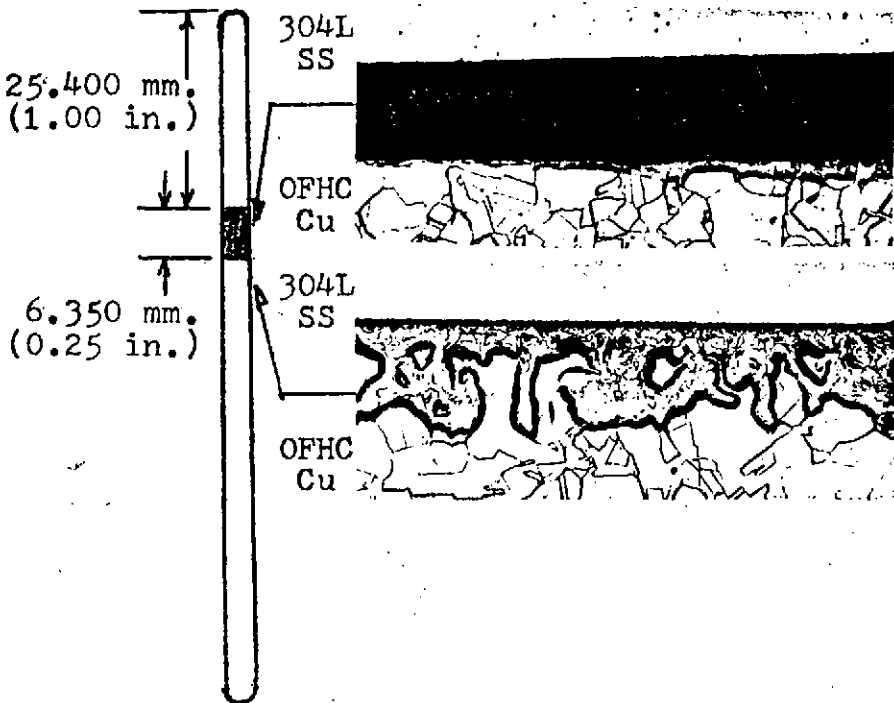
Planned nonbond area showing some braze wetting of the OFHC Copper but no wetting of the 304L SS. Magnification 50X.

Section of the full bond next to the planned nonbond. No failure occurred. Magnification 50X.

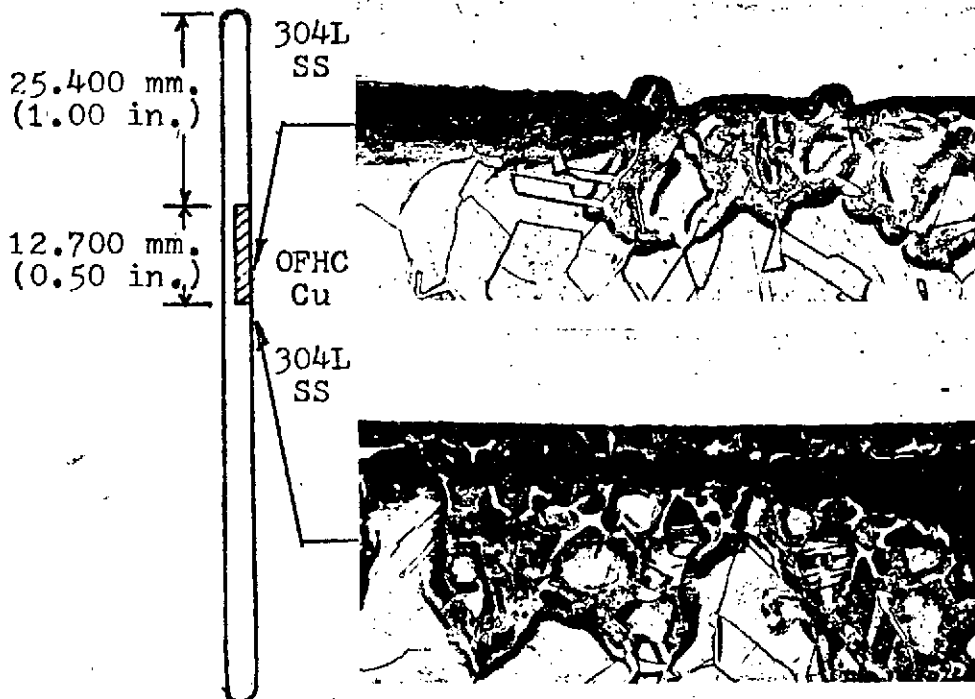
Section from planned weak bond showing end of defect. Slight separation occurred. Magnification 50X.

Full braze bond area next to the planned weak bond. In destructive test, failure occurred. Magnification 50X.
