NASA CR-134657
BAC Report No. 8654-953005

FINAL REPORT APPENDIX

NONDESTRUCTIVE TESTS OF REGENERATIVE CHAMBERS

JUNE 1974

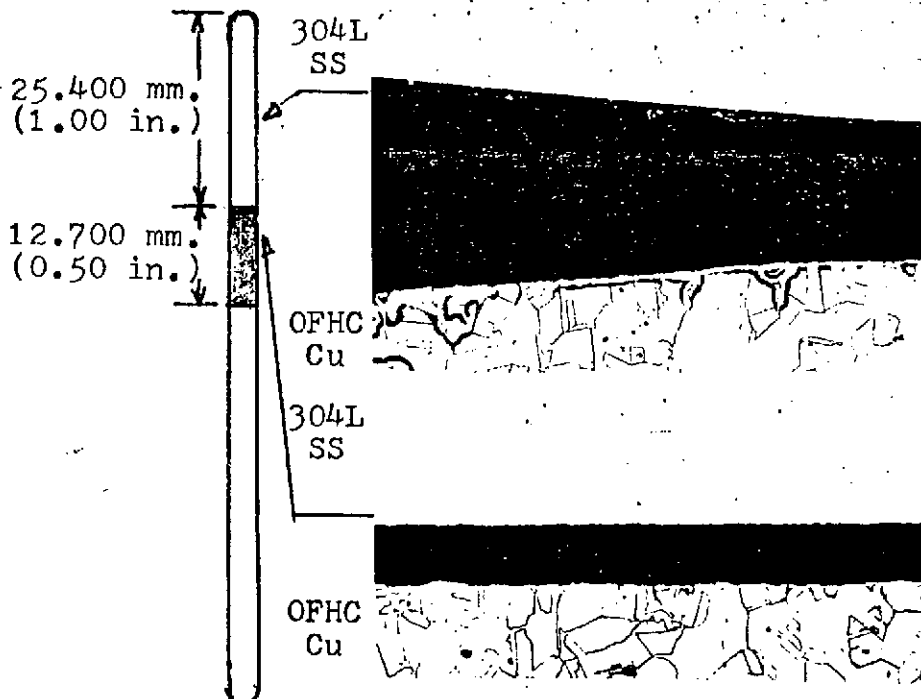
Full bond area showing failure through braze alloy. Braze layer appears thin. Magnification 50X.

Section from the planned nonbond defect showing coverplate separation. Magnification 50X.

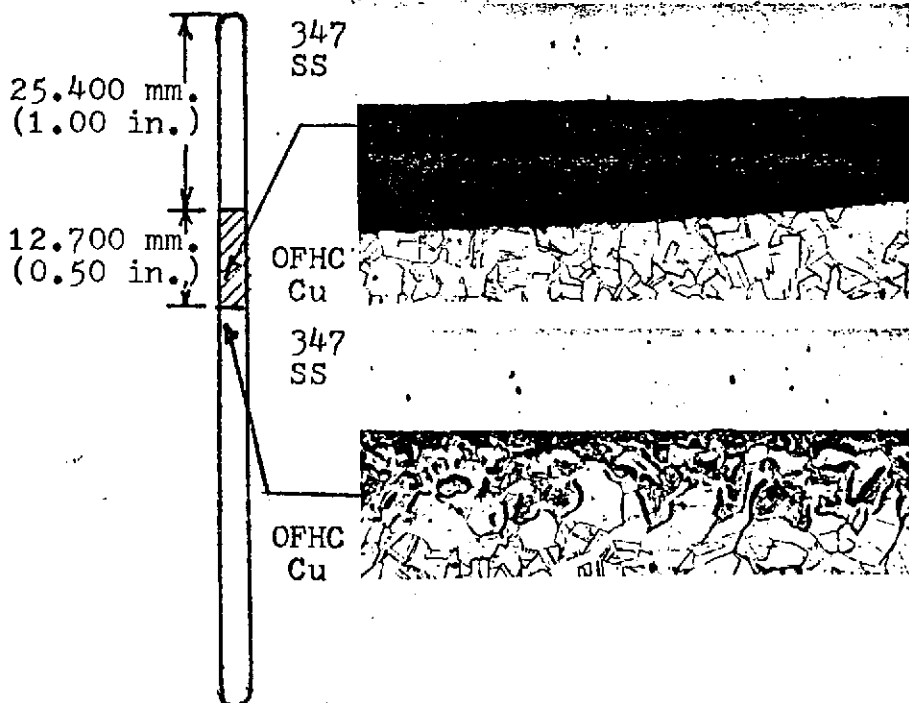
Section of planned weakbond which was actually a nonbond due to deficiency of braze alloy in the "weak bond" area. Magnification 50X.

View of planned full bond located adjacent to the planned weak bond. No failure is noted. Magnification 50X.

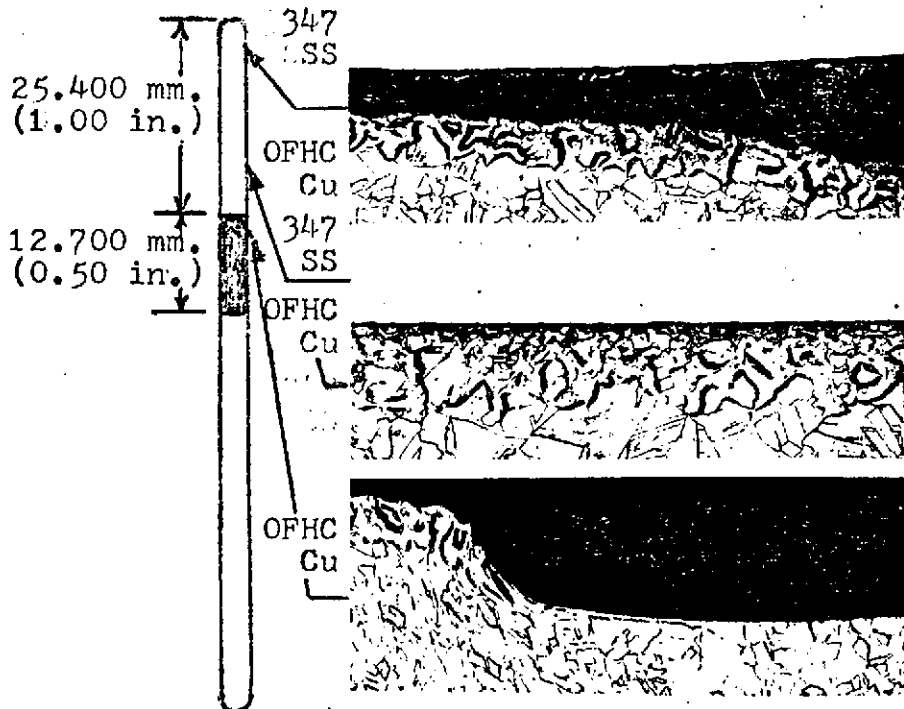
Full bond failure at top manifold end of land. Magnification 50X.

Full bond showing no failure after destructive test. Magnification 50X.
