# NASA TECHNICAL MEMORANDUM

NASA TM X-64824

MSFC SKYLAB STRUCTURES AND MECHANICAL  
SYSTEMS MISSION EVALUATION

Skylab Program Office

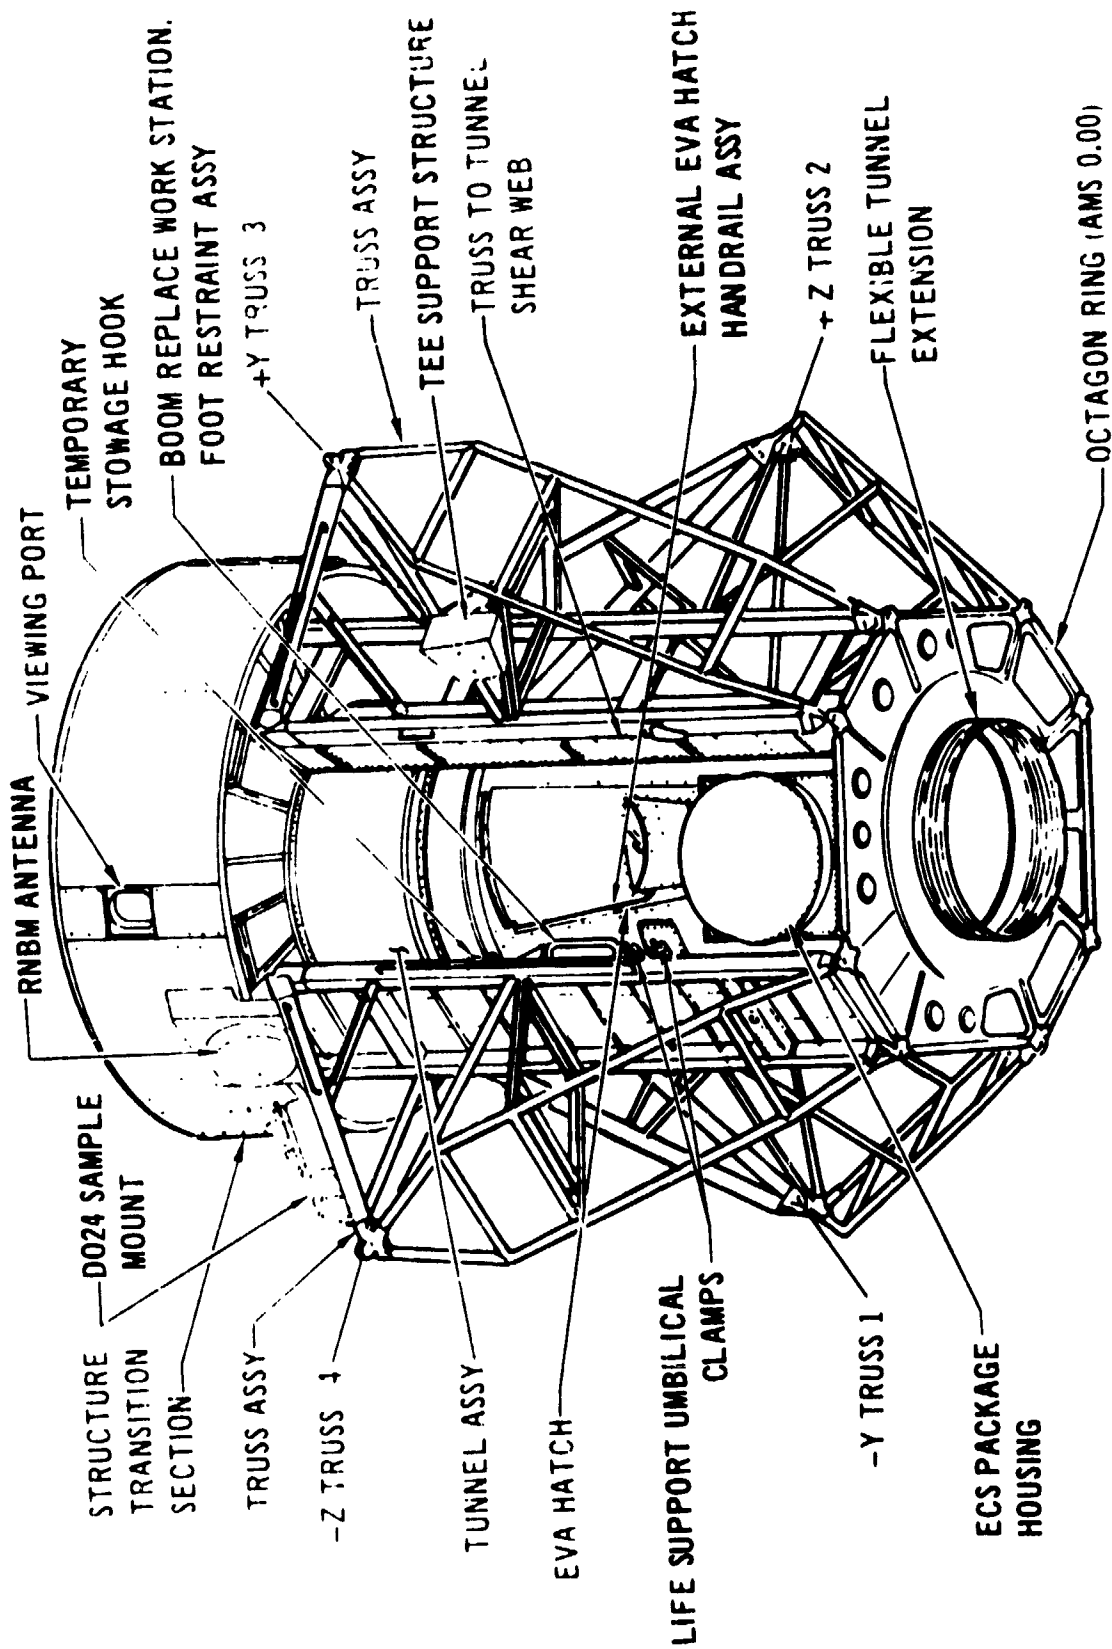
Figure VA-1. Airlock Module Structure

Accommodation of deflection with minimum load transfer between the airlock and workshop is provided by the 42.5-in. diam, 13-in.

long convolute, flexible bellows. Internal fluorocarbon coating provides a redundant bellows seal and a fiber glass laminate cylinder inside the bellows protects it from damage.
