INVESTIGATION OF TANTALUM WET SLUG CAPACITOR FAILURES IN THE APOLLO TELESCOPE MOUNT CHARGER BATTERY REGULATOR MODULES

INTERNATIONAL BUSINESS MACHINES CORP.,
HUNTSVILLE, ALA. ELECTRONICS SYSTEMS
CENTER

31 JAN 1973

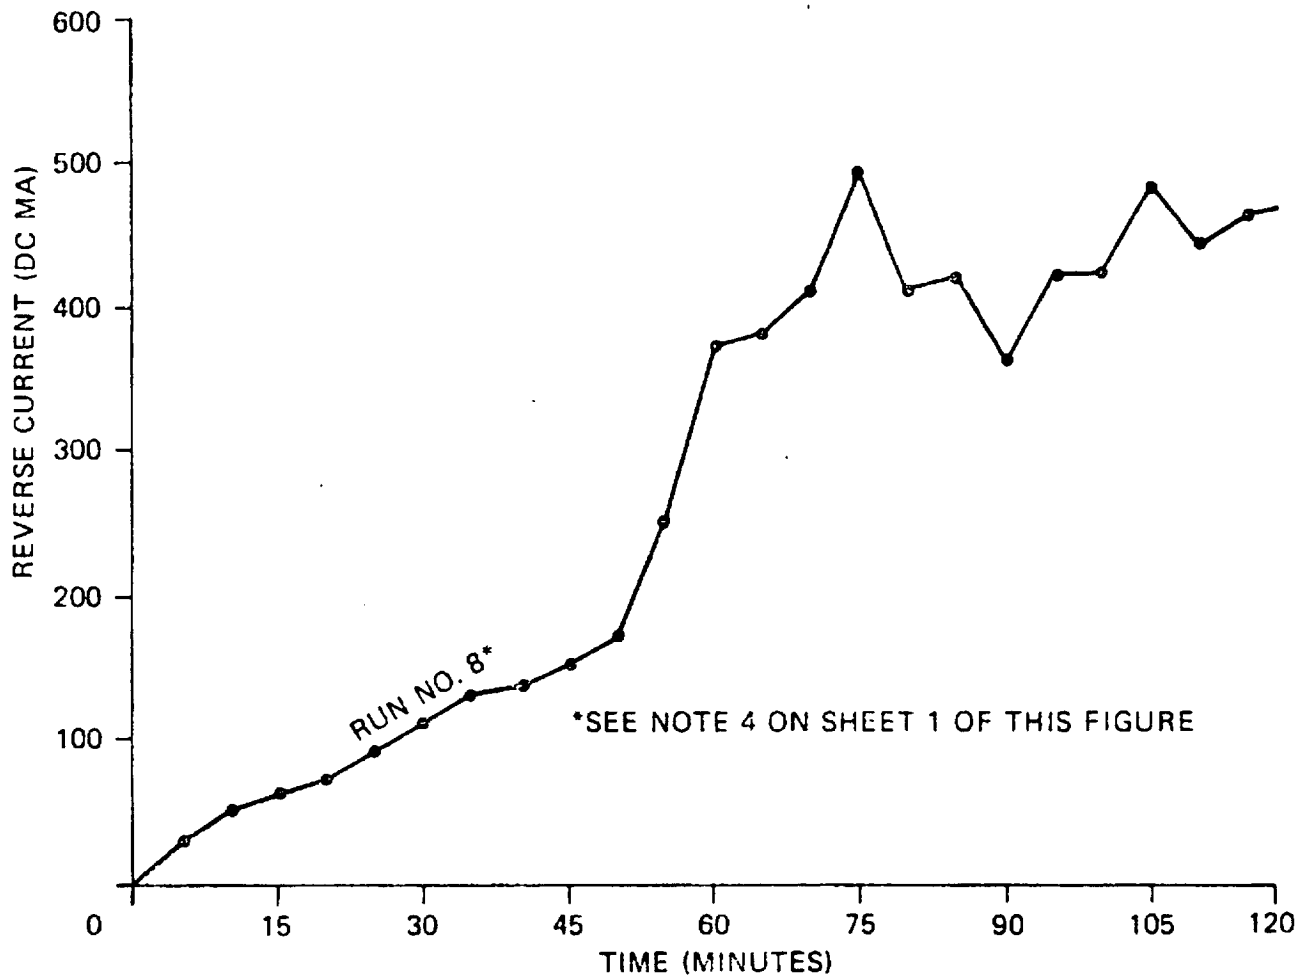
Figure 6.6.3.3.2-1. Sample No. 1 Data for Duty Cycle Test No. 2. (1 of 2)

third samples were evaluated in the same manner except the reverse bias was increased to 1.5 volts. The results of this evaluation are shown in Figures 6.6.3.3.2-1 thru 6.6.3.3.2-3.

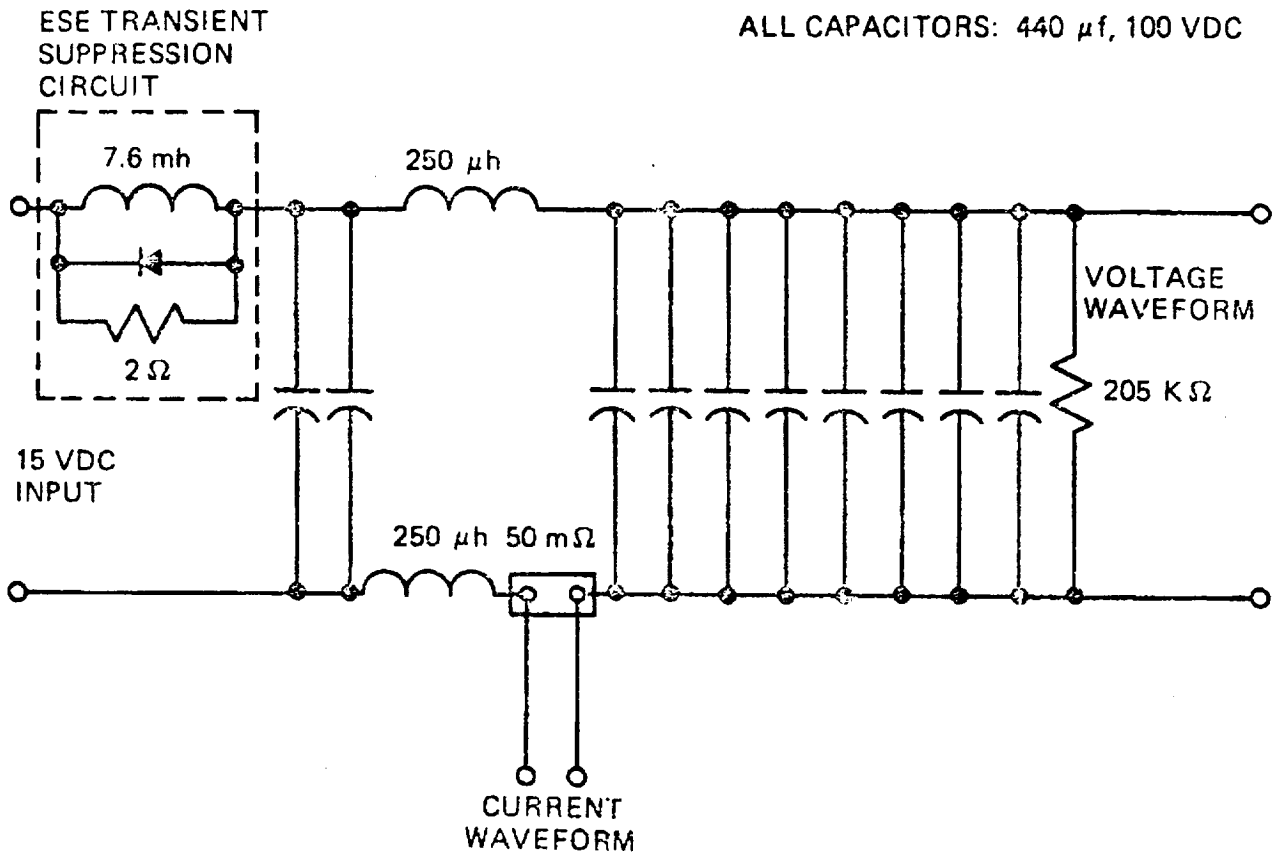
Figure 6.8.3-1. Schematic of Lab Model of CBRM Input Filter

A lab model of the CBRM input filter was built for the ringing tests. ESE transient suppression components were included in the circuit, and a 205 kohm resistor simulated the circuit load at power on. (See Figure 6.8.3-1).
