SDSU-RSI-74-2

Field Investigation Report

Remote Sensing For Evaluating
Post-Disaster Damage Conditions

The Pierre, S.D. Tornado
July 23, 1973

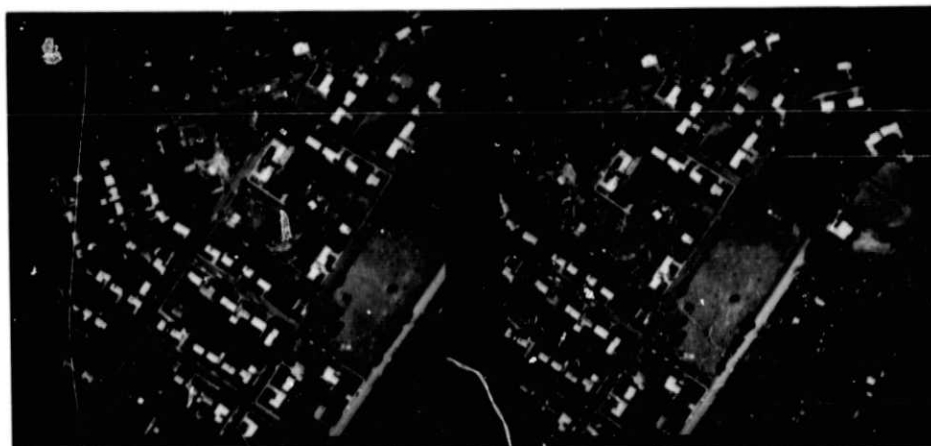
Figure 1.

Weather conditions were ideal for aerial data collection on the day following the tornado and excellent photographic coverage was obtained. The damaged area is clearly evident as shown on the color photographs in figure 1. These photographs are arranged for stereo viewing. The altitude of 450 meters (1500 feet) above ground was optimum for this mission, but a higher altitude might be required if it were necessary to obtain more broad coverage without making a number of parallel runs.

Roof damage, object dislocation, destroyed structures and scattering of debris can be easily identified on these vertical photographs. Note that the debris has already been cleared from the streets, even though the data collection mission was flown the day following the tornado damage.

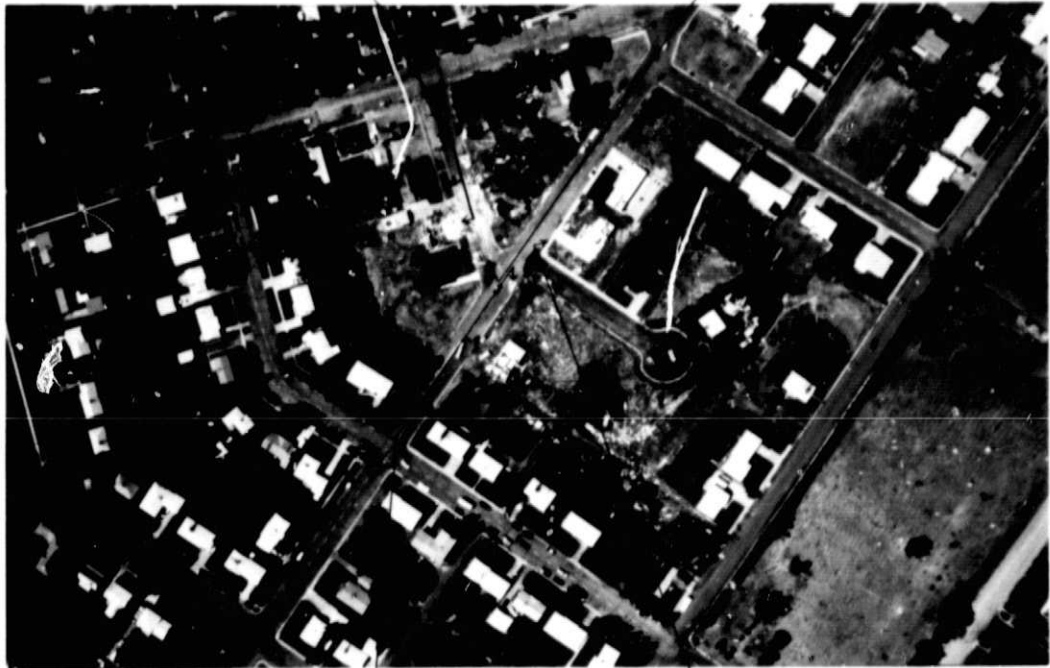
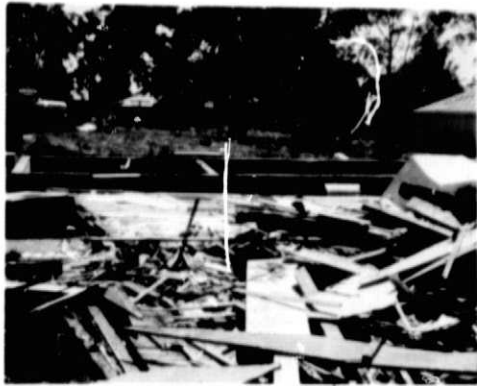
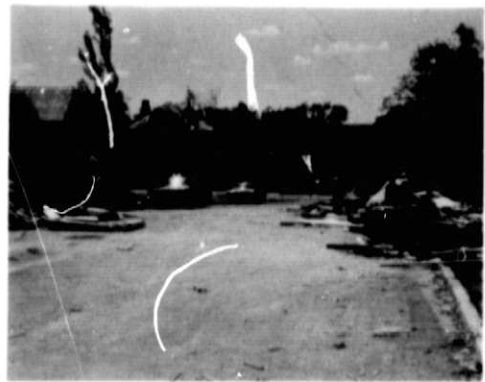
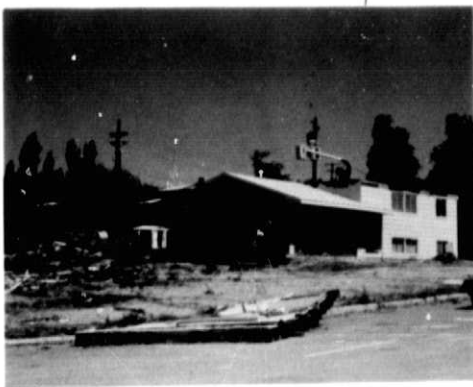
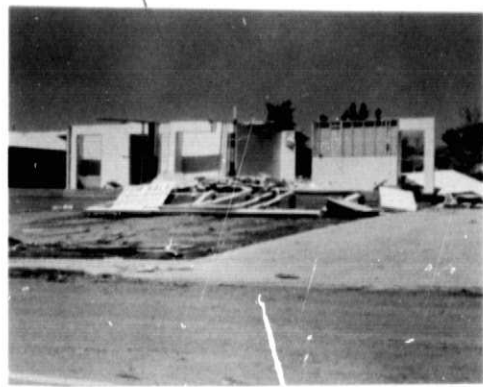
Figure 3.

The series of ground photographs displayed in figure 3 are keyed to an enlarged vertical view of part of the damaged area. These photos are useful for further documenting the extent of destruction.

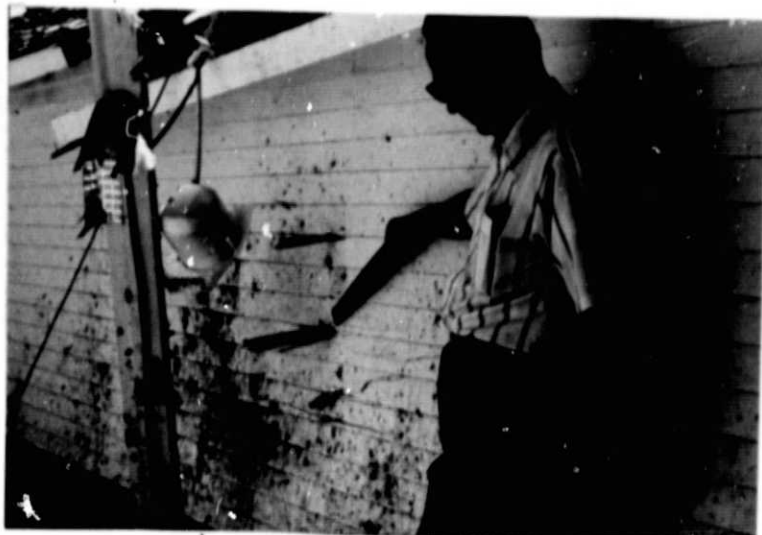
Figure 4.

Figure 4 shows small pieces of debris which were propelled by the tornado winds with sufficient force to penetrate the side of a building.

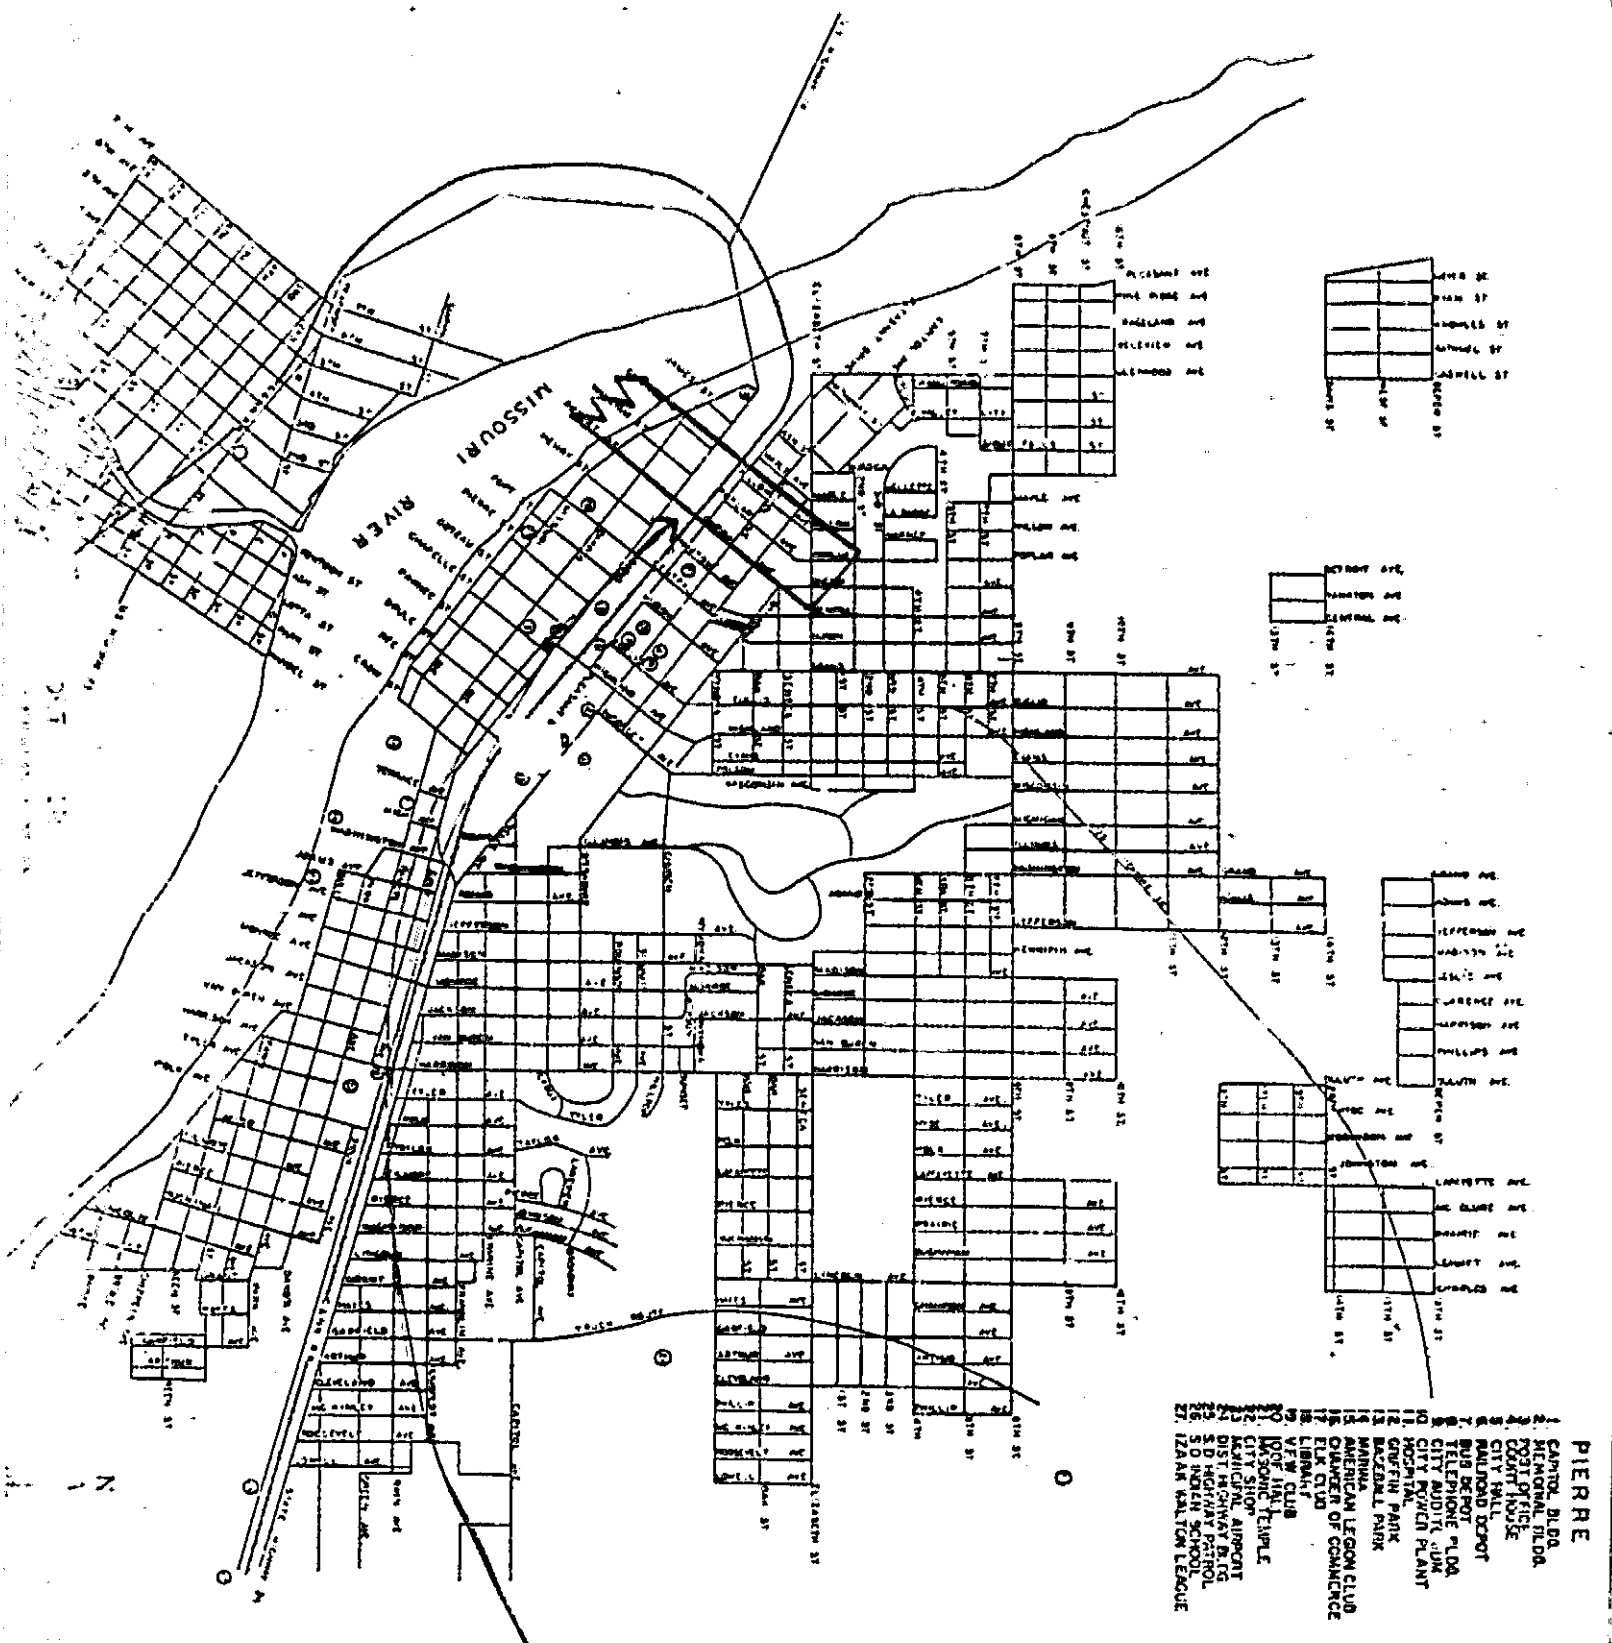
Enclosure 1

At about 3:45 P.M. on Monday, July 23, 1973, a tornado struck the city of Pierre, South Dakota. The tornado emerged from a heavy rain-shower area southwest of the city, descended over the river and moved northerly along Williams Street. (see enclosure 1). Approximately 20 city blocks were affected by the storm, with major damage occurring in the six block area bounded by Williams Street, Willow Avenue, Missouri Avenue and Second Street.

DAMAGE AREA - PIERRE TORNADO
 July 23, 1973
