NASA CR 134644

IMPROVING IMPACT RESISTANCE OF CERAMIC MATERIALS BY ENERGY ABSORBING SURFACE LAYERS

By H. P. Kirchner and J. Seretsky

NASA-Lewis Research Center
Contract NAS3-17765

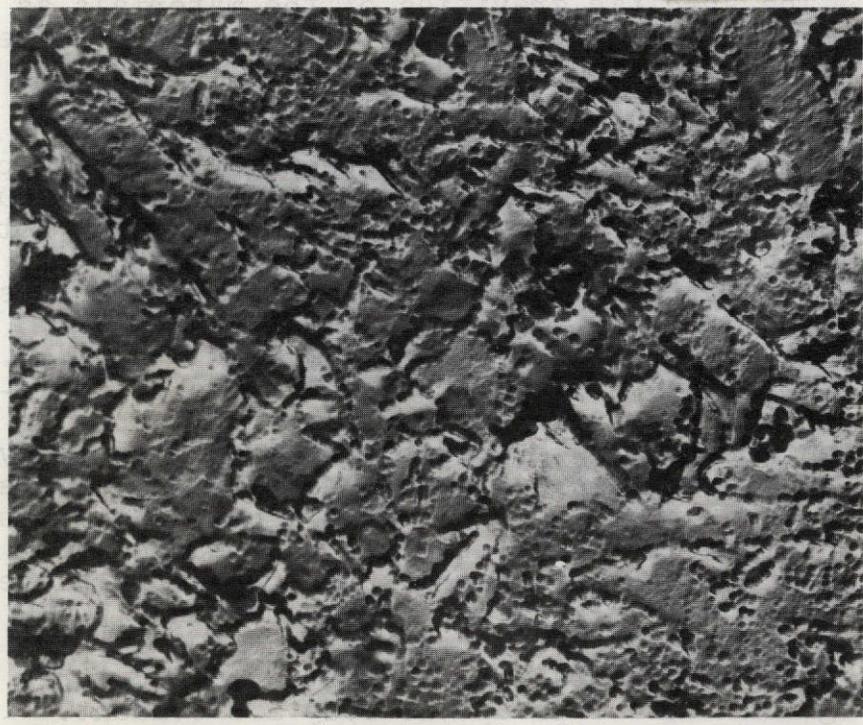
Figure 1 - Microstructure of Hot Pressed Norton NC-132
Silicon Nitride (12,500X, Specimen GB-23-14)

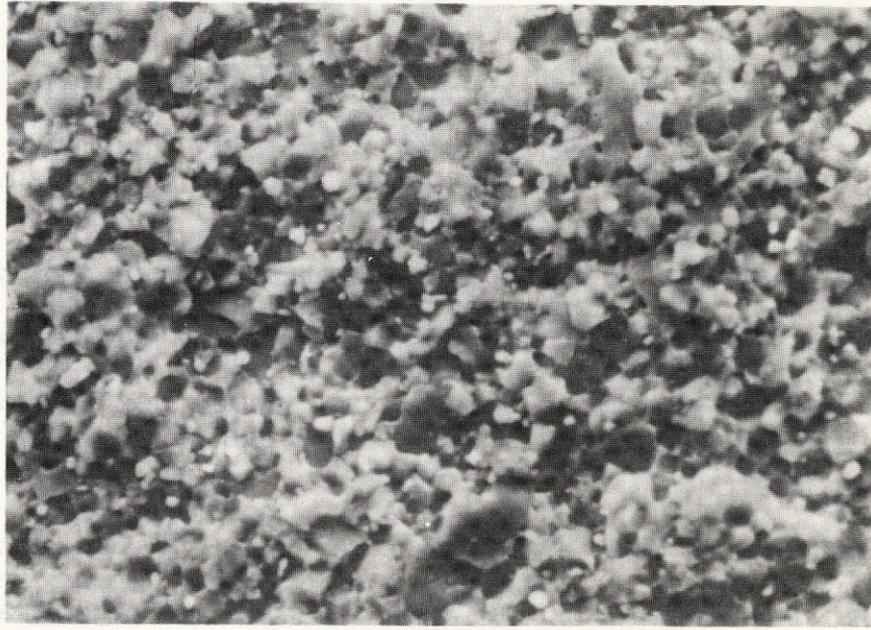
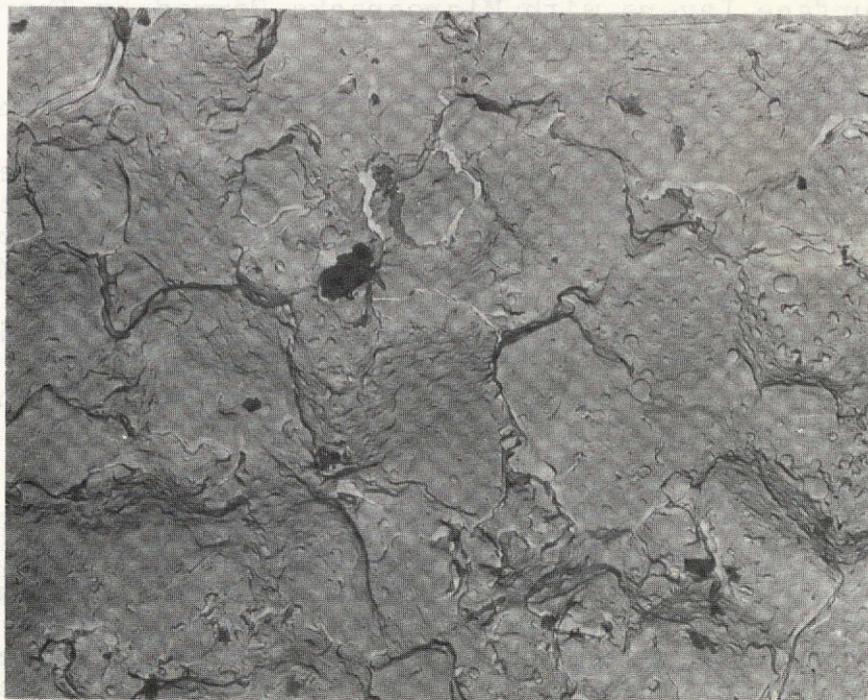
A. 1000X

B. 6035X

Figure 2 - Microstructure of Hot Pressed Norton NC-203 Silicon Carbide (Specimen JS-52-212, Billet no. 435556)

Photomicrographs of Norton silicon carbide are presented in Figure 2. The upper picture is a scanning electron micrograph of a fracture surface. This picture shows that the typical grains are three to ten micrometers in size. The fracture is predominantly intergranular. The lower picture is an electron micrograph of the fracture surface and shows the grains and grain boundaries at somewhat higher magnification.

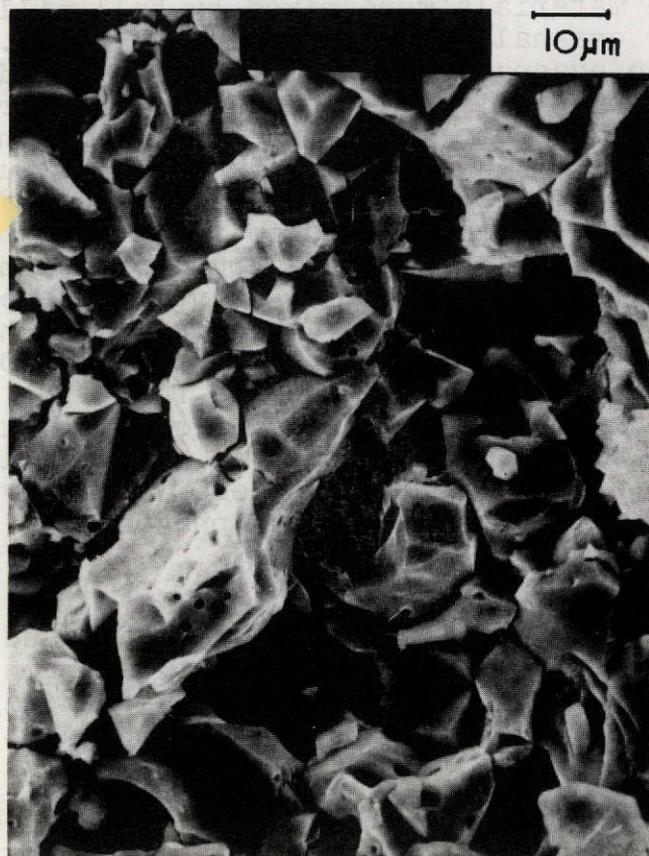
Figure 3 - Fracture Surface of Magnesium Dititanate, as Hot Pressed, Ten Micrometer Average Grain Size (1000X)

The picture shows a multitude of intergranular cracks resulting in a very loosely bonded structure. Also, occasional transgranular cracks are present. Therefore, the reasons for the low strength and low elastic modulus of this material are evident.

The microstructures of the magnesium dititanate material used for the cemented plates were presented by Kuszyk and Brandt(9). A scanning electron micrograph of a fracture surface of similar material hot pressed at Ceramic Finishing Company at 1200°C and 20.7 MNm⁻² for one hour is illustrated in Figure 3.

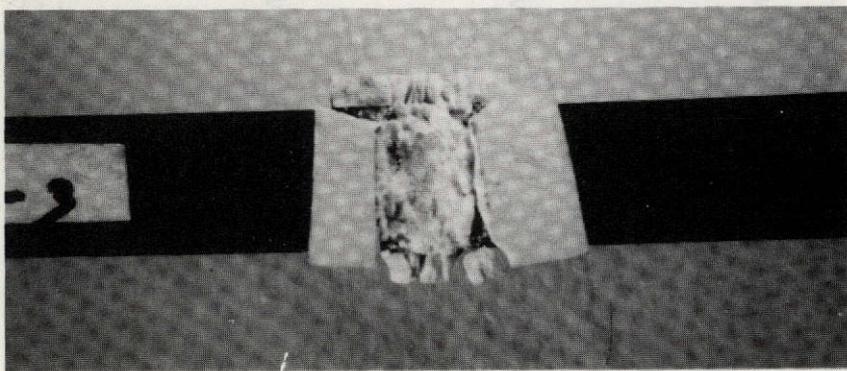
Figure 4 - Impact Test Specimen with Cemented Magnesium Dtitanate Plate (3X)

Thin plates of magnesium dititanate with 5 and 15 μm grain size were cemented on Norton HS-130 silicon nitride bars at the impact point. The impact resistances of the specimens were measured and are presented in Table VI. In tests at room temperature using a one foot pound hammer, none of the treated specimens fractured under the impact. These results indicate at least a three-fold improvement in impact resistance as a result of the low elastic modulus surface with microcracks caused by expansion anisotropy. One of these specimens is illustrated in Figure 4. This figure shows the crushing that occurred when the hammer struck the specimen.

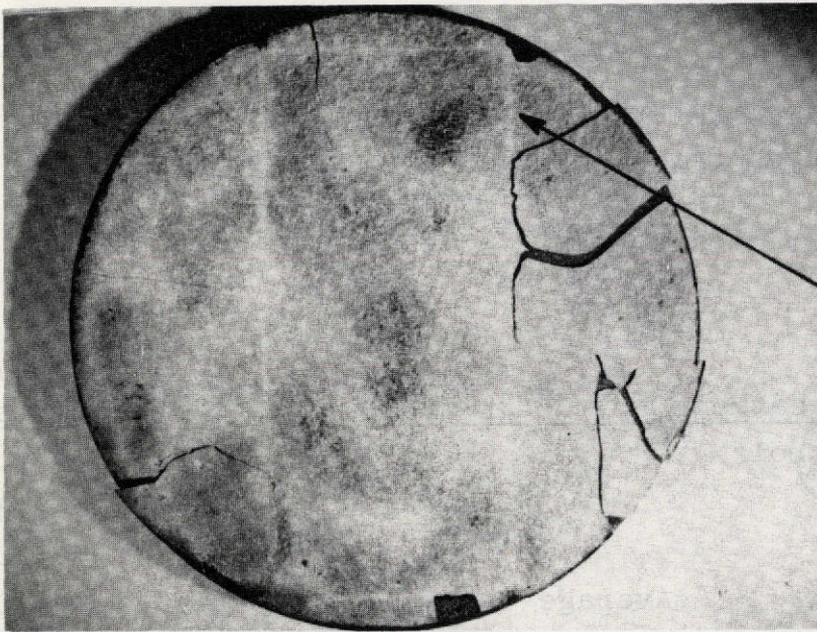
The white line is the boundary between graphite and silicon nitride

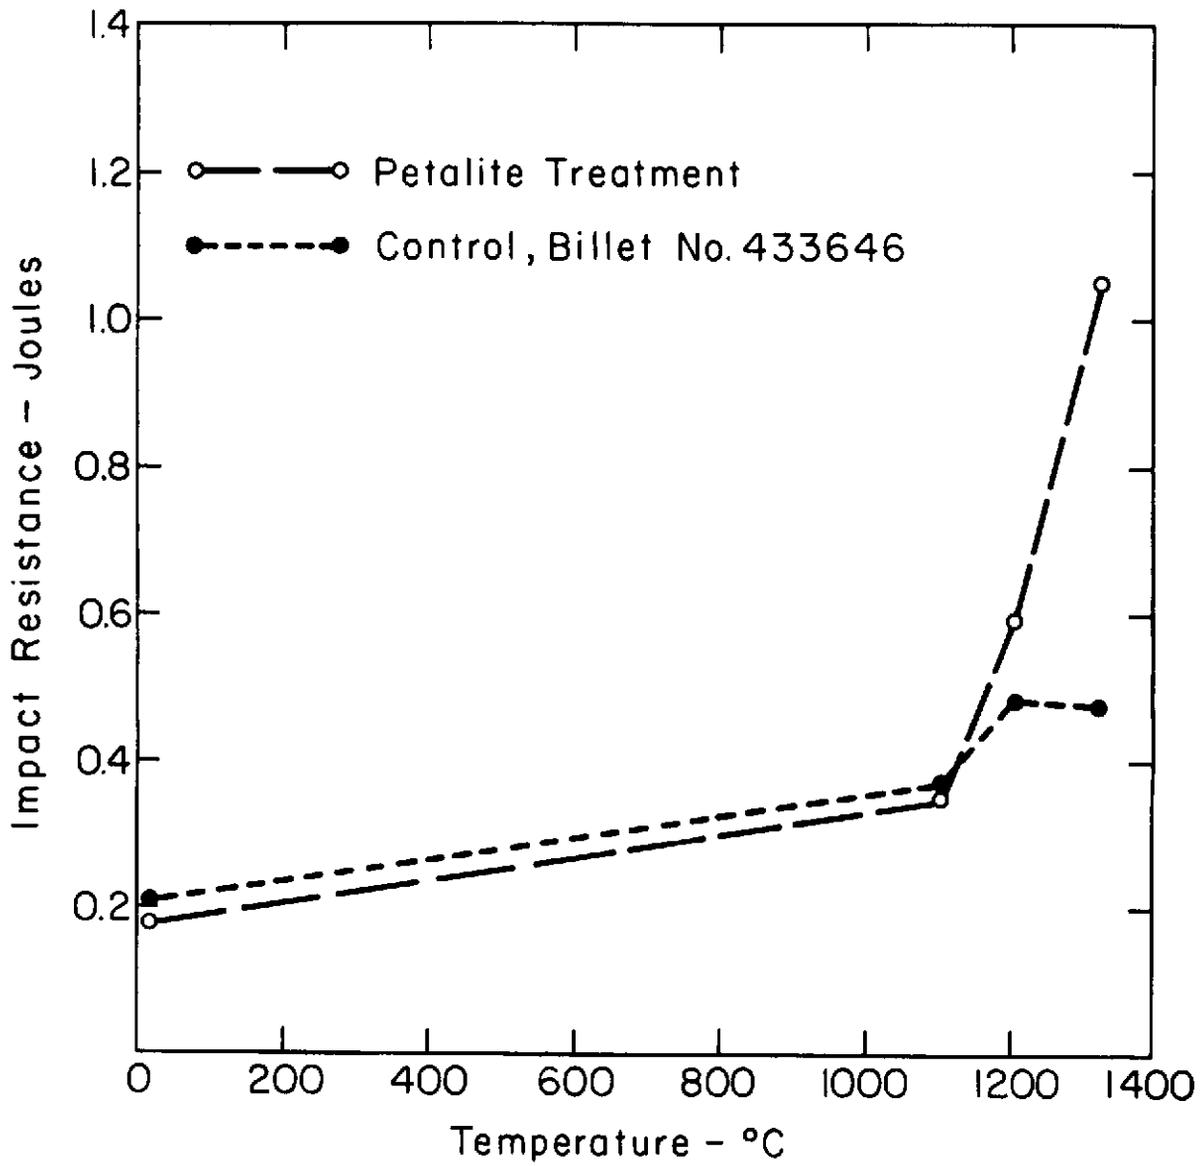
Figure 6 - Impact Resistance vs. Temperature for Norton NC-203 Silicon Carbide

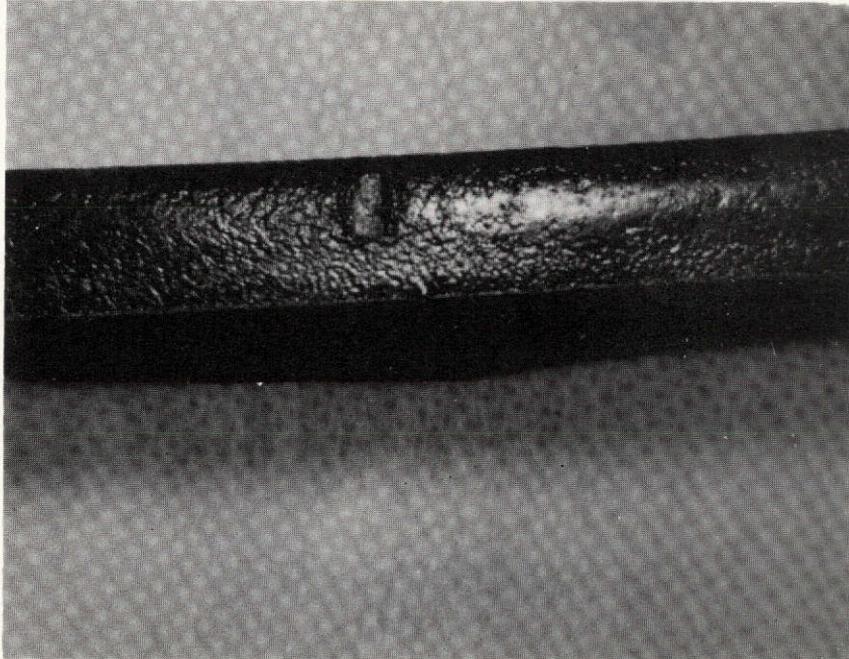
Figure 7 - Surface of AVCO Silicon Nitride Specimen with Petalite Surface, after Impact Testing (Specimen JS-31-BPET)

The specimens that survived the impact without fracturing were examined. As expected, an indentation in the surface was observed. One of these indentations in an AVCO silicon nitride specimen with a petalite surface is illustrated in Figure 7.

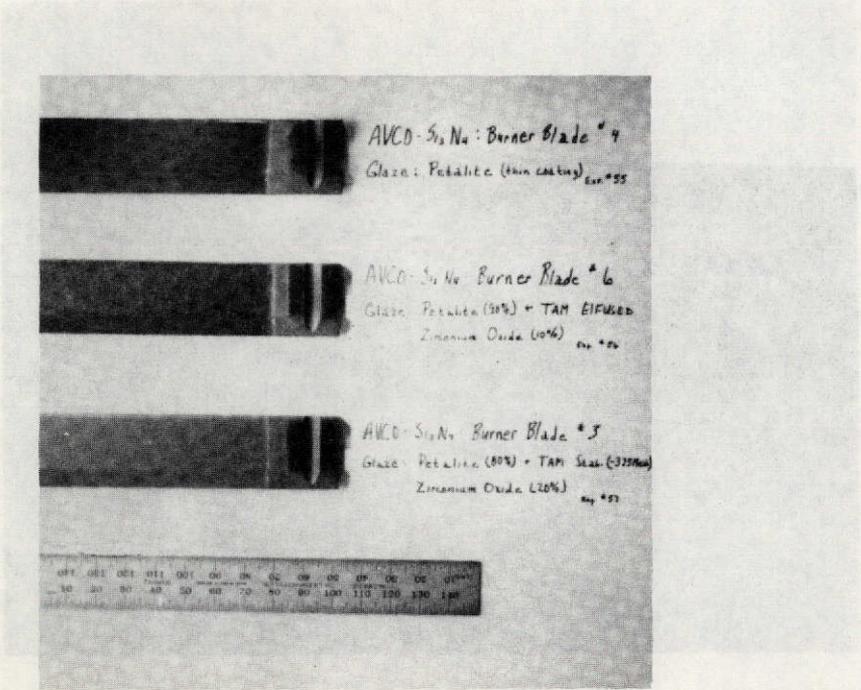
Figure 8 - AVCO Silicon Nitride Burner Rig Specimens with Petalite Surfaces

Specimens with petalite surfaces of various thicknesses and zirconia contents were prepared for burner rig tests. Some of these treated burner rig specimens are illustrated in Figure 8.
