COMPATIBILITY TESTING OF SPACECRAFT MATERIALS
AND SPACE-STORABLE LIQUID PROPELLANTS

FINAL REPORT ADDENDUM

May 1974

TRW
SYSTEMS GROUP

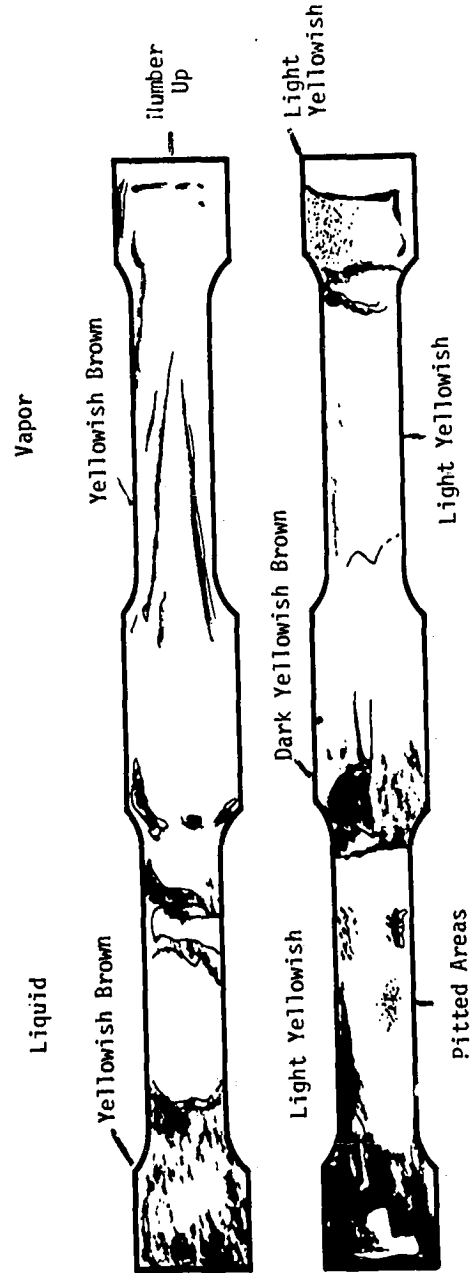
Figure B.6. Mapping of Surface Appearance of Double Dogbone Specimens 7202 and 7230 After Exposure

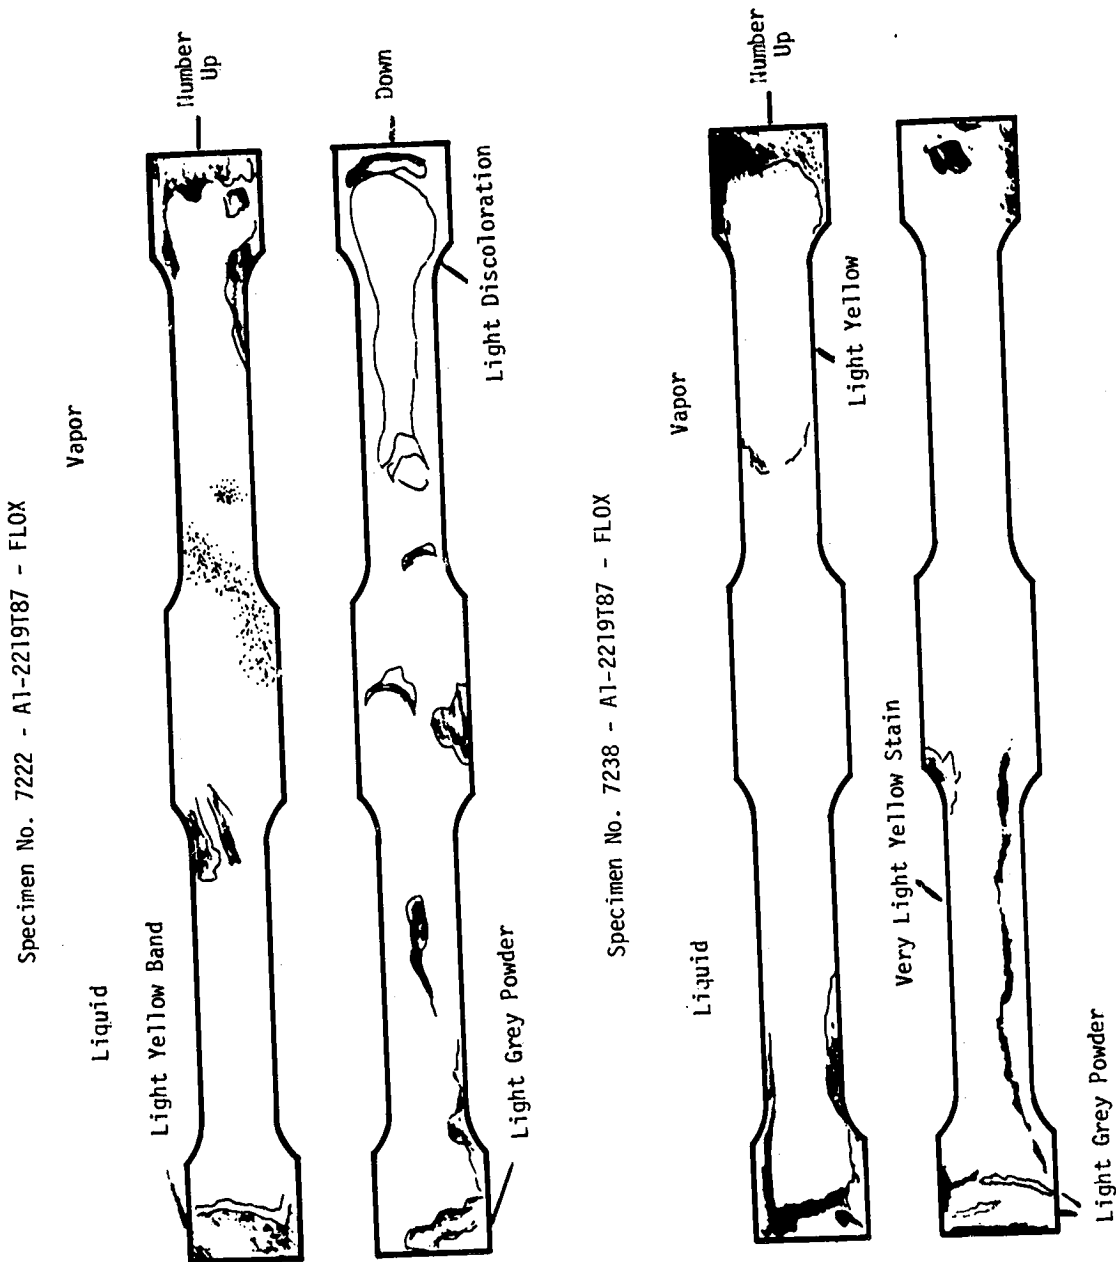
Figure B.8. Mapping of Surface Appearance of Double Dogbone Specimens Nos. 7222 and 7238 After Exposure
