NASA CR-134629
FR-6353

DEVELOPMENT OF SPUTTERED TECHNIQUES FOR THRUST CHAMBERS

TASK I - FINAL REPORT

Pratt & Whitney Aircraft
Division of United Aircraft Corporation

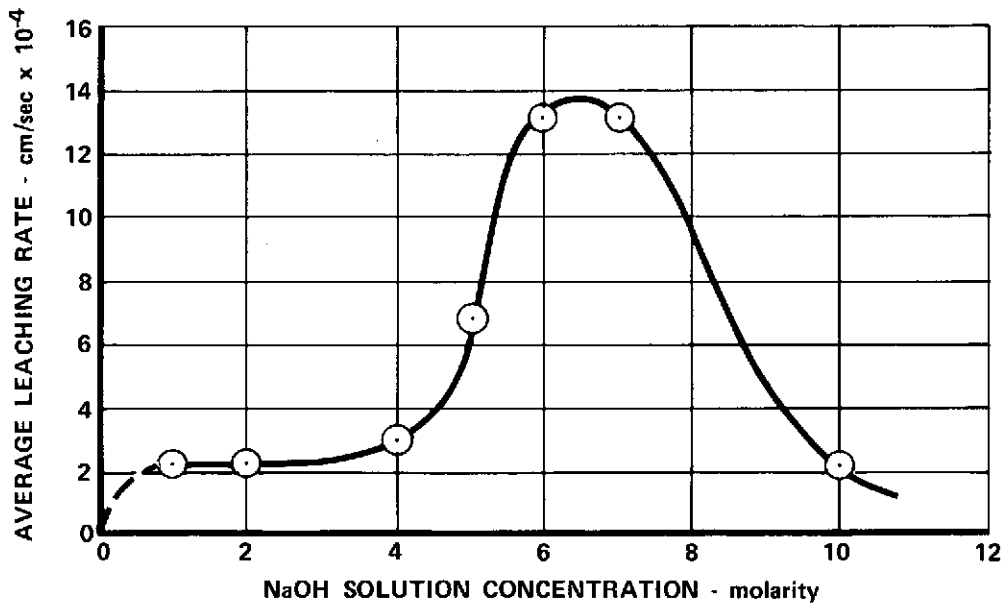
Figure 6. Effect of NaOH Solution Molarity on the Average Leaching Rate of the Flame-Sprayed Aluminum Filler of Ambient Temperatures

Techniques were established for removal of the CERROTRU and aluminum fillers. Removal of the flame-sprayed aluminum by leaching with NaOH was found to be most rapid between 6.0 and 7.0 molarity. (See figure 6.) Ultrasonic vibration and tilting of the sample did not result in significant increases in the rate of removal. A maximum rate of 1.3×10^{-4} m/s (0.48 cm/hr) was obtained using 7.0 molar NaOH at 348 to 353°K (75 to 80°C) without ultrasonic vibration. Removal of the CERROTRU was accomplished by placing one end of the cylinder in a pool of molten CERROTRU at 453°K (180°C) for about 300 seconds and withdrawing slowly. Final removal of the last remnants of the CERROTRU was accomplished by etching in a concentrated HCl solution.

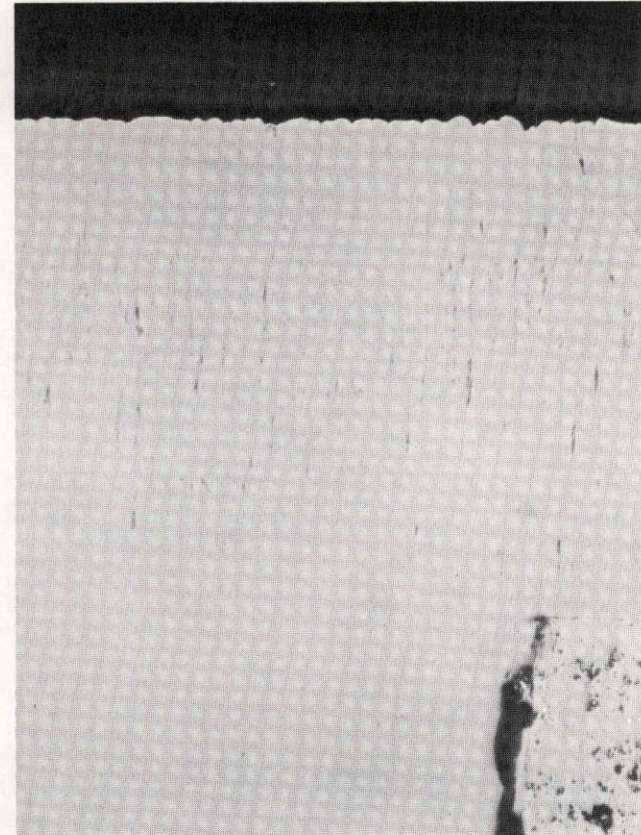
Figure 12. Appearance of Closeout Layer on Dry Machined and Sanded Substrate, Run I-20

Suspecting that the machining lubricants trapped in the filler material during milling also contributed to the crack formation through the introduction of contaminants, dry milling was used in run I-19. Though the outgassing rate of the aluminum filler was significantly reduced, the cracking problem persisted. Dry machining using a reversing cutting technique resulted in minimal cracking at the rib wall and reduced the extent of cracking in the closeout layer. (See figure 12.)

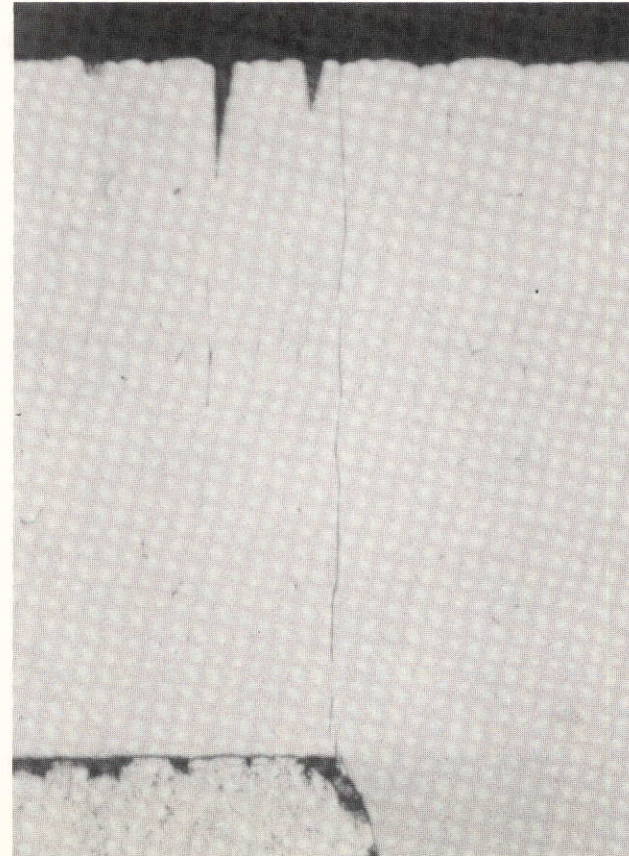
Figure 14. Cracking of Closeout Layer on Shot-Peened and Dry Milled Surface, Run I-19

Concurrent with the variations in machining, surface deformation techniques such as glass bead peening and shot peening were also tried as a means of further sealing the incipient cracks at the rib walls and, in the case of the flame-sprayed aluminum filler, densifying the surface layer to decrease outgassing and seal the surface porosity. Though these techniques resulted in further decreasing the cracking frequency and severity, the problem was not totally eliminated. (See figures 13 and 14.) Other techniques, such as vacuum baking prior to installation in the sputtering chamber (runs I-16 and I-24), radiation heating of the sample at high vacuum in the sputtering chamber for 54 ks (15 hr) (runs I-17 and I-18), and multiple sputter clean-pumpdown cycles (runs I-13, I-14, and I-16), were used to reduce filler outgassing and crack formation. Though these techniques were successful in reducing the filler outgassing, the cracking problem persisted.

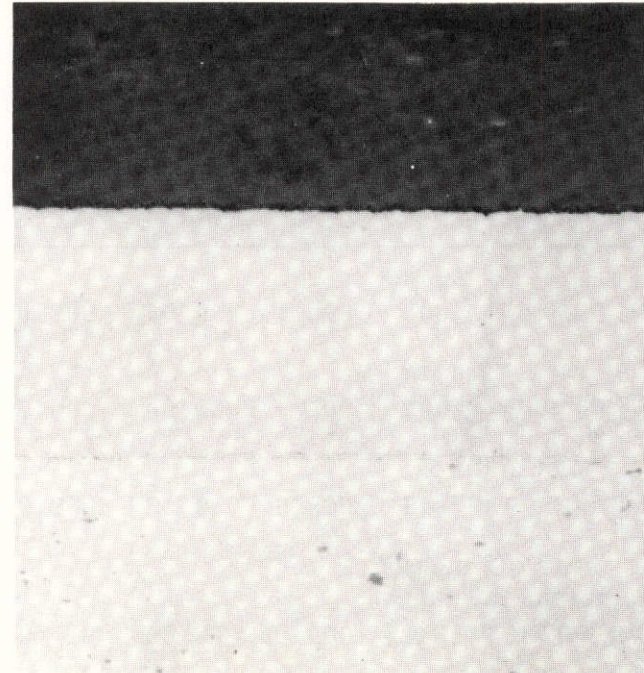
Figure 19. Microstructure of Sputtered OFHC Copper on 600-Grit-Sanded Region of Type 6061 Aluminum Alloy Substrate

The defects probably resulted because of the deposition rate difference between the concave regions and the convex regions. The concave regions exhibited a lower growth rate since these areas were exposed to a smaller segment of the cylindrical target (shadowing effect) than the convex regions. As the deposition continued, the difference in growth rate increased, resulting in deeper and deeper "valleys." The junction between the coating on adjacent "hills" eventually became a sharp cusp moving outward trailing a thin crack or open boundary. The vapor-blasted area exhibited the same effect, but with fewer resultant defects. (See figure 17.) This may have been due, in part, to the contamination at the interface, attributed to the vapor blasting process. It should be noted that vapor blasting usually resulted in a clean interface, (figure 18), so that the above result was not taken to indicate that vapor blasting should be discontinued. However, the preparation by sanding with 600-grit SiC paper resulted in a defect-free structure, smooth deposit surface, and a high quality interface. (See figure 19.) Hence, sanding was the preferred preparation technique for the latter runs.

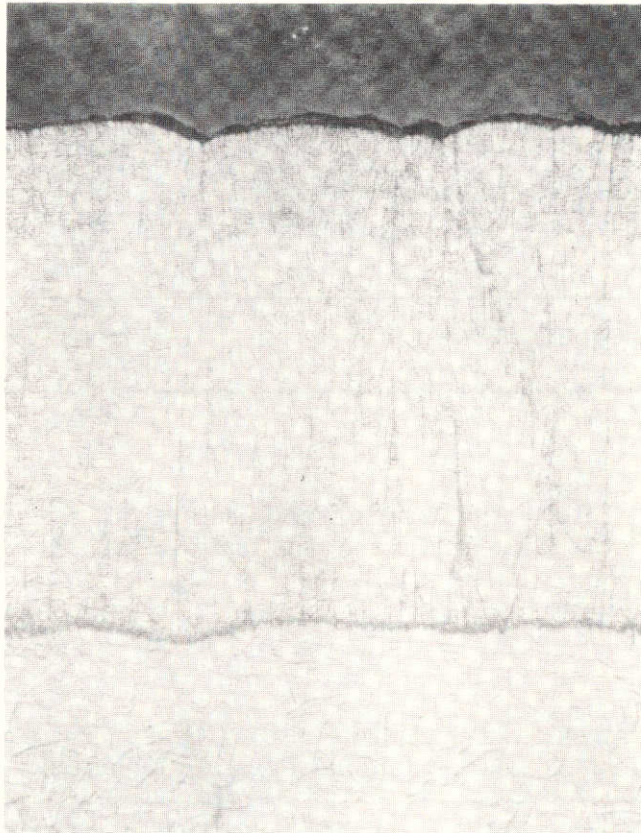
Figure 24. Microstructure of Sputtered OFHC
Copper Applied at a Substrate Temperature of 566°K (293°C), Run I-15

The effect of deposition temperature on coating structure generally correlated well with that observed by Thornton.⁽⁹⁾ The depositions performed at $T/T_m = 0.2$ to 0.3 (271 to 406°K) exhibited columnar grains. (See figure 23.) The depositions performed at $T/T_m = 0.3$ to 0.5 (406 to 678°K) exhibited a more equiaxed structure and, for the highest temperatures in this T/T_m range, showed indications of concurrent recrystallization. (See figure 24.) As was expected, the temperature of deposition affected the hardness of both the closeout layer and the substrate, (figure 25 and table VI). The scatter in the closeout layer hardness at low temperatures was attributed to the openness of many of the low temperature deposits. (See figure 26.)

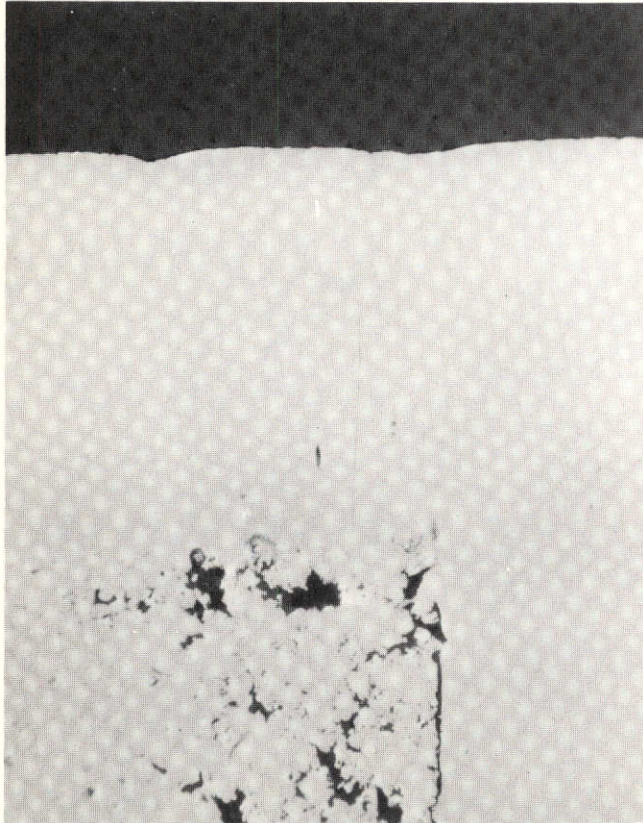
Figure 30. Microstructure of Closeout Layer Applied Using Lower Discharge Pressure, Run I-24

Based on the results of Thornton,⁽⁹⁾ lowering the sputtering gas pressure should permit the use of higher deposition rates without obtaining the characteristic open structures at the low deposition temperatures required by the OFHC copper substrates and/or the low melting point filler materials. Although the one run (I-24) performed with a lower discharge pressure did yield a closeout layer with fewer defects (figure 30), the improvement in quality could not be attributed solely to the lower pressure since several of the other parameters were also changed.
