PERFORMANCE OF LI-1542 REUSABLE SURFACE
INSULATION SYSTEM IN A HYPERSONIC STREAM

by L. Roane Hunt and Herman L. Bohon

April 1974

NATIONAL AERONAUTICS AND SPACE ADMINISTRATION
LANGLEY RESEARCH CENTER, HAMPTON, VIRGINIA 23665

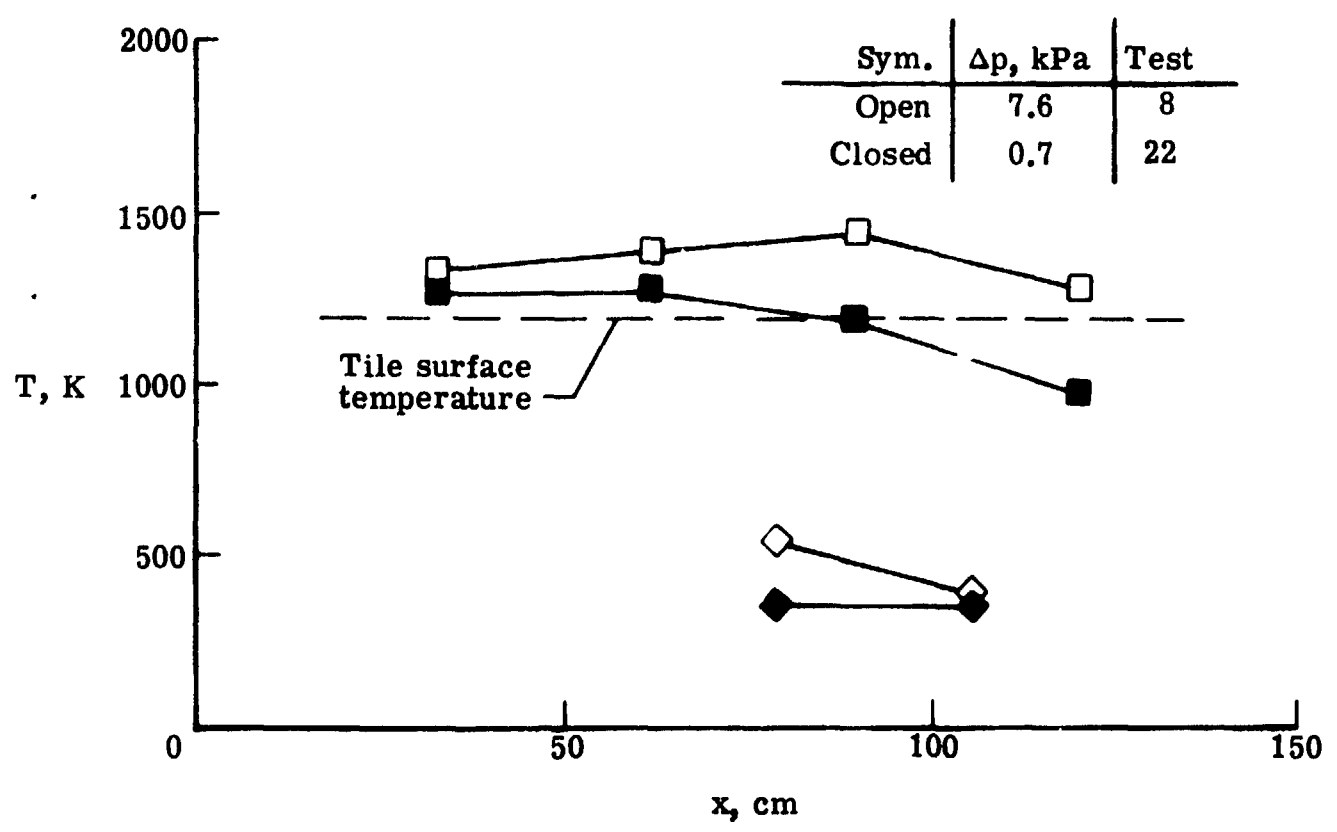
Figure 13.- Effects of differential pressure on gap and substructure temperature along row 5 after 40 s of aerodynamic heating.

The longitudinal border and subpanel gap temperatures were considerably higher than expected and suggest increased gap flow due to leakage through the thermal seals which permitted hot gas flowthrough to the substructure. The border gap temperature distribution along row 5 is shown in figure 13 for two differential pressure loadings, $\Delta p = 7.6$ kPa (test 8) and Δp (test 22). The difference in the temperature levels is indicative of increased gap flow as a result of seal leakage. Reducing the differential pressure resulted in a 100 K to 300 K reduction in border gap temperatures. The substructure temperature at E5 was 500 K during run 8 ($\Delta p = 7.6$ kPa) but only 300 K during test 22 ($\Delta p = .7$ kPa). Consequently, hot gas was apparently leaking to the substructure at E5 where lateral and longitudinal border seals meet. The effects of flow leakage along the longitudinal border gaps on lateral gap temperatures are shown in figure 14 where temperatures along row E are plotted for tests 8 and 22. The header temperature at $y = 0$ is

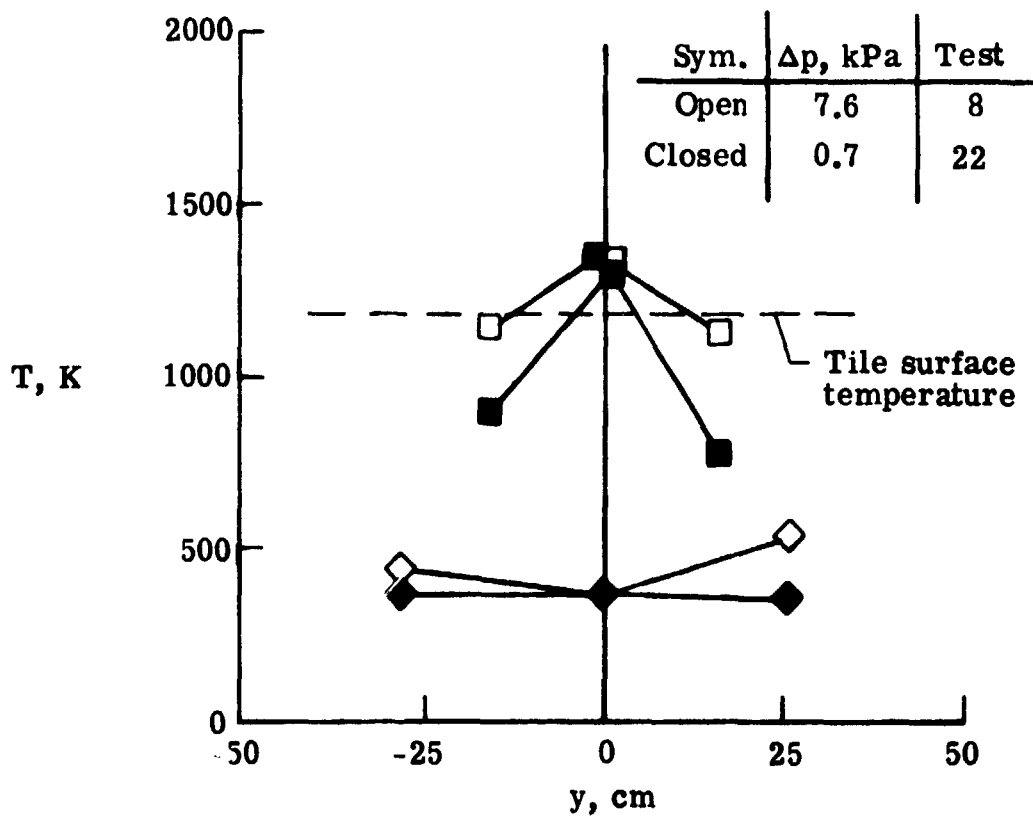
Figure 14.- Effects of differential pressure on subpanel gap and substructure temperature along row E after 40 s of aerodynamic heating.

unaffected by Δp . However, the adjacent temperatures, about 15 cm on each side, show 200 K to 300 K reductions when Δp is reduced. Note the difference in the substructure temperatures indicates flowthrough at both corners E1 and E5. These data strongly suggest that gas leakage at the corners causes gap flow transverse to the stream direction. The influence of transverse flow on gap temperature is dependent on the energy of flow in the longitudinal gap approaching the header, which is characterized by the temperature and pressure at the header region.

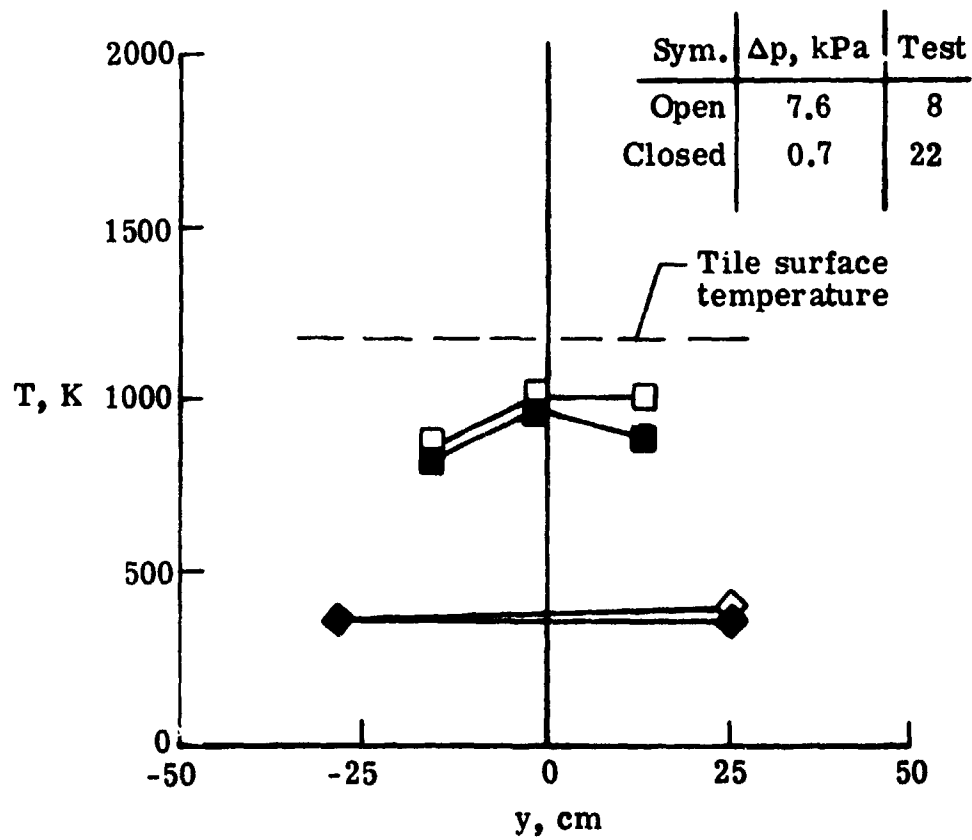
Figure 15.- Effects of differential pressure on interior gap and substructure temperature along row G after 40 s of aerodynamic heating.

The interior panel lateral gap temperatures in row G are shown in figure 15 for tests 8 and 22. Here, the effect of pressure gradient is seen to be small due primarily to the absence of an offset (or header) in the longitudinal gap at the center of the subpanel.

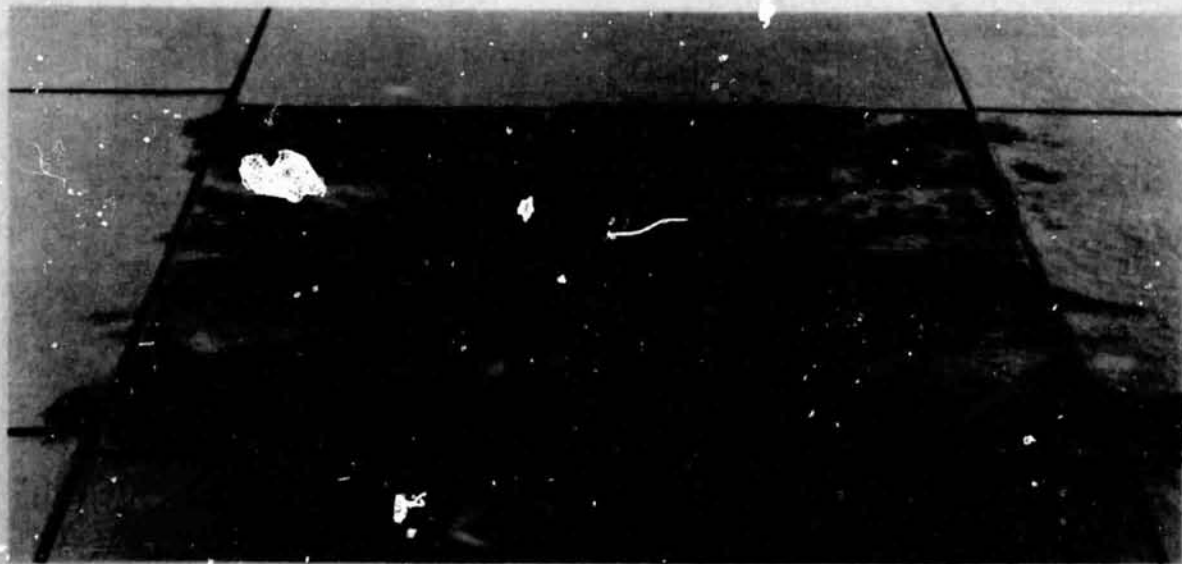
(a) Pre-test 4

(b) Post-test 4

Figure 18. - Crack patterns of tile coating (tile III).

Tile protective coating damage. - The coating is intended to protect the tile from water ingress and to prevent shear erosion of the basic silica tile. Although invisible to the naked eye, cracks were found in the coating before test 4, as indicated in figure 18(a) where the crack pattern is traced on a transparency. During test 4, tunnel flame-out occurred after 6.2 seconds in the stream (see table II); consequently, the hot tiles were exposed to extremely cold flow. A photograph of a typical tile crack pattern after test 4 is shown in figure 18(b). The tile is wetted by a volatile solvent to expose the hairline cracks. All of the tiles were crazed as shown in figure 18(b) after run 4, but did not seem to worsen with repeated tests. There was no flaking of the RSI which suggests the cracks did not penetrate the basic silica tile.
