NASA TN D-7617

**PERFORMANCE OF COATED COLUMBIUM
AND TANTALUM ALLOYS IN PLASMA
ARC REENTRY SIMULATION TESTS**

by Stanley R. Levine and John P. Merutka

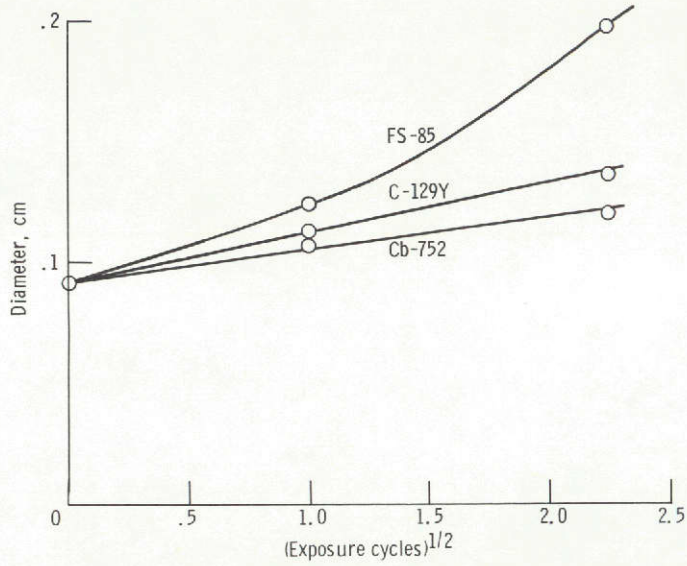
Figure 10. - Metal recession at 0.092-centimeter-diameter through-hole defects in R512E coated columbium alloys after plasma arc exposure at 1390° C.

Defect growth. - The four types of intentional coating damage (through-hole, coating removal from the upper surface, impact damage, and edge notching) did not produce serious columbium substrate degradation in up to five plasma arc exposure cycles. Only the growth of the through-hole defect was followed quantitatively. The increase in diameter of the defect as a result of substrate oxidation is plotted in figure 10 - the defect

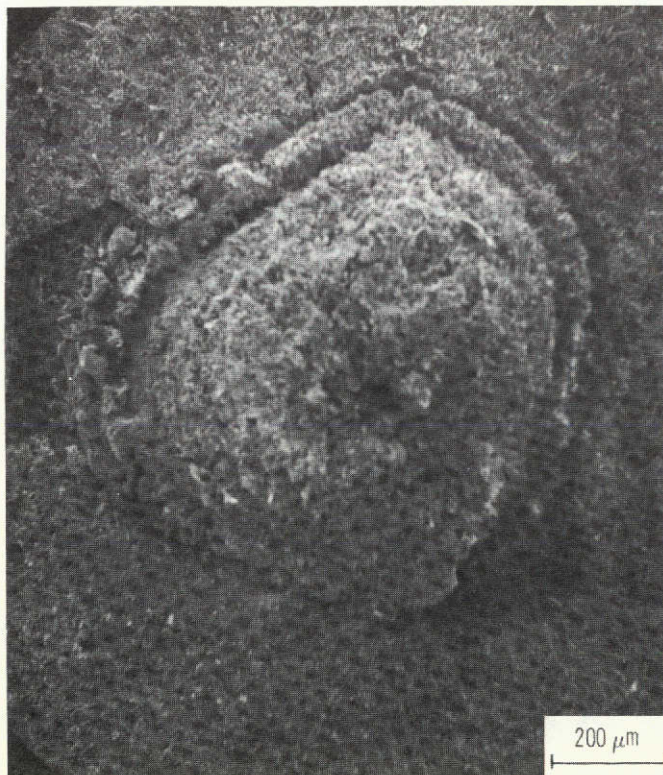
Figure 11. - Scanning electron micrograph showing plugging of 0.092-centimeter through-hole defect in R512E coated FS-85 with substrate oxide after five plasma arc exposure cycles at 1390° C. Scanning electron microscope conditions: 7 picoamperes, 25 kilovolts.

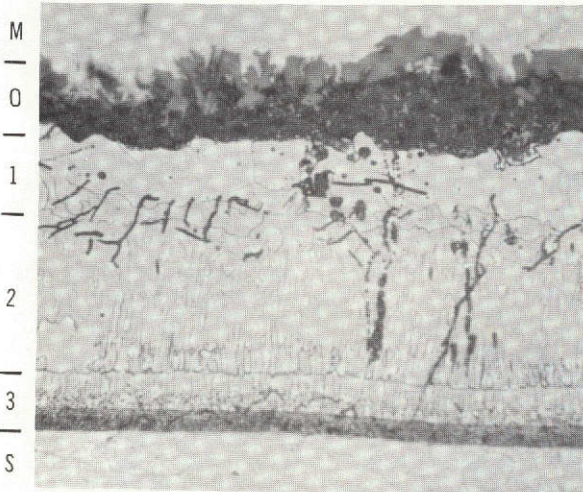
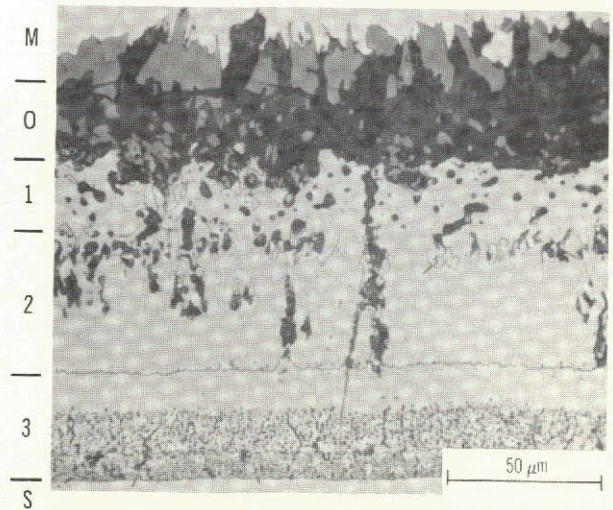
Figure 19. - Photomicrographs of R512E on Cb-752 and C-129Y after plasma arc exposure at 1390° C. Locations, top surface near forward edge.
