Flight Prototype Regenerative Particulate Filter System Development

FINAL REPORT

FLIGHT PROTOTYPE REGENERATIVE PARTICULATE FILTER SYSTEM DEVELOPMENT

MARTIN MARIETTA CORPORATION P.O. BOX 179
DENVER, COLORADO 80201

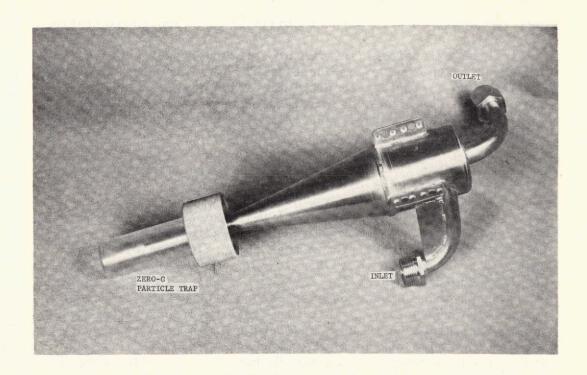
The vortex particle separator, Figure I-6, is a passive component with no moving parts. The separator employs a vortex action where the particles are thrown to the outer surface of the separator and eventually are forced down to the zero-g trap where they are accumulated and prevented from re-entering the normal flow. The particle trap is sized so that little or no change-out is required during a normal mission. The trap can be removed with no loss of fluid and can be either replaced or simply rinsed.

Figure I-6 Vortex Particle Separator

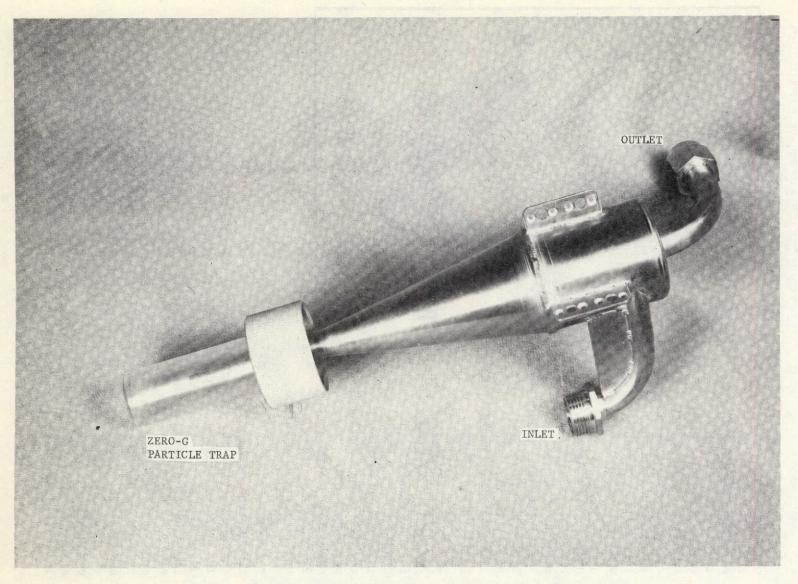
Figure IV-6 Flight Prototype Vortex Particle Separator

During the two-minute regeneration cycle, the backflush flow through the regenerative filter removes the particles from the filter element and carries them into the vortex particle separator, Figure IV-6, where 88% to 93% of the particles are removed from the fluid by centrifugal action. The particle separator is a key element in the regeneration unit and is used as a means of removing and collecting most of the backflushed effluent from the regenerative filter element. The vortex particle separator is a passive component with no moving parts. The separator
