EVALUATION OF SHUTTLE SOLID ROCKET BOOSTER CASE MATERIALS

L.J. Pionke
K.C. Garland

28 December 1973

McDonnell Douglas Astronautics Company
St. Louis, Missouri

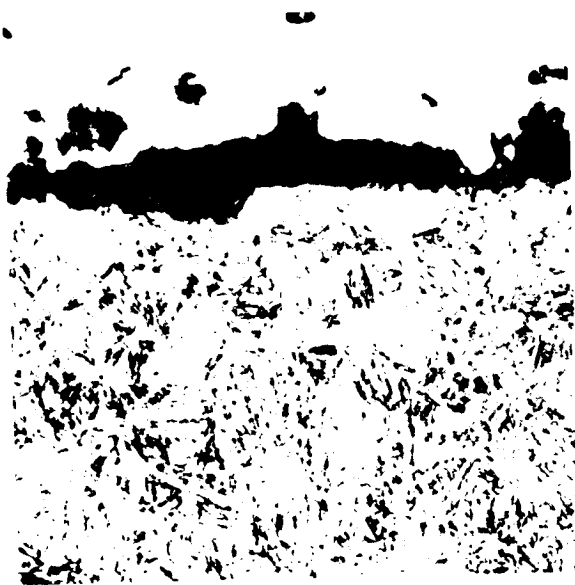
FIGURE 4-6
EXTENT OF CORROSION ON D6AC STEEL SPECIMENS AUSTENITIZED
AT 1158°K AFTER 15 AND 62 DAYS ALTERNATE IMMERSION EXPOSURE

Cross-Section, X400

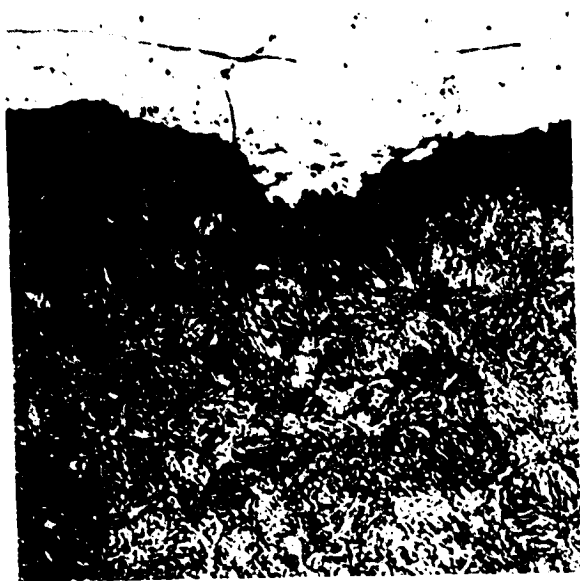
FIGURE 4-7
EXTENT OF CORROSION ON D6AC STEEL SPECIMENS AUSTENITIZED
AT 1200°K AFTER 15 AND 62 DAYS EXPOSURE

Cross Section, X400

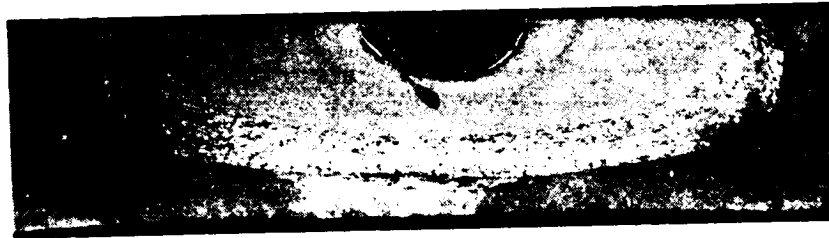
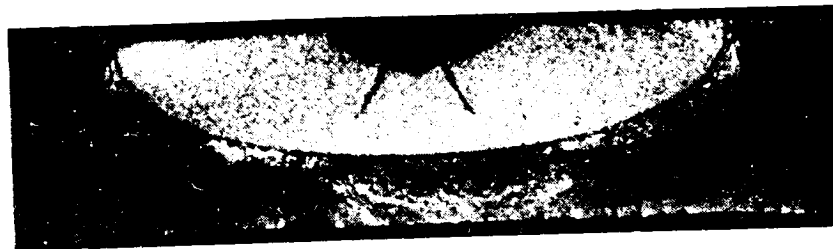
FIGURE C-1
FRACTURE SURFACES OF 18 NICKEL MARAGING STEEL
SPECIMENS AFTER LOAD CYCLING (X3)

- Specimen M1
- Cycled @ MEOP
 - >90 Missions to Failure

- Specimen M2
- Cycled @ 1.05 MEOP
 - 30 Missions to Failure

- Specimen M3
- Cycled @ 1.10 MEOP
 - 39 Missions to Failure

- Specimen M4
- Cycled @ 1.13 MEOP
 - 11 Missions to Failure

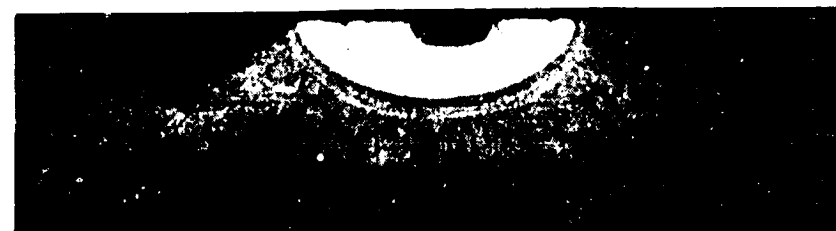
FIGURE C 4
FRACTURE SURFACES OF D6AC STEEL SPECIMENS
AFTER LOAD CYCLING (X3)

- Specimen D1
- Cycled @ 1.05 MEOP
 - 80 Missions to Failure

- Specimen D2
- Cycled @ 1.10 MEOP
 - 37 Missions to Failure

- Specimen D4
- Cycled @ 1.13 MEOP
 - 3 Missions to Failure
