REPORT NO. NASA CR-132380

**EVALUATION OF A METAL FUSELAGE PANEL'S
SELECTIVELY REINFORCED WITH FILAMENTARY
COMPOSITES FOR SPACE SHUTTLE APPLICATION**

FINAL REPORT

CONVAIR DIVISION OF GENERAL DYNAMICS

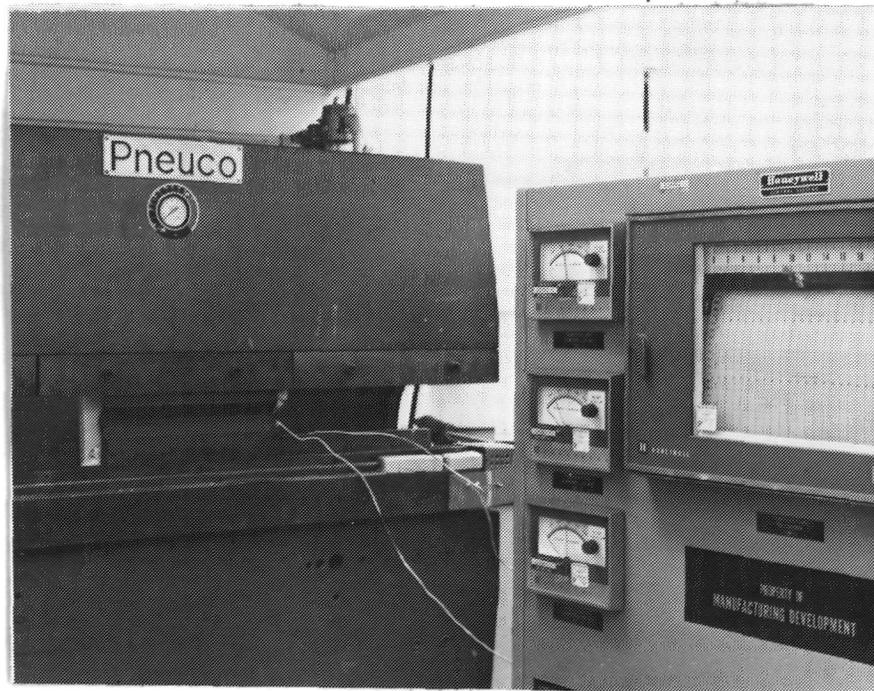
Figure 7.12. Hot Forming Facilities (Neg. 11952B).

Heat was supplied to the tools by a "Honeywell" power cart and temperature controller. The Honeywell unit had six control circuits, each supplying 480 volts, 30 amps, 3 ϕ power. Figure 7.12 shows the tooling setup in the press. In order to reduce costs, an existing heated die holder was utilized. The die holder had 3 "Calrod" cartridge heaters imbedded in it. A 30 cm (12 in) long punch and Vee die were fabricated from hot rolled steel to suit the die holder. The tools were 90° matched dies and the punch was made in a "Gooseneck" shape to accommodate the narrow width of the hat. Indexing was accomplished by press fitting dowel pins in the Vee die which accommodated slots in the ends of the blank along the bend axis. (Initially the pins were placed in the punch but preliminary testing indicated handling of the blank with this particular hat configuration was difficult with the pins in the punch.)

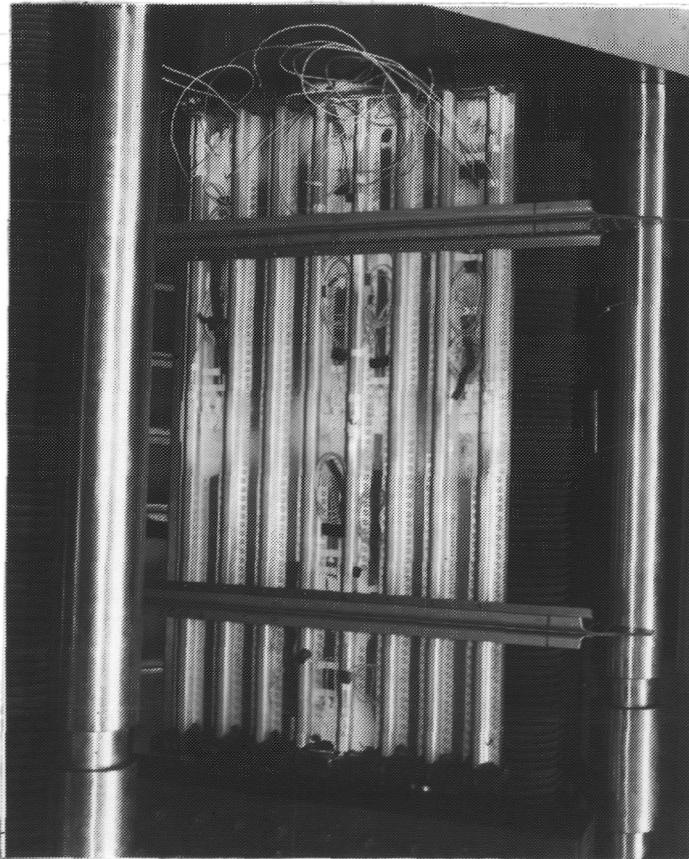
Figure 10.2. Compression panel in Test Machine. 139

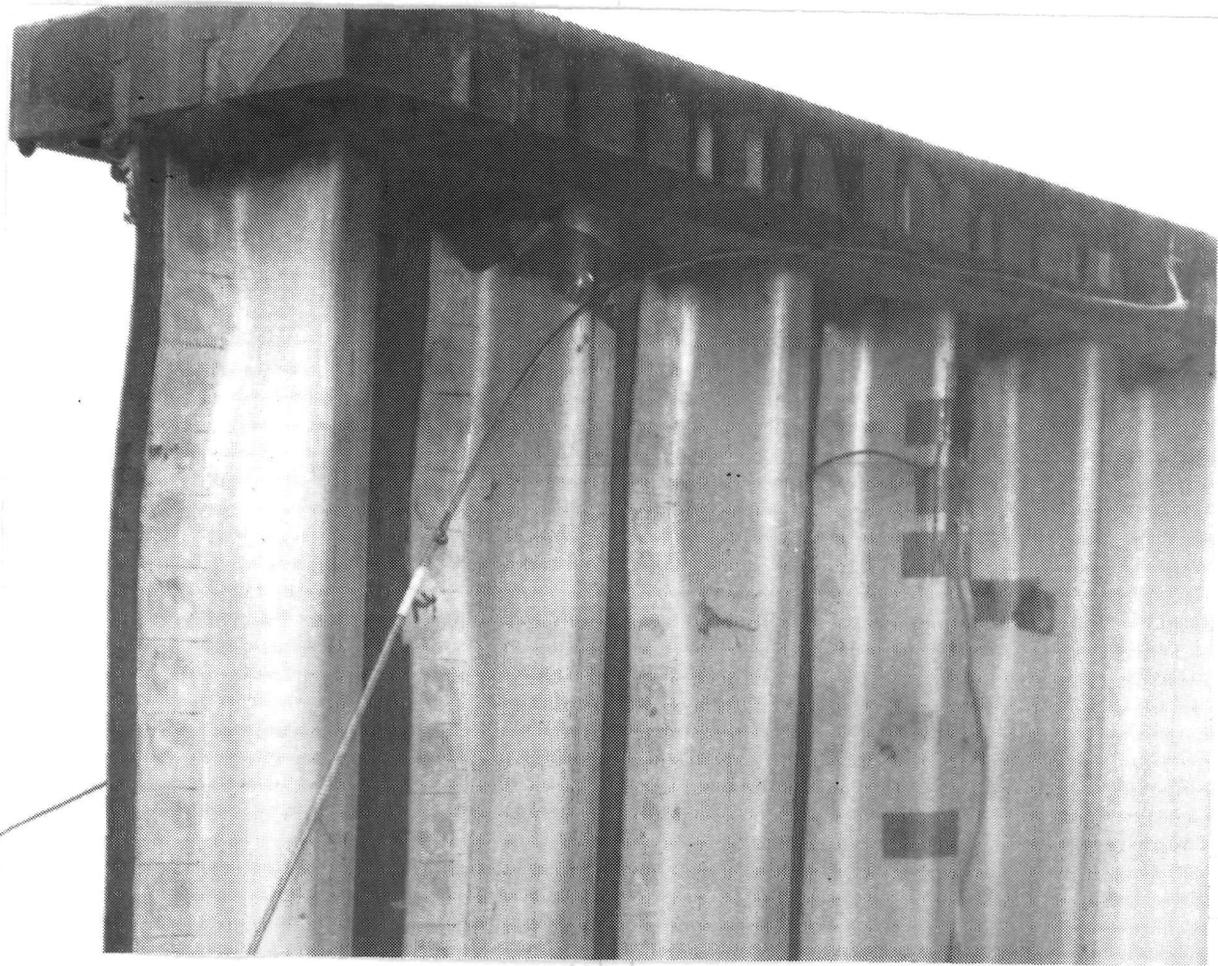
Figure 10.18 Buckles in Stringers at End of Compression Panel.
