NASA CR-134521
HSER 6241

FINAL REPORT

IMPACT RESISTANCE OF SPAR-SHELL COMPOSITE FAN BLADES

CONTRACT NAS3-16778

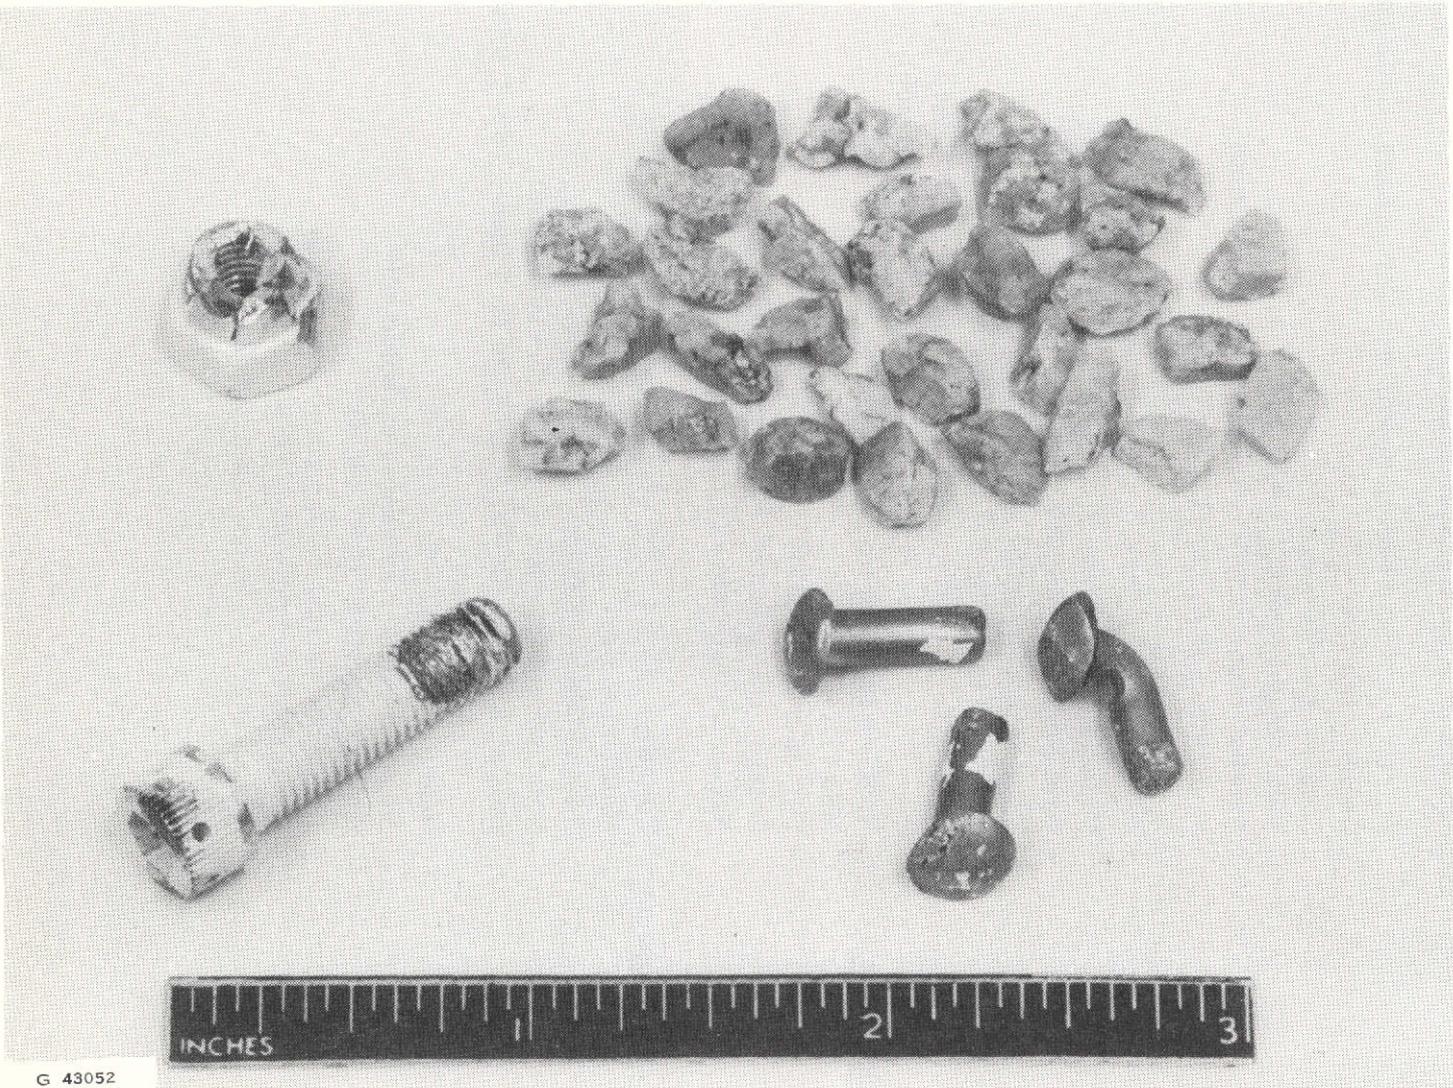
FIGURE 5. SMALL IMPACT MEDIA FOR FOD TESTING

The small impact media used in this program are listed in Table III. The selection of stones, rivets, nuts, bolts and iceballs was made to establish the capability of the blade to resist damage from a variety of typical impact media. The type of stones used in this program had been used at Hamilton Standard in tests on propeller blades, fan blades and blade specimens and was obtained from a lake bed at Edwards Air Force Base in California. As shown in Figure 5, the stones were sharp edged. In tests of blades at Edwards, gouging effects due to stone impact on fiberglass blade surfaces unprotected by the leading edge sheath were severe. The nuts, rivets, and bolts that were impacted, as well as unimpacted stones, are shown in Figure 5. The iceballs used in this program were molded from supersaturated carbonic acid to obtain the 0.80 to 0.85 specific gravity range typical of hail. The fabrication procedure is defined in Appendix B.

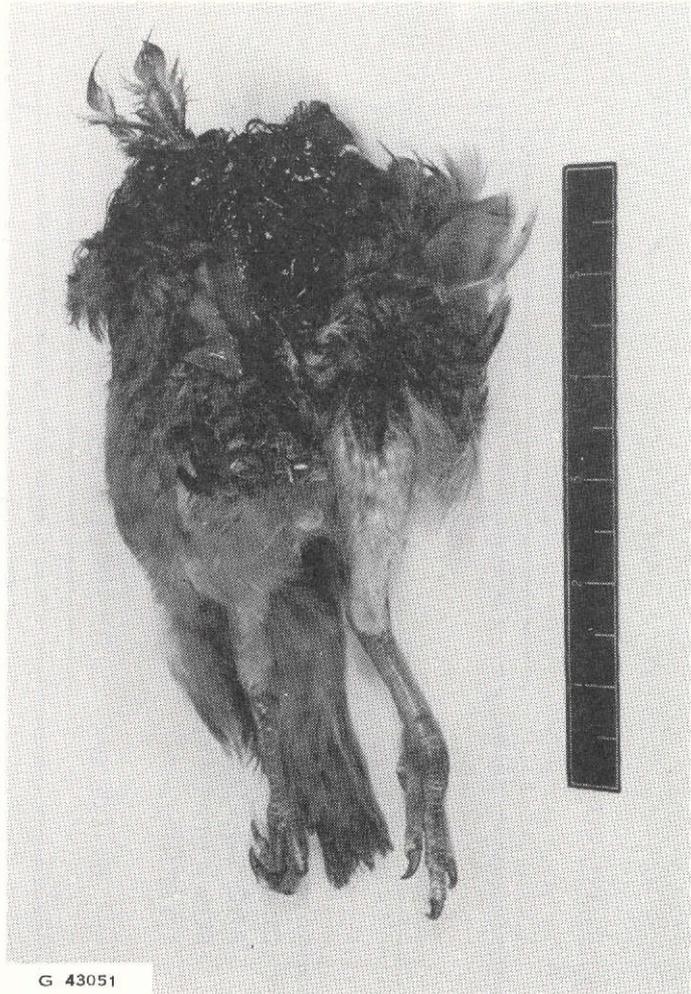
FIGURE 7. CHUKAR PARTRIDGE USED IN FOD TEST

The second large impact media was a real bird. Figure 6C also describes this assembly. The bird was a 499 gram (1.1 pound) chukar partridge (Figure 7) selected for weight on the basis of the results of the simulated bird tests. The frozen bird was thawed overnight prior to use in the test. Aluminum casings and styrofoam were used to mount the bird to the pendulum and to support the partridge. The bird was placed in a nylon bag with head held snugly against the body. The bird was installed for head first injection. The styrofoam casing was sized for a snug fit between bird and foam. The feet were attached by wire to the foam casing.

A) PRE TEST CONDITION
WEIGHT 499 GM (1.1 LB)

B) POST TEST CONDITION
WEIGHT 222 GM (0.50 LB)

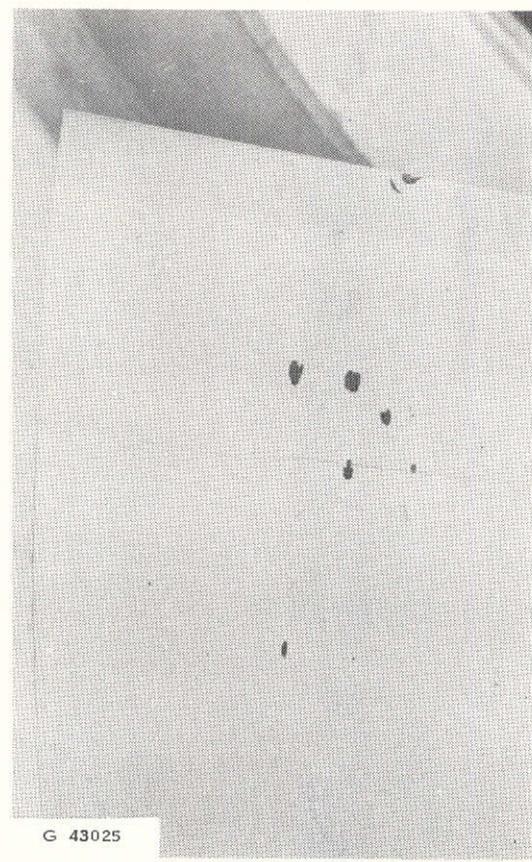
FIGURE 11. RIVET STRIKES – BLADE B-1

1. Stone test - The paint was blemished at the impingement sites. Indentions on the immediate leading edge extended to a depth of 0.005 cm (0.002 inch). Figure 10 shows this blade after the stone impact test run.
2. Rivet test - Paint was removed at the impact sites. Figure 11 shows this blade after the rivet test run.
3. Steel nut test - The strike was on the sheath on the face side of the blade. The depth of the indentation in the sheath was 0.102 cm (0.040 inch). The width was 1.52 cm (0.6 inch). Figure 12A shows the blade after nut impact.
4. Bolt test - The bolt impacted directly on the leading edge. The impact produced an indentation 0.19 cm (0.060 inch) deep and 0.508 cm (0.200 inch) wide. The leading edge was also slightly bent toward the face side, approximately 0.152 cm (0.060 inch). Figure 12B shows the blade after the bolt impact.

A) LEADING EDGE – CAMBER SIDE

B) FACE SIDE – UPPER BLADE

C) FACE SIDE – MID BLADE
