**VACUUM THERMAL-MECHANICAL
FATIGUE TESTING OF TWO IRON BASE
HIGH TEMPERATURE ALLOYS**

TOPICAL REPORT NO. 3

TRW MATERIALS TECHNOLOGY LABORATORIES
CLEVELAND, OHIO

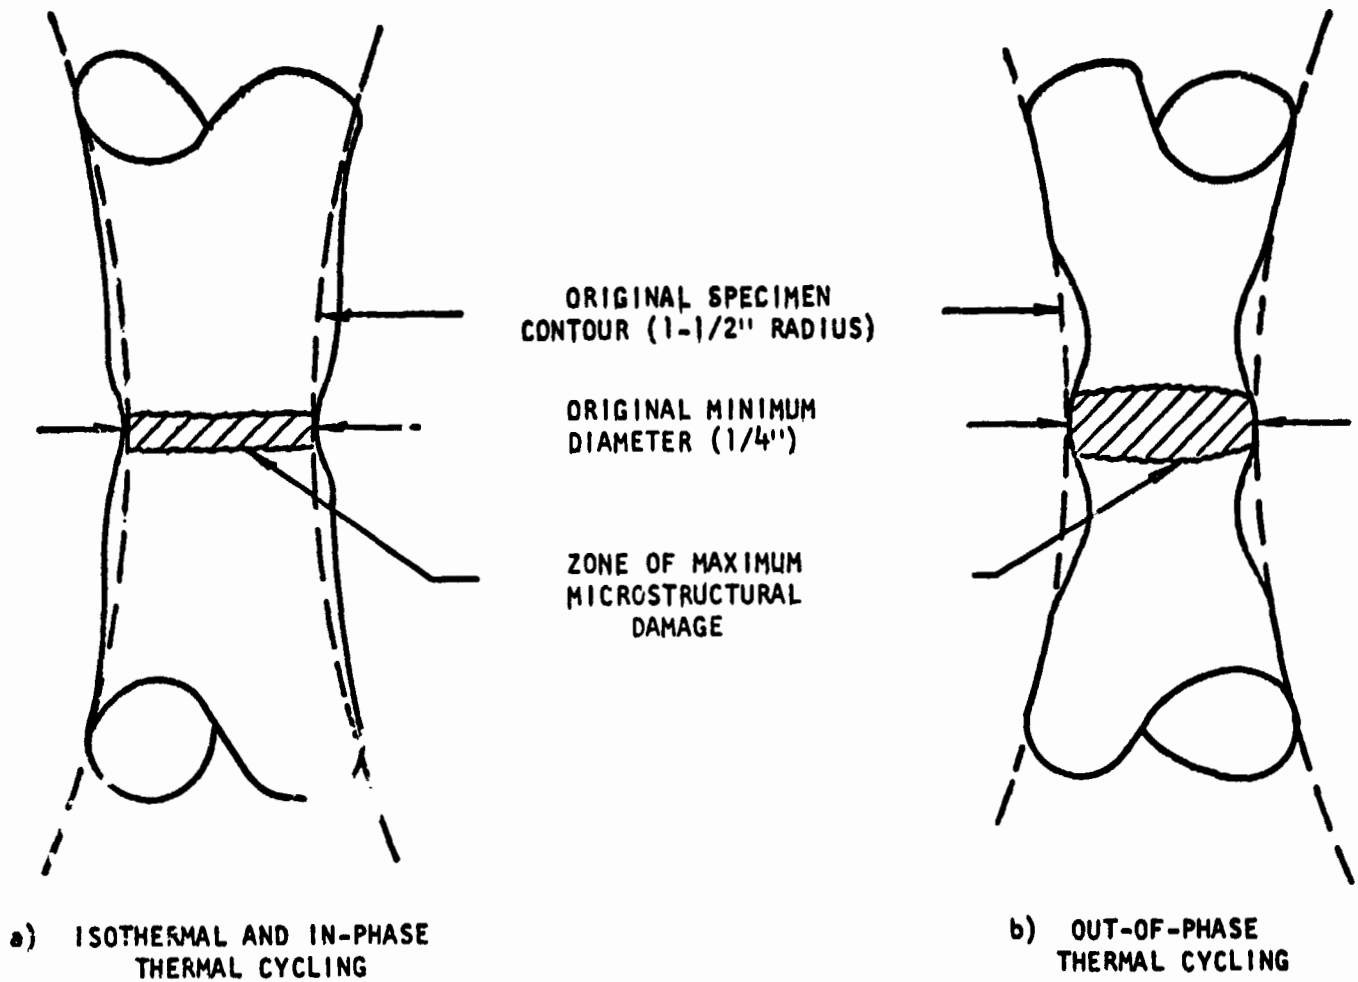
Figure 4. Schematic illustration of specimen geometry changes produced by thermal-mechanical fatigue cycling.

In previous thermal cycled tests conducted in this laboratory (5) the occurrence of mean tensile and compressive stresses caused geometry changes to develop in the hourglass specimens during fatigue testing. These geometry changes involved thickening of the test specimen in locations above and below the minimum diameter with isothermal and in-phase cycling and thinning of the specimen in these same locations with out-of-phase cycling (Figure 4). Similar geometry changes were observed in the 304 stainless steel but not in the A-286 specimens tested in the current program (Figure 5). While no definite explanation is available for the occurrence of geometric instabilities in the 304 stainless steel but not in the A-286, it may be observed that the three alloys which have shown pronounced geometry changes in these types of tests (two tantalum alloys and 304 stainless steel) are basically high ductility materials, whereas the A-286 is a relatively low ductility alloy. It is not possible to determine from the available results if this qualitative correlation is representative of a general trend, or is merely coincidental. Additional data on a wider range of materials would be highly desirable to clarify this point.

The above noted geometry changes did not influence the fatigue life results for the isothermal and in-phase tests, since the change left the area of controlled maximum strain unchanged. However, the out-of-phase geometry change was thought to have a significant influence on fatigue life since this type of change caused failure to occur at a location separate from the original minimum diameter (Figure 5d). Thus, the failure site represented an area where strain was both unspecified and uncontrolled. This qualification applies only to the 304 stainless steel TCOPS results, since geometry changes were not observed in the A-286 alloy.

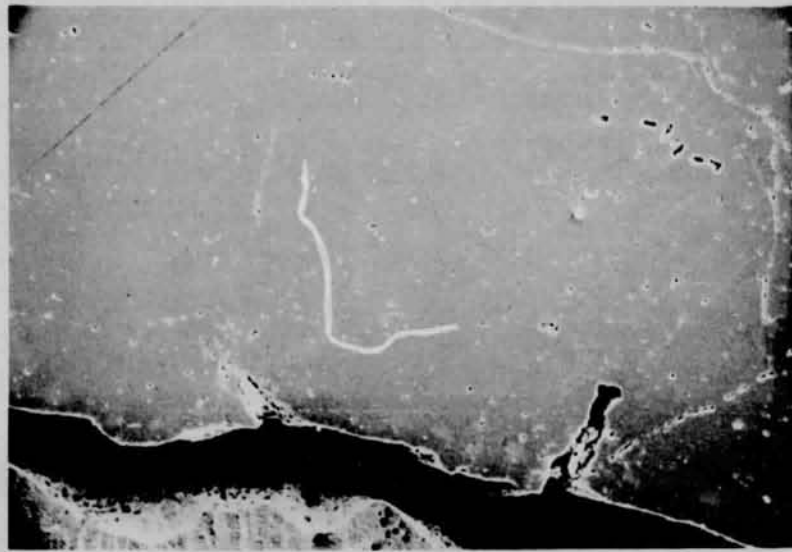
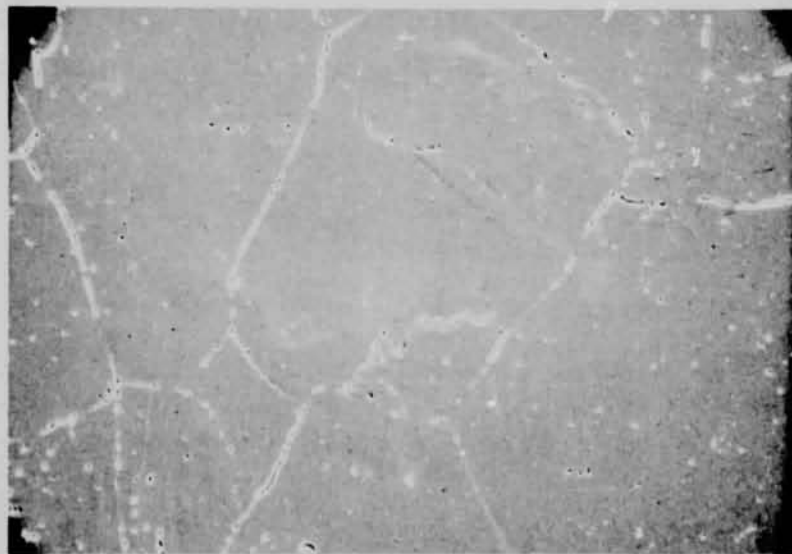
(a) Interior of specimen approximately .3mm below fracture surface

(b) Secondary grain boundary crack immediately below fracture surface.

(c) Transgranular and intergranular secondary cracks approximately 1.5mm below fracture surface.

Figure 8. 304 stainless steel fatigue tested isothermally at 1200°F (922°K), .65 Hz, longitudinal inelastic strain range 0.0108, cycles to failure 4483. Tensile axis parallel to long edge of photomicrographs. Magnification 500X

Microstructural damage observed in the fatigue tested specimens varied with both cycle type and test material, as shown in Figures 8 through 15. Neither alloy showed evidence of significant internal damage with isothermal high frequency cycling (Figures 8a and 9a). Both alloys exhibited mixed mode cracking under these test conditions, as shown in Figures 8 and 9b and c. Some tendency for cracking at twin boundaries was also observed in the 304 stainless steel (Figure 8c). Some of the secondary cracks observed in A-286 appeared to be associated with carbide inclusions (Figure 9d). While this association was assumed to have some influence on cyclic life of the A-286 alloy, it was not thought to influence the life differences caused by different types of cycles, since the carbide associated cracking was observed in A-286 for all cycle types.

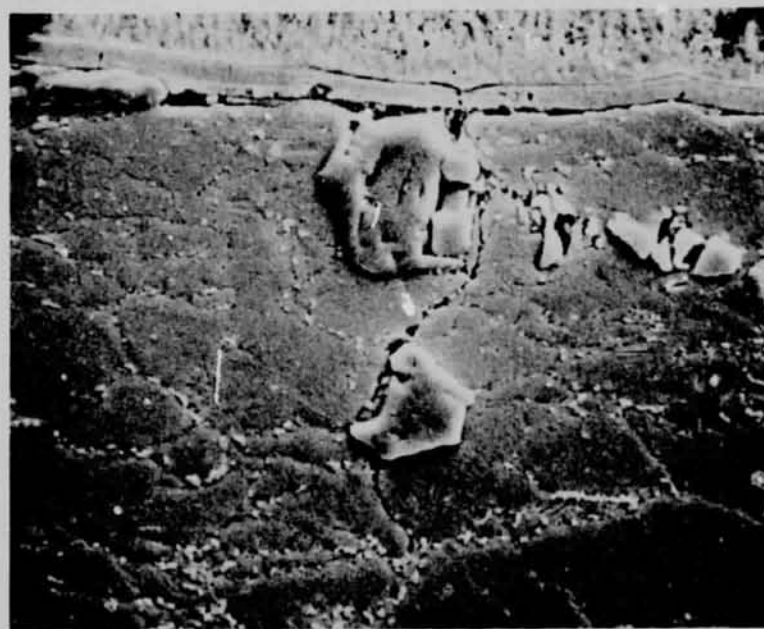
(a) Structure in interior of specimen approximately .3mm below fracture surface.

(b) Secondary crack approximately 1.8mm below fracture surface.

Figure 11. A-286 alloy fatigue tested isothermally at 1100°F (866°K), .0065 Hz, longitudinal inelastic strain range .0072, cycles to failure 2319. Tensile axis parallel to long dimension of photomicrograph. Magnification $\times 2000$.

Secondary cracking in the low frequency isothermal specimens was exclusively intergranular in both materials (Figures 10b and 11b). The A-286 alloy exhibited little internal damage except for the occasional appearance of carbide associated cracks (Figure 11). The 304 stainless steel alloy exhibited localized damage at grain and twin boundaries. This damage was characterized by boundary serration and localized intergranular cracking (Figure 10a).

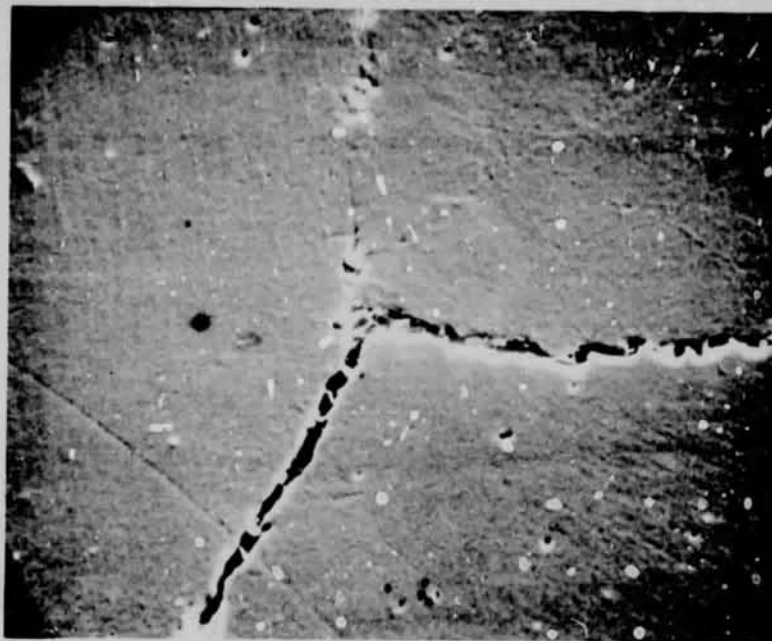
(a) Grain boundary decohesion in interior of specimen approximately 1.8mm below fracture surface. 2000X

(b) Intergranular secondary cracking approximately 2.6mm below fracture surface. 1000X

Figure 12. 304 stainless steel fatigue tested with in-phase thermal cycling (tension isothermal at 1200°F (922°K); compression isothermal at 600°F (589°K), .0065 Hz, longitudinal inelastic strain range .0103, cycles to failure 455. Tensile axis parallel to long edge of photomicrograph.

In-phase thermal cycling caused severe internal grain boundary cavitation in both alloys (Figures 12 and 13). This grain boundary decohesion was assumed to be the cause of premature fatigue failure. Boundary cavitation was attributed to unreversed tensile grain boundary sliding generated by inelastic tensile strain introduced at a high temperature where grain boundary sliding occurs, and reversed by inelastic compressive strain at a low temperature where grain boundary sliding does not occur. Numerous carbide associated cracks were observed in the in-phase cycled A-286 alloy (Figure 13d).
