APPLICATION OF ERTS-1 IMAGERY TO FRACTURE RELATED MINE SAFETY HAZARDS IN THE COAL MINING INDUSTRY

January 1974
Type II Report, July 1973—January 1974
Contract No. NAS5-21795

PROGRESS REPORT SUMMARY

TITLE: Study of Application of ERTS-A Imagery to Fracture-Related
Mine Safety Hazards in the Coal Mining Industry

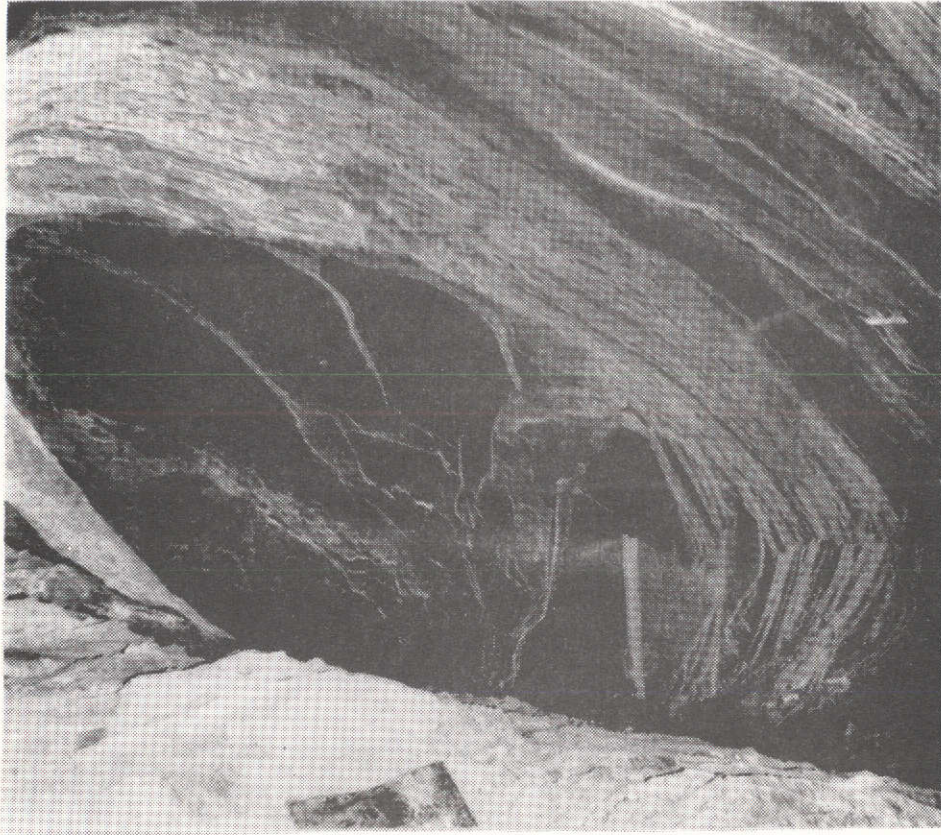
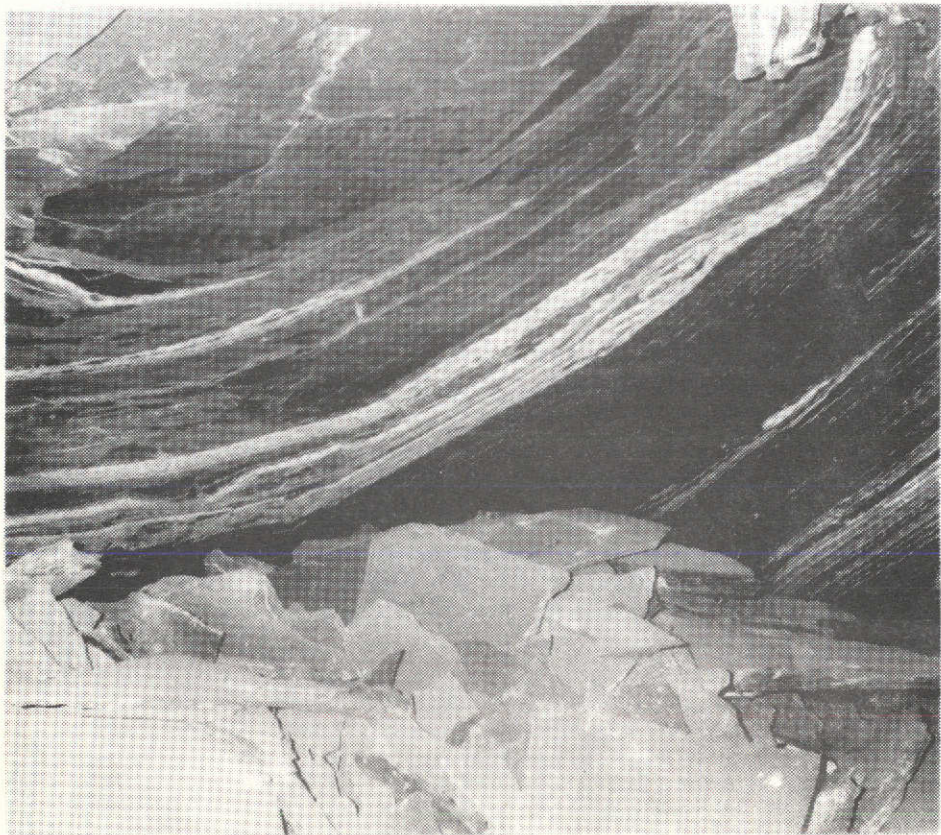
Figure 1.1. These photographs show examples of roof falls in an underground coal mine. The top illustration is looking vertically into a conical roof fall cavity over fifteen feet in the largest dimension and nearly as deep. An associated fracture can be observed at the right end of the cavity. The bottom photograph is of a larger roof fall before the debris has been removed. A fracture extending across the top of the cavity is readily discernable. A simple roof fall of this type can cost a mine operator over \$500 to rebolt and clean up.

Underground mining is generally more complicated than surface mining and the hazards to the miners are greater. About 75 percent of all coal mining fatalities occurred in underground mines. The U.S. Bureau of Mines identifies roof falls as the number one killer in coal mining (see Figure 1.1). More than 40 percent of the fatalities in underground mining are the direct result of roof falls and wall collapse. Any method or technique which will provide greater safety to the miners and better ensure continuous low cost coal production is desirable.

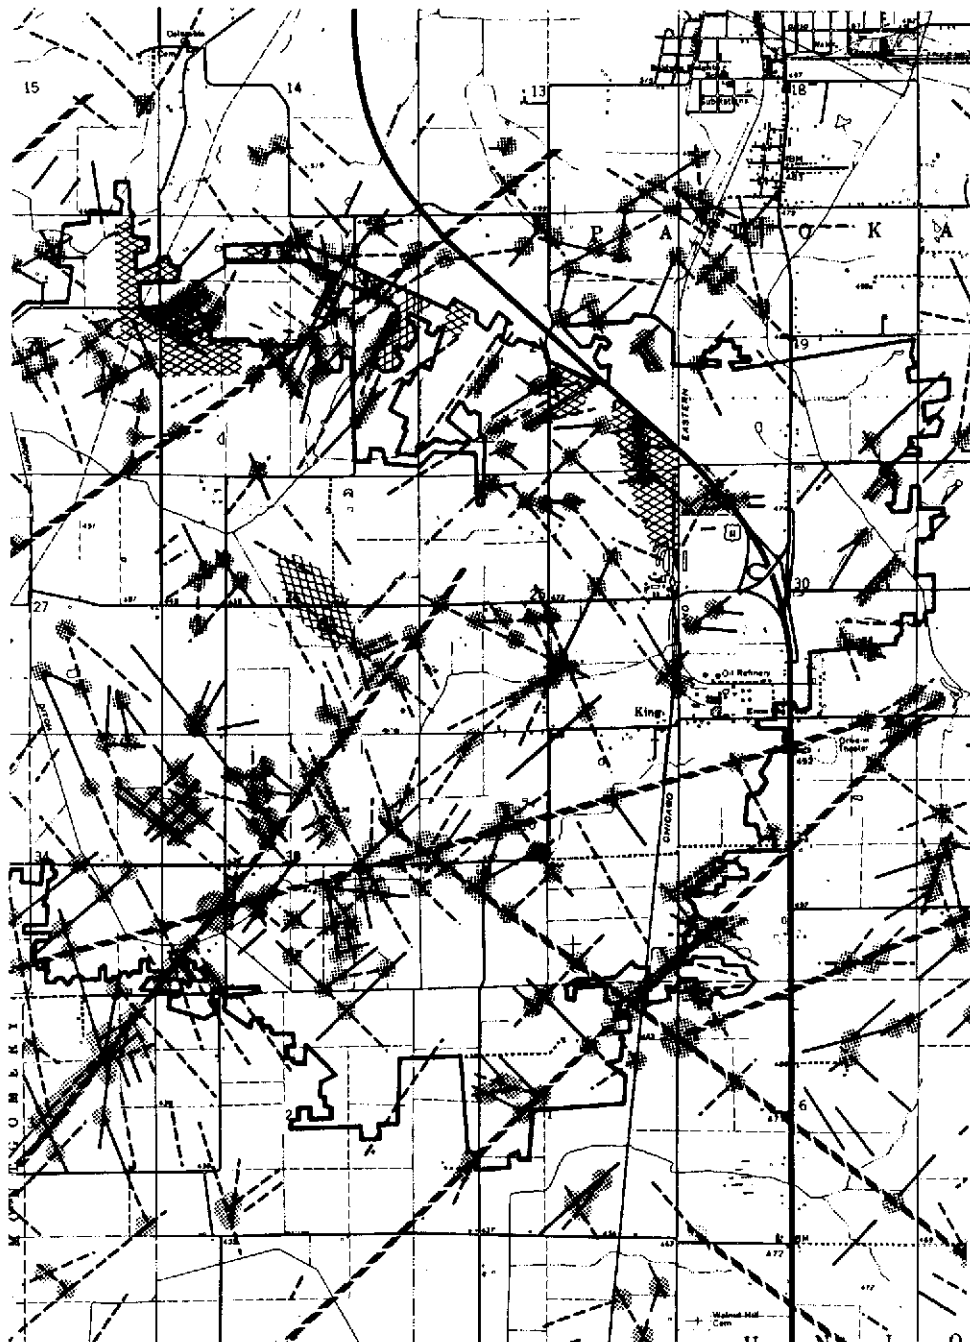
| Fracture-lineament mapped from ERTS-1 imagery | Fracture mapped from aircraft imagery |
| Predicted zones of high probability of roof falls | Zones of severe roof fall problems in mine |

Figure 5.1. A portion of the Kings Station Mine Hazards Prediction map showing the distribution of fractures and lineaments mapped from ERTS and aircraft imagery. Stippled areas represent predicted zones of high probability of roof fall occurrence which are based on intersection of fractures. The criss-cross patterns indicate areas identified by mine personnel as having severe roof fall problems in the mine.

A preliminary mine hazards map was compared with actual roof falls in the Kings Station Mine as indicated by mine personnel and by first-hand observation. Good correlation was found with over 4 out of 5 predicted hazard areas coinciding with areas of roof fall problems. These positive results are encouraging, but the technique needs further verification in other areas in the United States.

An underground visit to the Kings Station Mine was arranged through the courtesy of Old Ben Coal Company which provided an opportunity to make first-hand observations of roof fall problems and measurements of fractures. Prior to the visit, a preliminary hazards map was prepared. At least 4 out of 5 predicted hazards zones correlated with known roof fall areas identified by the mine officials (see Figure 5.1). Correlation of roof falls with the hazards map was limited to the north portion of the mine as the remainder of the mine has been closed-off for many years.

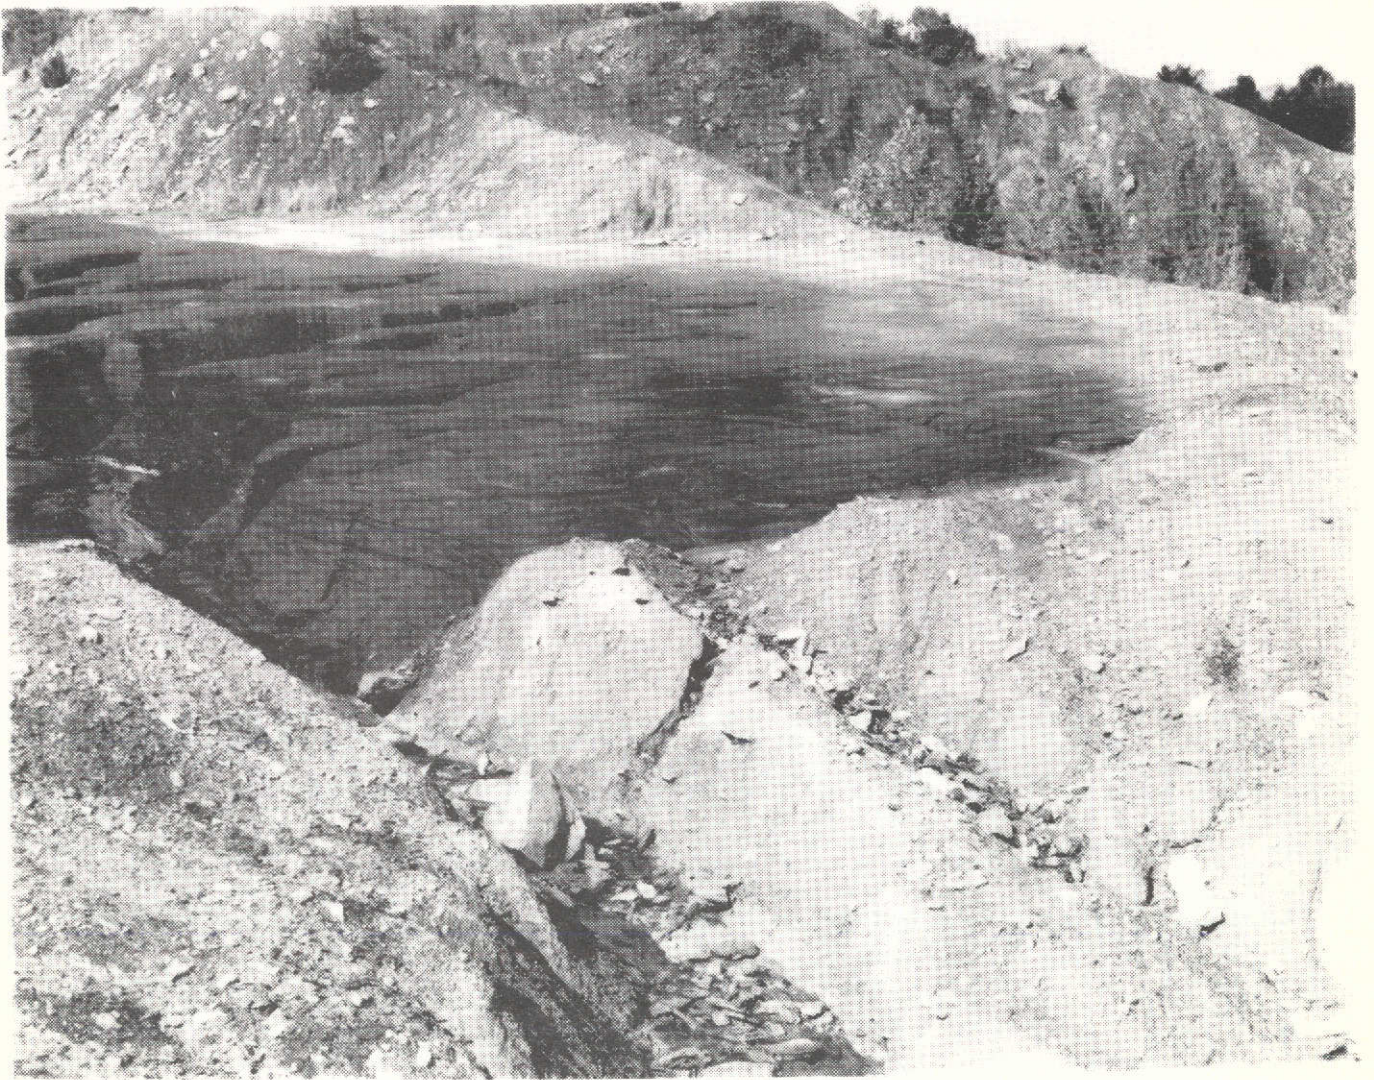
Figure 6.1. This breached slurry containment dam in Kentucky graphically illustrates the type of problem that can develop from old coal preparation sites. Here, thousands of cubic yards of toxic waste material is being eroded into a drainage system.

Coal processing (washing and screening) removes unwanted rock materials and coal dust. These materials are normally separated into two fractions. The larger boulder to pebble sized "gob" or refuse fraction has been disposed of in large piles as much as a mile long and many tens of feet high close to the preparation plant. The finer pebble to clay sized waste material is water-transported as a slurry and is normally piped to depressions created in mining or contained by dikes and dams (Figure 6.1).
