**HIGH GAS VELOCITY BURNER TESTS ON SILICON CARBIDE
AND SILICON NITRIDE AT 1200° C**

by William A. Sanders and Hubert B. Probst
Lewis Research Center
Cleveland, Ohio 44135

TECHNICAL PAPER presented at Army Materials
Technology Conference on Ceramics for High Performance Applications
Hyannis, Massachusetts, November 13-16, 1973

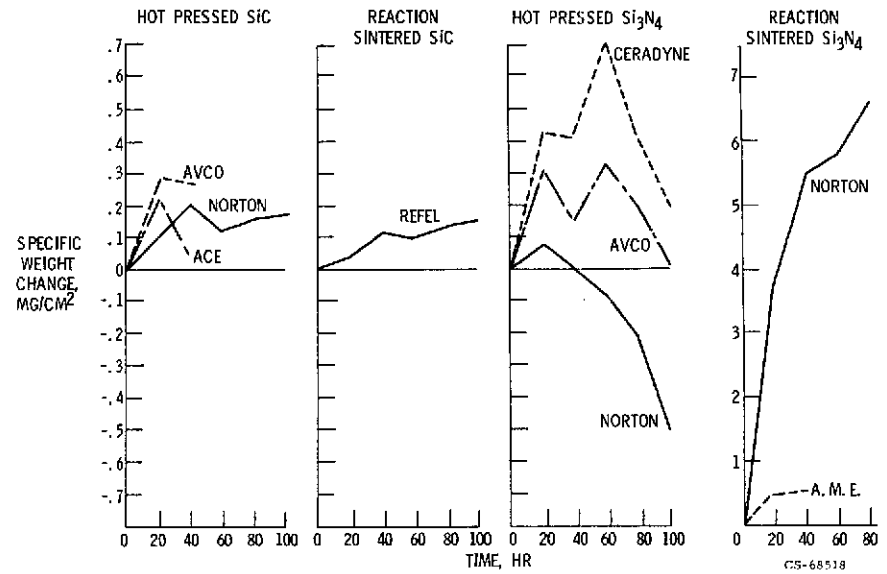
Figure 4. - Specific weight change for SiC and Si₃N₄ materials resulting from cyclic exposure at 1200° C in Mach 1 simulated gas turbine environment cycle; 1 hour at 1200° C, 5 minute still air cool.

The specific weight change data for Refel SiC are given in table IV and plotted in figure 4(b). The oxidation behavior of the Refel material was very similar to the behavior of Norton hot pressed SiC plotted in figure 4(a). No dimensional loss in thickness was noted for the Refel SiC

The oxidation behavior of samples of these two materials was considerably different as indicated by the specific weight changes given in table IV and plotted in figure 4(d). The Norton material gained weight at a very rapid rate to at least 80 cycles while the limited data for the A.M.E. material shows only a very slight weight gain in the 20 to 40 cycle interval. At 40 cycles, the Norton material had almost 10 times the weight gain of the A.M.E. material. The Norton 92 cycle specimen lost 11 micrometers in thickness. Damage to the salvaged hot zone section of the Norton sample precluded a determination of breadth loss. Due to damage, no dimensional measurements were possible on the A.M.E. material. Photos of the Norton and A.M.E. specimens after 80 cycle and 40 cycle respective exposures are shown in figure 17(a). These specimens subsequently failed because of loosening in the holder after 92 cycles (Norton) and 49 cycles (A.M.E.). Figure 17(b) shows SiO₂ flow lines noted on the A.M.E. hot zone leading edge at the 20 cycle mark. No flow lines were noted on the Norton specimen through 80 cycle exposure. X-ray diffraction analyses from the surfaces of salvaged specimen hot zones indicated the presence of α -Si₃N₄, β -Si₃N₄ and α -SiO₂ for the Norton specimen after 92 cycles and the A.M.E. specimen after 49 cycles.

As seen in figure 4 the weight gain behavior of the A.M.E. reaction sintered Si_3N_4 compares favorably with the weight gain of the much higher density Ceradyne hot pressed Si_3N_4 . This is somewhat surprising inasmuch as previous studies have reported much higher static oxidation weight gains for high porosity reaction sintered Si_3N_4 (Ref. 10) than for fully dense hot pressed Si_3N_4 (Ref. 7). The favorable behavior of A.M.E. material may well be at least partially caused by the high velocity gas stream. As illustrated in figure 19 a continuous SiO_2 scale does form which protects the underlying porous structure from continued rapid oxidation. The flow of SiO_2 augmented by the shearing forces of the gas stream no doubt contribute to the formation of this continuous protective scale.

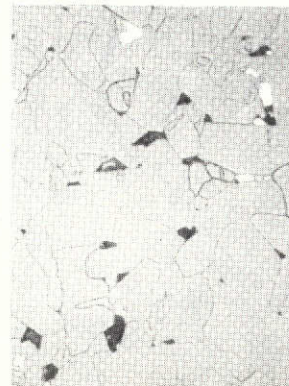
NORTON, 2 μm EQUIAXED GRAINS

A. C. E., 5 μm EQUIAXED GRAINS

AVCO, 14 μm x 40 μm TABULAR
GRAINS

CERADYNE, 7 μm x 20 μm TABULAR
GRAINS

Figure 6. - Microstructures of as-received hot pressed SiC materials. Etched, X750.

Microstructures of the as-received hot pressed SiC materials are shown in figure 6. The Norton material was equiaxed and had a grain size of about 2 micrometers and a rather homogeneously dispersed dark etching constituent. The A.C.E. SiC material also had equiaxed grains but the grains were larger with a size of about 5 micrometers. Dark areas, either porosity and/or pull-outs are evident in the A.C.E. material. Both the Avco and Ceradyne SiC materials had microstructures

consisting of tabular grains. The Avco SiC material was coarser grained than the Ceradyne by a factor of two, typically 14 micrometer x 40 micrometer tabular grains for Avco and 7 micrometer x 20 micrometer tabular grains for Ceradyne. Avco and Ceradyne microstructures also exhibit fairly large pores compared to either A.C.E. or Norton. The light etching phase apparent in Avco and Ceradyne are probably associated with the use of densification aides. The Norton SiC as-received microstructure is also shown by electron micrography in figure 7. Here the dark etching areas shown in figure 6 have the same shade and texture as the larger grains, however, they appear to be comprised of clusters of small grains with individual grain diameters usually less than 1 micrometer. Thus the "dark etching" areas of figure 6 would appear to be ultra fine grained SiC appearing dark because of the heavily etched grain boundaries, rather than being a separate phase.

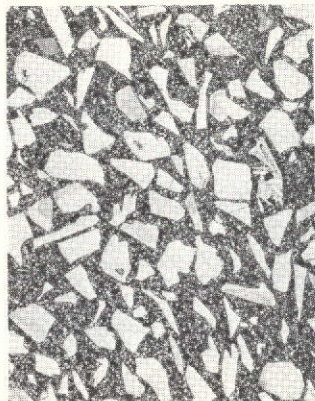
NORTON LOW FIRED SiC
DUPLIX GRAIN SIZE: 100 μm , 4 μm

NORTON HIGH FIRED SiC

Figure 11. - Microstructures of as-received reaction sintered (recrystallized) SiC materials. Etched, X100.

dark stringers are unreacted carbon, the light gray material is SiC and the white material is free Si. These three phases were identified by x-ray diffraction. In figure 11 the Norton low-fired and high-fired SiC materials can be compared. Both materials are prepared in the same way up to the point of firing a slip cast compact of bimodal powder particle size distribution. In the low-fired SiC, a duplex grain structure with very fine porosity is clearly evident. As a result of higher firing temperature the high-fired SiC microstructure appears as a material in the process of grain growth--the large grains growing by surface bonding with small grain clusters but with the formation of large pores.
