CHAPTER 4

All quiet on the sea bottom front? Lessons from the morphodynamic monitoring

Dries Van den Eynde, Matthias Baeye, Robin Brabant, Michael Fettweis, Frederic Francken, Piet Haerens, Mieke Mathys, Marc Sas and Vera Van Lancker

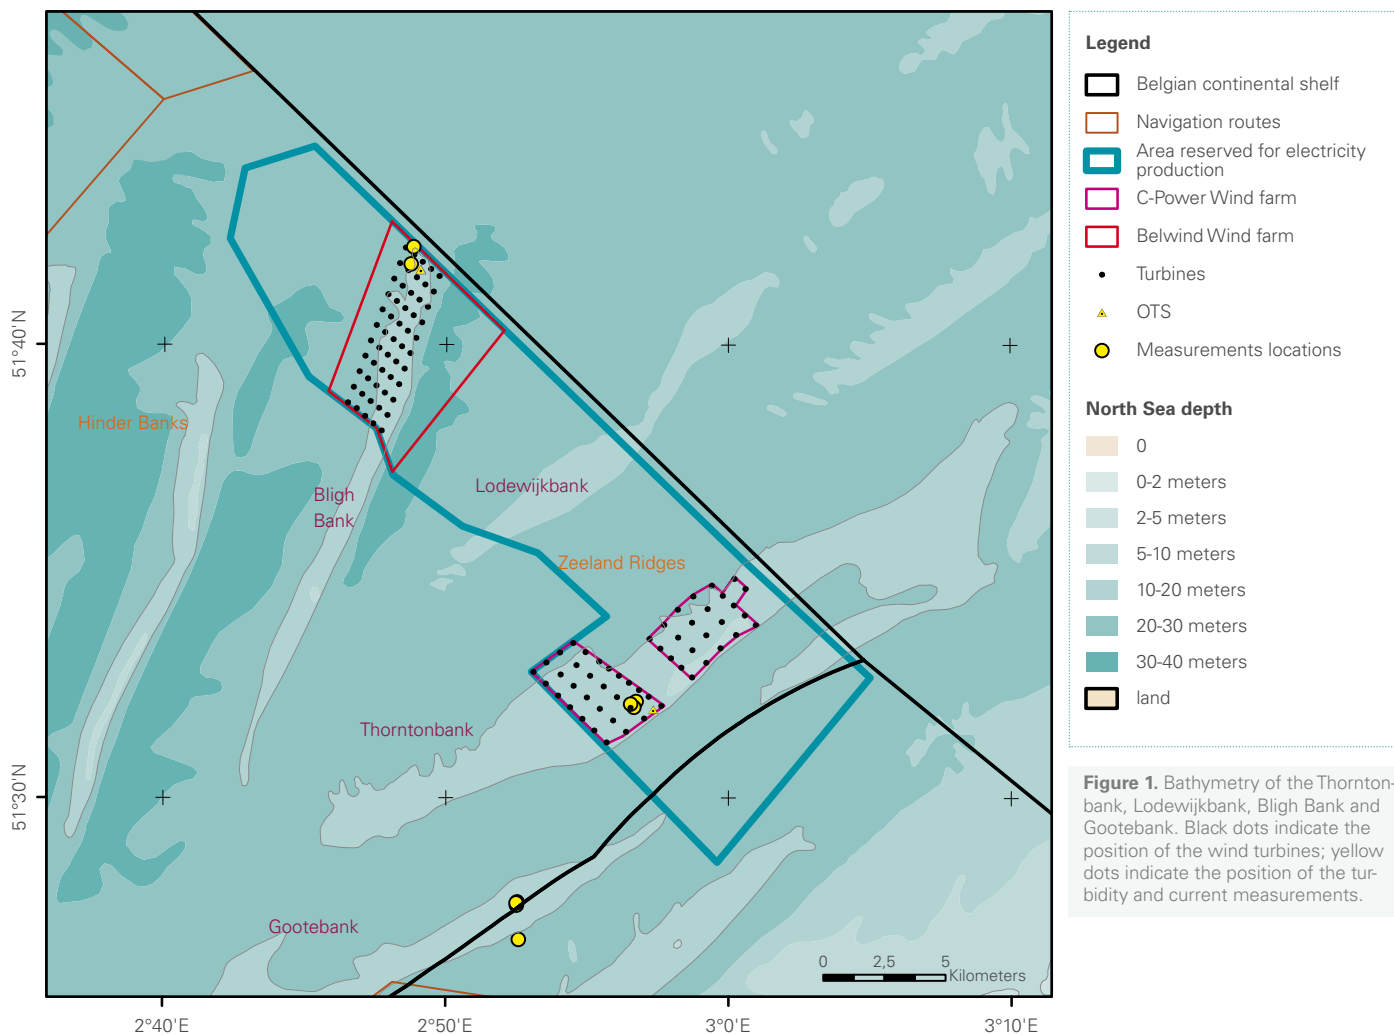
The Thorntonbank, Lodewijkbank and Gootebank are coast-parallel sandbanks, belonging to the Zeeland Ridges, whilst the Bligh Bank is one of the Hinder Banks, lying more obliquely to the coastline (Figure 1). Minimum water depths are close to -6 m (below the lowest water level) for the Zeeland Ridges and -9 m for the Bligh Bank. In the gullies, -28 m up to -36 m is reached, respectively. Sandbank lengths are 15 to 30 km, while the width varies from 1 km for the Bligh Bank, to up to more than 4 km for the sandbanks of the Zeeland Ridges. Sandbanks are covered with large to very-large dunes with heights varying from 2 m to 6 m (Van Lancker et al., 2007). Median grain sizes of the sandbanks range between 300 μm and 350 μm (Verfaillie et al., 2006).

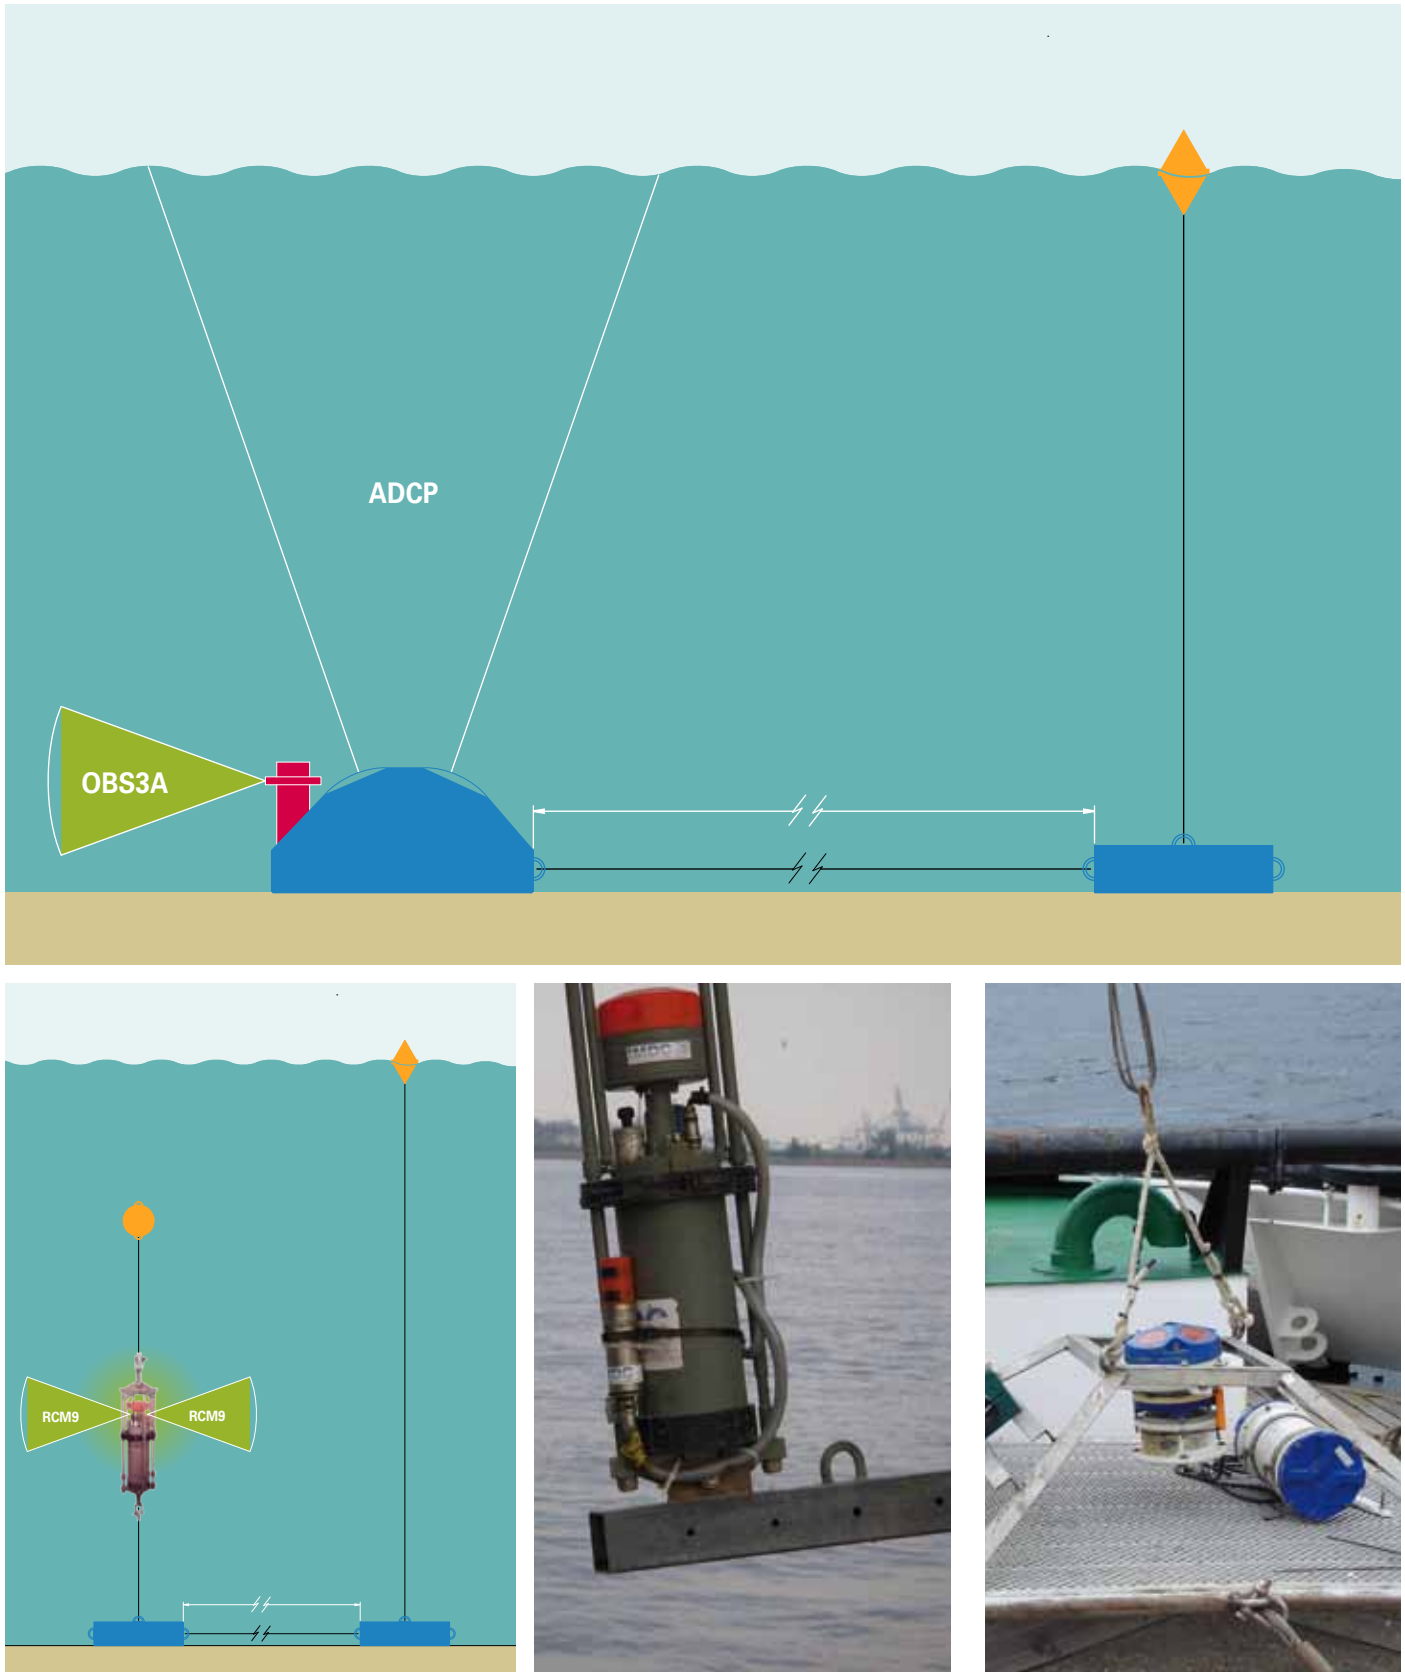
Figure 2. ADCP and RCM9 as deployed on the Gootebank in water depths of -17 m (IMDC, 2010).

The first part of the monitoring aimed at evaluating increases in turbidity, due to the installation works (e.g., of the GBFs on the Thorntonbank) or during the operation of the wind farms (e.g., as a result of the dynamic erosion protection in the Bligh Bank wind farm). From the monitoring specifications, measurements of currents, waves and turbidity were mandatory near the wind turbines before, during and after the works. Similar measurements were carried out at a nearby non-affected site, for which the Gootebank was chosen. A period of at least 15 days was chosen to cover a spring-neap tidal cycle. International Marine and Dredging Consultants (IMDC) executed the monitoring for the C-Power wind farm; RBINS-OD Natural Environment the one for Belwind. On the Thorntonbank and on the Gootebank, measurements were performed using a bottom-mounted Acoustic Doppler Current Profiler (ADCP) (IMDC 2008a; 2008b; 2008c; 2009a)

(Figure 2). This device measured current profiles over the entire water column, water level and wave heights. An optical back scatter sensor (OBS), measuring turbidity, was mounted on the ADCP at about 0.7 m above the bottom. Furthermore, an RCM9 current meter (Figure 2) was used as backup for current, turbidity and water level measurements. To convert the values from the OBS into material in suspension in mg/l, the instrument was calibrated in the laboratory using fine material from the harbour of Oostende. To estimate the effect of the construction works of the first phase on the suspended particulate matter (SPM) concentration, three measuring campaigns were executed: before (February-March 2008), during (June-July 2008) and after the works (June-July 2009). The positions of the measurements are indicated in Figure 1. The instruments were deployed along the gentle slope or on the top of the sandbanks in water depths of around -16 to -17 m.

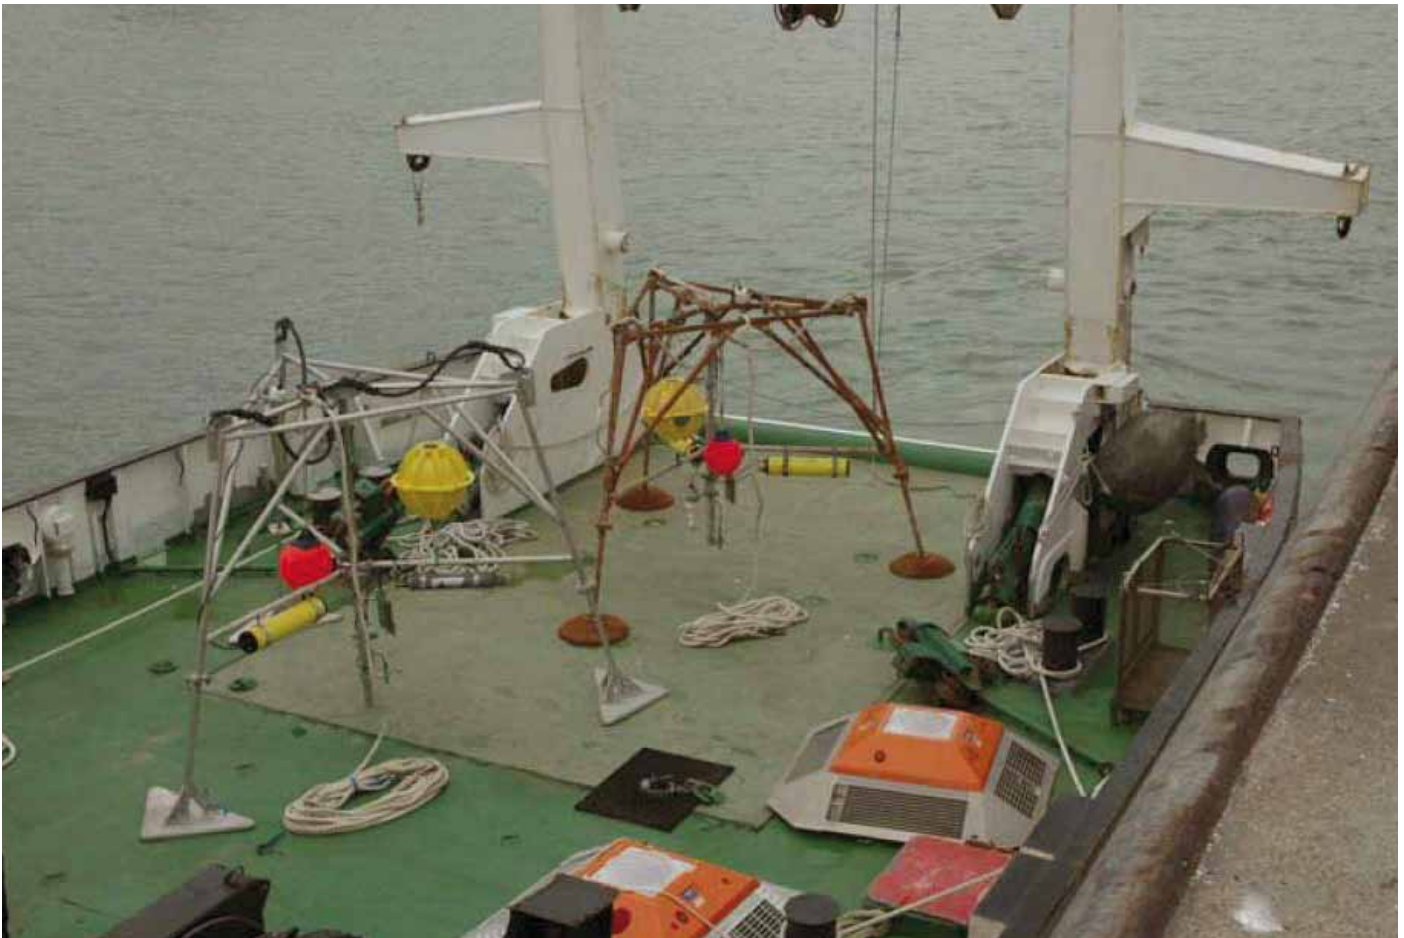
Figure 3. Two tripods and two ADCPs ready for deployment on the Bligh Bank and the Gootebank (RV Belgica).

On the Bligh Bank and on the Gootebank, two tripods (Figure 3) were used for measuring SPM concentration, suspended particle size distribution, salinity, temperature and current velocity. Water depths were around -26 m on the Bligh Bank, around -24m on the Gootebank. An Acoustic Doppler Profiler (ADP) measured the velocity profile from the top of the tripod to the bottom; an Acoustic Doppler Velocimeter (ADV) measured the velocity near the bottom with a high frequency; a CTD conductivity sensor system measured temperature, salinity and water depth; two OBS sensors measured turbidity at 0.2 m (SPM1) and 2 m (SPM2) above the bottom; finally a LISST 100C measured the particle size of the material in suspension. The ADP housed an altimeter, to measure the distance from the measuring point to the bottom, hence providing information on seabed evolution and

thus indirectly on sediment transport. Furthermore, from the backscatter of the ADP, also SPM concentration profiles were derived. To measure current profiles from the bottom to the water surface, a bottom-mounted ADCP was deployed nearby the tripod. Water samples were taken and filtered to obtain SPM concentration, further used for the calibration of the OBS measurements.

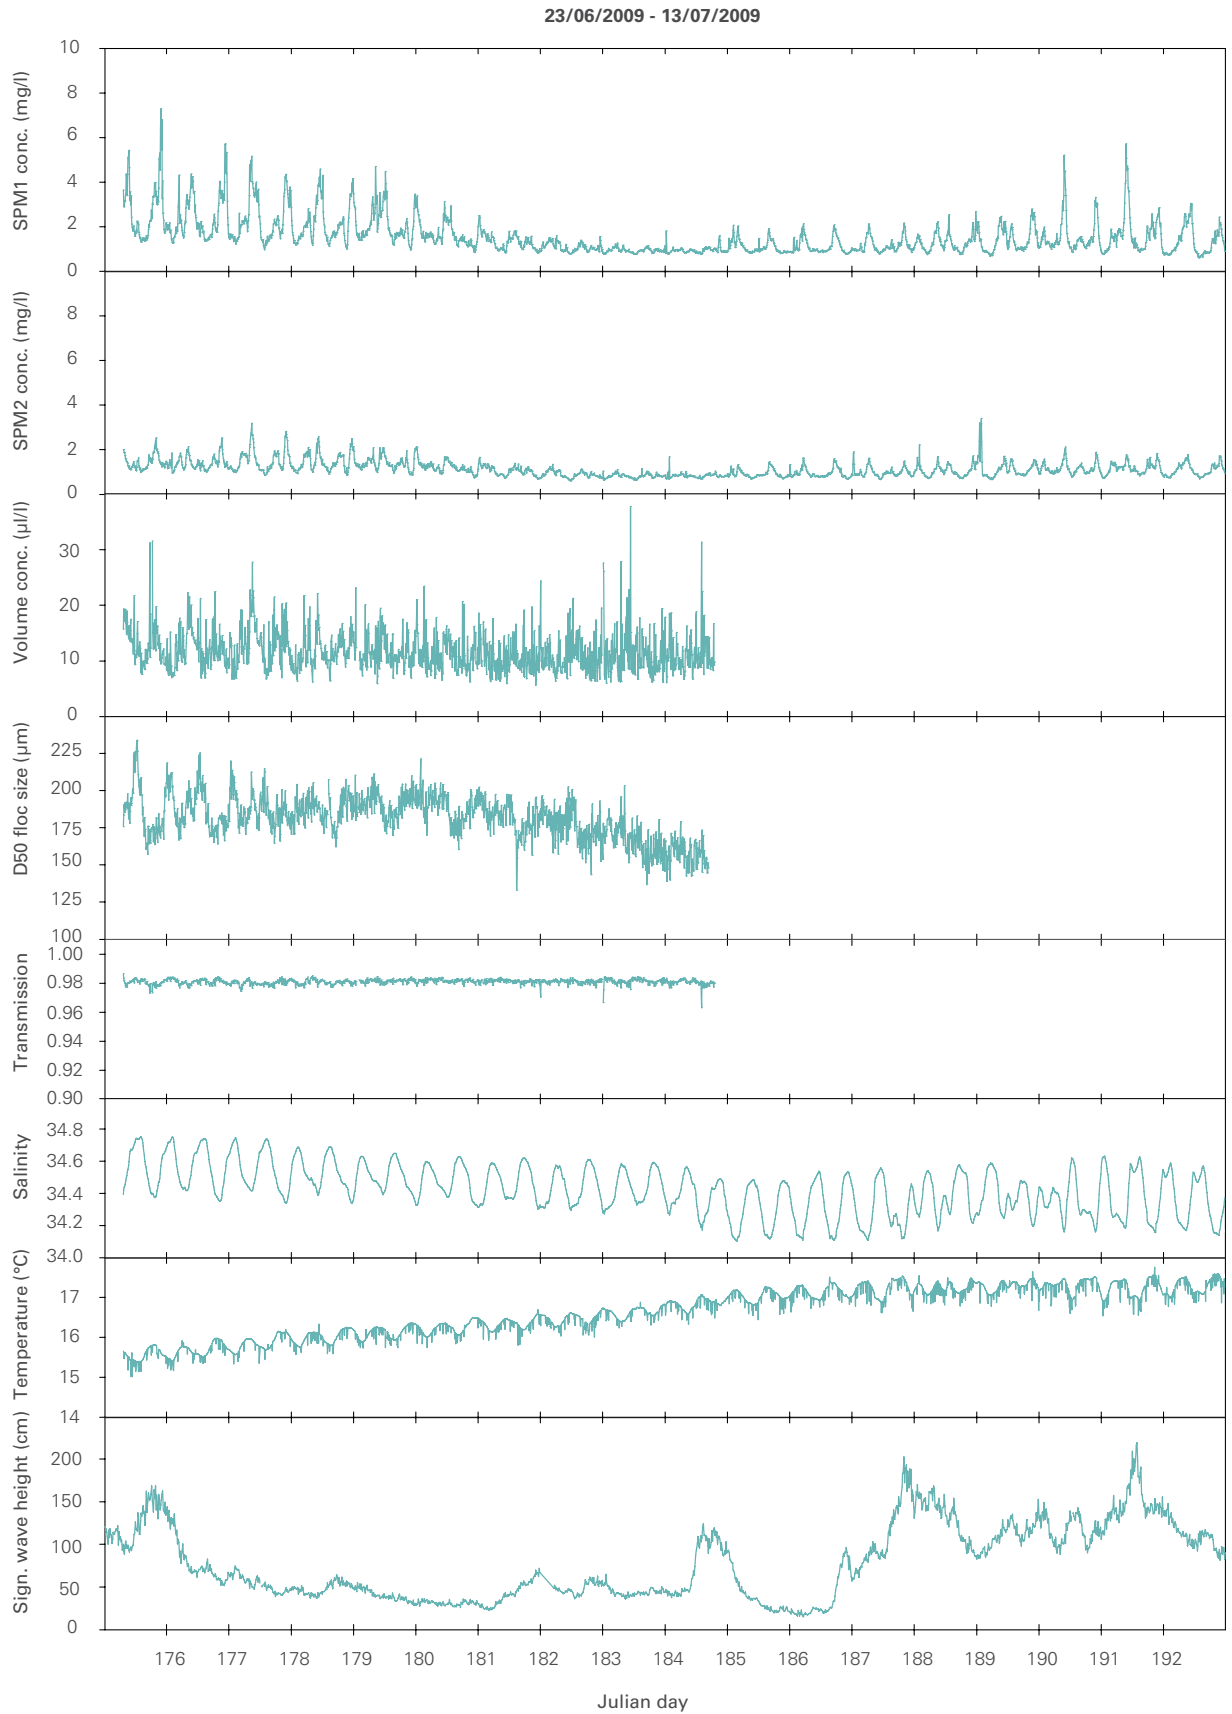
Figure 4. Variation in SPM concentration (from the OBS sensors); SPM volume concentration, median particle size and transmission (from LISST); and temperature and salinity (from CTD sensor) at the Bligh Bank (-26 m water depth) from June, 24th, 2009 until July, 14th, 2009. Wave height at Zuidwest Akkaert (from Meetnet Vlaamse Banken, Flanders Hydrography). SPM1 at 29 cm above the bottom, SPM2 at 234 cm above the bottom.

Figure 4 shows SPM mass and volume concentrations, transmission, median particle size, temperature and salinity at the Bligh Bank, before the start of the construction works. Also the significant wave height at the Zuidwest Akkaert (Meetnet Vlaamse Banken, Flanders Hydrography) is shown. Figure 5 shows SPM concentration profiles (from the backscatter of the ADP) and seabed evolution (from the ADP altimeter), after the execution of the construction works at the Bligh Bank. SPM concentrations were very low (< 5 mg/l) at both locations and during almost all campaigns (Van den Eynde et al., 2013). SPM concentrations showed a clear correlation with spring-neap tidal cycle variation, without a clear visible influence of wave activity. This is also shown in the scatter plot between significant wave height and SPM concentration on the Bligh Bank after the works (Figure 6). Remark that before and after the works, the significant wave heights were relatively low, with waves up to 2.2 m, before the works, and up to 2.0 m,

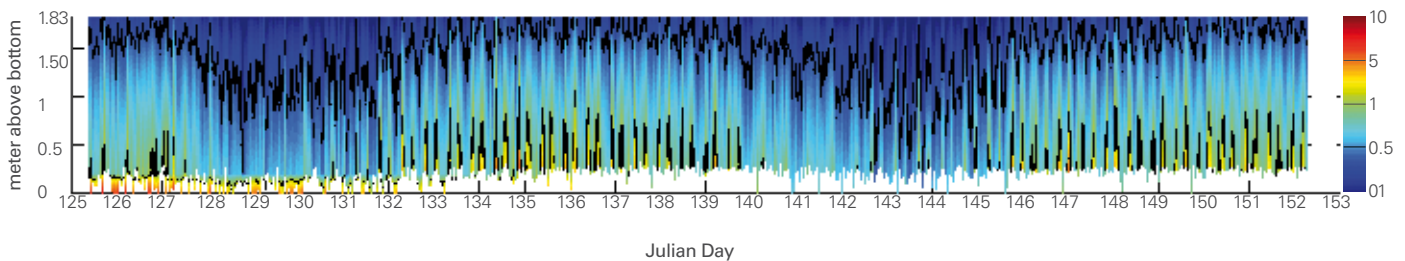
Figure 5. Measurements of SPM concentration in the lowest 1.5 m above the bottom, derived from the backscatter of the ADP, together with the seabed evolution from the ADP altimeter, at the Bligh Bank from May, 5th, 2010 till June, 3th, 2010.

Altimeter data showed a seabed variation of several tens of centimetres, probably due to migrating bed forms. During spring tide, the bottom is lower than during neap tide, possibly caused by higher erosion.

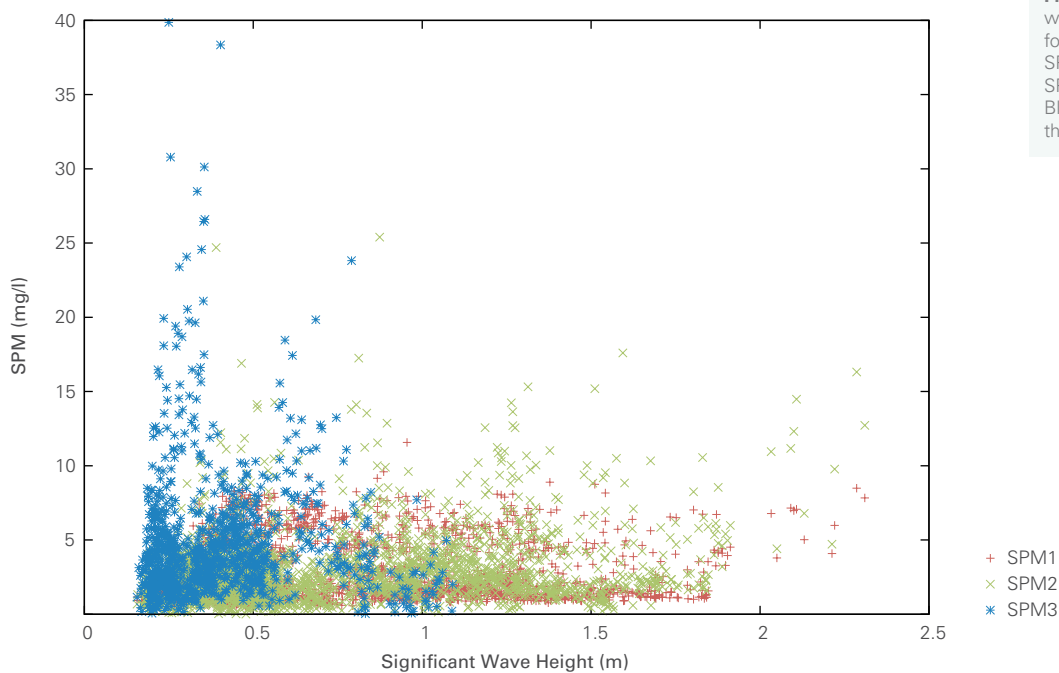
Figure 6. Scatter plot of significant wave height and SPM concentration for SPM1 (0.2 m above the bottom), SPM2 (2 m above the bottom) and SPM3 (1 m above the bottom) at the Bligh Bank (-26 m water depth), after the works.

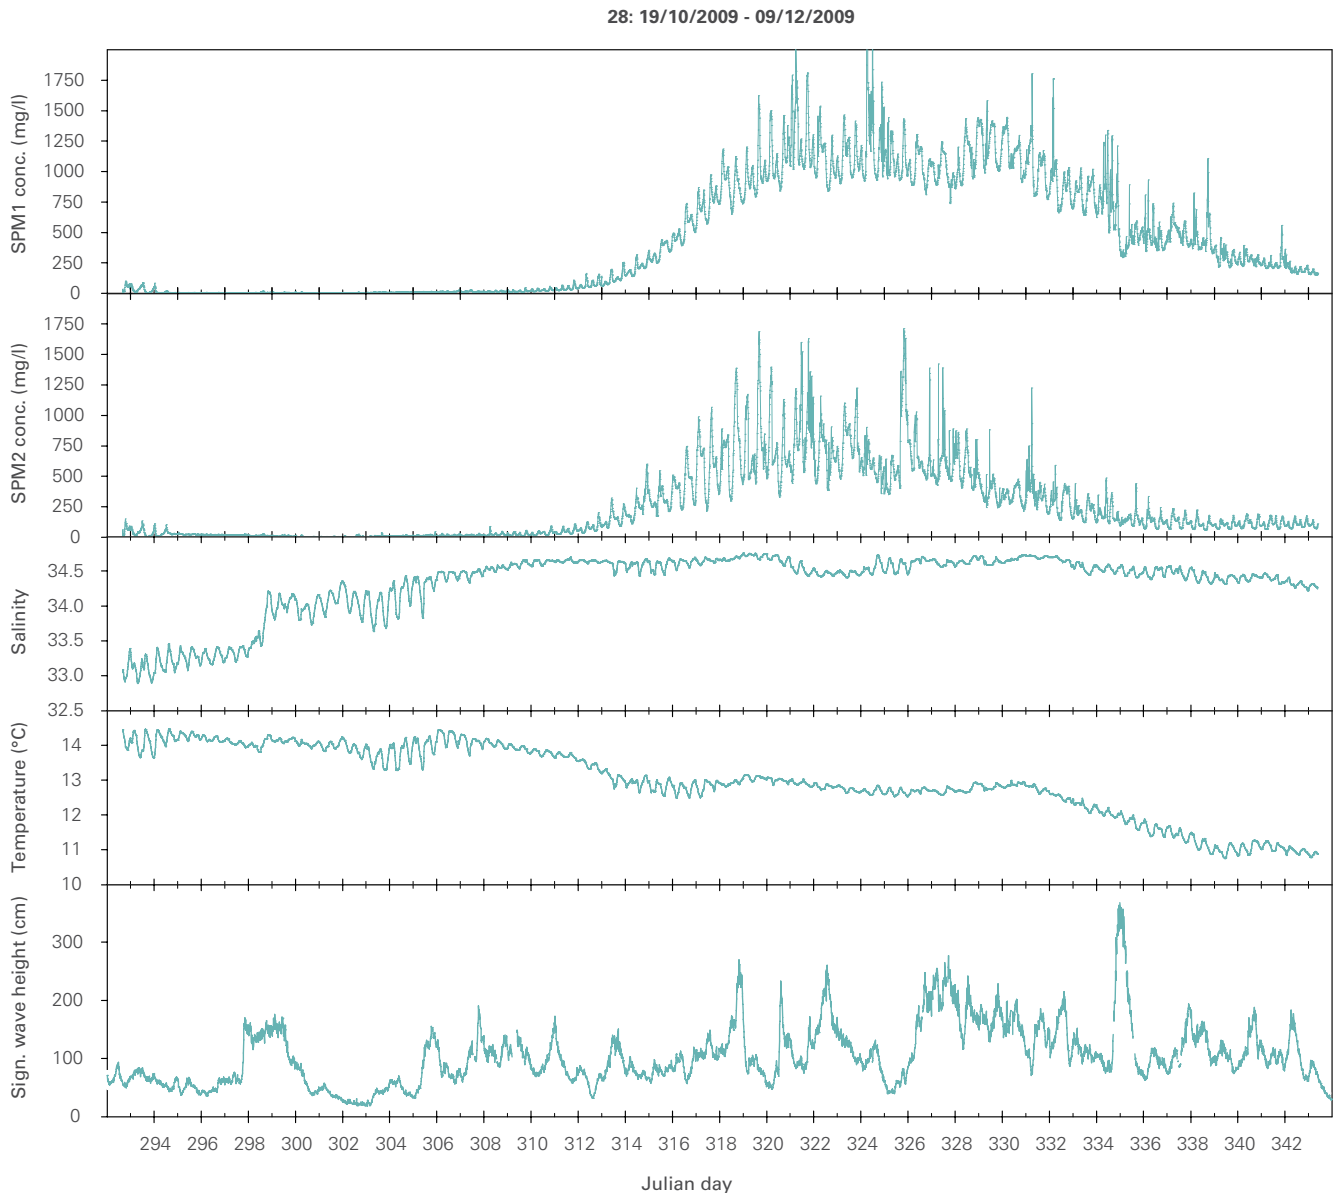
Figure 7. SPM concentration (SPM1 at 29 cm above the bottom, SPM2 at 234 cm above the bottom), temperature, salinity at the Gootebank from October 19th, 2009 to December 9th, 2009. Significant wave height at Zuidwest Akkaert (Meetnet Vlaamse Banken, Flanders Hydrography).

While the SPM concentrations remained low during most of the measuring campaigns at the Bligh Bank and the Thorntonbank, this was clearly not the case at the Gootebank (Figure 7). At the Gootebank, from November 1st, 2009 onwards, the SPM concentrations increased considerably to high values up to 2000 mg/l close to the bottom, and 1700 mg/l at 2 m above the bottom. This was a result of a long period of prevailing southerly winds (Van den Eynde et al., 2013) that can cause an offshore shift of the coastal turbidity maximum (Baeye, 2012) and the introduction of associated high concentration mud suspension layers at the measuring location as observed in the ADV altimetry time series.

These findings indicate that the Gootebank is not a good reference station for the Bligh Bank and/or Thorntonbank. Under varying conditions or events, SPM dynamics might differ between these locations. Therefore longer time series

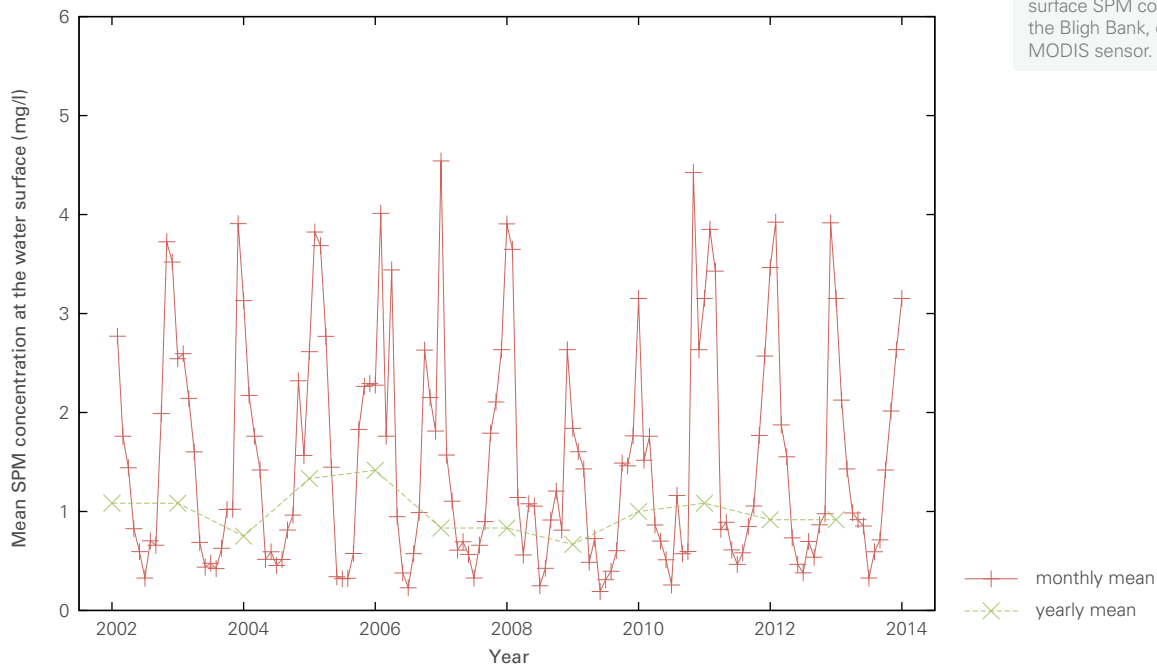
Figure 8. Monthly and yearly mean surface SPM concentration values at the Bligh Bank, calculated from the MODIS sensor.

In a first attempt to use longer time series to evaluate the effects of the wind farms on turbidity, satellite images were used from the MODIS and MERIS multi-spectral sensors on the EOS-PM and ENVISAT satellites (Van den Eynde et al., 2013). The spectral bands of these sensors can be used to estimate the SPM concentration at the water surface. Using the MUMM/GRIMAS tool (Vanhellemont et al., 2011) the SPM concentration time series was extracted at a point central on the Bligh Bank. These satellite data are available since 2002 and consist of one image per day, taken around noon. However, almost 86 % of the measurements are disturbed by clouds, resulting in 559 good values of surface SPM concentration at the Bligh Bank from the MODIS satellite and 397 good values from the MERIS satellite. The surface SPM showed a very clear seasonal cycle, resulting in higher surface SPM concentration values in winter months

(3-4 mg/l) and lower SPM concentration values in summer months (< 1 mg/l). Since the good values are not evenly distributed over the years and the months, the monthly values were calculated first, replacing the missing values by the climatological monthly means, before calculating the yearly mean values of the surface SPM concentrations. These monthly and yearly means from the MODIS sensor are presented in Figure 8. Student's T-test indicated that the yearly mean surface SPM concentration before the works (2002-2009) were not significantly different from the yearly mean surface SPM concentrations after the works (2010-2013). Also the monthly means did not differ significantly in most cases before and after the construction works. Only for a few months the differences were significant, but these results could be related to meteorological events, rather than to the construction and operation of the wind farms.

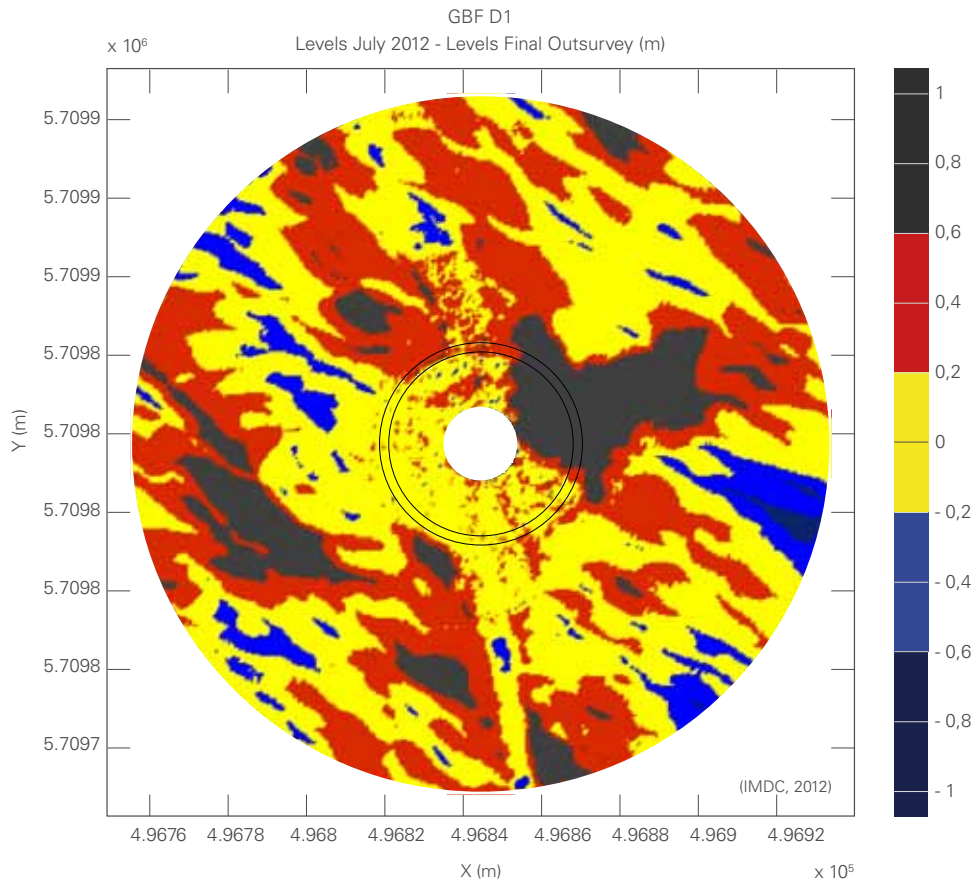
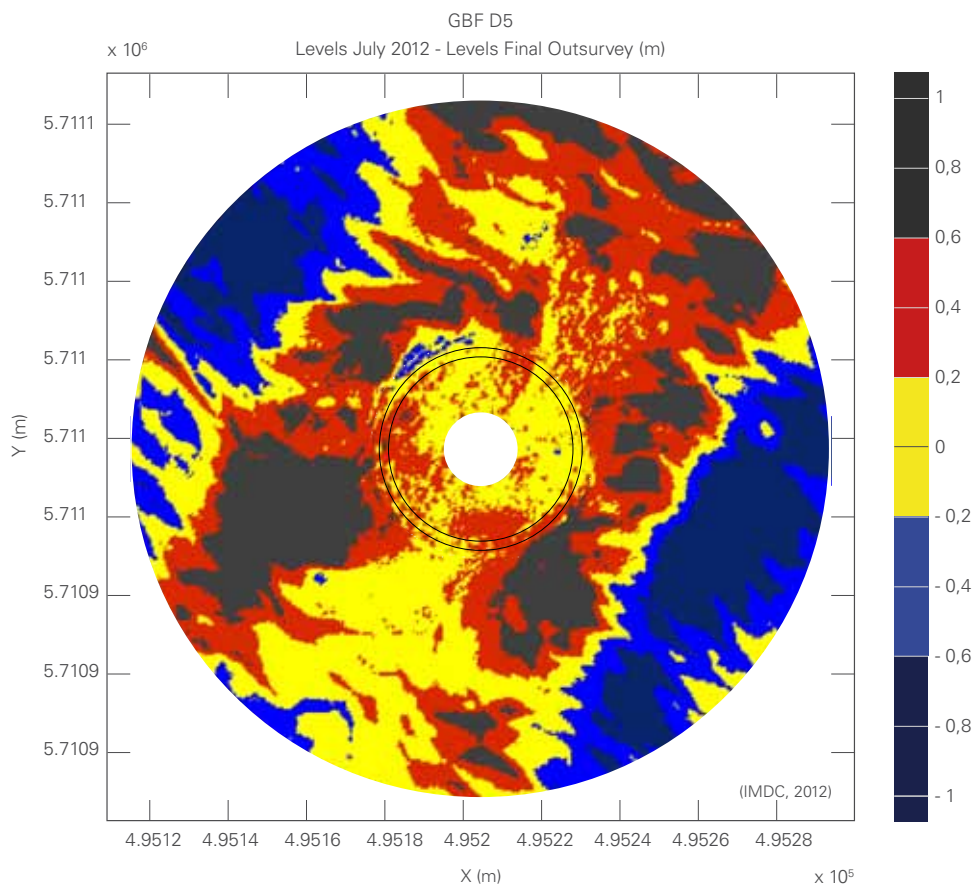
Figure 9. Difference maps of the bathymetry around GBF D1 and GBF D5, comparing the bathymetry after installation against the situation in July 2012 (C-Power, 2012a).

In some cases, small areas were found where erosion exceeded a pre-set alarm level. This was mostly levelled out by natural sedimentation, apart from one location where rocks were deposited (northeast of GBF D1, see figure 9), preventing erosion at the foundation.

Overall, sedimentation occurred in the dredged pits (e.g., GBF D5, see figure 9). Around the erosion protection, similar seabed levels occurred, though important erosion or deposition was also observed. The erosion protection functioned without any secondary erosion.

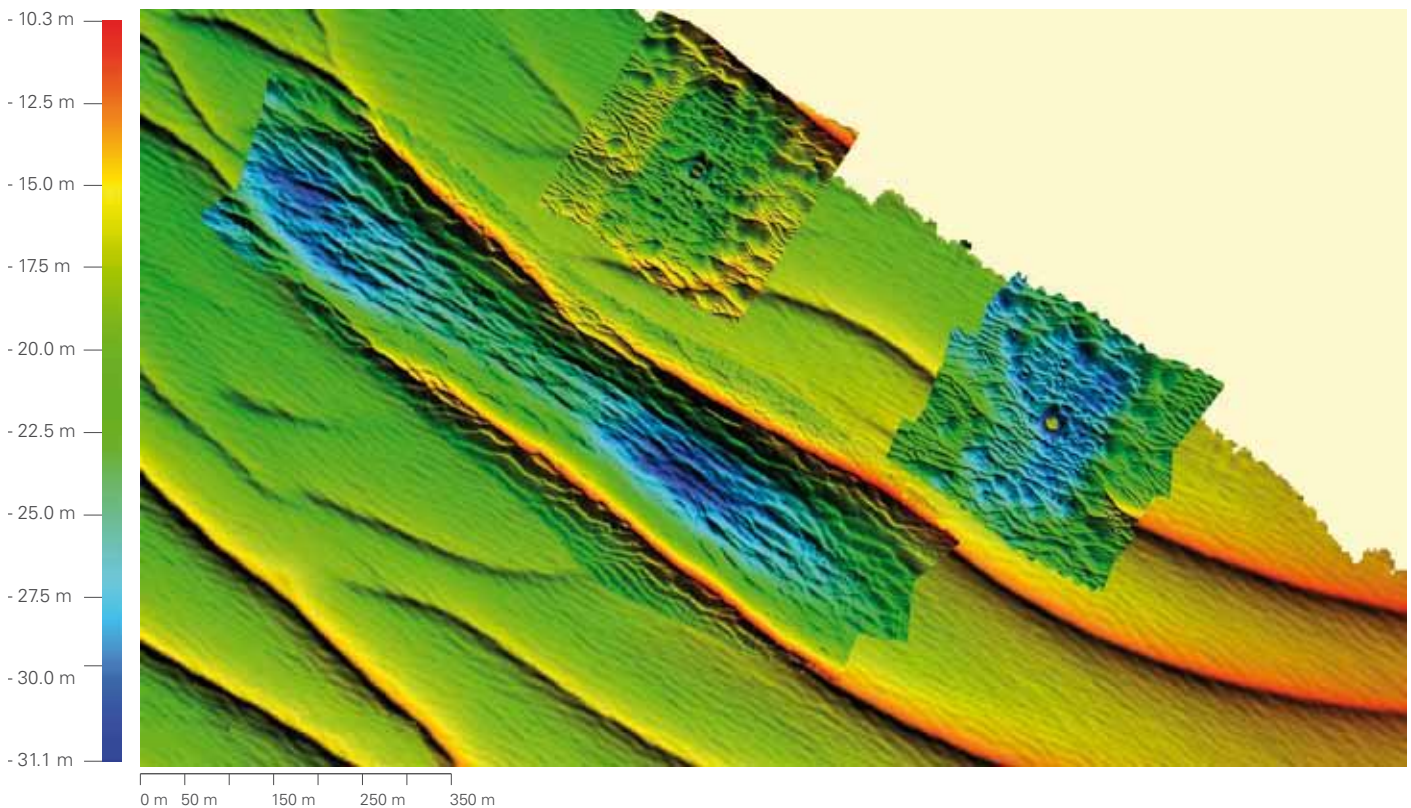
Figure 10. Depression generated in the C-Power concession area. Background bathymetry is from 2006 (FPS Economy).

sites, from which some 588,000 m³ was used effectively for the backfill and infill operations. IMDC (2009c) concluded that the sand was mostly lost during dredging (10 %) and disposal works (20-25 %). Due to these losses, no excess material was found at the disposal sites after the construction of the foundation pits and the backfill and infill operations, but instead 480,000 m³ sand was extracted. The bathymetry of one of these sand pits is shown in Figure 10.

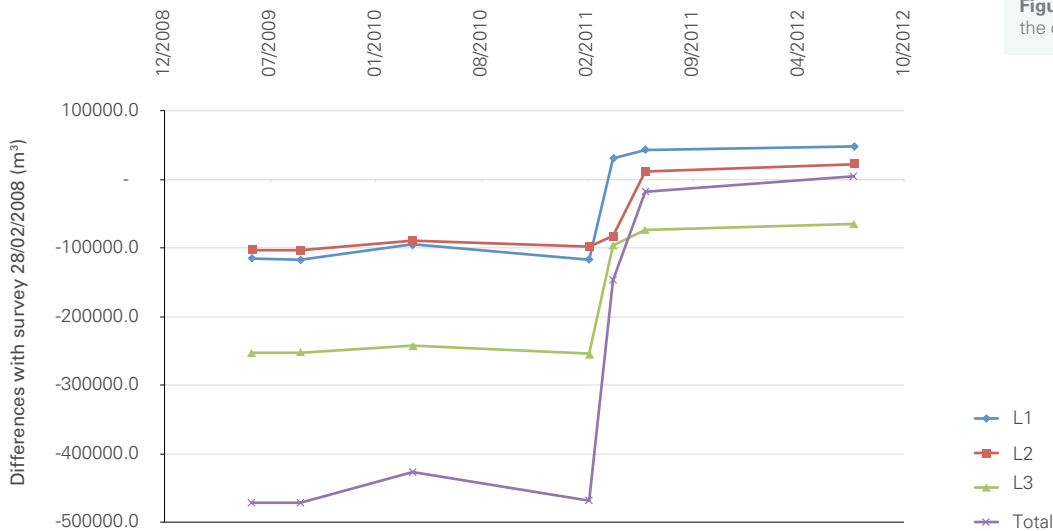
Figure 11. Evolution of the material in the disposal areas (C-Power, 2012a).

Compared to October 2008, the continued monitoring of the depressions showed that in June 2009, 471,000 m³ was still missing, indicating that over a period of 8 months only 9,000 m³ were naturally deposited in the depressions (Figure 11). Between September 2009 and April 2010, some deposition resulted in a volume increase of 45,000 m³, but due to dune migration the material almost entirely disappeared again in February 2011. In February-March 2011, the sand pits were filled again, by using material from the foundation pits that were dredged for the installation of jacket foundations (second phase of the C-Power wind farm). The difference between the original sites and June 2011 amounted -18,000 m³. The last survey of July 2012 showed some additional deposition in the area, resulting in a total difference of +5,000 m³.

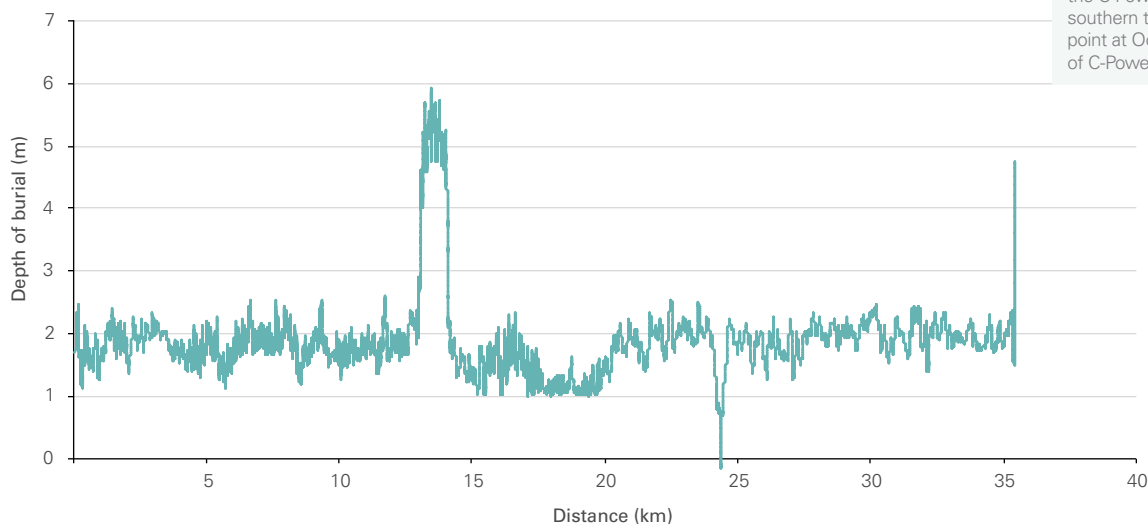
Figure 12. Original depth of burial (January 2009) of the export cable from the C-Power wind farm from the most southern turbine (km 0) to the landing point at Oostende (km 36) (From data of C-Power, 2009b).

To assure that the export cables remained buried, their coverage was verified on a regular basis. Along the entire length of the 150 kV (A) export cable from the C-Power wind farm to the cable landing at Oostende, a burial depth of 2 m was aimed for. In some areas, due to clay layers, only 1 m burial depth was reached (Figure 12) with a much deeper burial around km 14 where the cable crosses the navigation channel 'Scheur'. This was required in the environmental permit for safety reasons. At km 24, a surface communication cable was crossed and gravel was disposed to protect the cable. Verification of the depth of burial (DOB) of the cable showed

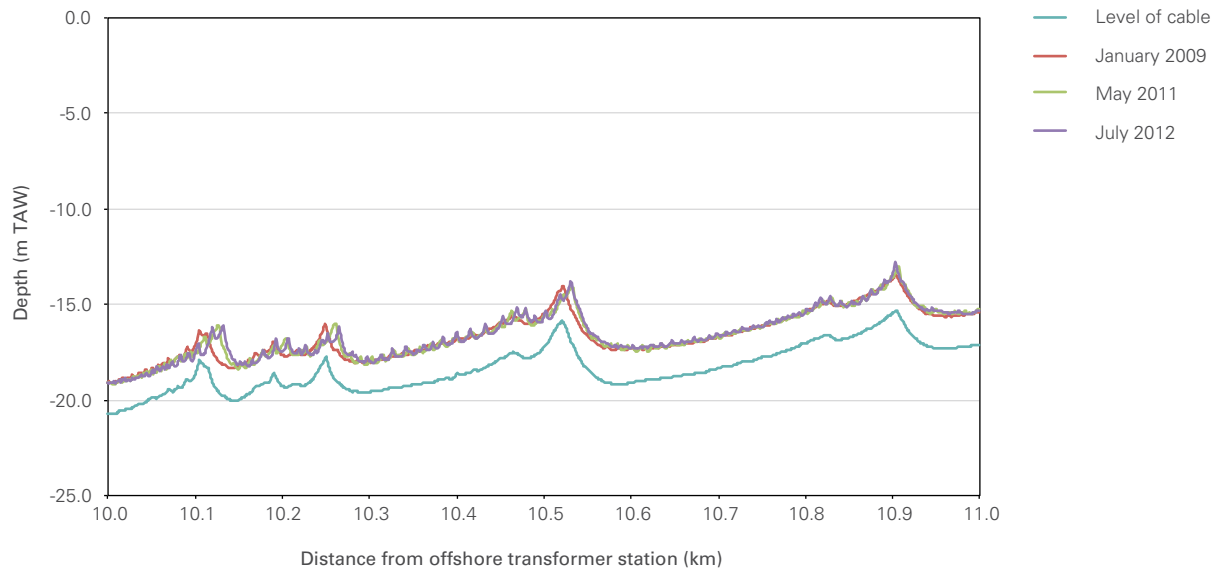
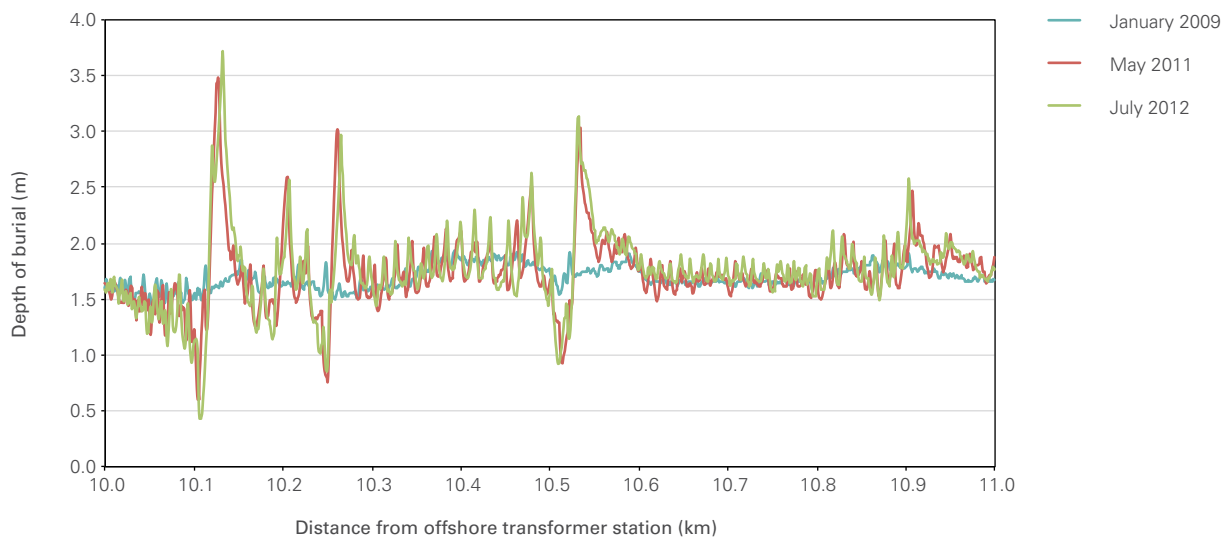
Figure 13. Bathymetry during different surveys and depth of burial of the 150 kV cable from the C-Power wind farm between km 10 and km 11 (From data of C-Power, 2012a).

that at some areas, especially near the GBF D1 and at the Scheur, the DOB was less than 1 m. At three locations, the cable was exposed at the seabed and needed re-burial. This was due to sand dune migration (Figure 13). Remediation works were executed to assure that the cable remains covered. From this, C-Power decided that the second export cable (B) would be buried 1 m below the base of those sand dunes. Similar difficulties were encountered with the export cables from the the Belwind wind farm to shore. Rocks were deposited on the locations where the cable was exposed.
