Brownjohn, J.M.W., Carden, E.P., Goddard, C.R., Oudin, G. (2010) *Real-time performance monitoring of tuned mass damper system for a 183 m reinforced concrete chimney*, *Journal of Wind Engineering and Industrial Aerodynamics*, 98 (3), pp. 169-179

Real-time performance monitoring of tuned mass damper system for a 183m reinforced concrete chimney

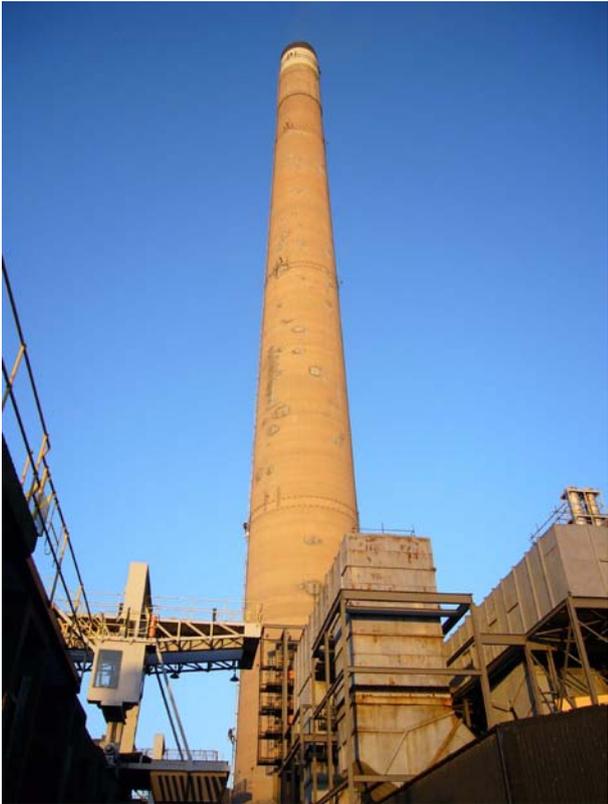
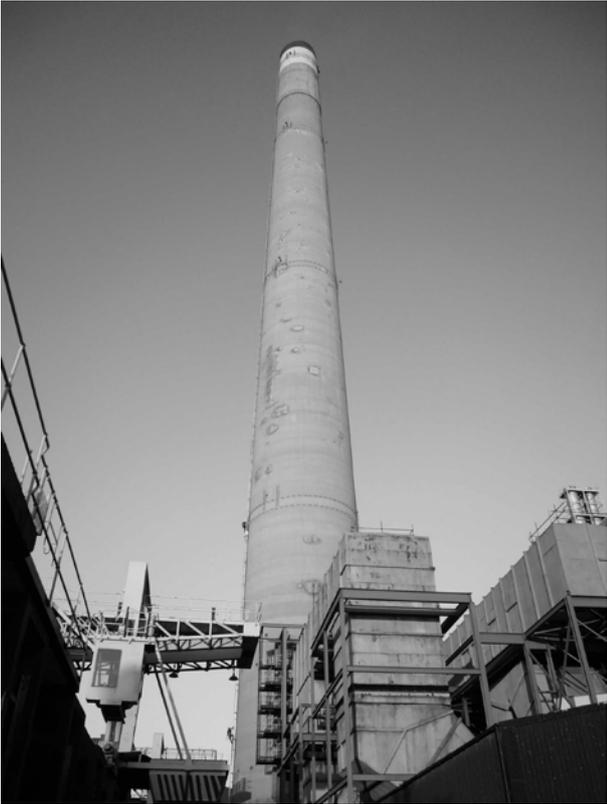
Figure 1 Chimney at Rugeley Power station

The research presented here originated when theoretical studies (Galsworthy and Vickery, 2006) predicted that excessive across wind oscillation of a 183m concrete chimney (Figure 1) might occur resulting from the up-wind construction of a replacement structure (Figure 2). The focus of this paper is the monitoring technology employed to track the performance of the chimney and evaluate the effectiveness of a tuned mass damper (TMD) that was installed to enhance the damping of the old structure and maintain its safety and serviceability during its remaining service life. By the time this paper is published the old chimney is likely to have been demolished.

The old chimney at the Rugeley Power Station, at coordinates 52 45'29.63"N 1 55'07.90"W, was constructed around 1968 and consisted of a 183m high reinforced concrete windshield, internally protected by a sectional, acid resisting brickwork lining supported from concrete corbels cast monolithically with the shell. The windshield tapered from an external diameter of 9.4m at the top to 15.7m at the base. Its outer surface suffered from the usual environmental actions and an external reinforced concrete cladding was installed in 1998 over the upper 24m. Figure 3 shows orthogonal elevations, showing the chimney as almost symmetric except for flue openings aligned with an axis between old and new chimneys.

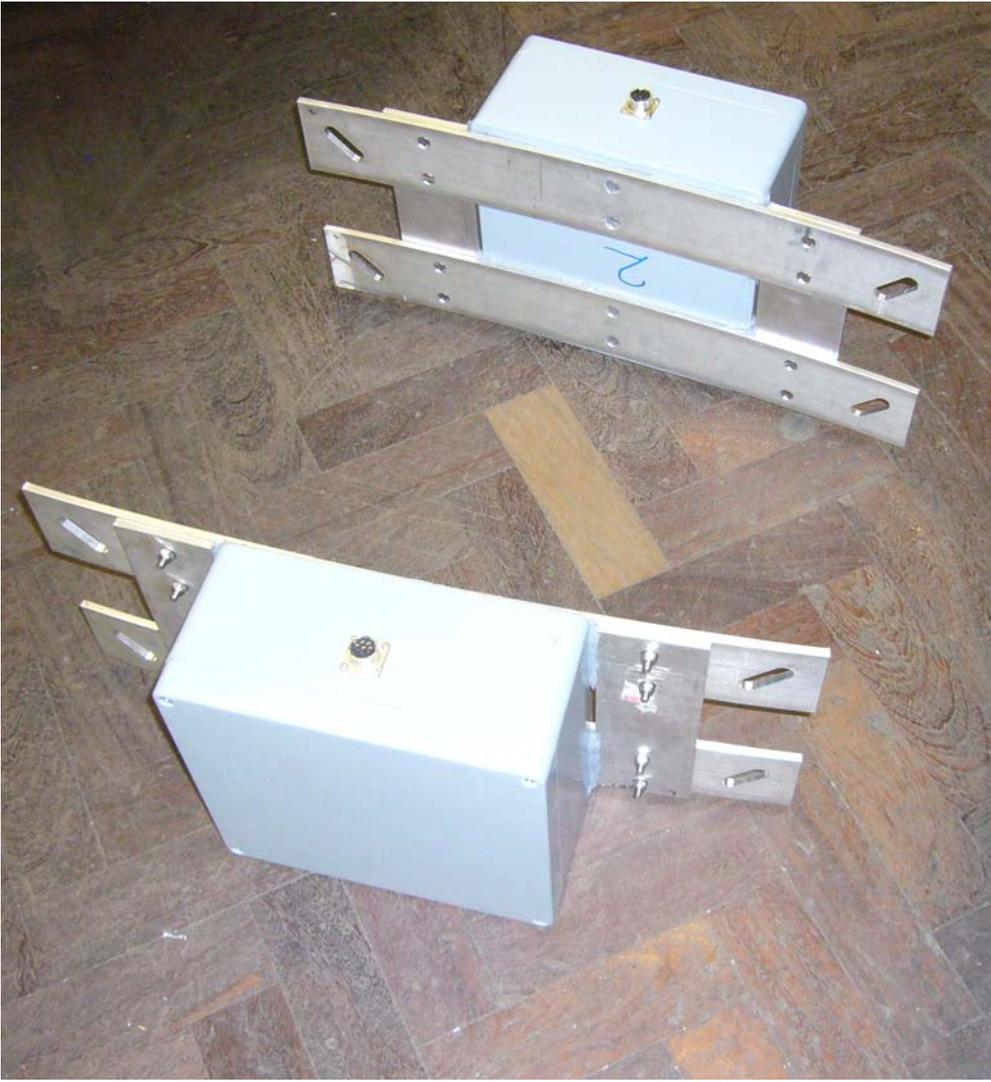
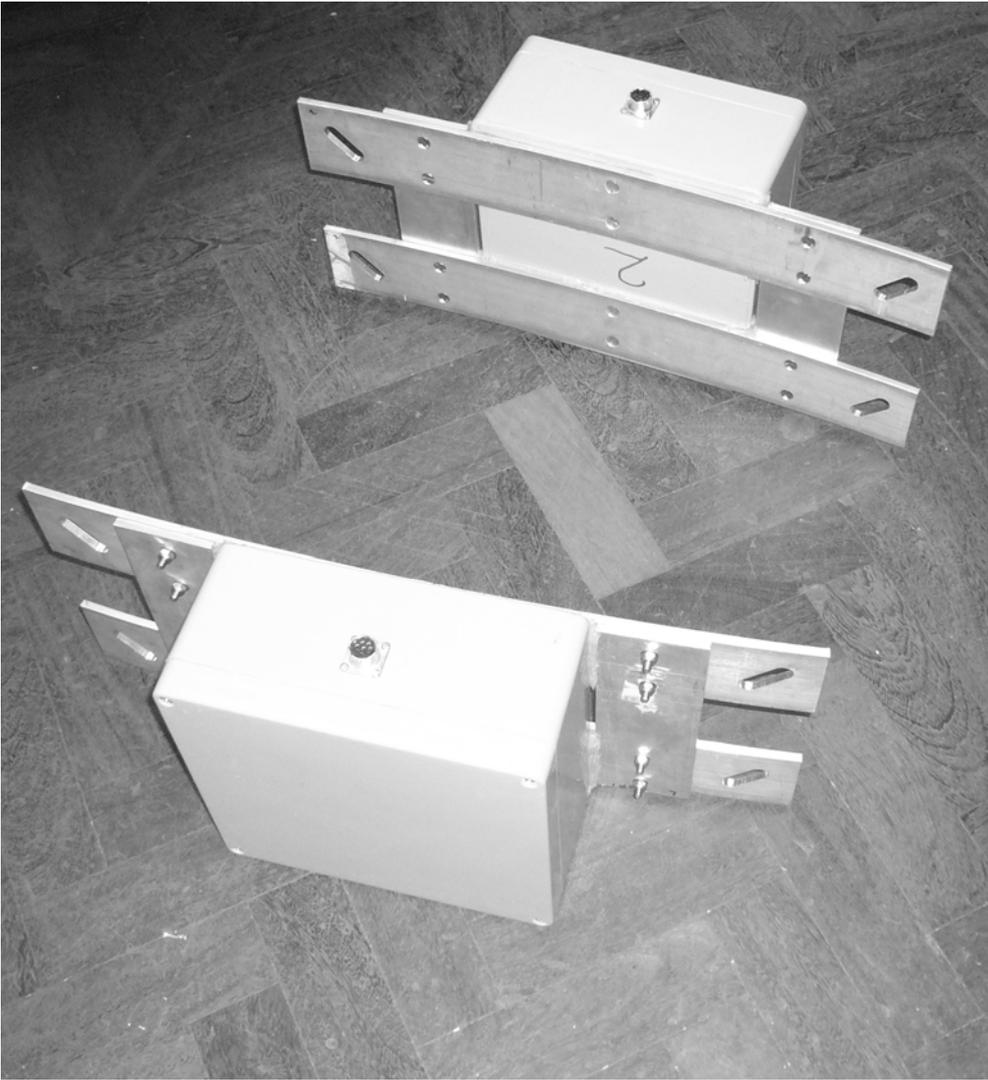
Figure 4 Accelerometer boxes, with curved and slotted plates for easy attachment

The two accelerometer boxes (Figure 4) were installed by steeplejacks, who attached them to the exterior of the windshield at heights of 180m and 40m, with instrument cable tied at intervals to an existing power conduit for aviation warning lights. The purpose of measurements at the lower position was to provide a more accessible backup in case of problems with the accelerometers at the top level. With a reliable estimate of the operational deflection shapes around first mode frequency, top level response values could be estimated. Figure 5 shows the TMD under construction at a later date, with the lower accelerometer box visible at the level of the access rungs.

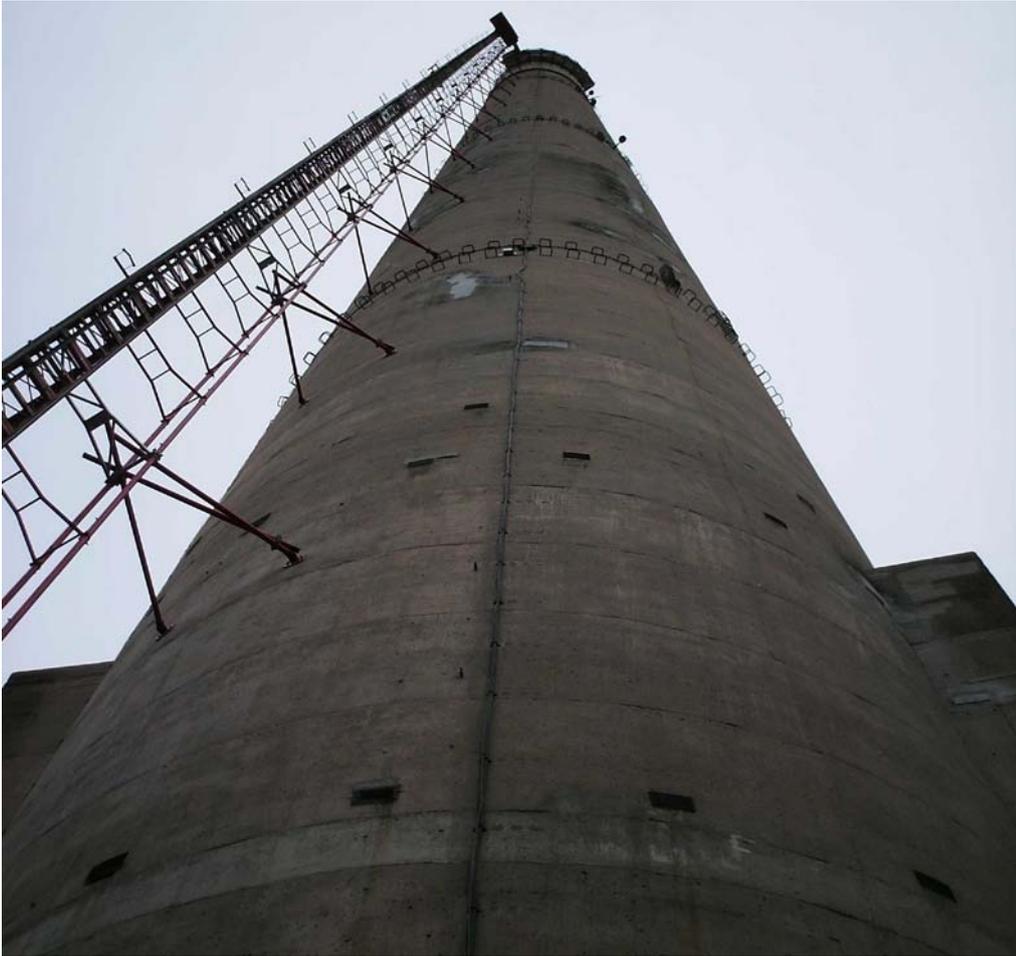
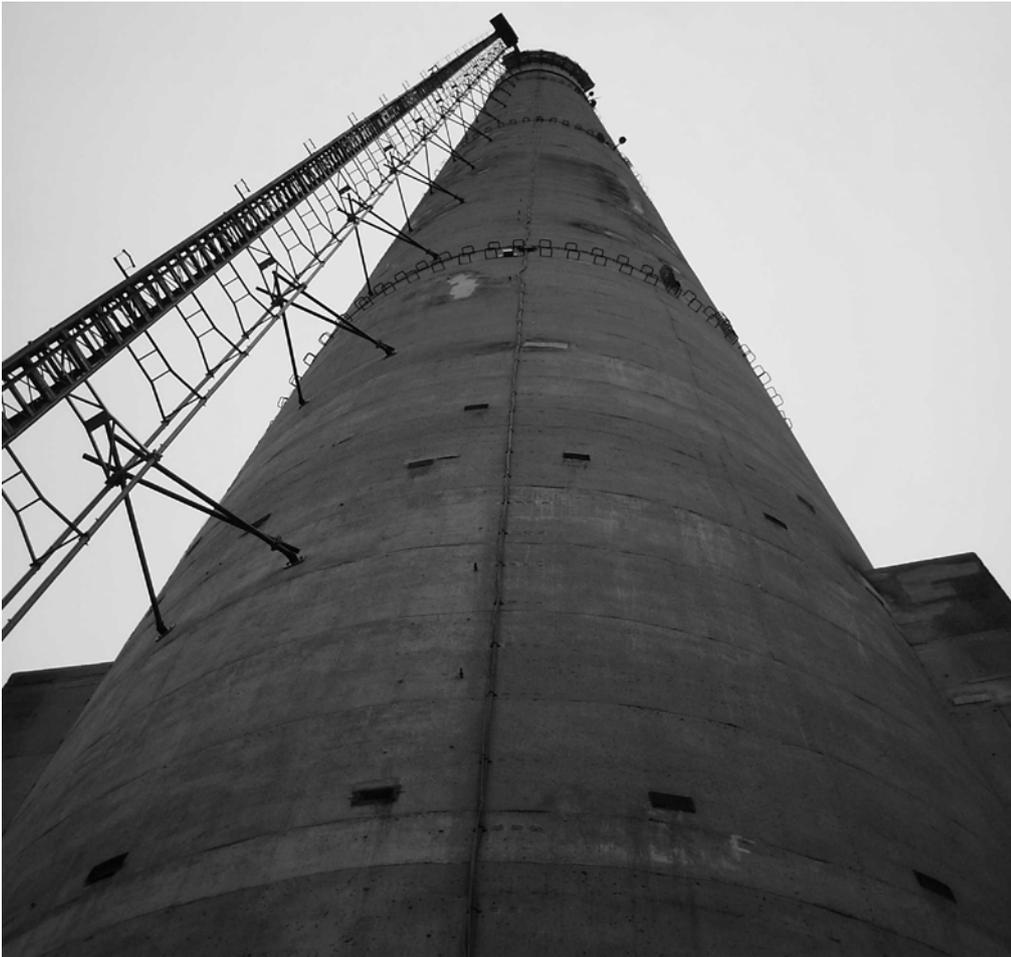
Figure 5 TMD under construction, with lower accelerometer box in position and flue openings flanking chimney

The installation of the broadband internet line was substantially delayed but on the 15th March remote monitoring was finally available and on 20th March, with access to the top of the chimney for TMD construction (Figure 5) the cabling for the top accelerometers was replaced so that signals could be obtained from all four accelerometers.

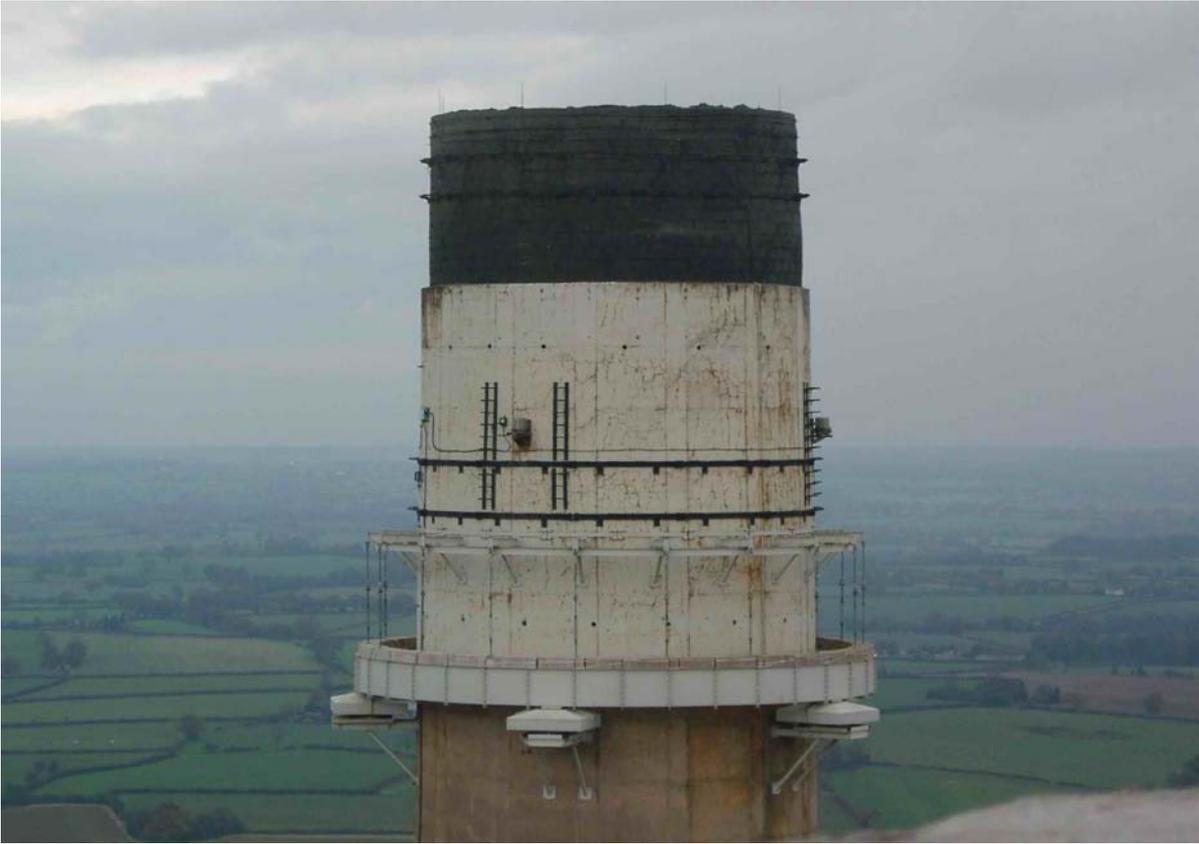
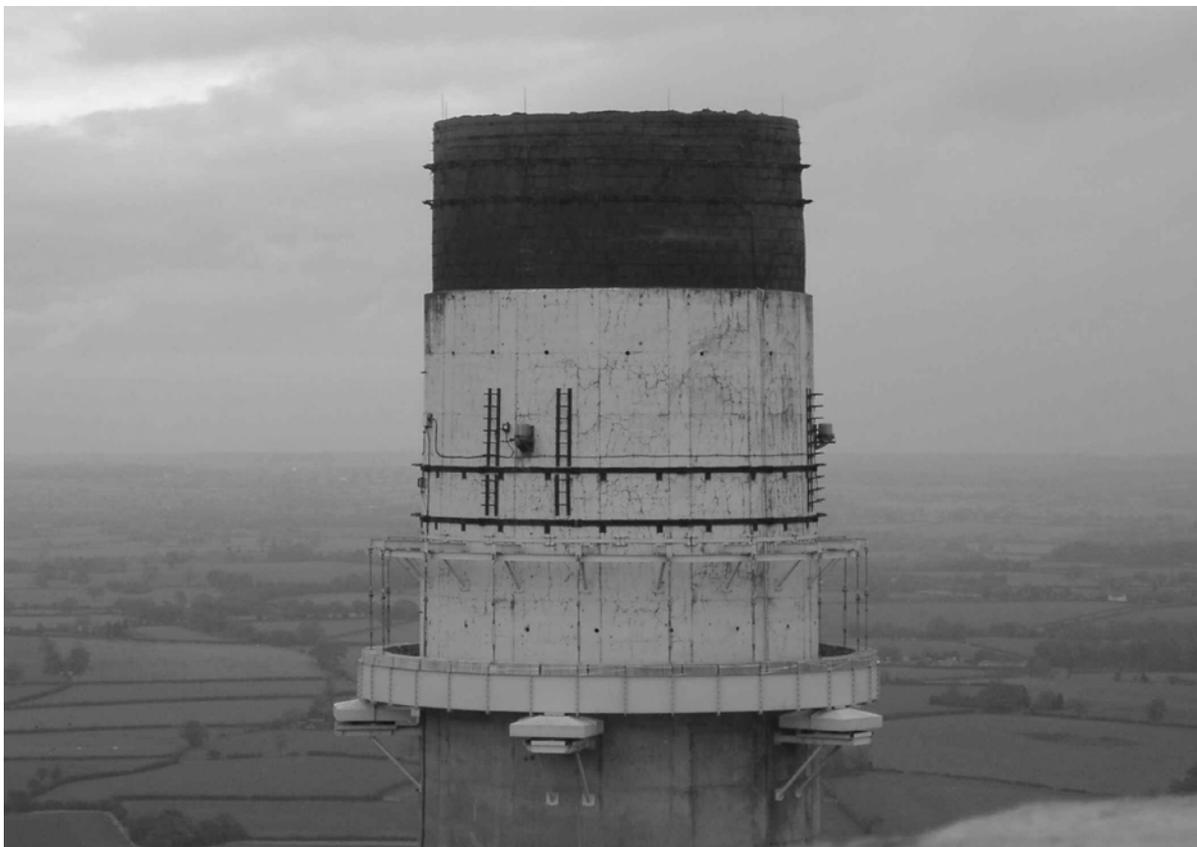
Figure 7 View from new chimney showing TMD supports, mass ring and dampers

6 Installation and operation of tuned mass damper (TMD), Figure 7

In order to limit the cost of erection the damper was designed so as to have the smallest moving mass possible consistent with being able to generate sufficient overall damping. It was also beneficial to limit the weight of the moving mass in order to simplify the connection of the brackets onto the old concrete shaft by using only post-drill anchors.

The design of the damper was done in order to allow as much as 450 mm relative displacement between the stack and the moving mass. The viscous dampers were tested in the laboratory in order to meet the design requirements and an extra length of pendulum was necessary to compensate for the stiffness of the viscous damping set which had also been determined in the laboratory.
