This is an author produced version of a paper published in **Wear**.

Lewis, R. (2009) *Friction in a hydraulic motor piston/cam roller contact lined with PTFE impregnated*. *Wear*, 266 (7-8). pp. 888-892.

**FRICITION IN A HYDRAULIC MOTOR PISTION/CAM ROLLER
CONTACT LINED WITH PTFE IMPREGNATED CLOTH**

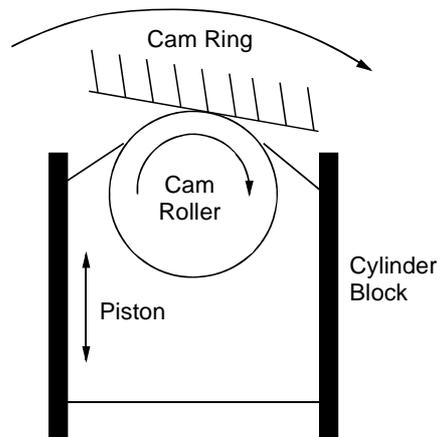
Figure 1

The components tested in this work were from a radial motor configuration design as shown in Figure 1. The cam rollers slide against the pistons as they rotate and against the cam ring, which is profiled to move the piston in and out as it rotates. The surface of the piston, where the cam roller is making contact, is usually coated to help reduce friction and wear. The aim of this work was to investigate the possibility of using a PTFE impregnated cloth material instead of the current PTFE impregnated sintered bronze coating used, which would create a cost benefit. In normal operation the parts are all submerged in oil. The major concern with using the cloth was that problems may exist under dry conditions due to lubricant loss during operation or at start-up.

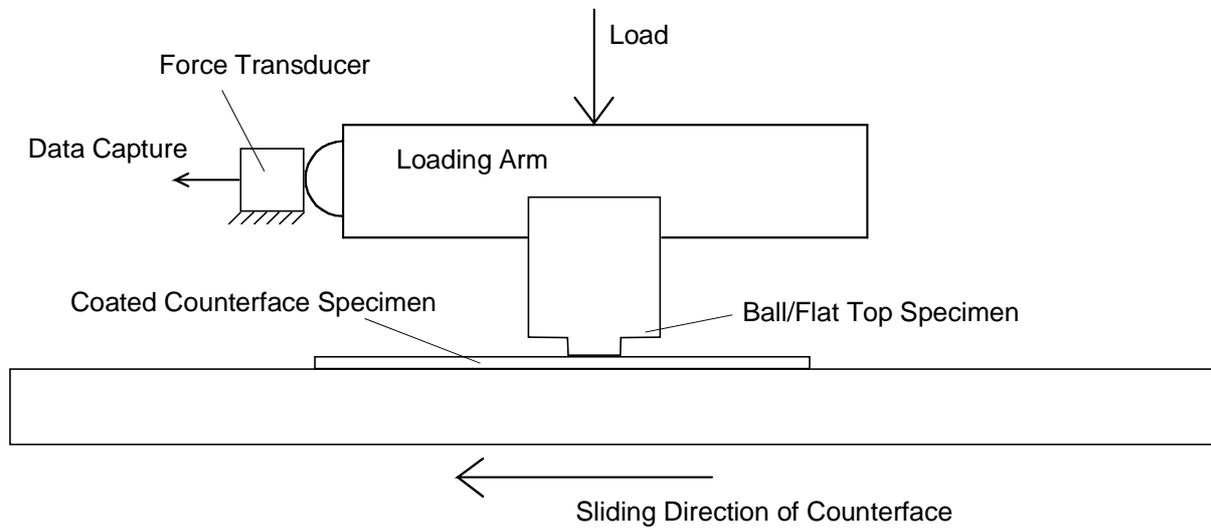
Figure 2

A Bowden & Leben type friction tester was used for the testing, as shown in Figure 2. Tests were carried out in dry and lubricated conditions. A standard 15W40 automotive lubricant was used. Flat-on-flat tests were carried out at a contact pressure of 2.7MPa and ball-on-flat at 2000MPa. These were dictated by the limitations on specimen sizes and loads on the rig rather than representing what actually happens in the hydraulic motor. The actual operating contact pressure is around 100MPa. The sliding speed in the tests was 5mm/s, again dictated by the rig. Actual sliding speeds are several orders of magnitude higher.

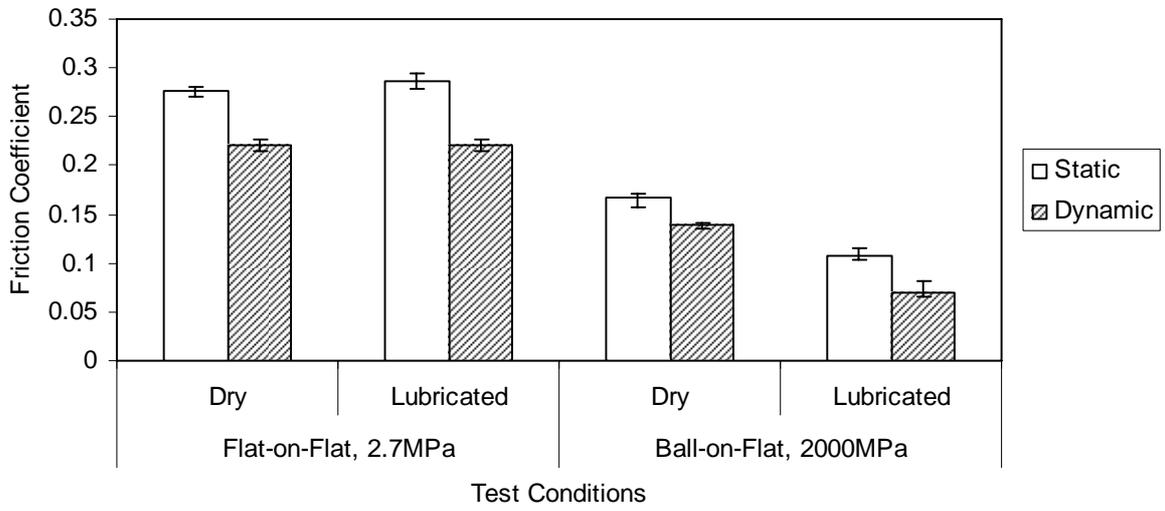
(a) Sintered Bronze

Results of the specimen sliding friction tests are shown in Figures 3a and 3b (sintered bronze and cloth respectively). As can be seen there is little difference between the two materials. Flat-on-flat friction was higher, but it was seen that the flat specimens cut into the cloth/bronze, which would have increased the lateral force measured. While these results

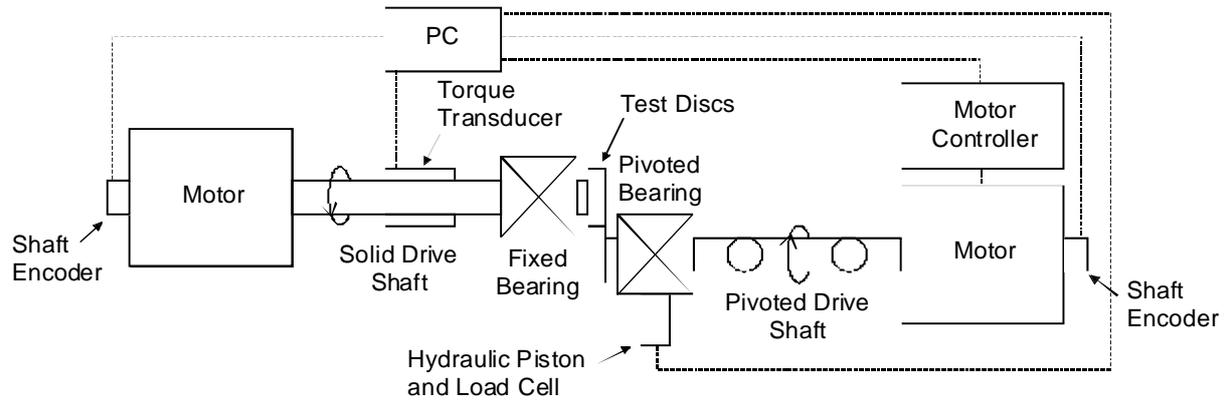
Figure 4

The twin disc test machine used to carry out the testing is shown schematically in Figure 4. More details on the use of the machine are given in Lewis et al. [3]. In its usual operation the test discs are hydraulically loaded together and driven at controlled rotational speed by independent electric motors. Shaft encoders monitor the speeds continuously. A torque transducer is assembled on one of the drive shafts and a load cell is mounted beneath the hydraulic jack. Different slip ratios can be achieved by adjustment of the rotational speeds. All data is acquired on a PC, which is also used for load and speed control.

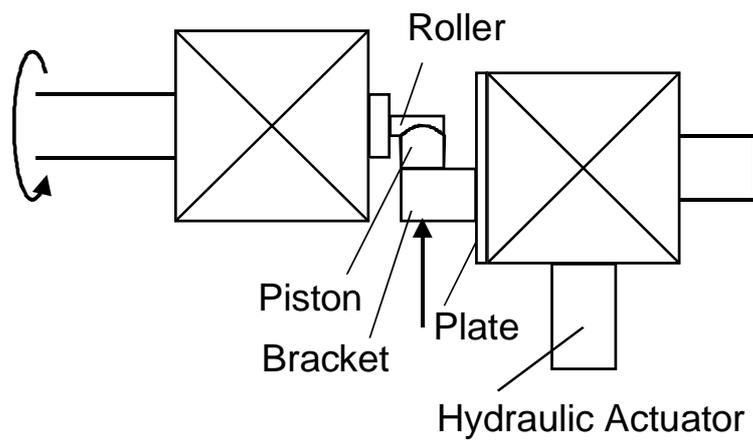
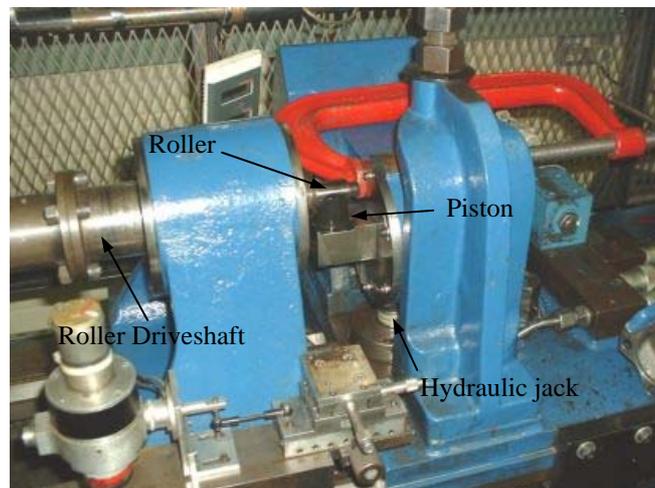
Figure 5

For the purposes of this testing the pivoted drive shaft was disconnected and a plate and bracket were attached to the bearing housing to support the piston (as shown in Figure 5). The roller had a hole and recess accurately machined through it so that it could be bolted to the disc mounting on the left hand shaft. The rig was set up so that the roller was in position in the piston before load was applied (see Figure 5). The hydraulic jack could now be used to load the piston up against the roller.

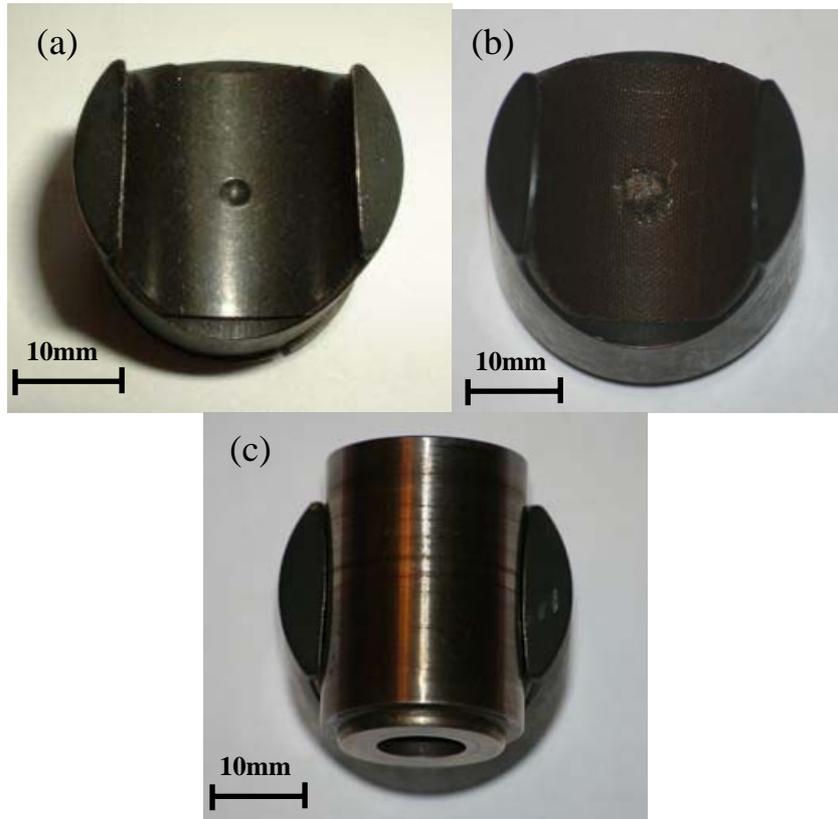
Figure 6

The roller and piston specimens used are shown in Figure 6. The roller has a diameter of 22mm and a length of 35mm. The piston has an outer diameter of 31mm. The PTFE cloth material was initially attached to a thin strip of steel that was then mounted on the piston. The cloth was approximately 0.3mm thick and had an initial roughness (R_A) of $9\mu\text{m}$. The roller roughness was $0.46\mu\text{m}$.

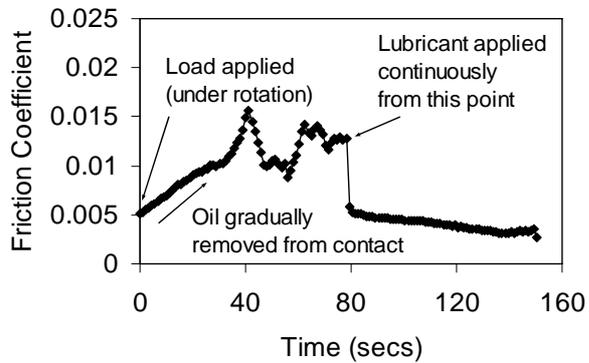
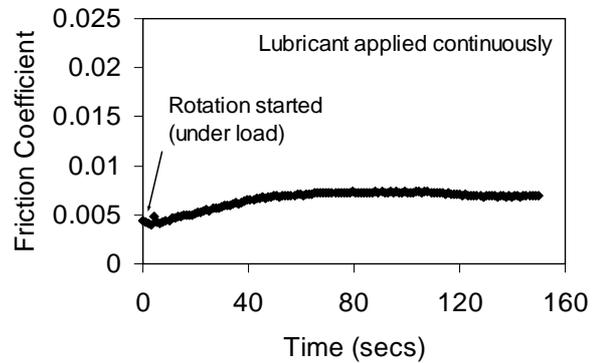
(a) Lubricant applied pre-test/continuously, rotation started, load applied

Figure 7 shows the friction results for both materials and all test conditions. For the initial lubricated tests it was intended to supply lubricant constantly, but for the test using the sintered bronze material the flow was interrupted. This caused the friction to rise, as the lubricant that was present was removed from the contact, until reaching a peak and then becoming quite variable. When lubricant was supplied continuously the friction dropped and levelled off. With a constant supply of lubricant, the cloth friction rose initially before levelling off at a value just below that of the sintered bronze. The cloth material showed signs of polishing and the thread pattern was less prominent (see Figure 8a).

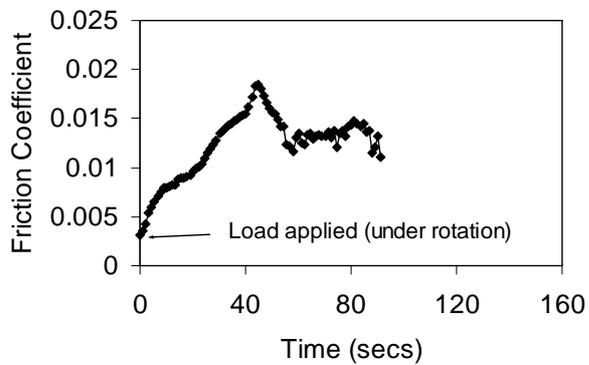
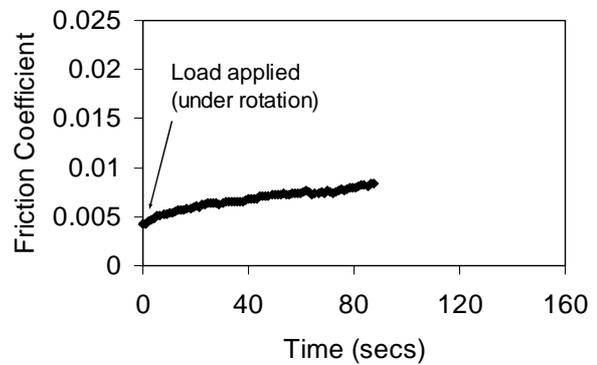
(b) Lubricant allowed to run off for 5 minutes, rotation started, load applied

The lubricant run off test for the sintered bronze material gave a similar result to that seen in the first lubricant test where supply was interrupted, confirming the original response was repeatable. Slight damage was seen to the material surface as shown in Figure 9a. The friction for the cloth rose, but at a much slower rate. This may be because it absorbed lubricant when it was applied at the start of the test. The post test roughness (R_A) of the cloth was $2.84\mu\text{m}$. Clearly the surface has been smoothed. This may have been due to wear or deformation of the surface.

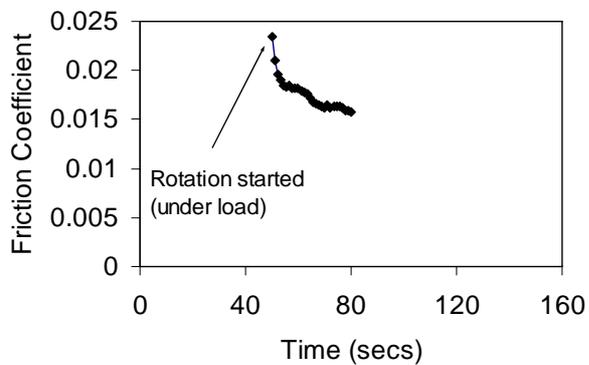
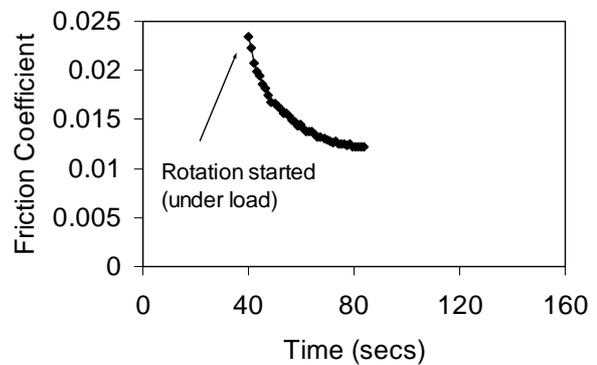
(c) Dry test, load applied, then rotation started

For the dry tests where the load was applied and then the rotation was started, the friction dropped sharply for both materials, the cloth finally reaching a slightly lower value.

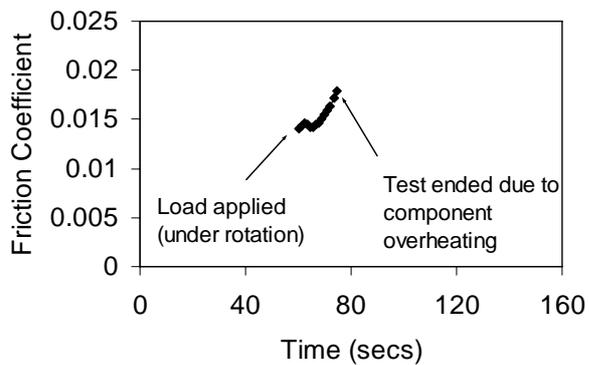
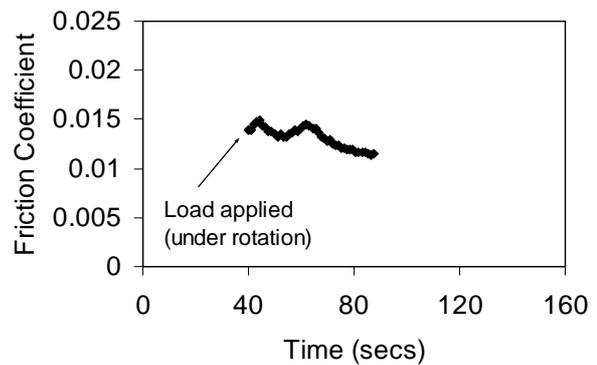
(d) Dry test, rotation started then load applied

For the dry tests where rotation was applied first the friction climbed sharply for the sintered bronze material (the test was eventually stopped as the components were showing evidence of overheating), but remained more stable for the cloth around the level reached in the first dry test. The sintered bronze material sustained damage during the dry testing, as is shown in Figure 9b, where severe scuffing is evident, as did the cloth material (see Figure 8b).
