Jones, C.A., Stewart, D.I. and Danilewicz, C.J. (2008) Bridge distress caused by approach embankment settlement. *Geotechnical Engineering*, 161 (2). pp. 63-74. ISSN 1353-2618

## Bridge distress caused by approach embankment settlement

**Surtees Bridge, which carries the A66(T) over the River Tees near Thornaby-on-Tees in the UK, has been showing signs of distress that predate its opening in 1981. Subsequent investigations have shown that the bridge distress is related to unexpectedly large settlement of the eastern approach embankment. Recent ground investigations prompted by a proposed widening of the river crossing have produced many new data on the alluvial deposits underlying the site, and explain why embankment settlement was so much larger than originally anticipated. Comparison of the geotechnical parameters obtained from the original and more recent ground investigations suggests that the original investigation significantly underestimated the thickness of an alluvial clay layer underlying the site, and that its coefficient of consolidation was overestimated. Settlement analyses using geotechnical data from the original ground investigations predict moderate embankment s

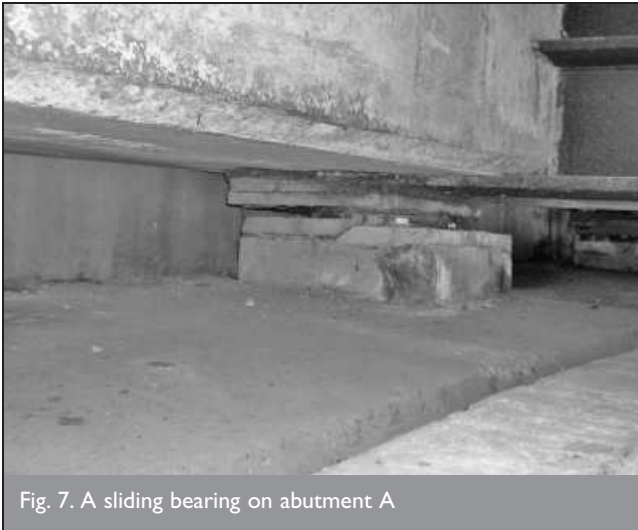
The bridge deck is horizontally restrained at abutment F and partially restrained at piers C and D (labelled R in Fig. 4). There are sliding bearings (labelled S in Fig. 4) at abutment A and piers B and E. Abutment F provides horizontal restraint of the bridge deck via the pile arrangement. Piers C and D are restrained to reduce their effective length in relation to buckling. Piers B and E are half the length of piers C and D and do not need to be restrained by the deck. There is an expansion joint between the deck and abutment A that is filled with a flexible plastic inlay. This allows for thermal expansion of the

A bridge inspection undertaken in 2000 indicated that the bridge deck had moved westward relative to abutment A and pier B. The displacement of the bridge deck relative to pier E is easterly, however. The articulation of the bridge is such that only piers C and D and abutment F can transfer horizontal forces to the bridge deck. Piers C and D are unlikely to be the cause of the bridge deck movement, because their foundations are remote from any source of lateral load. It was therefore deduced that the bridge deck had moved westward due to forward movement of abutment F. The movement of the bridge deck relative to pier E therefore indicates that there has been a westward movement of the head of pier E greater than westward movement of the bridge deck. Westward displacement of pier E during construction of abutment F is noted in a report prepared by Bullen and Partners in 1993.<sup>18</sup> Movement of abutment A is not thought to be the primary cause of closure of the expansion joint above that abutment, because there are no visible signs of settlement of the western approach embankment, and it cannot account for the movement of the bridge deck relative to piers B and E.

Fig. 7. A sliding bearing on abutment A
