Camacho, J., Lewis, R. and Dwyer-Joyce, R.S. (2007) *Wear of a chute in a rice sorting machine*, *Wear*, Volume 263 (1 - 6), 65 - 73.

# WEAR OF A CHUTE IN A RICE SORTING MACHINE

In a rice sorting machine, rice grains drop onto and slide down an anodised aluminium chute. The purpose of the chute is to separate the grains and provide a controlled distribution. At the bottom of the chute the grains are examined optically and contaminants or defective grains are removed from the stream by jets of air. The machine has the ability to sort low quality rice which contains a large element of contaminants such as husk. The husk is extremely abrasive and this, along with other factors, can lead to a reduction in the life of the chute by wear of the surface.

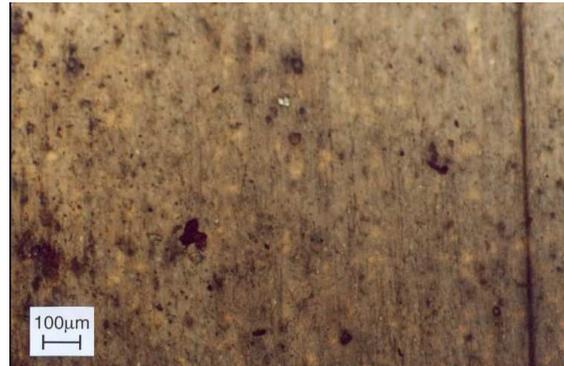
**Figure 4**

Figure 4 is a micrograph taken at point A on Figure 2. This shows the appearance of the unworn anodised surface, to allow comparison with the subsequent images of worn regions of the chute. Note all photographs are orientated parallel with the groove direction.

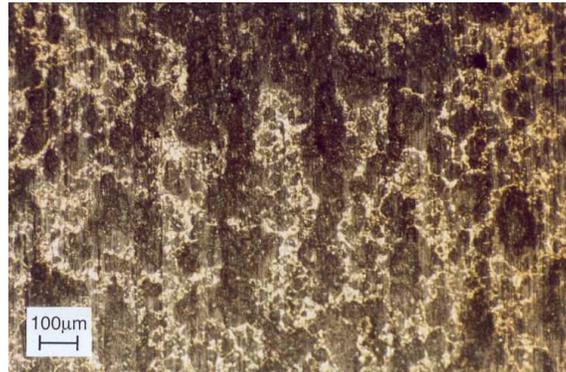
**Figure 6**

Figure 6 shows the surface in one of the wear tracks seen at the base of the channels (point D). Clearly here the anodised surface has not been completely worn through. There are some linear features just about visible.

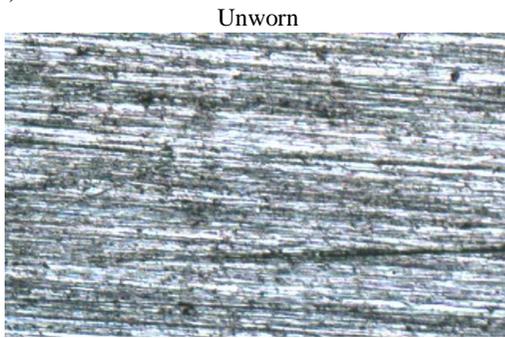
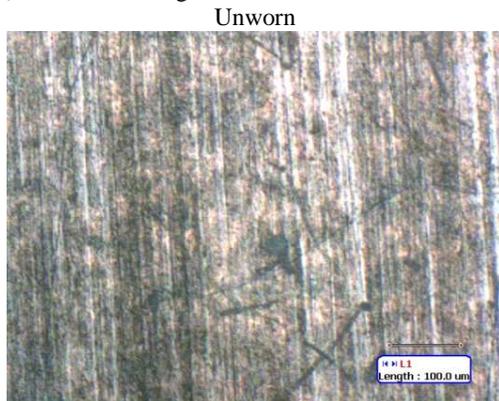
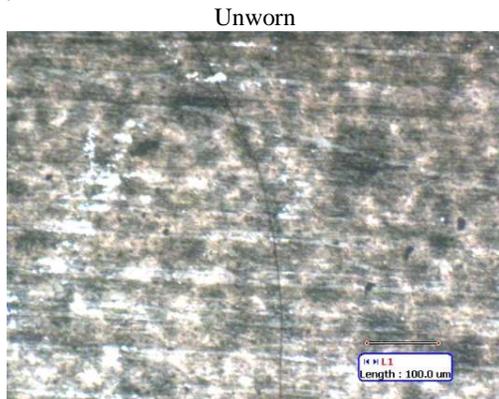
**Figure 11**

Figure 11 shows the material surfaces before and after testing with just rice. The untreated aluminium suffered the most severe wear. Aluminium wear debris was found to be picked up and adhered onto the rice grain. This led to an acceleration of the two-body abrasive wear process.

The treatment that saw the greatest wear was hard anodising with PTFE. In Figure 11b it can be clearly seen that the surface layer has been worn more severely than the other surfaces. Linear scratches in the direction of rice motion are visible indicating that abrasive wear is again occurring on the substrate. Features were similar to those seen on the actual rice chute wear scars. The chrome plated and hard anodised aluminium showed less wear. After 30 minutes the coatings were largely intact (see Figure 11c and 11d).

The materials tests have shown that the best (and commercially viable) alternative appears to be the hard anodised aluminium or chrome plating which performed better in the wear tests with and without abrasives. There was no real difference between materials in the friction testing, which suggests in terms of rice sliding down the chute none of the materials would present a problem. The function of the chute itself does not directly depend on friction coefficient, provided it remains constant throughout the rice path. If the friction fluctuates during the particle motion it would be difficult to ensure all grains arrived at the detector head in a uniform manner. During these tests no major temporal friction variations were observed.
