Degradation modes and tool wear mechanisms in finish and rough machining of Ti17 Titanium alloy under high-pressure water jet assistance

Y. Ayed ^{a,*}, G. Germain ^a, A. Ammar ^a, B. Furet ^b

A B S T R A C T

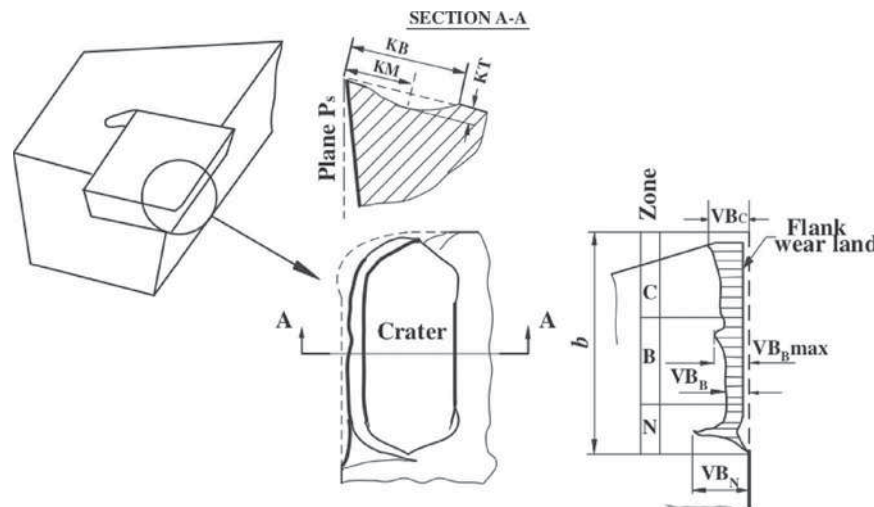
Fig. 1. Types of wear [9].

Tests were carried out to highlight the wear mechanisms and their evolution in conventional machining (without assistance) as well as under high-pressure water jet assistance. The machine used for these tests is a LEADAWELL LTC25iL lathe with a maximum power of 24 kW. Force measurement is done using a Kistler 9257B dynamometer which allows the acquisition of the three cutting force components. In order to inspect tool wear, a binocular microscope and a scanning electron microscope (SEM) were used. Fig. 1 shows the types of wear.

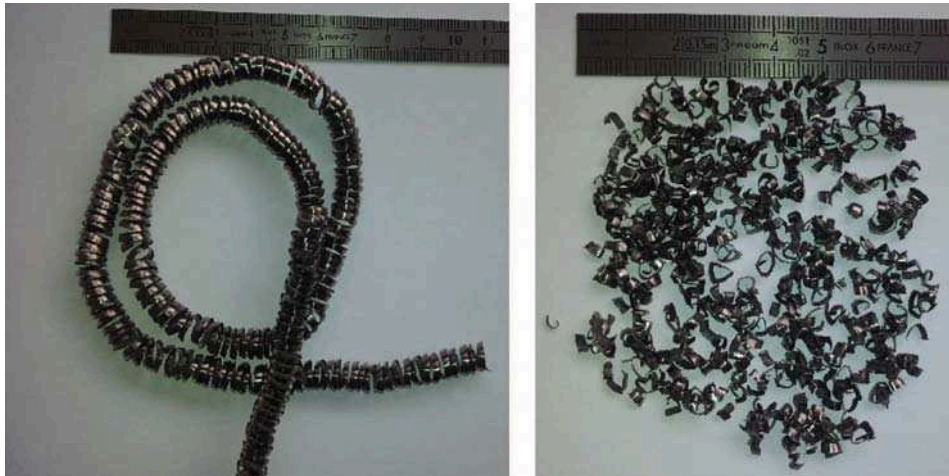
Fig. 2. Chip fragmentation at 100 bars (finishing condition).

Fig. 2 shows the morphology of the chips obtained when machining with conventional lubrication and with HPWJA at 100 bars, respectively. It can be seen that HPWJA ensures chip fragmentation.

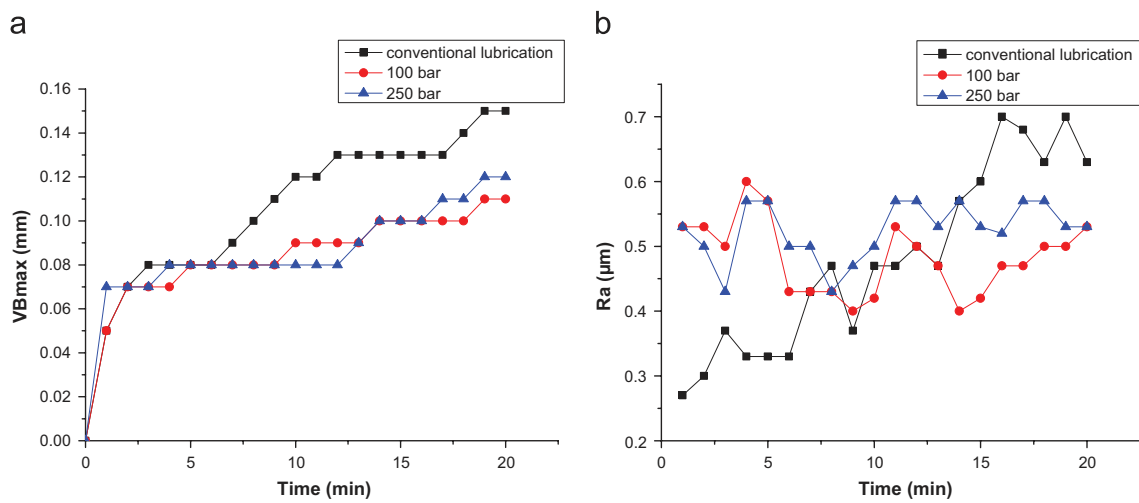
Fig. 3. (a) Flank wear (VB) and (b) surface roughness (R_a).

Fig. 3(a) shows the evolution of the flank wear criterion (VB) and (b) the evolution of the R_a criterion. For all the configurations, flank wear (VB) does not exceed 0.15 mm after 20 min of machining, but its evolution is slower with HPWJA. Indeed, in conventional lubrication after the running-in phase, flank wear increases linearly to 0.15 mm after 20 min.

However, for the HPWJA condition, after the running-in phase, the flank wear remains constant for a significant period. Indeed, in both assistance configurations (100 bars and 250 bars), flank wear remains constant at about 0.08 mm for approximately 6 min at a pressure of 100 bars and for about 9 min at a pressure of 250 bars. After this stable regime, flank wear increases in a way similar to conventional lubrication. Fig. 3(b) shows a significant variation of surface roughness. For conventional lubrication, the surface roughness tends to increase linearly as a function of machining time, going from $R_a = 0.25 \mu\text{m}$ to $R_a = 0.7 \mu\text{m}$ (i.e. R_a reaches three times its initial value). For tests with high-pressure water jet assistance, the initial surface roughness is higher, but its value remains globally constant (between $0.4 \mu\text{m}$ and $0.6 \mu\text{m}$ throughout the test). In addition, there is no marked tendency for the surface roughness to increase even at the end of the test. The surface roughness thus appears uninfluenced by flank wear.

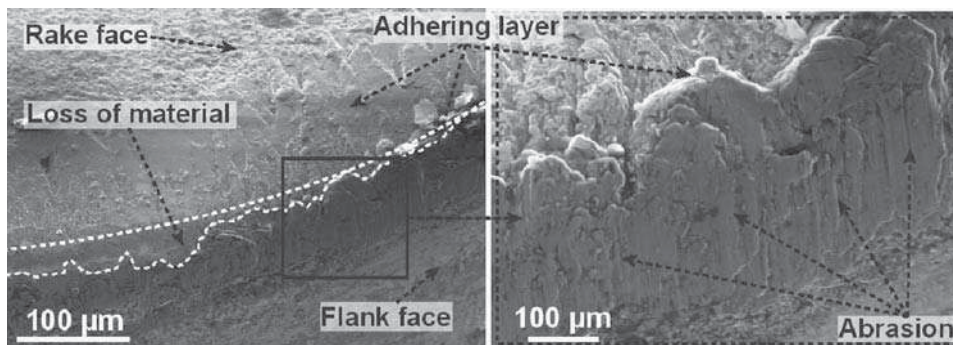
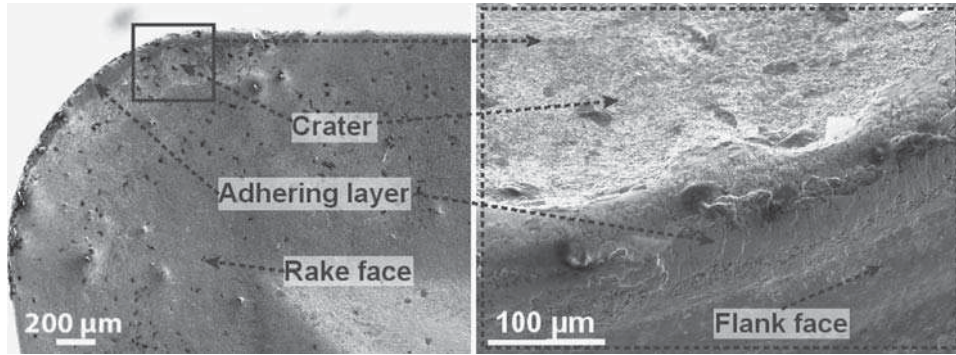
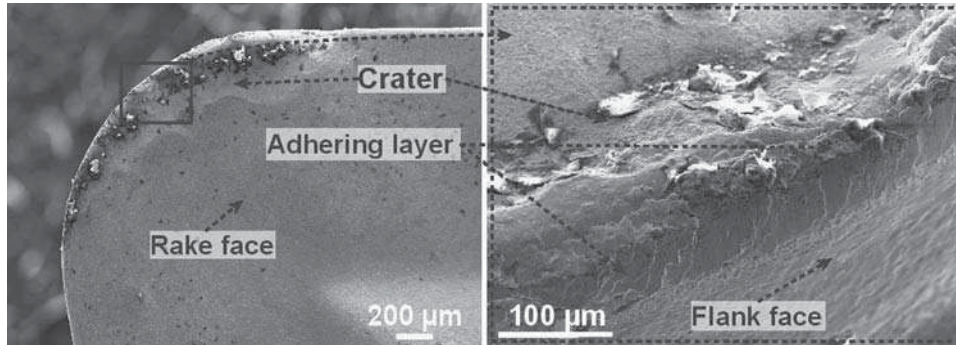
Fig. 4. SEM image of the tool rake/flank face after 20 min of machining in the finishing configuration with conventional lubrication.

Fig. 5. SEM image of the tool rake/flank face after 20 min of machining in the finishing configuration with 100 bars.

Fig. 6. SEM image of the tool rake/flank face after 20 min of machining in the finishing configuration with 250 bars.

Figs. 4–6 show the SEM images of the worn areas on the tool rake face and on the tool flank face for the three tests in the finishing condition. For conventional lubrication, significant flank wear at the nose radius (VB_c) is observed. In addition, layers adhering to the rake face are noticed. During machining, the chip rubs on these adherent layers which appear to protect the rake face. However, when the formation of these layers reaches a stagnation level, they become instable and may be peeled-off

leading to wear by adhesion [10]. Alternatively, with HPWJA, a loss of material on the tool rake face and the formation of a crater can be seen. Damage in these areas is more important at a pressure of 250 bars. In this case, it seems that the most important wear mechanism is adhesion accompanied by abrasion and erosion.

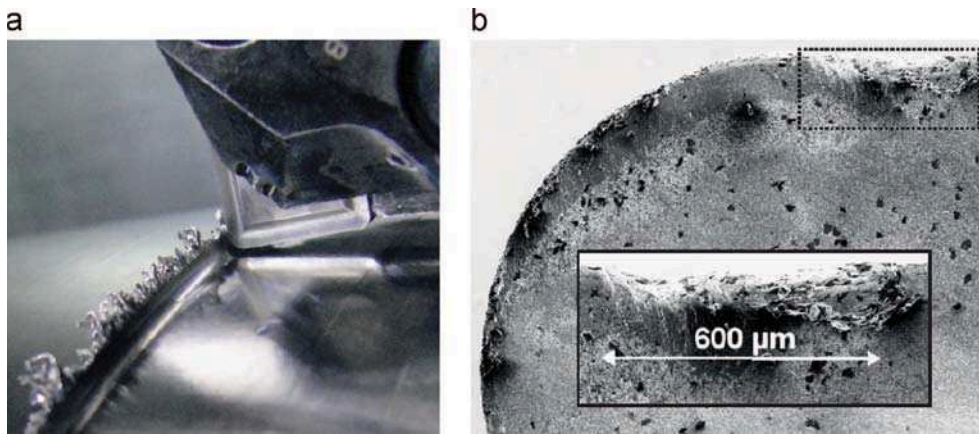
Fig. 7. (a) Formation of burr on the work-piece and (b) notch wear after 20 mm of finishing machining with conventional lubrication.

For conventional lubrication conditions, burrs are formed on the work-piece during machining, as shown in Fig. 7. At the height corresponding to these burrs, significant notch wear (VBn) is formed. The width of the notch is around 600 μm after 20 min of machining. However, no burrs and no notch wear are visible under high-pressure water jet assistance. The specific effort has a slow and gradual evolution, but it is slightly lower in HPWJA.

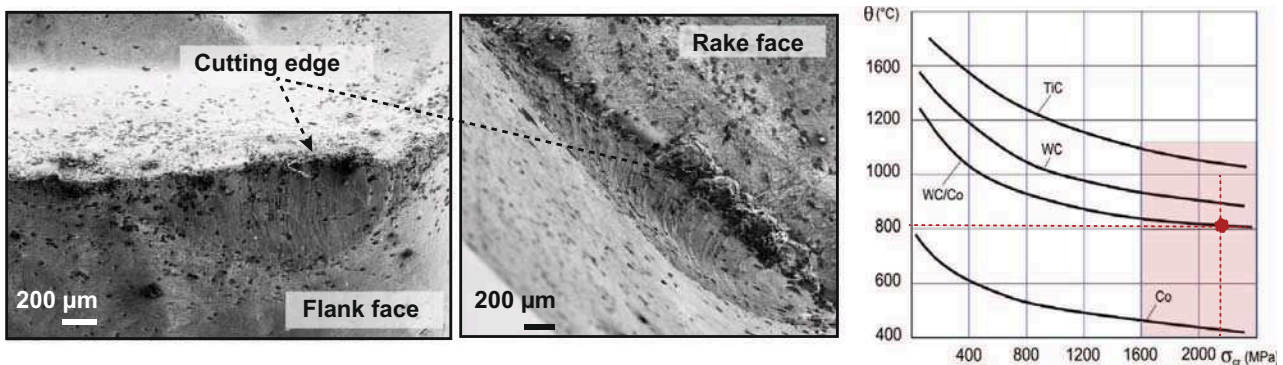
Fig. 8. (a) Image of the cutting edge after 75 s of roughing machining with conventional lubrication and (b) creep resistance [12].

pressure K_C (about 2100 MPa). Fig. 8(a) shows tool rake and flank faces after 75 s of roughing machining.

The measurement of the cutting force reveals that the average specific pressure is around 2100 MPa in conventional machining. Fig. 8(b) shows that, to avoid creep in the tool when exposed to a contact pressure of 2100 MPa, the cutting temperature must not exceed 900 $^{\circ}\text{C}$ for the WC and 800 $^{\circ}\text{C}$ for the WC/Co inserts. However, these temperatures correspond to those obtained when machining titanium [13–15]. This result confirms the degradation mode of the cutting edge by creep in conventional machining.

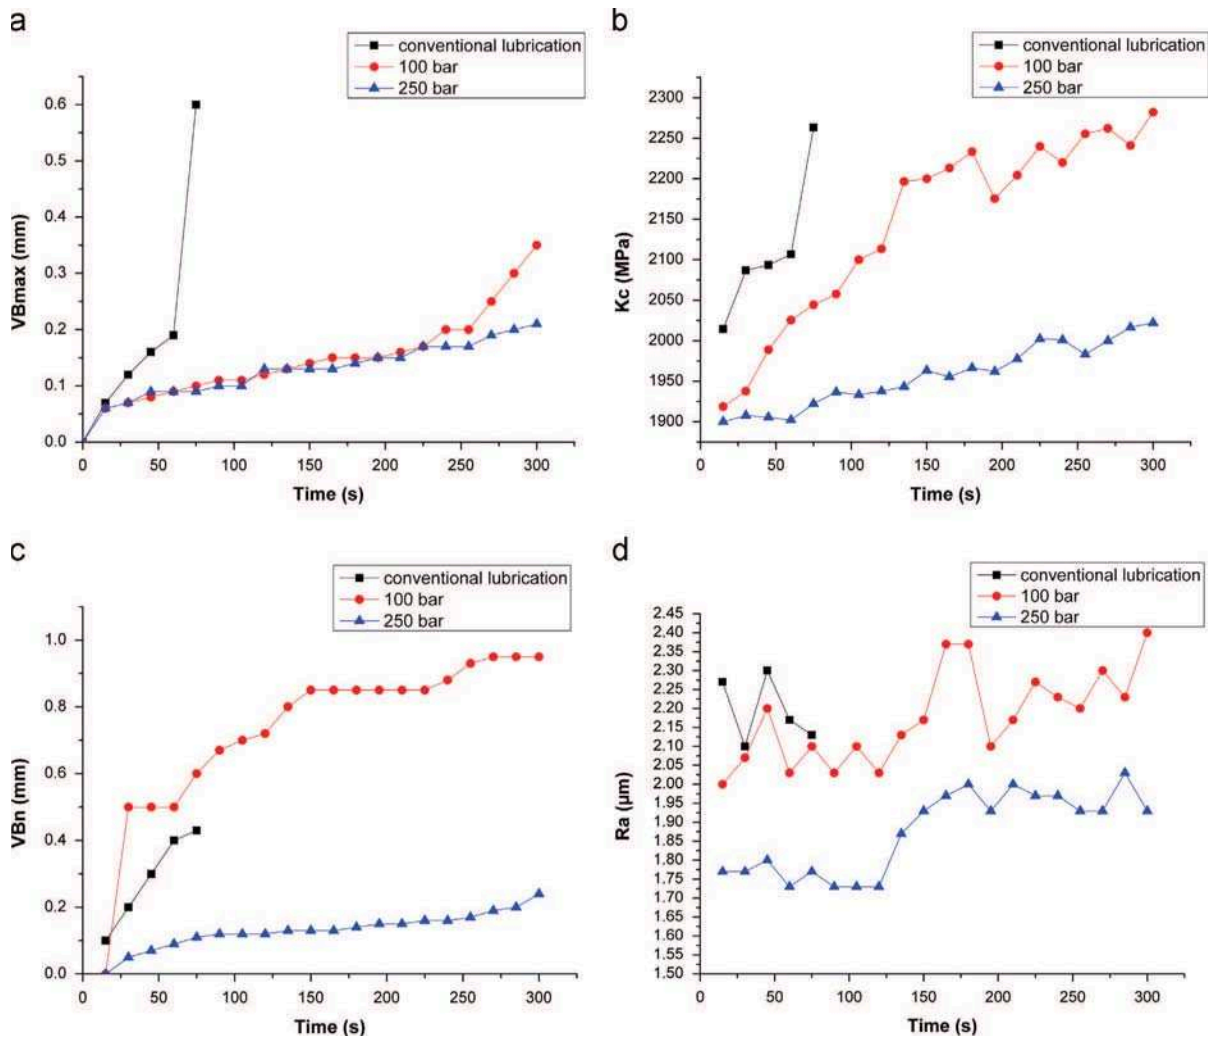
Fig. 9. Evolution of (a) flank wear, (b) specific cutting pressure, (c) notch wear, and (d) surface roughness.

This evolution is the same for both assistance pressures. However, from 4 min of machining, wear is accelerated at 100 bars. For a machining time of 5 min, flank wear is around 0.35 mm at 100 bars and around 0.21 mm at 250 bars. For a tool wear criterion set to 0.2 mm, tool life is less than 1 min in conventional machining and about 5 min at 250 bars; so, tool life is multiplied by a factor of 5.

The notch wear, VBn was also observed. Fig. 9(c) shows the evolution of notch wear for the three lubrication configurations in the roughing condition. With conventional lubrication, the notch size increases significantly with machining time. It reaches a value of 0.4 mm when the tool cutting edge collapses. Therefore, the tool degradation mode is the collapse of the cutting edge by plastic deformation, not by notch wear. With water jet assistance at 100 bars, a relatively large notch (0.5 mm) is present from the start of the test and progresses constantly until it reaches 0.95 mm after

Fig. 9(b) shows the evolution of the specific cutting pressure versus machining time. The specific cutting pressure seems to increase with increasing tool wear. It can also be noticed that the cutting force under HPWJA is lower than in conventional machining. Indeed, with a pressure of 250 bar, the specific cutting pressure K_c is about 10% lower than in conventional machining for an unworn tool. This could be due to a decrease in the friction coefficient. Indeed, the lubricant jet is inserted between the chip and the tool, which may change the coefficient of friction. The cooling is mainly localized at the tool and the tool–chip interface. The primary shear zone does not seem significantly cooled.

Fig. 9(d) shows the evolution of the surface roughness. For the three configurations, R_a is generally stable despite a slight tendency to increase over time.

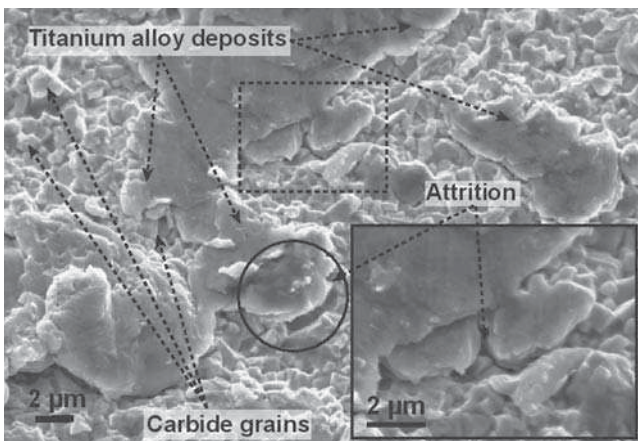
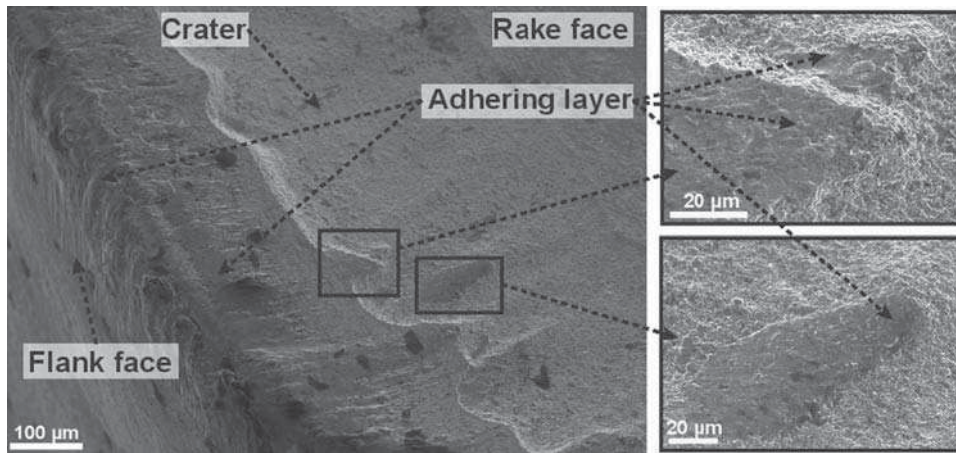
Fig. 10. Adherent layers on the tool rake face after 5 min of roughing machining at a pressure of 100 bars.

Fig. 11. Adherent layers on the tool rake face after 5 min of roughing machining at a pressure of 250 bars.

Fig. 10 shows material deposits sticking to tungsten carbide grains. Furthermore, it shows the attrition or loss of carbide grains. Fig. 11 shows that the areas with material deposits are protected and are not subjected to damage.

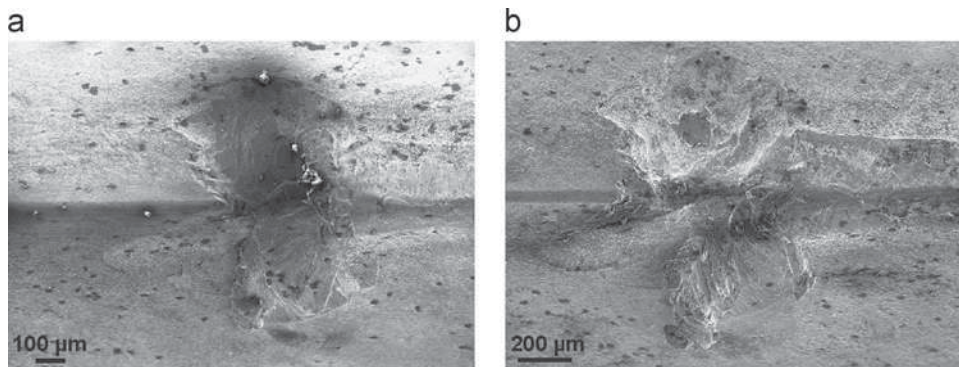
Fig. 12. Evolution of notch wear in roughing condition: (a) 4 min and (b) 5 min.

Fig. 12(a), taken after 4 min of machining, shows layers adhering to the notch. After 1 min of additional machining, the same notch is observed. Fig. 12(b) shows that the previously observed layers are pulled out, leaving a larger notch. Indeed, significant material loss was noted in the areas where material deposits were located. These observations confirm the wear mechanism by tearing-off of adhering layers.

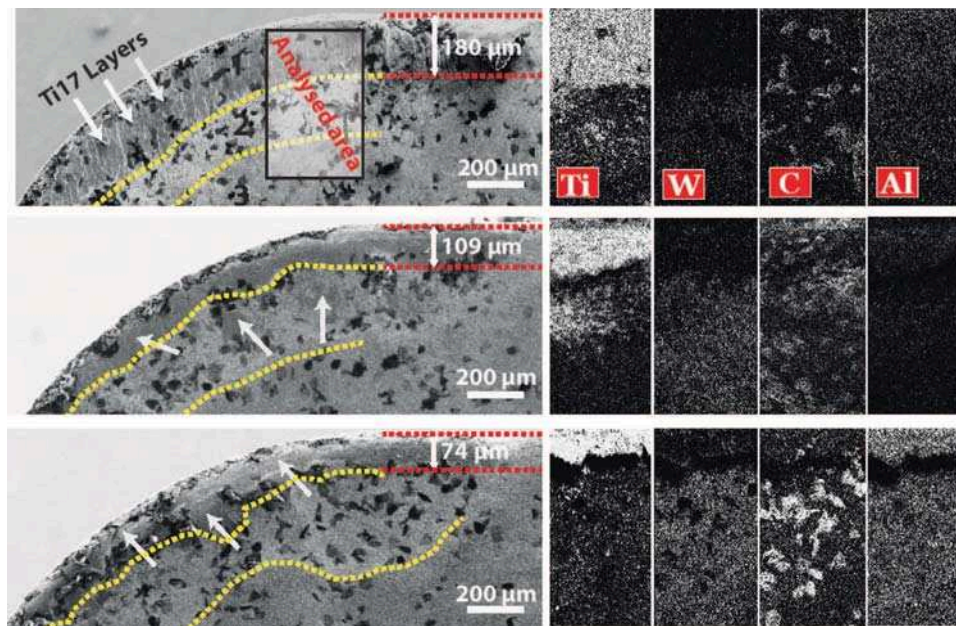
Fig. 13. Analysis of material deposits on the rake face after 15 min of finishing machining: (a) conventional machining, (b) 100 bars and (c) 250 bars.

operation, the control and analysis interval was reduced to 30 s. Fig. 13 shows the results of the qualitative analysis. Three zones can be distinguished.

- The first is formed by Ti17 layers. This is the sticking and adhesion zone;

- The second is an area of material abrasion and tearing-off, characterized by localized loss of material (and formation of a crater);
- The last zone is the area that remains intact.

In addition, the EDS analyses show the distribution maps of the elements forming the tool and the titanium alloy. The distribution maps of the elements Ti, W, C, Al are presented in Fig. 13. It can be seen that increasing the water jet pressure results in a reduction of the adherent layers zone. This reflects a decrease of the zone of strong adhesion and sticking of the chip on the tool rake face. This zone can be related to the tool/chip contact length (LC). Hence, these observations show a decrease in the tool/chip contact length with increasing pressure. The contact length decreases from 180 μm in conventional lubrication, to 74 μm under high-pressure water jet assistance (at 250 bars). In fact, for HPWJA, the fluid infiltrates between the chip and the tool. It has therefore the tendency to separate the chip from the tool rake face, thus decreasing the contact length, LC, and reducing friction between the tool and the chip.

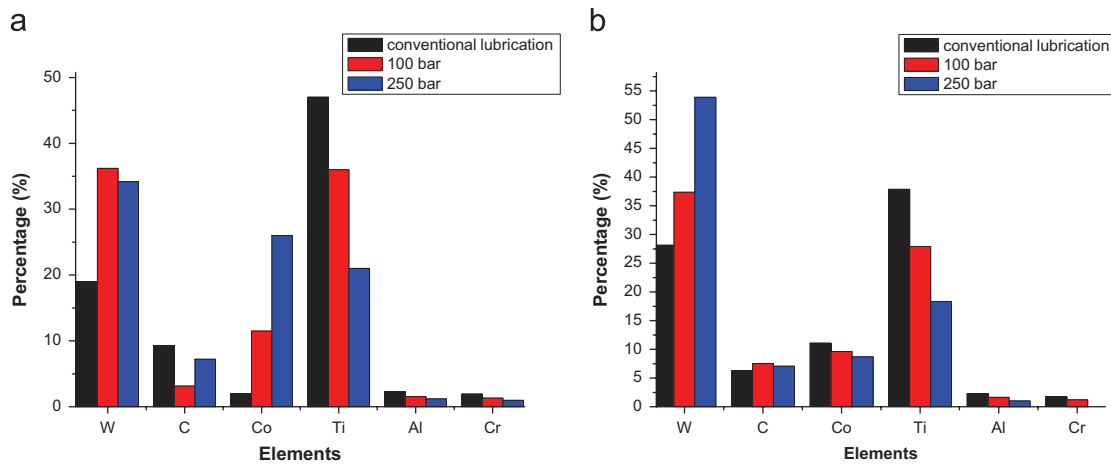
Fig. 14. Elements percentage: (a) roughing (2 min) and (b) finishing (15 min).

The same measurements have been made for the roughing condition. Fig. 14 shows the results of the analysis. Note that for the conventional lubrication condition the results are recorded after 75 s of machining. For both the roughing and the finishing conditions an increase in the jet pressure leads to a decrease in the

size of the adherent layers. For example, the percentage of the alloying elements is reduced from 45% for conventional lubrication to 21% at 250 bars for the finishing condition. In all tested conditions, the deposit rate of titanium decreases by about 25% with a pressure of 100 bars and by about 55% with a pressure of 250 bars.

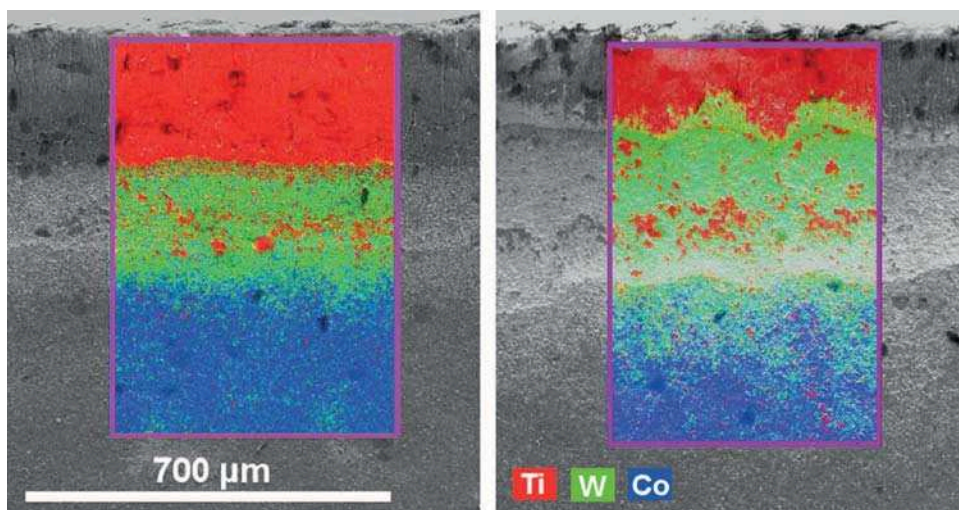
Fig. 15. EDS analysis after 4 min of roughing machining (100 bars and 250 bars, respectively).

Fig. 15 shows the tool rake face of two inserts after 4 min of roughing machining at 100 bars and 250 bars, respectively. It can be seen that the area of the adherent layers becomes smaller when the pressure is increased from 100 bars to 250 bars. In fact, the order of magnitude of the contact length is close to that found in the finishing condition.

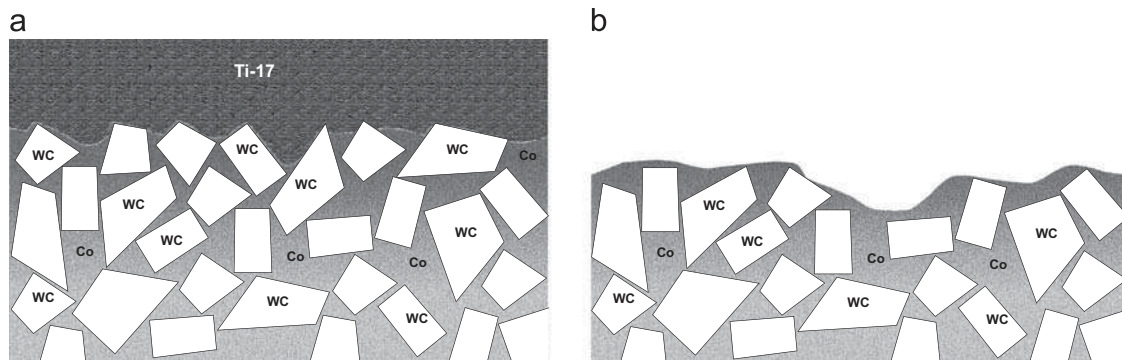
Fig. 16. Mechanism of adhesive wear.

Fig. 16 illustrates wear by adhesion. In fact, during the tool/chip contact, an interfacial layer of titanium is formed. Combined with the high temperature and high contact pressure, this layer reacts chemically with the tungsten carbide and adheres to the surface of the insert [8,11]. Thus, an increase in the cutting temperature promotes the diffusion between the tool and the chip. This deposited layer seems to protect the tool since the chip is no longer directly in contact with the carbide tungsten. However, after a period of time, the deposit may become unstable and so can be torn off by the chip. In this case, it tears fragments of the tool material leading to wear by adhesion. These findings confirm the results of other studies on adhesive wear of nickel-based alloys. Devillez et al. [19] and Bhatt et al. [11] show via SEM pictures and EDS analysis the formation of a sticky layer; it is to be noted that when this layer is pulled-out, it causes the adhesive wear.
