# Evaluation of in-service non-destructive inspection methods for composite aerospace structures

NLR-TP-2011-336

J.H. Heida  
D.J. Platenkamp

November 2011

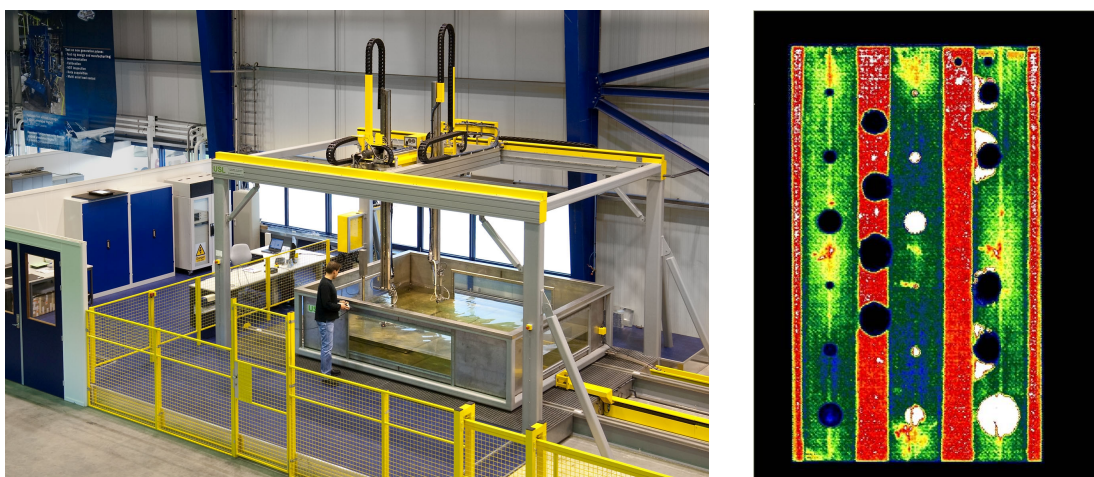
Fig. 2 Ultrasonic C-scan equipment (left) and an example of the inspection of panel NTP-B (solid laminate with 3 T-shaped stiffeners; pulse-echo inspection with monitoring of the backwall-skin reflection)

Ultrasonic C-scan inspection of the specimens was done to provide a base-line view of the present defects against which the selected mobile *in-service* NDI methods would be compared. UT C-scan is currently the primary *production* inspection technique for composite structures after manufacturing. Figure 2 shows the NLR C-scan equipment and an example of the base-line inspection for panel NTP-B (solid laminate with 3 T-shaped stiffeners). Both the immersion and water-jet method (for the sandwich structures) were used for the base-line inspection.

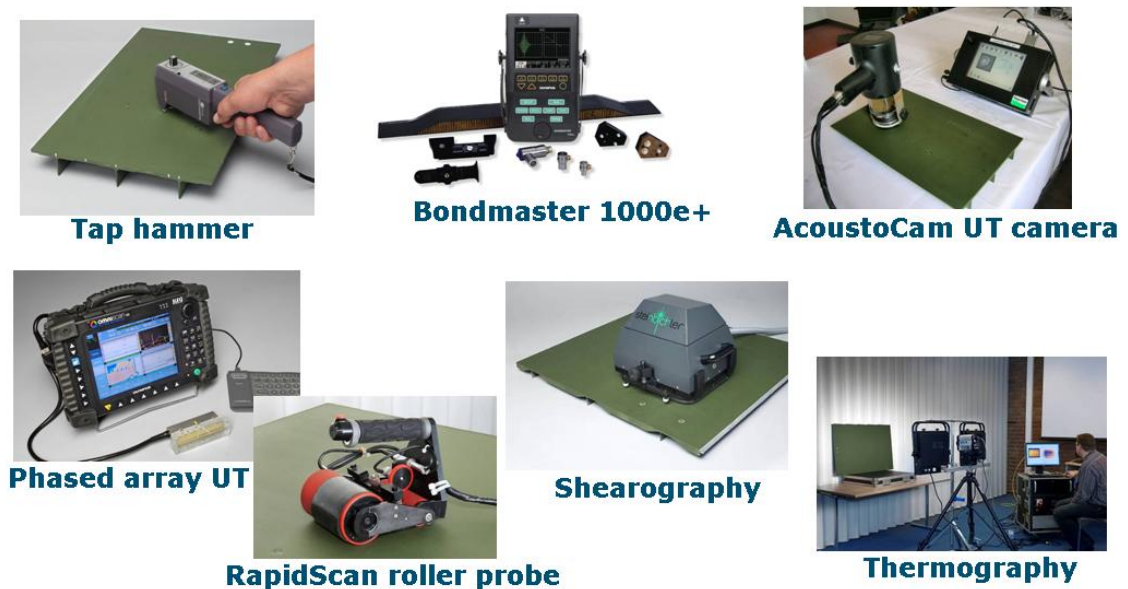
Fig. 3 Selected in-service NDI methods for inclusion in the NTP inspection programme

Figure 3 gives a presentation of the selected NDI methods.

Automated tap test of the NTP-panels was performed by NDT personnel of the Netherlands Defence using the Woodpecker WP-632 (Fig. 3). The Woodpecker is a light-weight hand-held device (about 0.5 kg) that uses a battery-driven solenoid hammer with a force sensor (accelerometer) built in the hammer tip. Practically, the time during which the hammer is in contact with the surface of the test part is measured. This contact time will increase in areas with defects such as disbonds that lower the local contact stiffness of the part. The Woodpecker is a low-cost, couplant-free inspection unit for smaller areas where damage is suspected; for global inspection of large surface areas it is less suited because of its spot measurement performance. Impact damages are generally well detectable; only a few minor impacts were missed in the evaluation. The detectability for delaminations and disbonds, on the other hand, was varying and not always consistent. Furthermore, a varying skin thickness (e.g. lay-up differences) or the presence of back-up structure can influence the tap tester response. The capability for defect sizing is limited and the technique is not suited for defect depth estimation. The newer model WP-632AM (with LCD display that shows the measured contact times) together with a separate WP-632M monitoring unit may have an increased detection performance for in-service defects.

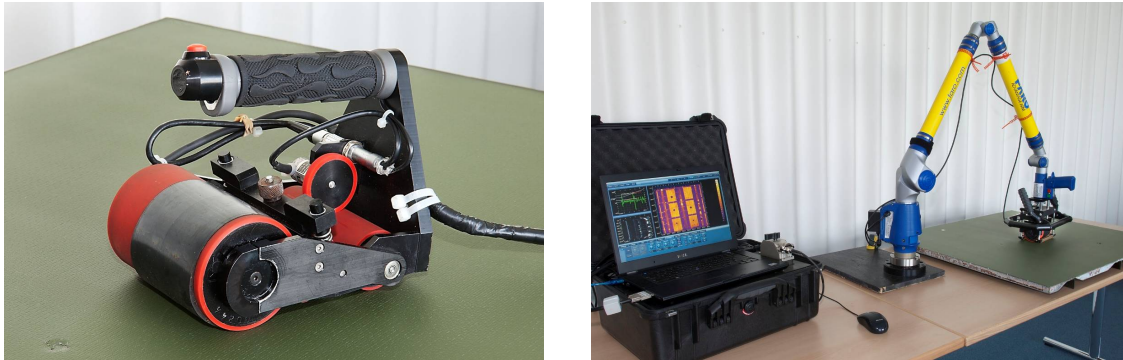
Fig. 7 UT-PA RapidScan™ with 50 mm wheel probe and 7-axis Faro scanning arm (right)

The RapidScan™ of Sonatest Ltd. employs a UT phased array probe housed within a rubber coupled and water-filled wheel probe (Ref. 5). The rubber tyre is acoustically matched to water, providing low loss coupling into the test part. The probe can be used without couplant but, generally, a fine water spray on the test part is used for optimum coupling. Wheel probes with 50 mm active array width (64 elements with 0.8 mm pitch) or 100 mm width (128 elements with 0.8 mm pitch) are available. The larger probe is meant for flat surfaces, the smaller one can also be used on slightly curved parts. The transducer frequency can be selected as 2, 5 or 10 MHz. The handheld roller probe together with a 7-axis Faro scanning arm can be used for fast and real-time UT inspection of relatively large areas (figure 7).

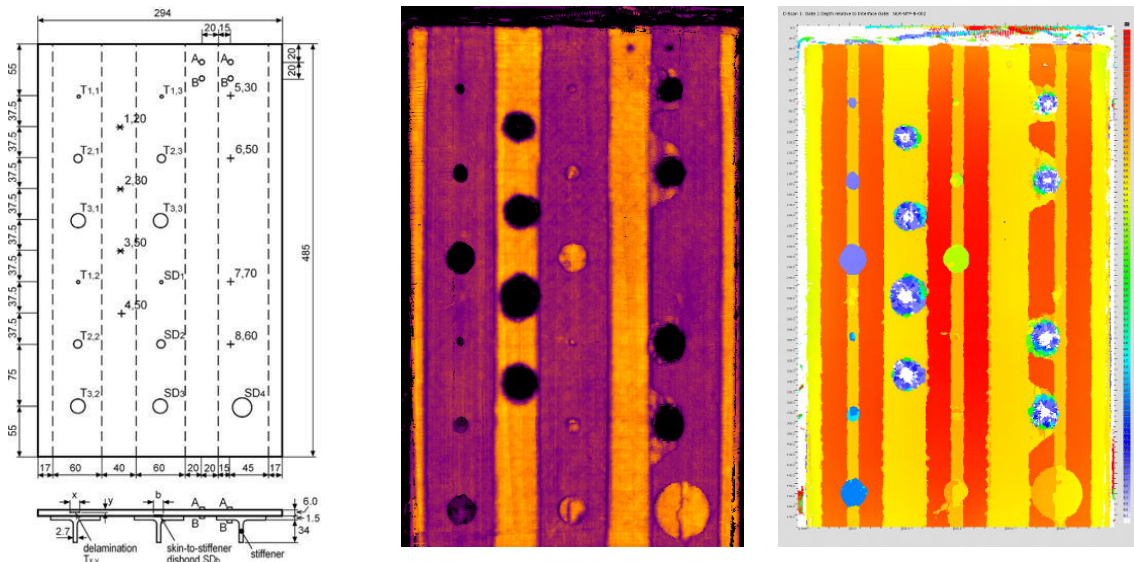
Fig. 8 RapidScan™ inspection of panel NTP-B (solid laminate with 3 T-shaped stiffeners). Amplitude backwall skin C-scan (middle) and TOF-scan (right)

Inspection of the NTP panels by Sonatest Ltd. showed that the RapidScan is very suitable for the in-service inspection of composites, being a special UT-PA technique. The detectability for defects such as delaminations, disbonds and impact damages is excellent. Figure 8 gives an example of the inspection of panel NTP-B (solid laminate with 3 T-shaped stiffeners). No defects were missed and only some small defects with size of 6 mm were qualified as detectable with limitation. The RapidScan can further be used for defect sizing and defect depth estimation with a fair accuracy (about 2 mm for defect sizing and 0.2 mm for depth estimation; only in some cases larger deviations occurred). The RapidScan scored best in the NTP evaluation but a limitation can be the relatively high cost of a complete inspection system including scanning arm. The portability of the system may limit its use for inspection areas with limited access.
