The masonries of the Roman bridge of Sant'Antioco (Sardinia, Italy)

Abstract

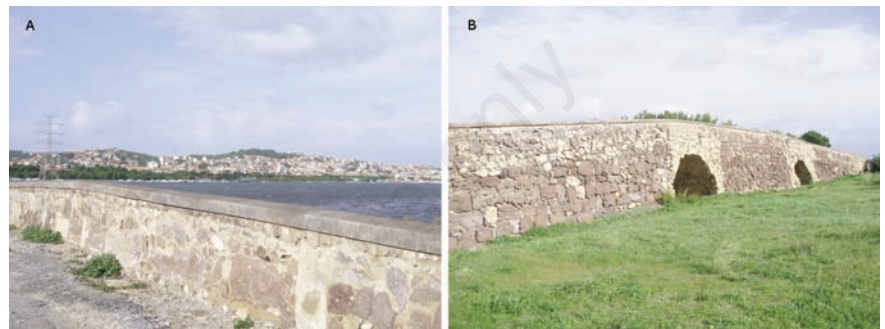
Figure 1. View of Sant'Antioco town from the bridge (A) and detail of the south front (B).

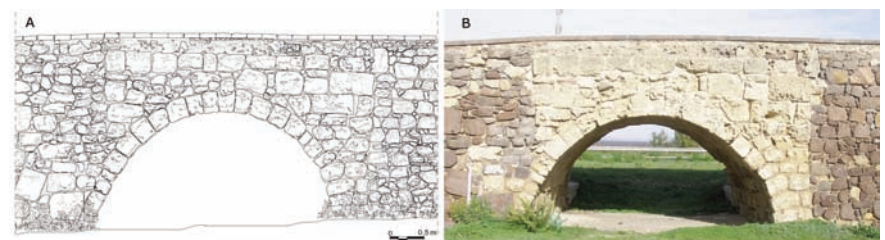
Figure 3. Drawing (A) and picture (B) of one of the arches of the south prospectus (drawing by courtesy of V. Pintus and M. Porcu). It shows an advanced degradation, with the presence of alveolisation, pulverisation and pitting processes.

With reference to the masonries, as we can see, the various changes have contributed to their deterioration and structural composition. In fact, at the arches, in some places regular sandstone blocks have been replaced with smaller-sized rustic stones of the same material (Figure 3). Even in some of the rhyolite

In the specific case, the bridge is prevalently made of two different types of stones: i) sandstone, used as regularly cut blocks mainly for arches; ii) rhyolite rock used as regular and irregular shape in the masonry; iii) some limestone ashlar (Figure 3). While the rhyolite – *trachyte auctorum* – is well conserved and simply shows different patinas, the sandstone shows a deeper degradation (Prokos, 2008), as it is testified by the presence of exfoliation, disintegration, loss of strength and alveolization phenomena (Figure 5).

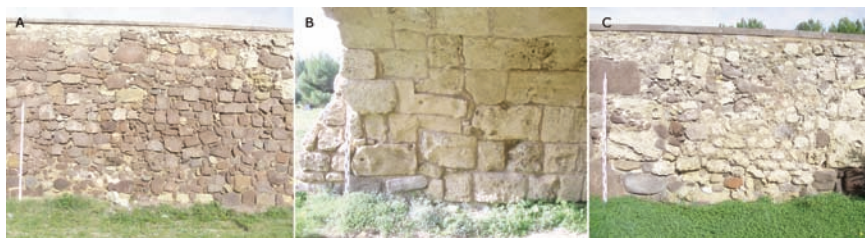
Figure 4. Sequence of the masonries concerning the south façade: A) part near the first arches towards west; B) detail of the interior of one of the arches; C) the terminal part towards east.

masonries there is the presence of large-sized square blocks of stone, usually placed at the base, disposed following a random arrangement, maybe dating from the Roman period. In addition, there are often mistakenly placed stone elements, with the long side vertical, or simply glued or used as cladding, rather than with structural function. This solution, quite common in recent times, does not adhere to the concept of the Vitruvian *firmitas* and believes restoration to be reduced to mere aesthetic matters (Figure 4).

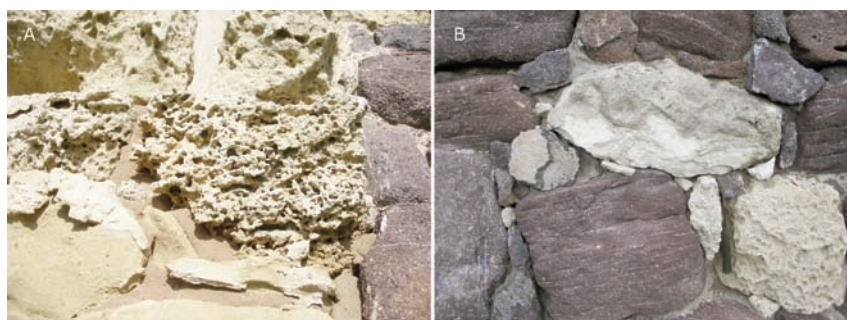
Figure 5. A) Sandstone ashlars composing the arches. Some of them show a deep alveolization phenomenon. B) Rhyolite, limestone and sandstone ashlars, characterising the masonry surrounding the arches.

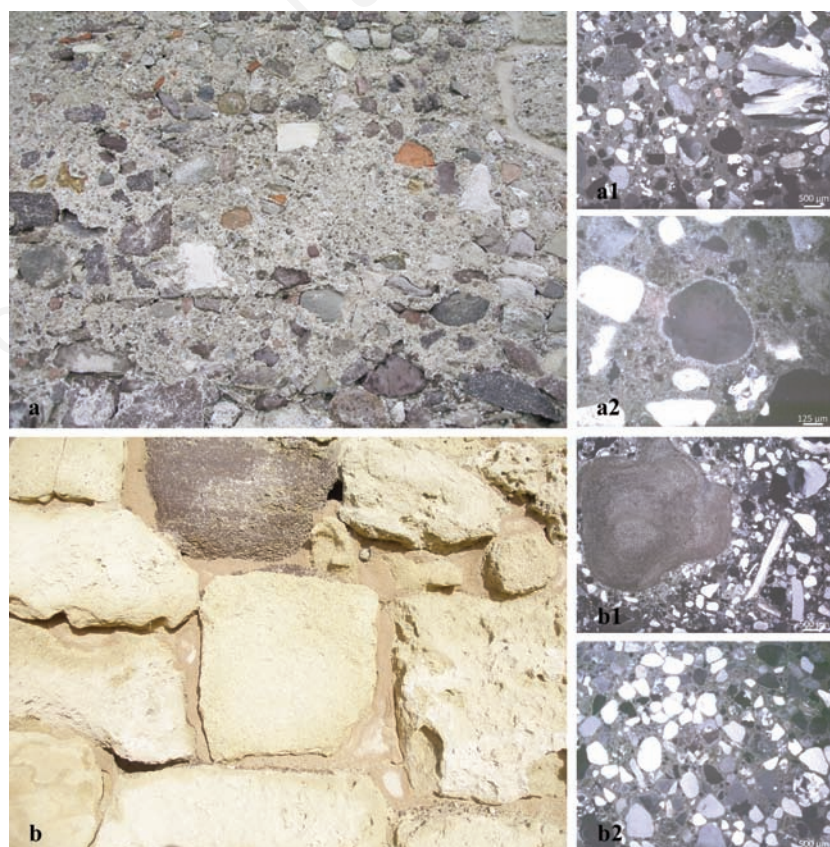
Figure 6. Plaster of the north prospectus (a) and mortar of the south façade (b). a1, a2) Thin section photomicrographs (crossed polarizer) of plaster with grained quartz-feldspar, volcanic and quartzite aggregates. The binder is micritic with cryptocrystalline reaction rims around mineral grains. b1-b2) Thin section photomicrographs (crossed polarizer) of mortar with grained quartz-feldspar and very poor volcanic and quartzite aggregates. The binder is micritic with lime lumps.

The aggregates in the mortars are of different kind from a granulometric and chromatic point of view, while petrographically they are characterized by quartz, k-feldspar, fossil fragments, carbonate and fragments of quartzite and volcanic rocks. The difference in the petrographical composition is linked to the different kinds of mortars, used during the several restoration projects that involved the building (Figure 6).

The study of thin sections of plaster mortar showed the presence of grained quartz-feldspar and volcanic and quartzite aggregates. The binder is micritic with cryptocrystalline reaction rims around mineral grains (Elsen *et al.*, 2004).
