Seismic Behaviour and Retrofitting of a School Masonry Building subject to the 2012 Emilia-Romagna Earthquake

Conference Paper · September 2014

A. Formisano

**Department of Structures for Engineering and Architecture
University of Naples “Federico II”
Naples, Italy**

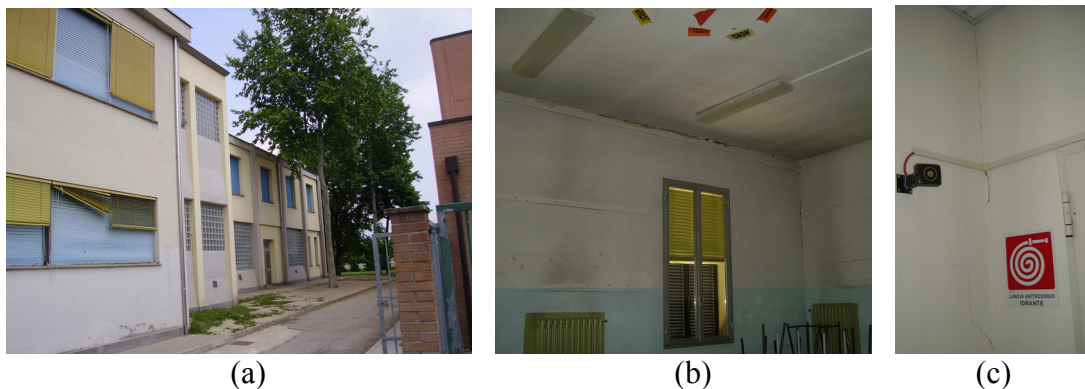
The primary school Menotti in Bomporto is a three structural units aggregate (Fig. 2a).

The oldest building was built before 1919. The detected damages were represented by the floor - wall detachment due to their poor connection (Fig. 2b), cracks in the vault key, horizontal cracks in the floors and vertical cracks among walls (Fig. 2c). The central structural unit of the building, built in the 80's, suffered light damages to non-structural parts, such as interior walls, ceilings and plasterboard. The last structural unit, built in the 90's and designed as the school dining hall, did not record any damage to structural and non-structural components.

Figure 2: The primary school Menotti: external view (a), wall-to-floor detachment (b) and a vertical crack between walls (c).

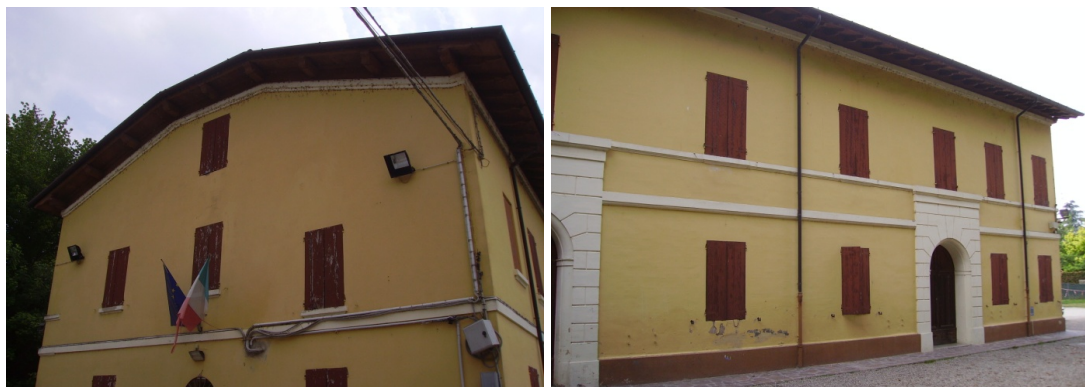
As in the case of the Vesuvius area, the seismic vulnerability exam of Emilia masonry schools was conducted with reference to a case study, namely the “Sorelle Luppi” school (Fig. 4), developing on two levels plus an attic with total height of 9.94 m from the foundation level (Fig. 5).

Figure 4: The main facades of the "Sorelle Luppi" school building.

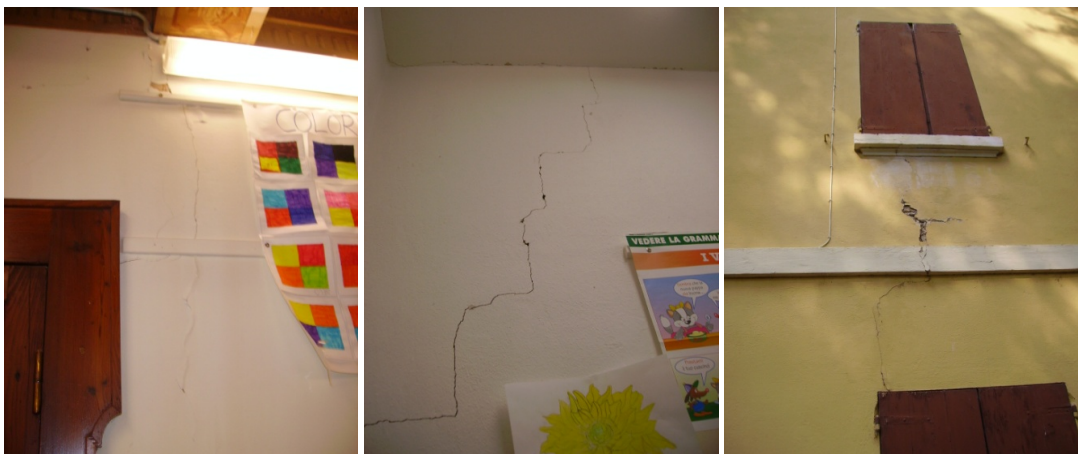
In principle, the building was the manor house of the Luppi family, who gave the name to the school still used today. In the early '70s the municipality of Bomporto bought its property aiming at transforming it into a school through restructuring works started in 1973. For the architectural merit, the school is currently covered by the bond of Superintendence for Cultural and Architectural Heritage. After earthquake, in the building few damages among walls and floors were detected, but vertical and diagonal cracks in masonry piers and spandrels (Fig. 6) and horizontal cracks in some vaults were noticed.

Figure 6: Details of some internal and external cracks.

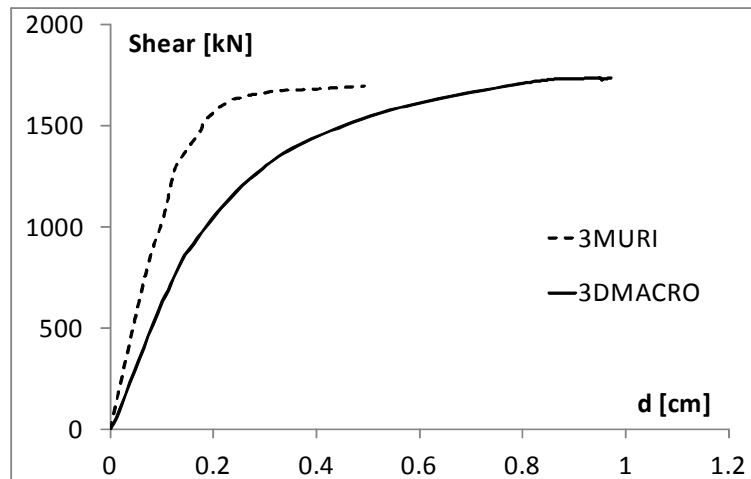
For the sake of example, the school building seismic response gotten by two examined analysis programs is plotted in Figure 10 with reference to the analysis in the direction x with positive eccentricity and forces proportional to masses.

Figure 10: Comparison between building capacity curves in direction x .

From the comparison performed in the non-linear static field, it was found that:

- The two programs allow to attain the same maximum base shear value.
- In terms of ductility a difference due to the diverse ultimate deformation limit of masonry panels is noticed. In fact, 3Muri adopts code limitations for panels, neglecting their tensile behaviour, whereas 3DMacro uses an ultimate deformation limit depending on the elasto-plastic law of springs, providing a larger (about two times) ultimate displacement. However, even if this difference in terms of ultimate displacement between the programs has been noticed, they provide more or less the same ductility (equal to about 3).

- The building stiffness given by 3Muri is about twice greater than the 3DMacro one. This difference is due to the way to calculate the modal participation factor, achieved through a modal dynamic analysis by 3Muri and by means of a simplified relationship in relation to the number of floors by 3DMacro. In addition, 3Muri assumes as control node the one having as displacement the average value among displacements of the top storey nodes, while with 3DMacro the top-storey representative point can be chosen only among three points identified by the program itself. In this latter case, as a result, the top-storey barycentre displacements cannot be monitored.

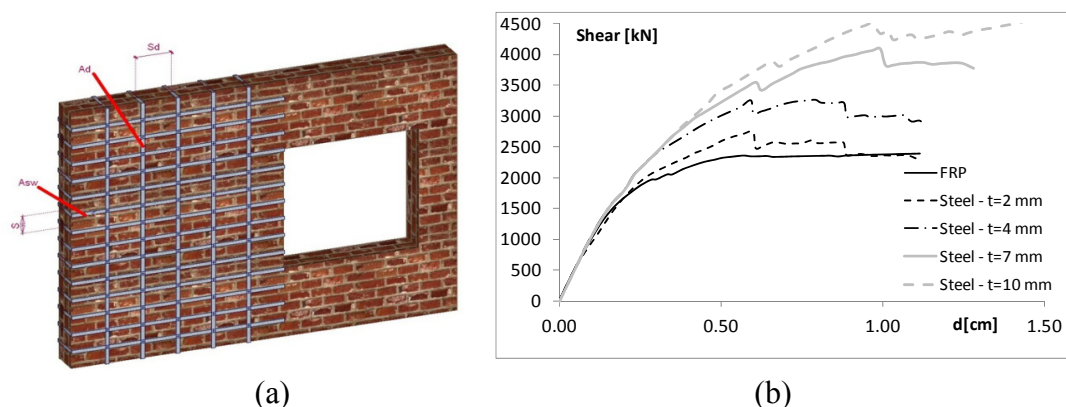
The comparison among retrofitting curves is shown in Figure 13b.

Figure 13: Retrofitting intervention with bidirectional strips (a) and comparison among building capacity curves with different reinforcing interventions (b).

The employment of these bidirectional strips has satisfied all seismic analyses, conferring to the building a better seismic performance in terms of strength and, especially, of ductility. Thereafter, in order to ensure the same invasiveness and, more or less, the same global response drawn with the use of composite materials, a further structural reinforcement intervention through bidirectional S275 steel strips, fixed to the walls by steel bars and having thickness of 0.2 cm, width of 7 cm and the same pitch of FRP strips, has been used. Subsequently, steel strip thickness has been changed from 2 mm to 10 mm in order to individuate, through a sensitivity analysis, the best thickness solution.

From the previous figure it is noticed that, even if a unique optimal solution does not appear, 7 mm thick strips represent the best intervention, they allowing to increase significantly the building base shear with respect to that achieved with FRP and with a little bit difference in terms of strength and lesser cost than 10 mm thick strips.

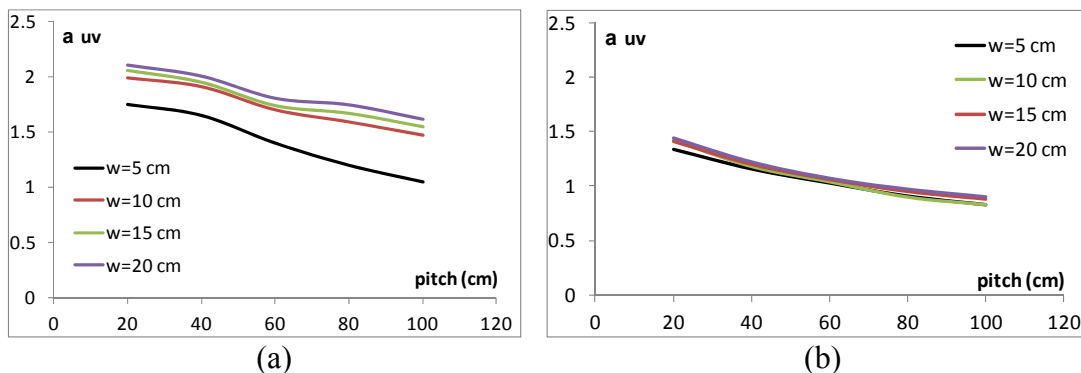
In Figure 14 the seismic risk index has been calculated for different retrofitting solutions with FRP strips. First of all, from these pictures it is apparent that all solutions provide index greater than one in direction x only, whereas in direction y some solutions do not confer to the school the capacity to sustain the design seism. Moreover, it is noticeable that in direction x the strip width increase gives an increase of seismic performance, while in direction y all considered strips provide more or less the same seismic safety grade. This is due to the greater extension of the retrofitting intervention in direction x than in direction y . Therefore, the optimal strip width is equal to 10 cm in direction x and 5 cm in direction y , since these solutions allow to achieve the maximum benefit with the lesser cost.

Figure 14: Seismic risk index vs. pitch among strips for the school retrofitted with different FRP strips in directions x (a) and y (b).
