# Recommendations for Restoration of Ancient Buildings and the Survival of a Masonry Chimney

P.B. Lourenço<sup>1</sup>

Therefore, a second aim of the paper is to present a real case study of a masonry structure with severe damage and major constraints on strengthening possibilities. The structure is a chimney from the 18<sup>th</sup> century located in the main kitchen of the Monastery of Arouca. The Monastery is located in the North of Portugal and was founded in the 10<sup>th</sup> century. In the 13<sup>th</sup> century, the monastic community embraced the feminine Cistercian rule. The compound was significantly expanded with major works in the 17<sup>th</sup> and 18<sup>th</sup> centuries.

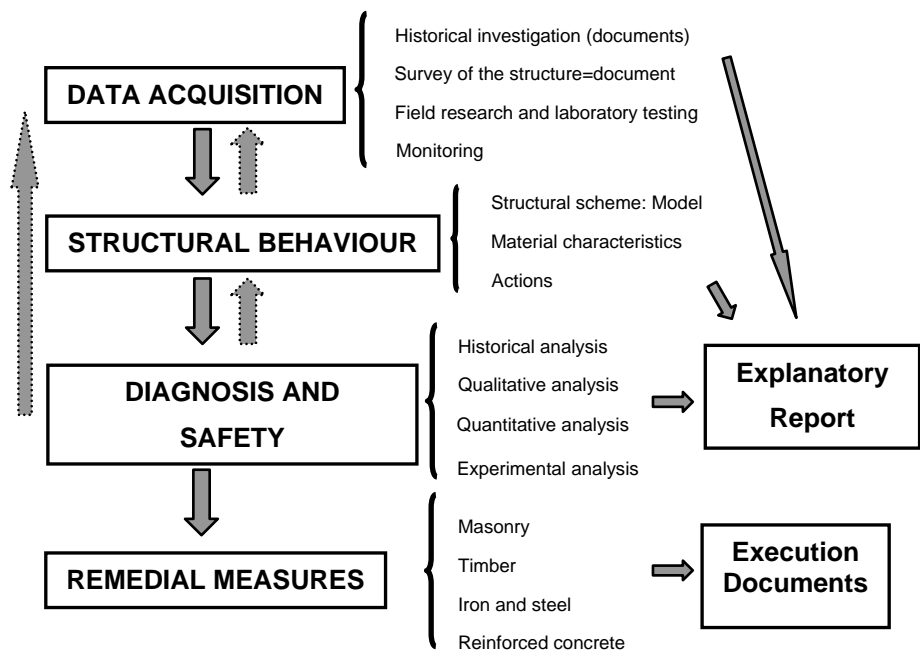
Figure 1 – Flowchart with the methodology for structural interventions proposed by ICOMOS [1]

The recommended methodology for completing a project is shown in Figure 1, where an iterative process is clearly required, between the tasks of data acquisition, structural behaviour, and diagnosis and safety. In particular, diagnosis and safety evaluation of the structure are two consecutive and related stages on the basis of which the effective need for and extent of treatment measures are determined. If these stages are performed incorrectly, the resulting decisions will be arbitrary: poor judgement may result in either conservative and therefore heavy-handed conservation measures or inadequate safety levels. Evaluation of the safety of the building should be based on both qualitative (as documentation, observation, etc.) and quantitative (as experimental, mathematical, etc.) methods that take into account the effect of the phenomena on structural behaviour. Any assessment of safety is seriously affected by the uncertainty attached to data (actions, resistance, deformations, etc.), laws, models, assumptions, etc. used in the research, and by the difficulty of representing real phenomena in a precise way.

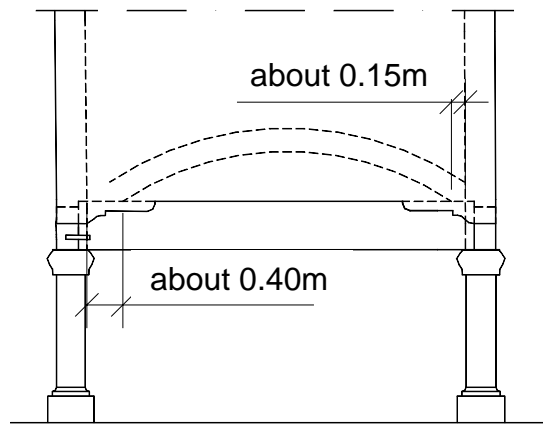
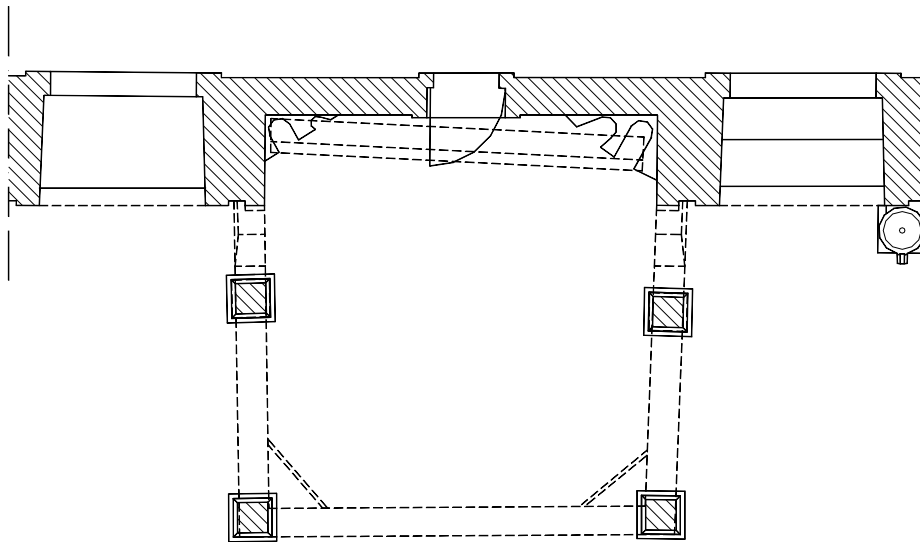
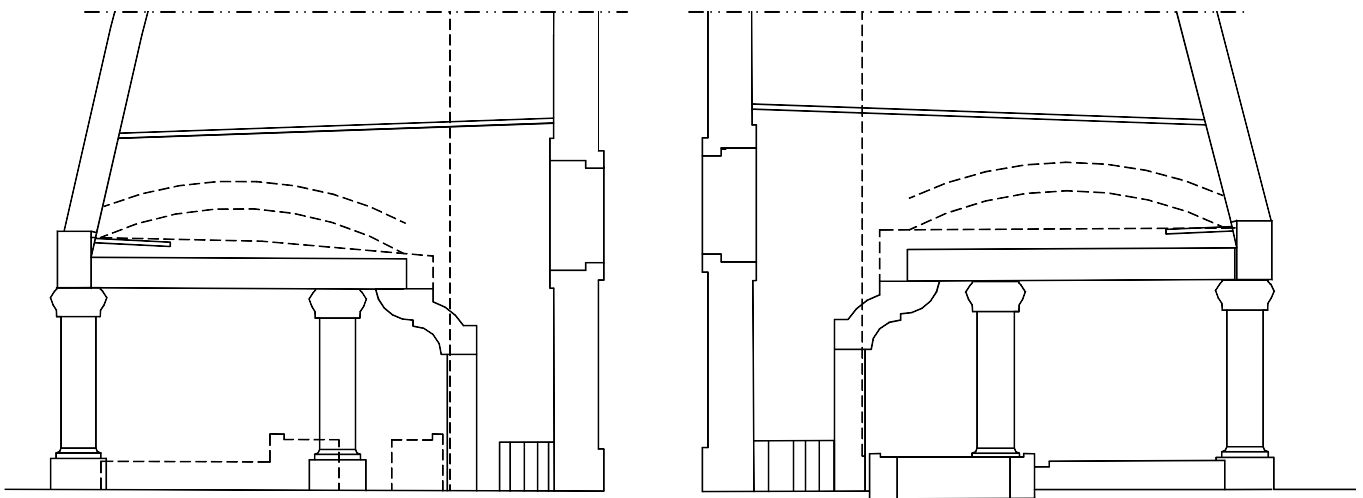
Figure 2 – Geometry of the chimney: (a) front view, (b) plan and (c) lateral views

The chimney is made of three brick masonry walls, making a tapered channel section leaning against a thick masonry wall from the Monastery envelope, supported by three stone granite lintels, see Figure 2. The maximum cross section of the chimney (at the base) is  $4.3 \times 4.1 \text{ m}^2$  and the minimum cross section of the chimney (at the top) is  $0.28 \times 3.8 \text{ m}^2$ , for a height of 16.4 m. The cross section of the side lintels is  $0.33 \times 0.46 \text{ m}^2$  and the cross section of the main lintel is  $0.31 \times 0.52 \text{ m}^2$ . The lintels are supported in stone columns and corbels. Hidden by the plaster, internal brick arches with 0.25 m thickness were found, see Figure 2a,c. The function of these elements is obvious, aiming at reducing the bending / tying load of the stone lintels by transmitting part of the load from the walls directly to the columns.

In order to uncover the hidden structure of the arches, four inspection openings were made in the plaster, see Figure 3. It could be observed that the rubble masonry fill between the arches and the lintels was not separated from the arches, as expected from good building practice. Two other defects were found, namely: (a) the main arch is asymmetrical with respect to the lintel, see Figure 2a; (b) the cross section of the left side lintel has a tapered shape, with a height reduction towards the external wall support, see Figure 2c.

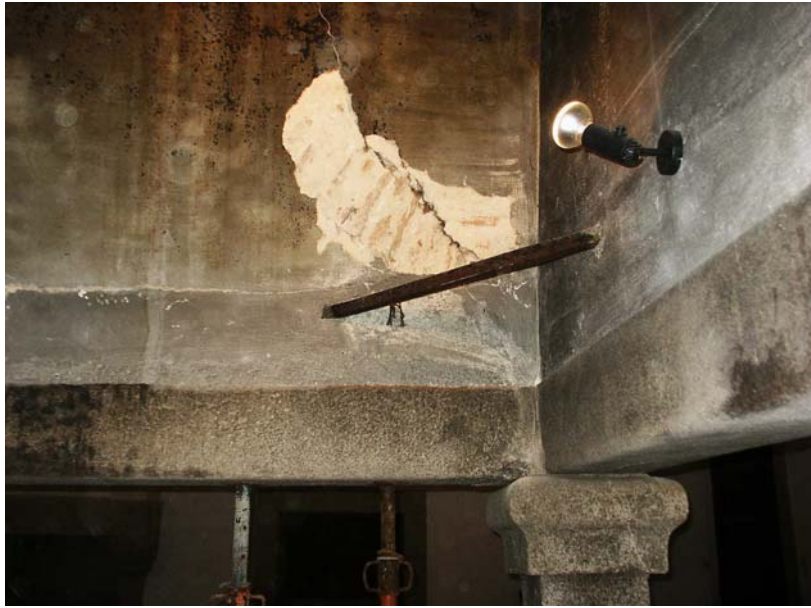
Figure 3 – Typical aspect of an inspection opening to uncover the internal arching system

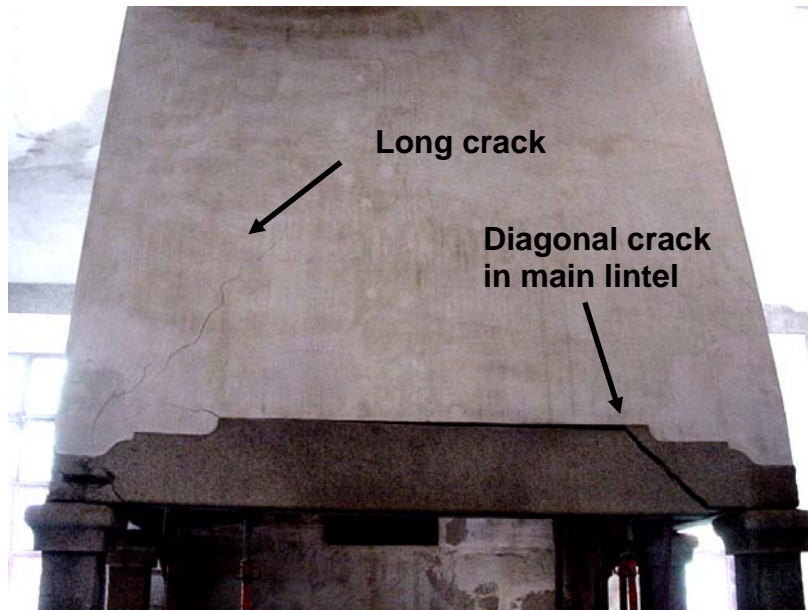
The main damage exhibited by the chimney consists of a sudden diagonal crack, which appeared suddenly in the main lintel, close to the right support, and resulted in temporary propping of the structure, see Figure 4a. This crack intercepts the anchoring zone of the  $45^\circ$  iron tie that connects the main lintel and the right lintel, which is a singular and weaker part of the lintel. It is also noted that this tie is corroded close to the

Figure 4 – Damage observed in the chimney: (a) diagonal crack in the main lintel and cracks in the upper masonry wall; (b) corrosion of the tie in the connection with the main lintel (intercepting the diagonal crack); (c) detail of the cracking and spalling of the main lintel, in the vicinity of the iron cramp; (d) crack in the left side lintel

The most relevant damage exhibited by the chimney is a diagonal crack in the main lintel, close to the right support. This crack intercepts the anchoring zone of an iron tie, which exhibits corrosion. The left support of the main lintel is also severely damaged with a long crack along the extrados of the internal arch in the wall. This pre-collapse situation is particularly dangerous as the propagation of the left crack leads to failure of the system. Besides other less severe damage, an old crack with considerable extension is also observed above the left side lintel.

The results of the structural analysis clearly indicate that the sudden collapse of the main lintel is not due exclusively for structural reasons, being probably triggered by corrosion of the tie that connects the main lintel and the right side lintel (here, it is noted that the environment is aggressive due to rising damp, salt and organic materials from the old kitchen activity). Certainly the local discontinuity associated with the hole for anchoring the iron tie also contributes to weaken the main lintel. The non-linear analysis carried out indicated that, in the most unfavourable conditions (without the internal arching action), the safety factor of the structure is 2.0 and, even then, possible collapse would occur in the side lintels and not in the main lintel.

In both solutions, the requirement that the chimney can be used for firing exceptionally is fulfilled. Also, stainless steel ties must replace the two iron ties that connect the main lintel with the side lintels, and the iron cramp applied in the left support of the main lintel must be removed. The rest of the ties along the chimney height must be depassivated, and protected against fire and corrosion. The left corner of the main stone lintel must be reconstituted and, finally, the crack in the left lintel and wall must be injected with epoxy resin and fluid lime mortar, respectively.

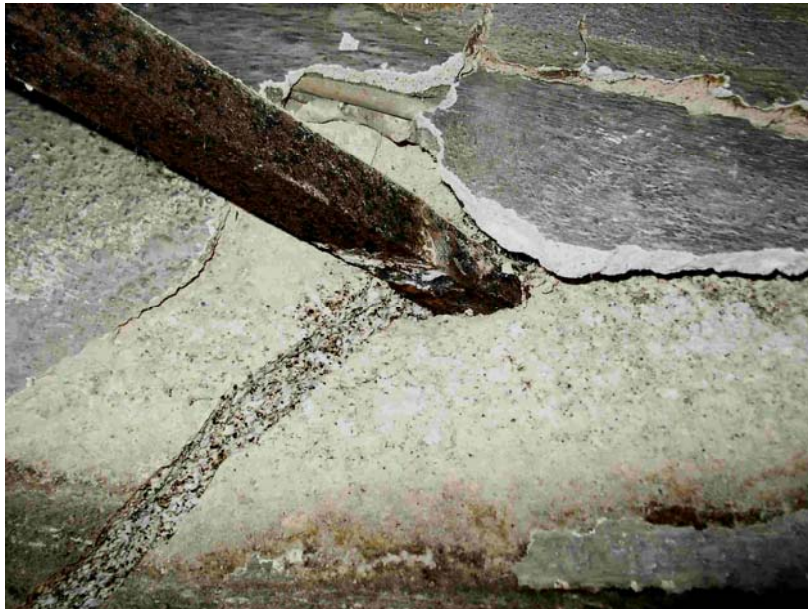
(b)

anchoring zone, see Figure 4b. The main lintel exhibits also several cracks close to the left support and in the vicinity of the iron cramp, which is severely corroded, see Figure 4c. In the masonry wall above the main lintel, a set of diagonal cracks is present, see Figure 4a. The inspection openings in the plaster indicate that the cracks do not intercept the hidden masonry arch, but they run through the arch extrados, see Figure 5a. This set of cracks represents significant danger and a pre-collapse situation of the left support, with a failure mechanism involving rotation of the wall with a hinge forming at the right support.

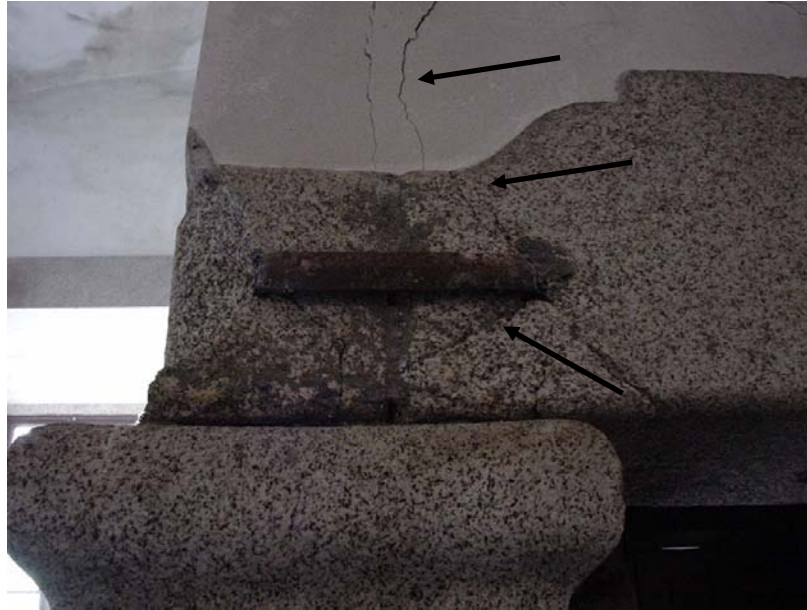
Figure 4 – Damage observed in the chimney: (a) diagonal crack in the main lintel and cracks in the upper masonry wall; (b) corrosion of the tie in the connection with the main lintel (intercepting the diagonal crack); (c) detail of the cracking and spalling of the main lintel, in the vicinity of the iron cramp; (d) crack in the left side lintel.

Finally, the cracks and damage observed in the main lintel close to the left support are due to the corrosion of the iron cramp and also to the collapse of the right support, as the rotation of the main lintel was responsible for the long crack along the extrados of the internal arch in the main wall.

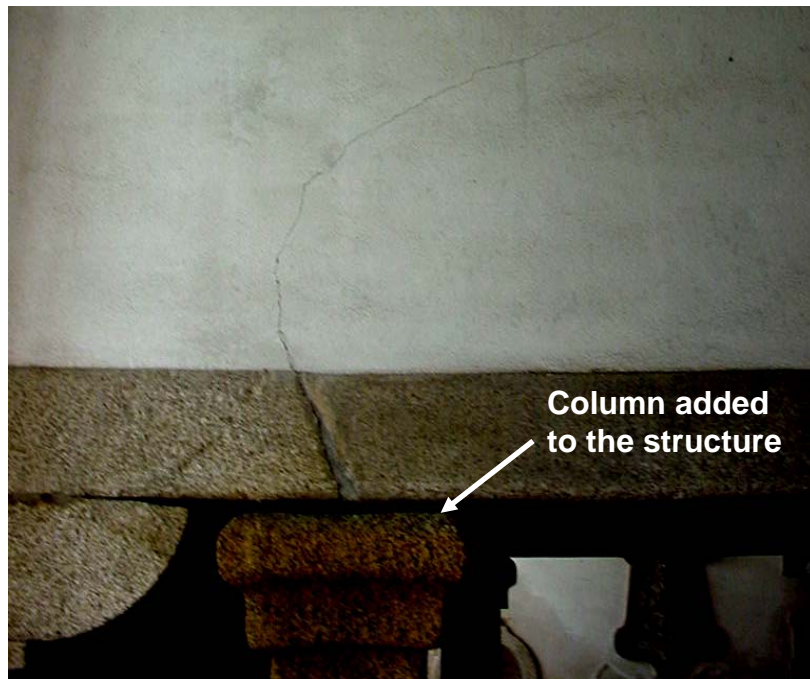
(d)

It is noted that an ancient crack is also present in the left side linter and wall, probably due to the reduction of height of the stone lintel in the corbel region, as discussed above, see Figure 4d and Figure 5b. As a result of this crack, two stone columns under each side lintel were added to the structure in an unknown date.

The structural analysis results justify the ancient damage in the left side lintel. In fact, the numerical simulation does not take into account the cross section reduction in the left side lintel (the height varies linearly from 0.46 m to 0.30 m), which would reduce the safety factor significantly. This justifies the remedial measures adopted in the past by adding new stone columns close to the back supports of the side lintels.

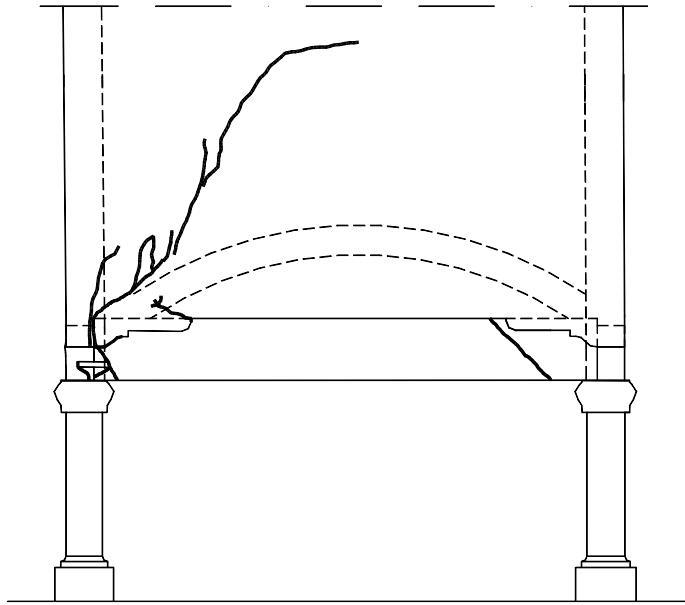
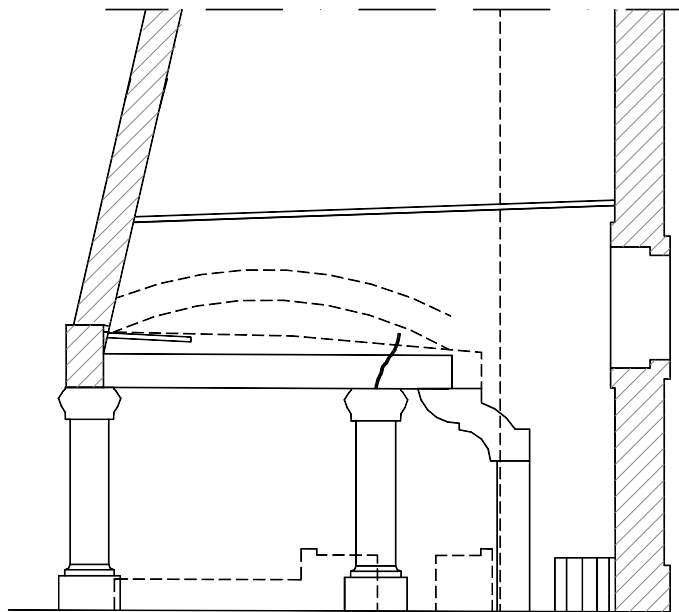
Figure 5 – Observed cracking patterns: (a) main wall and (b) left side wall

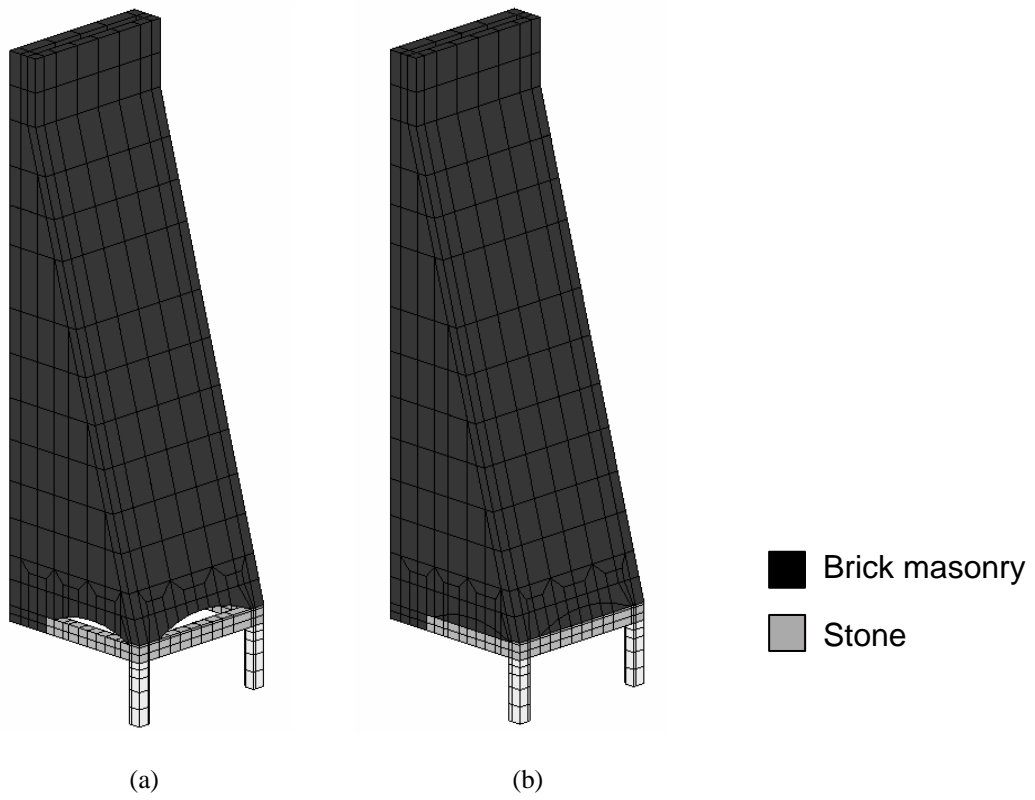
In order to complete the diagnosis and safety evaluation, two three-dimensional models of the chimney were prepared aiming at simulating extreme possibilities, which take into account the fact that there is notseparation between the arches and the material filling the space between the arches and the lintels. The two extreme possibilities regarding the arching effect in the walls are considered here. Therefore, the first model does not include the filling material under the arches (Model 1) and the second model considers that the walls are fully supported in the lintels (Model 2), see Figure 6. Obviously, Model 2 is more unfavourable for the stone lintels, being the most conservative approach.

In Model 1 the asymmetric location of the masonry arch has been considered in the simulation. The reduction of the cross section in the left side lintel was not considered, in order to reduce the complexity of the geometry, but the consequences of this simplification will be considered in the analysis of the results. The geometry of the columns was also considered constant, and equal to a square of  $0.40 \times 0.40 \text{ m}^2$ . It is shown later in the paper that the average stresses in the columns are very low and the adopted geometric simplification is negligible.

Figure 6 – Finite element model and materials adopted in the simulation: (a) Model 1 (full arching action);  
(b) Model 2 (no arching action)

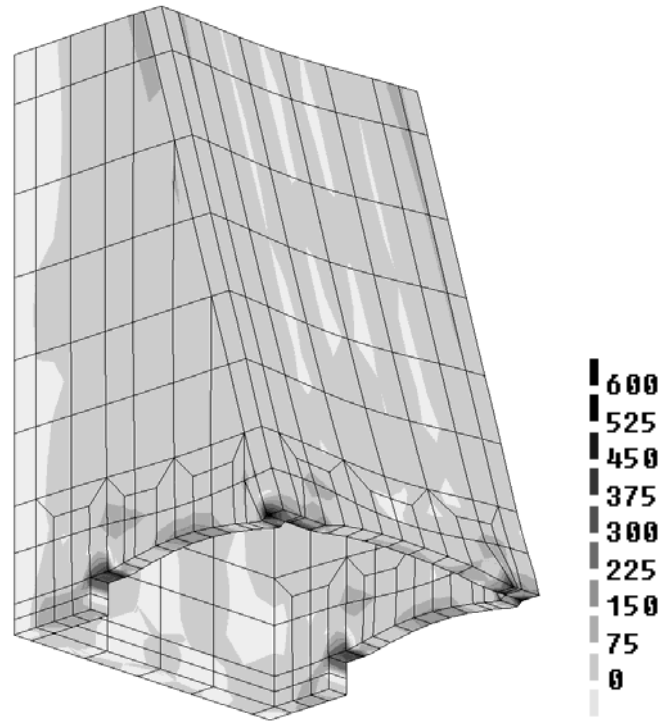
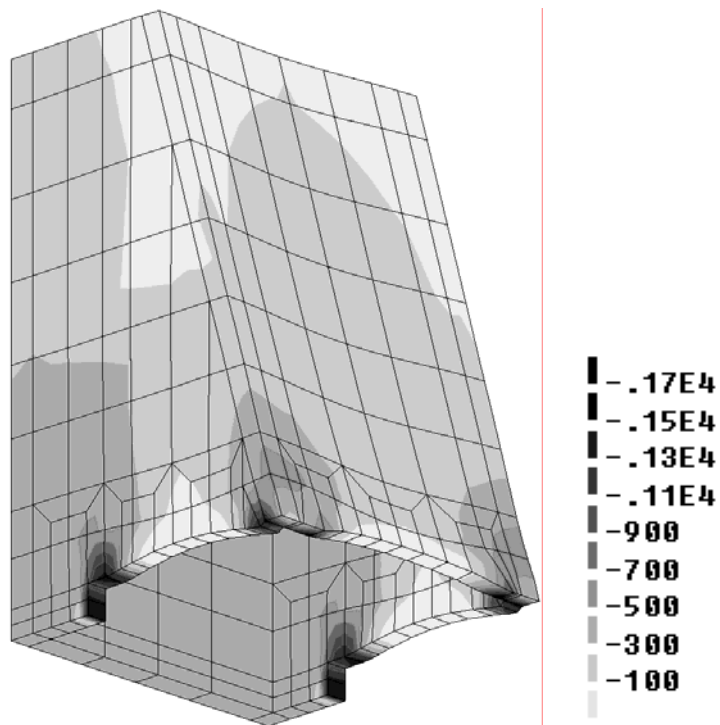
For Model 1, the elastic results in terms of maximum and minimum principal stresses are given in Figure 7 and Figure 8 for the brick masonry part of the model and the stone columns and lintels, respectively. With respect to the brick masonry, the results indicate that the maximum stresses, both in tension and

compression, occur close to the supports and key of the side arches and also in the vicinity of the support from the main arch (due to the arch asymmetry). The maximum values found, even if very localised, clearly exceed the strength assumed for the materials, with a maximum of  $0.6 \text{ N/mm}^2$  in tension (three times larger than the tensile strength) and  $1.7 \text{ N/mm}^2$  in compression (70% larger than the compressive strength). The maximum average values in the most severe locations are much lower, typically  $0.3 \text{ N/mm}^2$  for tension and  $0.9 \text{ N/mm}^2$  in compression. Figure 7b illustrates also the reduction in the compressive stresses in the span of the arches due to the arching effect of the masonry wall.

Figure 7 – Principal stresses for the brick masonry part of the model, plotted in the deformed mesh configuration (Model 1, linear elastic analysis): (a) maximum (tension) e (b) minimum (compression). Results in  $\text{N/mm}^2 \times 10^3$

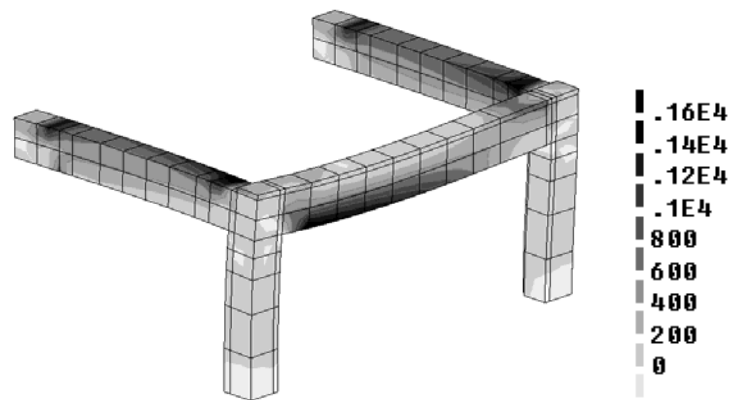
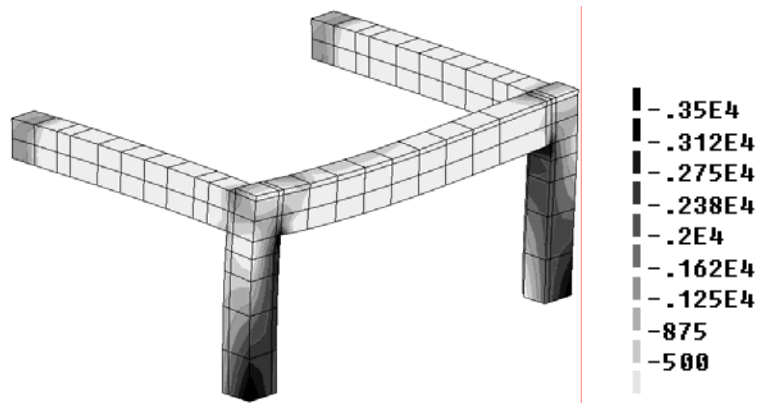
With respect to the set lintels-columns, see Figure 8, the maximum tensile stresses are found in the side lintels, close to the supports of the arches, and in the lower surface of the main lintel, being clearly higher in the left part of the lintel due to the asymmetry of the upper masonry arch. Such tensile stresses result from the bending of the lintels. Nevertheless, it is noted that the side lintels exhibit approximately uniform distributions of stresses through the thickness (uniaxial bending), whereas the main lintel exhibits a stress distribution that varies significantly through the thickness (biaxial bending), due to torsion induced by the slope of the main wall. The tensile stresses found are moderately high, but their maximum corresponds only to 80% of the tensile strength of the granite. The compressive stresses reach a value of  $3.5 \text{ N/mm}^2$  in the column-lintel connection. This value is very low, when compared to the compressive strength of the stone ( $60 \text{ N/mm}^2$ ).

Figure 8 – Principal stresses for the stone columns and lintels, plotted in the deformed mesh configuration (Model 1, linear elastic analysis): (a) maximum (tension) e (b) minimum (compression). Results in  $\text{N/mm}^2 \times 10^3$

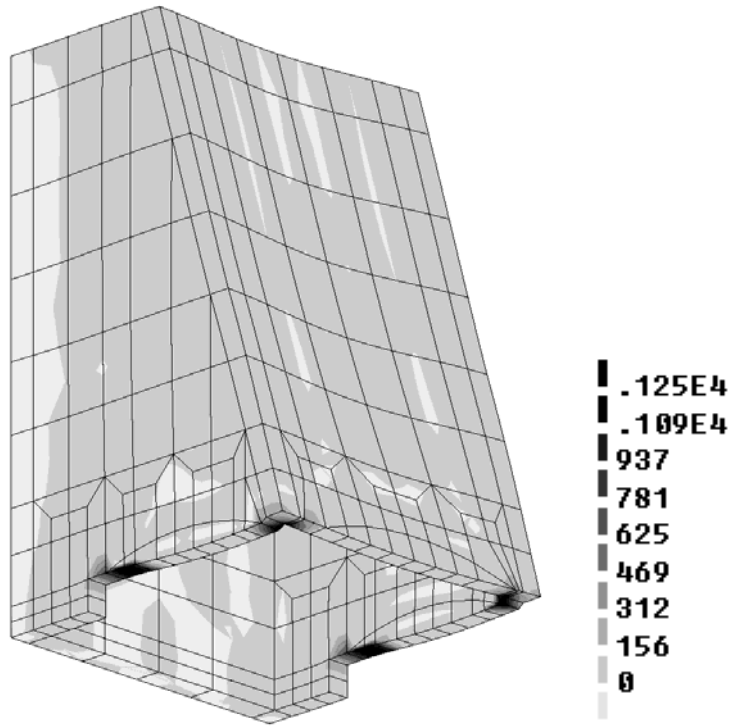
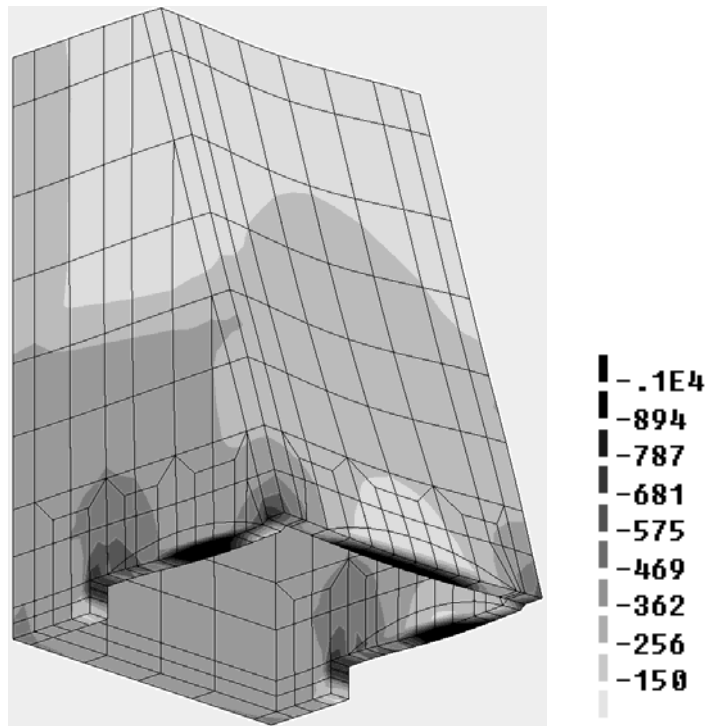
For Model 2, the elastic results in terms of maximum and minimum principal stresses are given in Figure 9 and Figure 10 for the brick masonry part of the model and the stone columns and lintels, respectively. In this case, the peak obtained for the tensile principal stresses is doubled due to the inexistence of the internal arching system. The maximum tensile principal stresses are located close to the supports of the lintels. With respect to the compressive stresses in the brick masonry part, the highest values are located above the mid-span of the lintels, where values close to the compressive masonry strength are reached. High compressive stresses are also found close to the supports.

Figure 9 – Principal stresses for the brick masonry part of the model, plotted in the deformed mesh configuration (Model 2, linear elastic analysis): (a) maximum (tension) e (b) minimum (compression). Results in  $\text{N/mm}^2 \times 10^3$

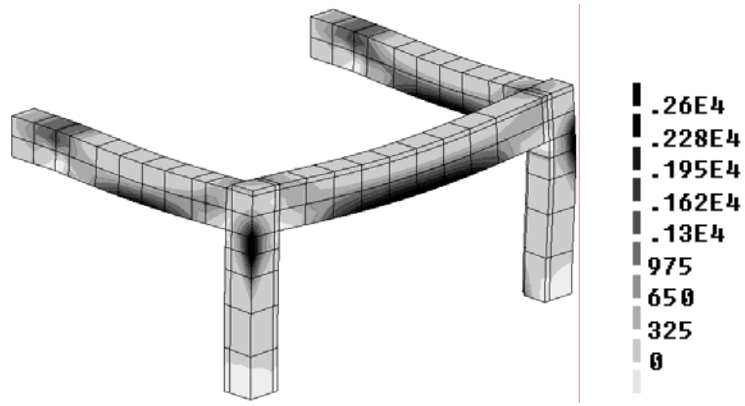
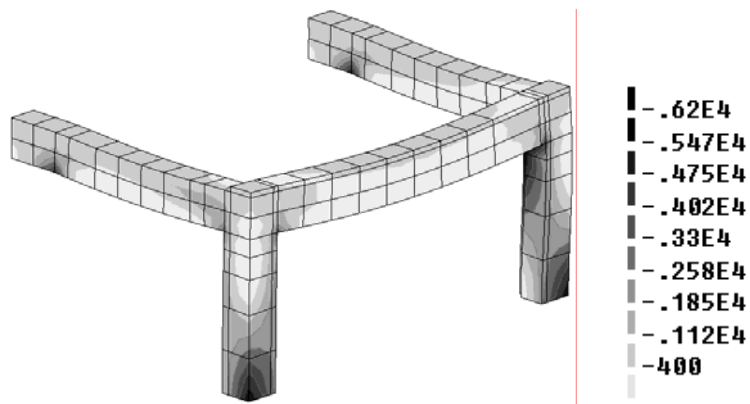
With respect to the set lintels-columns, see Figure 10, the maximum tensile stresses are found in the span of the three lintels, with peak values of  $2.6 \text{ N/mm}^2$ . High tensile stresses are also found at the back supports of the side lintels, in the connection with the external wall. The zones with higher compressive stresses are close to the supports of the lintels and at the columns base but the maximum values are localised and moderate, reaching only about  $6.2 \text{ N/mm}^2$ .

Figure 10 – Principal stresses for the stone columns and lintels, plotted in the deformed mesh configuration (Model 2, linear elastic analysis): (a) maximum (tension) e (b) minimum (compression). Results in  $\text{N/mm}^2 \times 10^3$

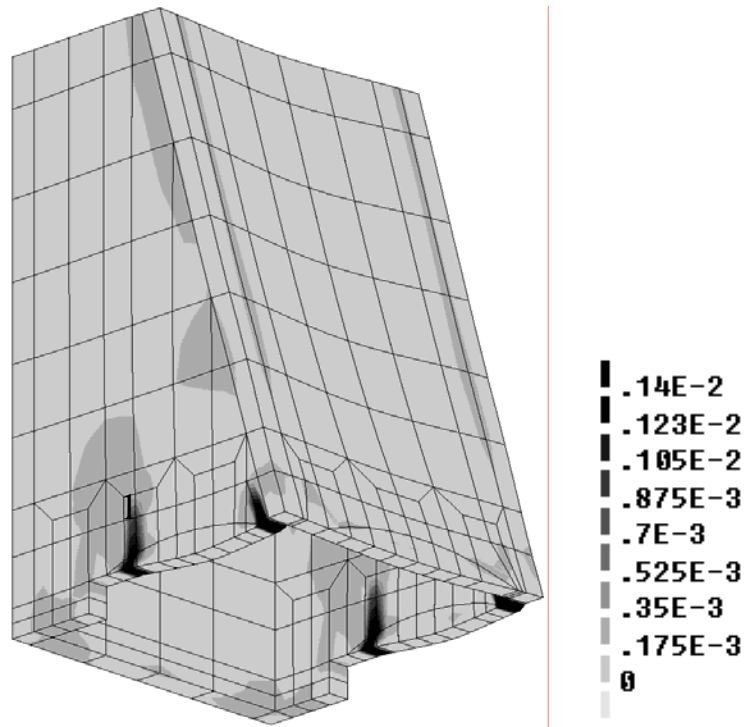
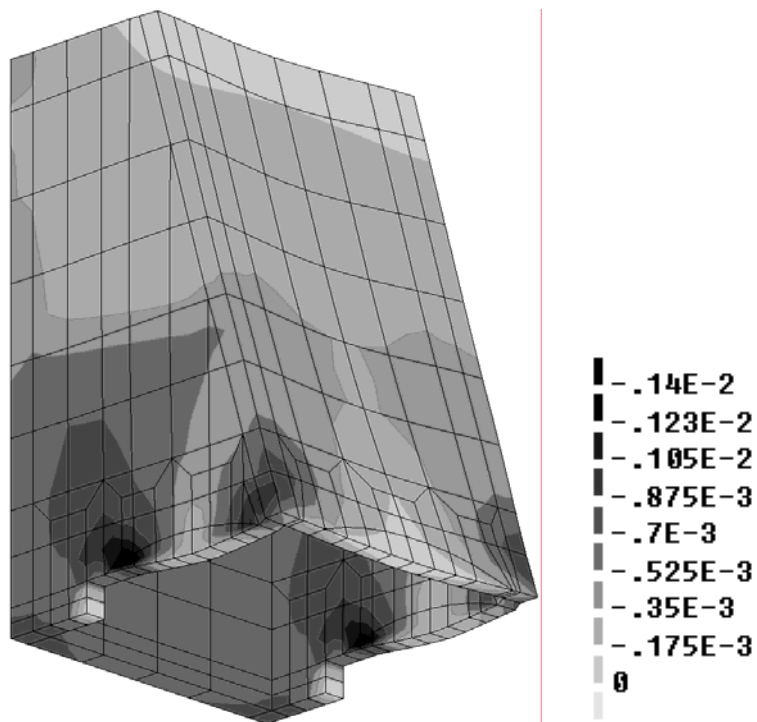
The linear elastic results indicated that the model without the internal arching system leads to the most unfavourable loading conditions, as expected. Therefore, this model has been selected for performing a non-linear analysis up to the collapse of the structure. The non-linear system of equations following from the finite element discretization was solved with an incremental-iterative globally convergent Newton-Raphson method with arc-length control and line-search technique [11]. Structural collapse was found for a load factor of 2.04, where the load factor represents the ratio between the applied loads and the original reference loads detailed in Section 4.2. For the ultimate load factor, the most damaged zones in the masonry walls occur close to the supports of the side lintels, see Figure 11. This damage occurs mostly in tension. Figure 12 illustrates the damage (measured by the maximum principal strains) for the lintels-columns set, which clearly defines the collapse mechanism. Three plastic hinges appeared in the side lintels, one hinge at mid-span with cracking at the lower face of the lintels (positive bending moments), and two hinges at the supports with cracking at the upper face of the lintels (negative bending moments). Figure 13 shows the force-displacement diagram for the mid-span of the side lintels, where the non-linear behaviour is clearly visible. The global response is approximately linear until a load factor of 1.0. Afterwards, a progressive non-linear response dominates until collapse, followed by a descending branch (softening regime) captured only with a reduction of the applied load. Obviously, in a real physical situation a load reduction would be impossible and the chimney would just collapse in an uncontrolled manner.

Figure 11 – Principal strains for the brick masonry part of the model, plotted in the deformed mesh configuration (Model 2, non-linear analysis and a load factor of 2.0): (a) maximum (tension) e (b) minimum (compression). Results are dimensionless

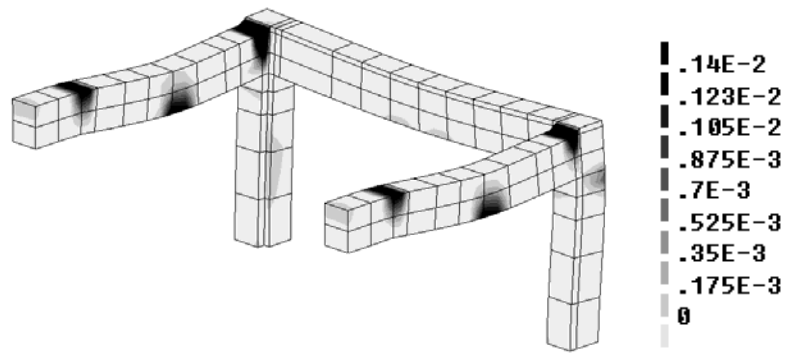
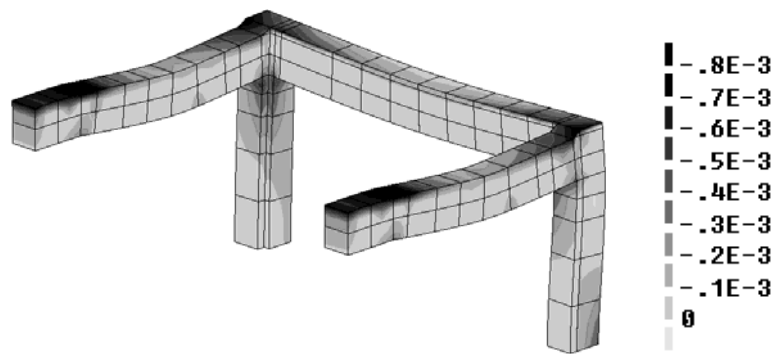
Figure 12 – Principal strains for the stone columns and lintels, plotted in the deformed mesh configuration (Model 2, non-linear analysis and a load factor of 2.0): (a) maximum (tension) e (b) minimum (compression). Results are dimensionless

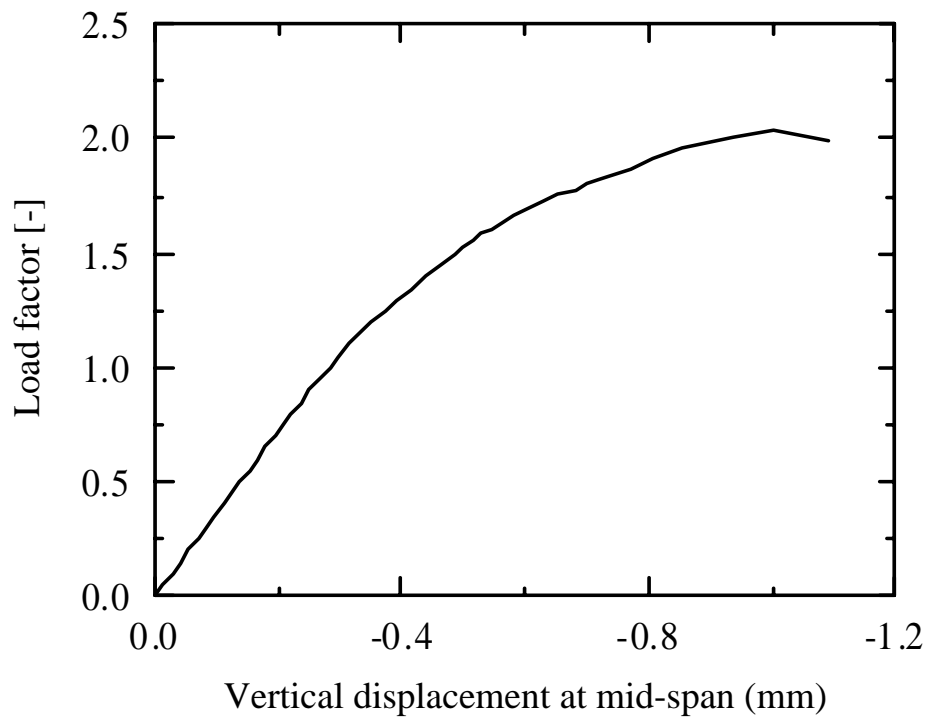
Figure 13 – Force-displacement diagram for the non-linear analysis (internal arching system not considered).

The vertical displacement is measured at the mid-span of a side lintel

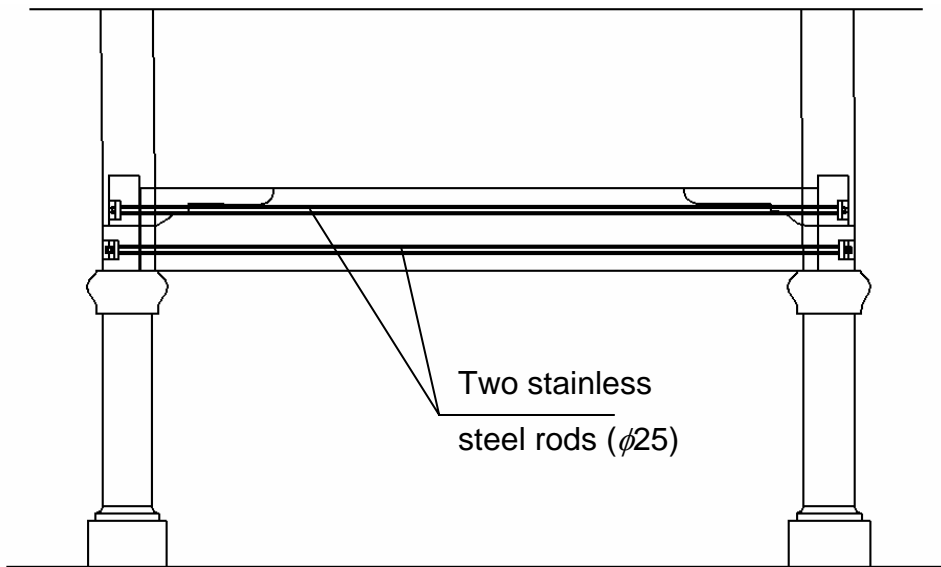
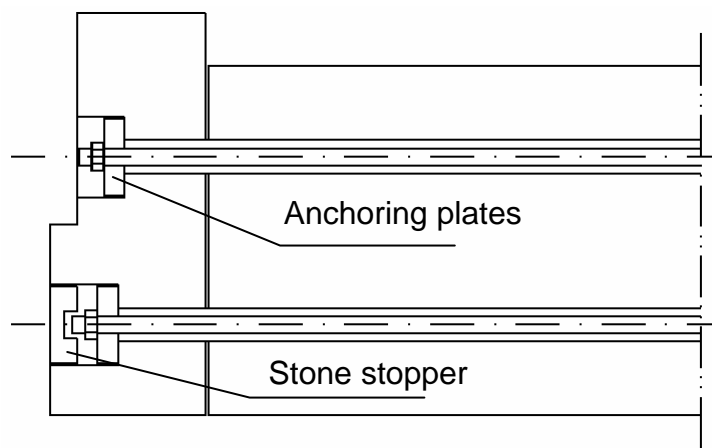
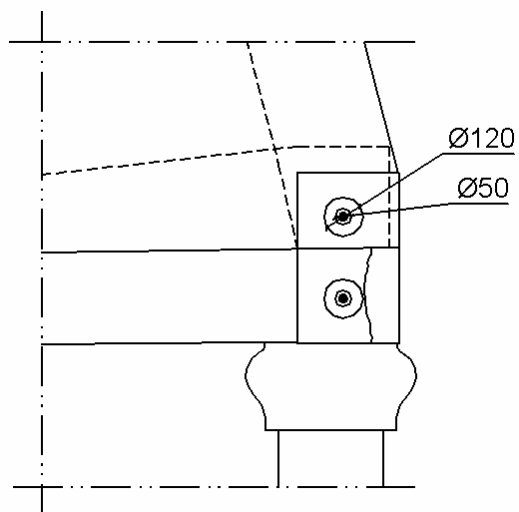
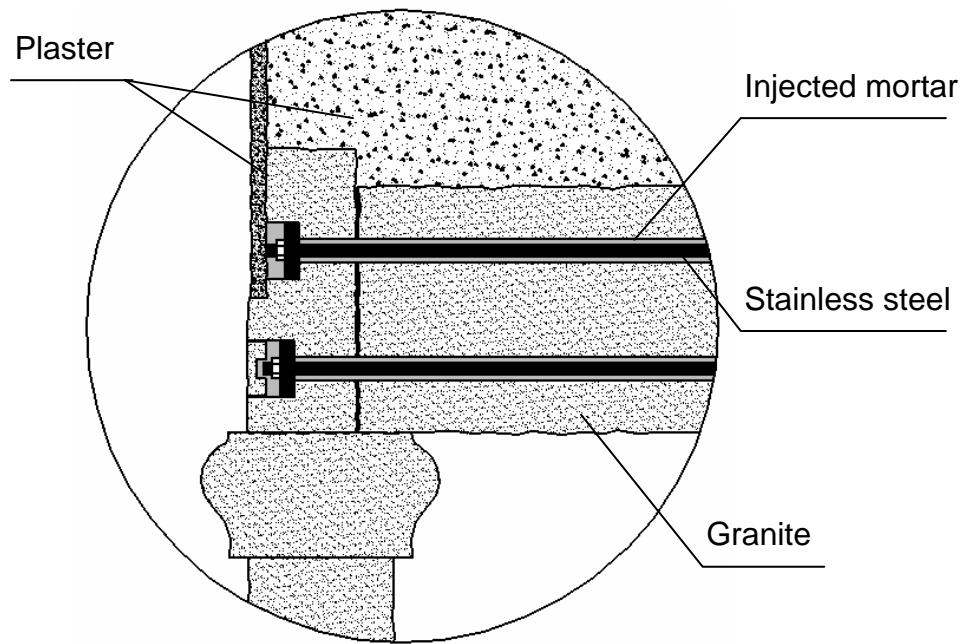
Figure 14 – Strengthening design: (a) front view; (b) detail of anchoring zone; (c) side view; (d) final aspect

Taking into consideration the above constraints and the absolute need of repairing the structure, two possible repair solutions have been proposed. The first solution consists of strengthening and repairing the main lintel including: (a) reconstitution of the original stone integrity by injection of epoxy resins; (b) hole drilling of the stone along its full length (4.70 m); (c) insertion of bars and injection of the hole. The second solution consists of replacing the original lintel by a new stone lintel, including: (a) propping of the complete chimney; (b) lifting the main wall with auxiliary centring of the internal arch; (c) replacement of the original stone by a new one, selected according to mechanical requirements and original granite lithotype.

Taking into account the historical significance of the old lintel, the risk involved in the second solution of replacement and the preliminary cost estimates (the second solution is around 1.5 to 2.0 times more expensive), the solution of strengthening the original lintel with internal ties was adopted. Figure 14 illustrates various details of the solution, which includes two stainless steel rods with a diameter of 25 mm as internal ties / reinforcement of the granite lintel. The ties were designed after the integration of the tensile stresses of the linear elastic results for the numerical model without arching action, which is conservative. These rods are inserted in drilled holes of 50 mm and are provided with anchoring plates of 120 mm. After adjustment of the bolts, the drilled holes are injected with fluid lime mortar (Albaria Iniezione 200). Stone stoppers at both ends of the bottom tie are also included so that the anchoring plates are not visible. The stoppers are glued with epoxy resin and are made from the actual core removed from the lintel, after cutting. For the top tie, this operation is not needed because the surface finishing is plaster. It is noted that the usage of stone stoppers in both ends of the ties requires the drilling to be executed from both sides, which requires precision and qualified workers.

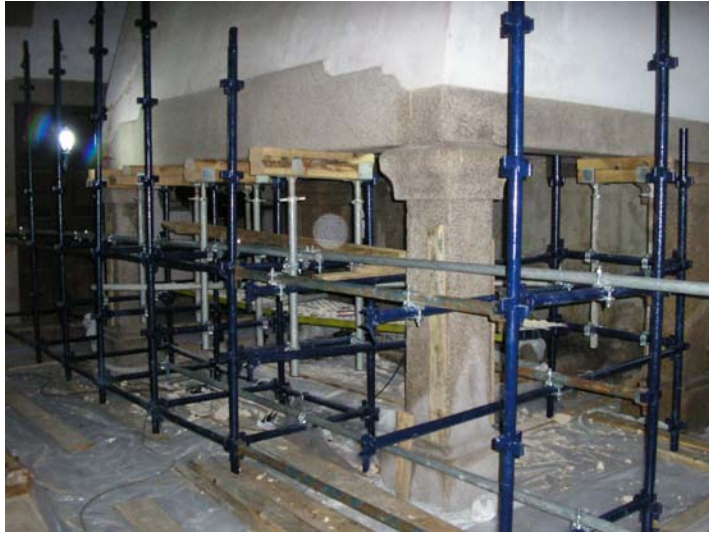
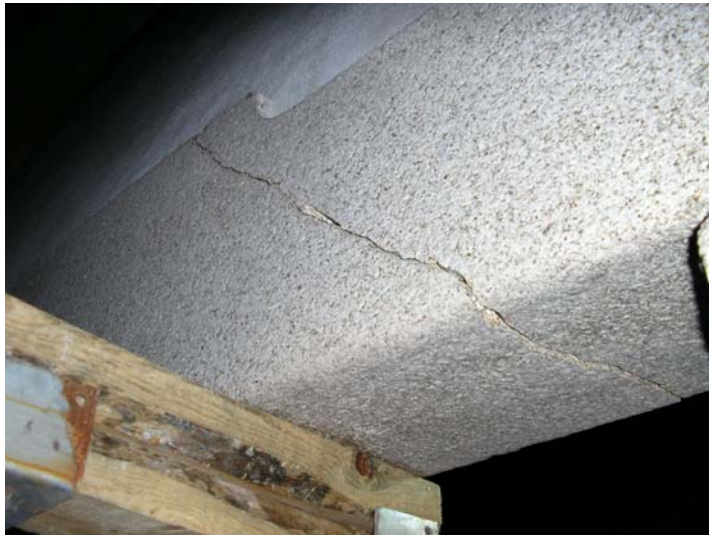
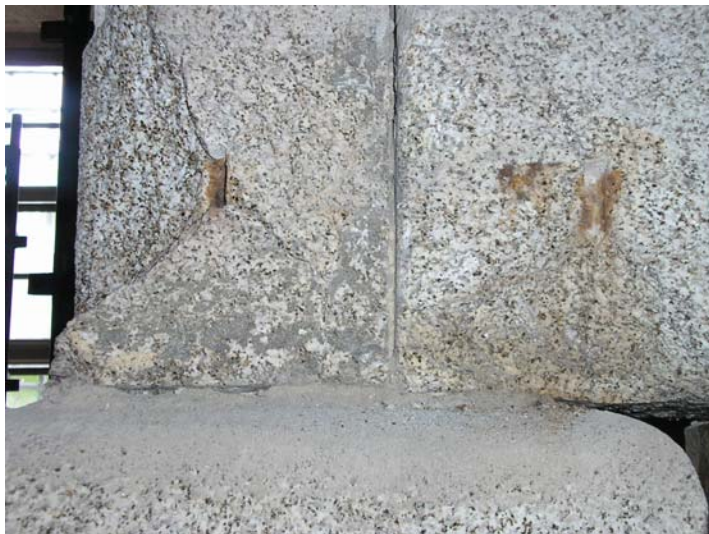
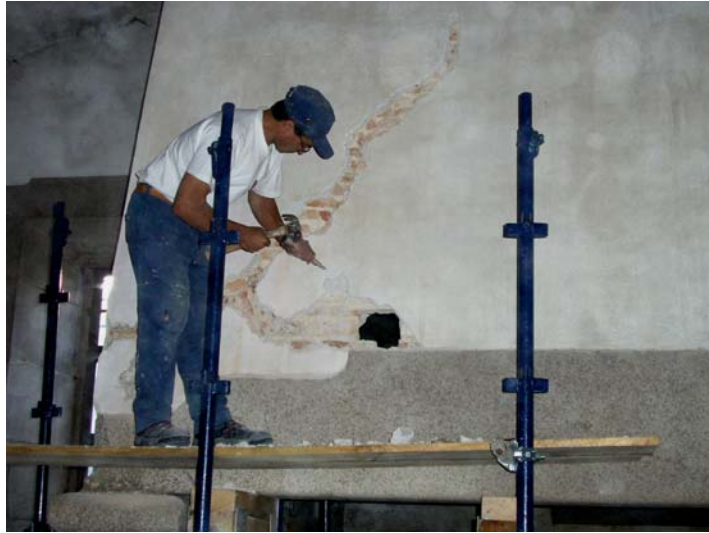
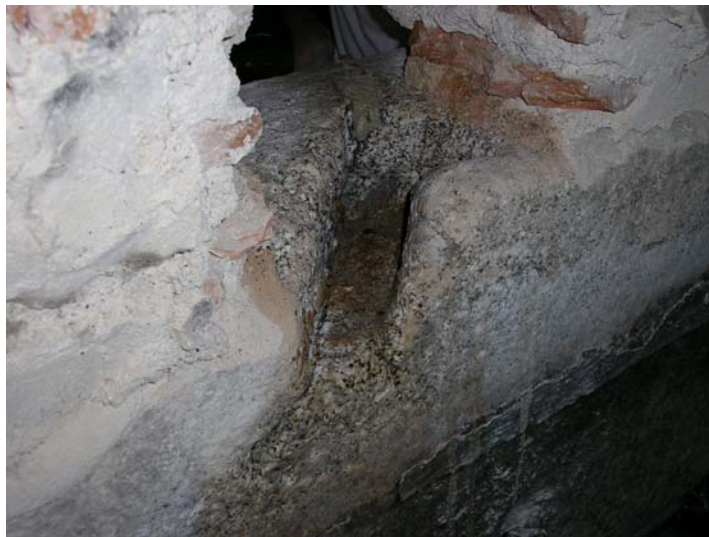
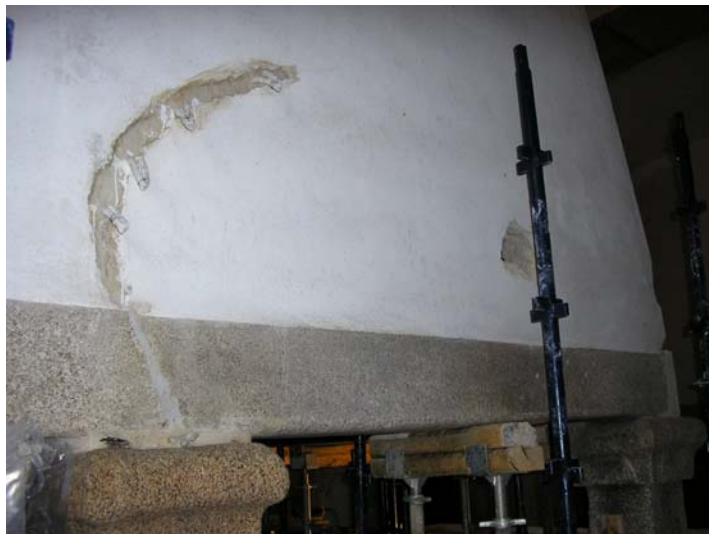
Figure 15 – Aspects of the works carried out in the chimney: (a) temporary propping of the chimney; (b) lifting of the main lintel; (c) detail of the damage left support after removal of the iron clamp; (d) removal of plaster in the main wall for masonry crack injection with fluid lime mortar; (e) detail of the original reduction in the cross section of the main lintel for anchoring the removed iron ties; (f) aspect of the left side lintel after injection of the stone lintel (epoxy resin) and masonry wall (fluid lime mortar); (g) aspect of the holes drilled for the ties and for the anchoring plates; (h) aspects of the steel anchoring plates, bolts and injection tubes; (i) aspect of the stainless steel replacing tie; (j) final aspect of the chimney after the remedial works

The full list of works carried out included the followings: (a) temporary propping of the three lintels, with adjustable propping in the main lintel; (b) lifting of the main lintel back to its original position; (c) removal of the light projectors inside the chimney, respective cabling and the iron cramp; (d) injection of the supports

provided by the capitals of the stone columns, with fluid lime mortar; (e) injection of the cracks in the stone lintels with epoxy resin and injection of the brick masonry cracks with fluid lime mortar; (f) replacement of the iron corner ties with stainless steel ones (AISI 316); (g) insertion of stainless steel ties inside the main stone lintel; (h) reconstitution of the stone corner in the left lintel; (i) anti-corrosion and fire protection treatment of the iron ties; (f) plastering of the missing or damaged rendering with lime mortar; (g) full painting of the chimney from the exterior with traditional limewash. Figure 15 illustrates the main aspects related to the complete remedial measures and the final aspect of the chimney.
