Shear testing of stack bonded masonry

P.B. Lourenço^{1†}, J.O. Barros² and J.T. Oliveira³

Stack bonded masonry is scarcely used in practice, except for aesthetic reasons. Nevertheless, a regular array of units allows to place reinforcement in the joints, which can be of major importance for masonry shell roofs, as proposed by Eladio Dieste. In order to contribute to the knowledge of the behavior of stack bonded masonry under shear loading, which seems not to have been addressed before, an experimental research program using the triplet test was carried out. The specimens incorporate aligned joints along two orthogonal axes, filled with micro-concrete. The main results of the experimental program are herein presented and discussed.

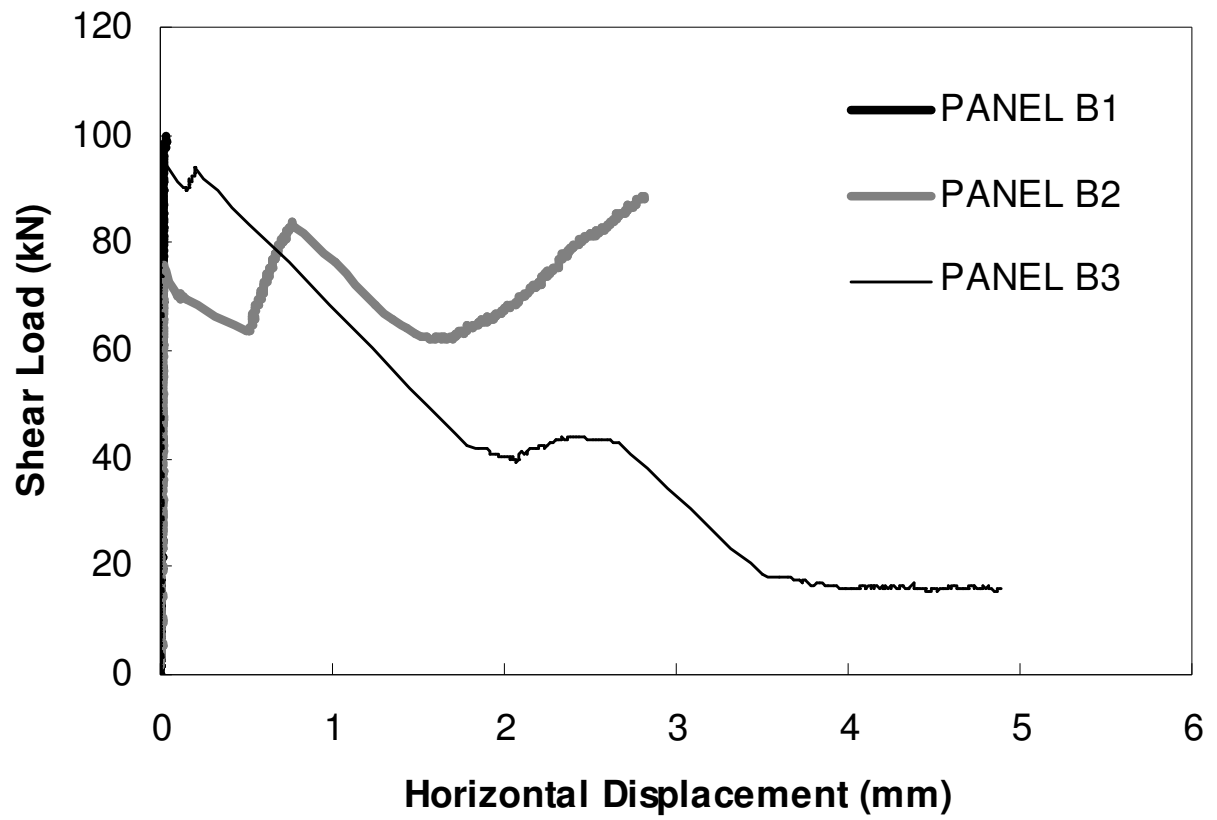
Figure 5 – Experimental results for series 1, in terms of: (a) shear load vs. horizontal displacement; (b) relation between the horizontal displacements of the top and bottom joints

Figure 5a shows the relation between the shear load and the horizontal displacement at the joints for series 1. Here, the horizontal displacement represents an average of the measurements recorded using LVDTs 1-4 (the average of LVDTs 1-3 measurements was averaged with the measurement recorded in LVDT 4), placed on the horizontal direction. Figure 5b illustrates the relation between the horizontal displacements of the two horizontal joints. Here, the bottom joint value is the average of the recordings from LVDTs 1-3 and the top joint value is the recording of LVDT 4.

in Figure 5b, where the vertical line for panel B2 indicates that no average horizontal displacement in the bottom joint could be recorded. This also indicates that the use of an average horizontal displacement in Figure 5a is debatable, for this particular panel.

The results for Panel B3 in terms of force-displacement diagram are coherent and follow the expected pattern. The residual plateau found in the response is associated with the friction of the joint. Nevertheless, a sudden increase of strength is observed at an average displacement of 2.0mm. This corresponds to the sudden jump in the diagram of Figure 5b. It is believed that the different displacements in the top and bottom joint are related to interlocking associated with the gravel size and to movements in the lateral supports. This clearly demonstrates the complexity of the phenomena involved in the failure of the triplet test.

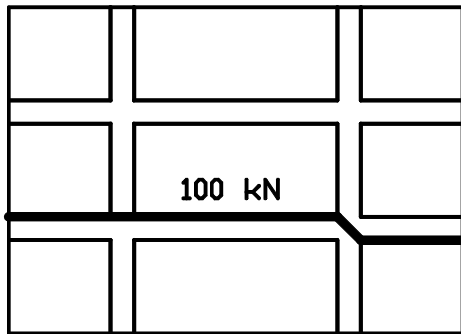
Figure 6 – Failure mode of the panels for series 1: (a) Panel 1; (b) Panel 2; (c) Panel 3.

Finally, Figure 6 presents the failure mode of the panels. It is noted that the variation of the recordings amongst LVDTs 1-3, located at the bottom joint, is usually minimal for all specimens. The sole exception is the case of complex failure modes that include head joints or diagonal cracks through the units, e.g. Panel B2.

Panel B1 collapse exhibits a stepped crack at the bottom joint and minor diffused cracked at the top joint. This indicates a probable displacement at the right top support that lead to minor sliding of the top joint. The collapse load of this test was similar to the other two tests, which indicates that both joints effectively slide.

Finally, the failure modes illustrated in Figure 6 show a clear trend for the occurrence of stepped crack in the right side of the joints, in the intersection of horizontal and vertical joints. It is believed that this stepped crack is due to the triplet test set-up, which is known to induce rotation of the principal stresses in the joint near the left and right edges.

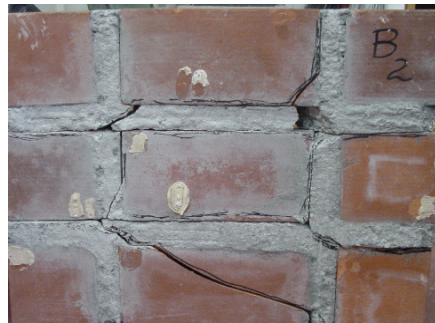
Figure 6 – Failure mode of the panels for series 1: (a) Panel 1; (b) Panel 2; (c) Panel 3.

In panel B2, the cracks deviated from the horizontal joints and progressed through the units and head joints. This can be due to the presence of firing cracks in the joints and deficiently filled head joints. The existence of gravel in the crossed joint can also preclude the crack propagation along the interface. This peculiar shape of collapse is stressed

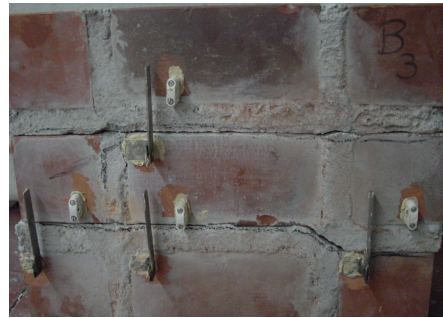
Figure 6 – Failure mode of the panels for series 1: (a) Panel 1; (b) Panel 2; (c) Panel 3.

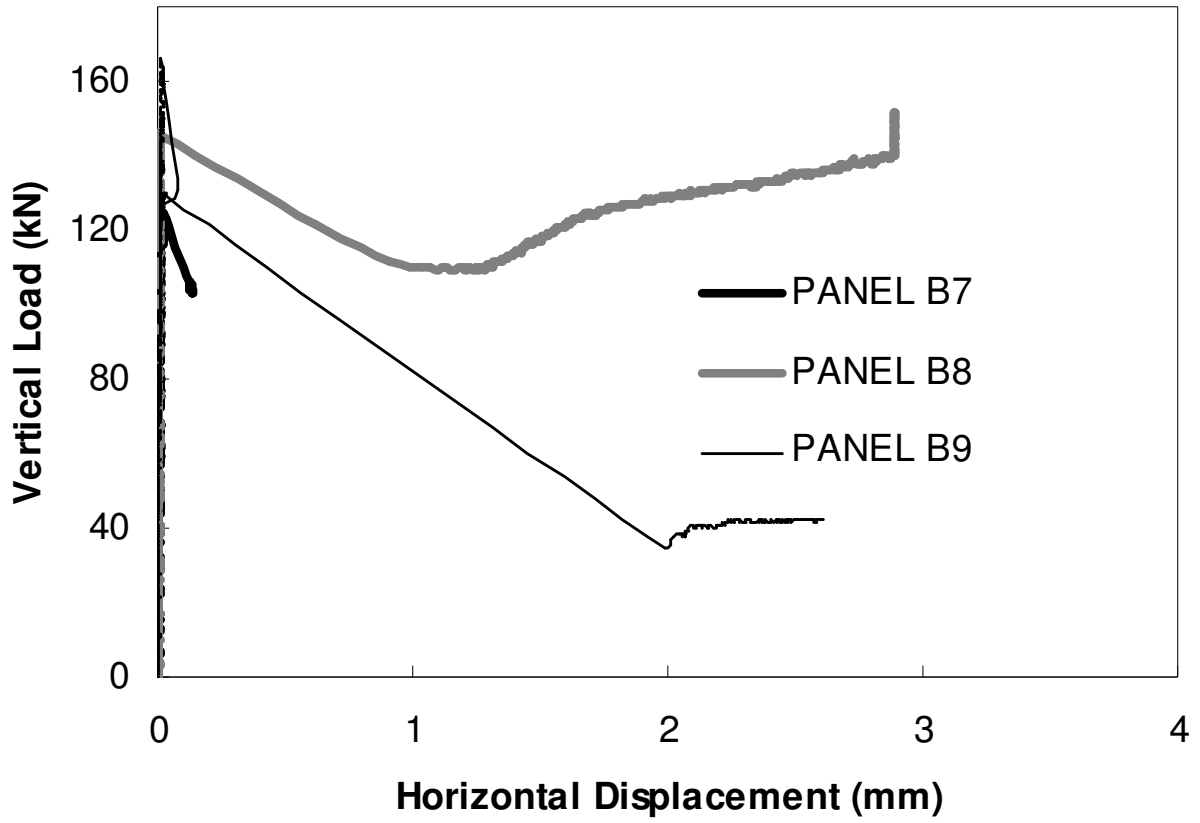
Figure 8 – Experimental results for series 3, in terms of: (a) shear load vs. horizontal displacement; (b) relation between the horizontal displacements of the top and bottom joints

Figure 8a shows the relation between the shear load and the horizontal displacement at the joints for series 3. Due to the higher pre-compression level, again the maximum shear load was increased. Figure 8b illustrates the relation between the horizontal displacements of the two horizontal joints.

The post-peak response of panel B7 could not be recorded but the post-peak response of panels B8 and B9 could be recorded until termination of the test. Panel B7 exhibited a full crack of the bottom joint at a load of 120kN. This crack resulted in a rigid body rotation between the top and bottom part. Panel B8 and Panel B9 exhibited different load-displacement diagrams. The response of Panel B9 follows the expected pattern whereas a very ductile response was found for Panel B8. The first crack occurred in the top joint, as it can be seen in Figure 8b.

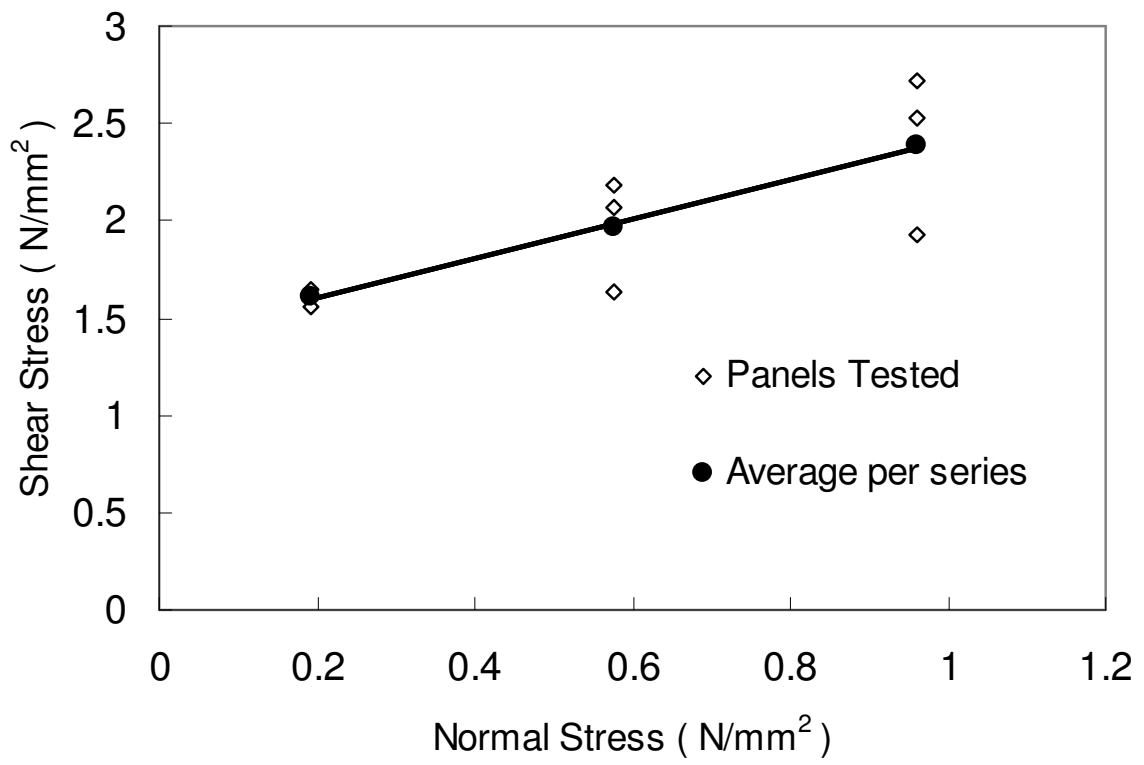
Figure 9 – Relation between shear strength and normal stress

Figure 9 shows the relation between the normal stress and the shear strength for all tests, as well as a linear regression carried out with the shear strength average for each series of tests. The correlation coefficient r^2 of the linear regression is 0.997, which indicates an excellent correlation.

The linear regression indicates a cohesion value c equal to 1.39 N/mm^2 and a tangent of the friction $\tan\phi$ equal to 1.03, see eq. (1). In standard masonry, the value of the tangent of friction angle seems to range between 0.7 and 1.2, according to different combinations of units and mortars [3]. The value obtained can therefore be considered acceptable. It is also stressed that according to the European Norm EN1052-4 [11], the characteristic value of the initial shear strength or cohesion is only 80% of the experimental value, or 1.11 N/mm^2 in this case.
