Structural analysis of two King-post timber trusses. Non-destructive evaluation and load-carrying tests

Jorge M. Branco, Maurizio Piazza and Paulo J.S. Cruz

August 11, 2009

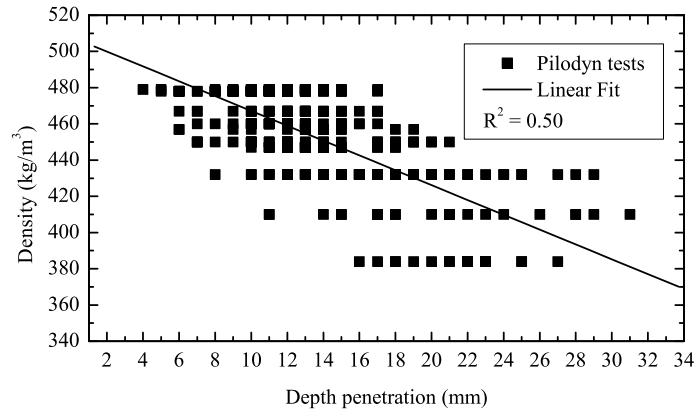
Figure 4: Correlation between depth penetration obtained with Pilodyn[®] and density

elements that compose both trusses, in each section used for the geometric assessment, the penetration depth obtained through the Pilodyn[®] in the 4 faces was measured, in a total of 548 tests. Table 6, presents the average values of the depth penetration measured for each element of both trusses. A linear correlation between density and depth penetration seems adequate to represent the test results, despite the lower coefficient of determination $R^2 = 0.50$ (Figure 4).

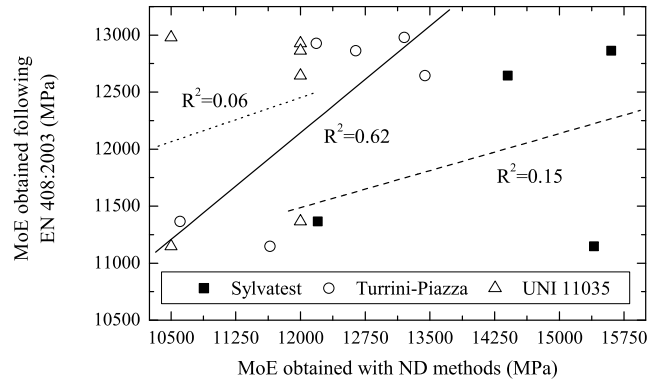
Figure 5: Correlation between MoE values given by non-destructive methods and found through mechanical evaluation according EN408 (2003).

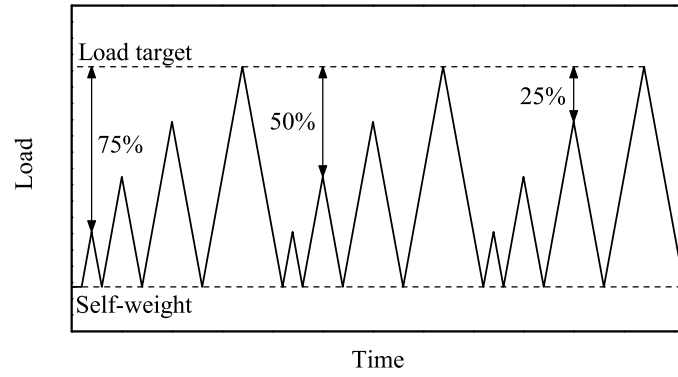
Figure 6: Load procedure applied in the load-carrying tests.

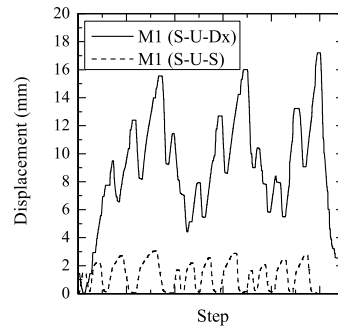
(a) Global displacement

(b) M1 displacement

Figure 11: Asymmetric behaviour emphasised under non-symmetric loading of *Truss 1* during S-U-Dx test.

Under non-symmetric loading conditions, the asymmetric behaviour of the trusses, already pointed out, is emphasised. Channels A6 and A7 show non-symmetric displacement and the horizontal movement in the bottom of the king post, recorded by channel M1, is largely higher than under symmetric loading, Figure 11. This asymmetric behaviour of the trusses introduces bending stress in the rafters and tie beam. Due to the rotational stiffness of the king post-tie beam connection, the asymmetric response of the overall truss induces distortion in the tie beam (Figure 12). This distortion induces important bending stresses

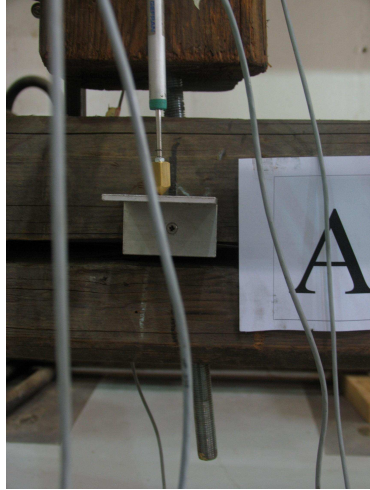
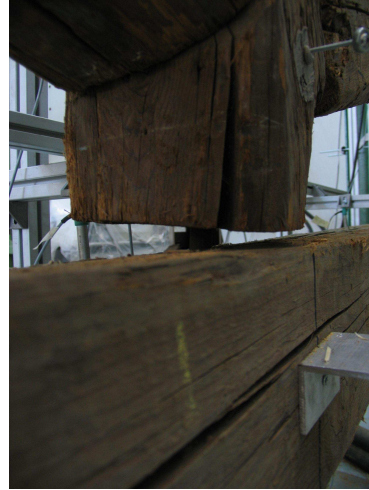
(a) In the plane truss

(b) In the normal plane of the truss

Figure 13: Bending of the steel rod inserted in the tie connection.

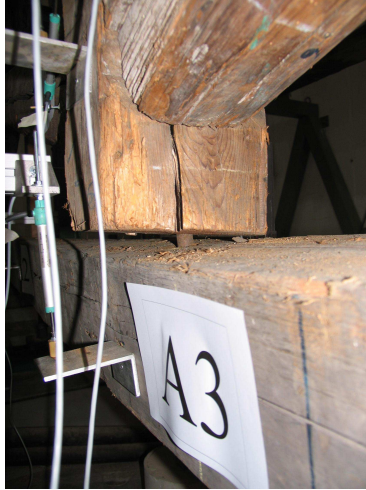
Figure 14: Out-of-plane movement observed in the *Truss 1* (unstrengthened) under ULS at the end of 1st cycle.

Strengthening of *Truss 1* aimed essentially at repairing the out-of-plane movement observed and preventing this instability, allowing tests corresponding to the ULS. The out-of-plane deformations were removed and a UPN profile was bolted to the king post. The objective was to prevent the out-of-plane movements, increasing the stiffness of the connection in this direction, keeping the tie beam suspended to the king post (Figure 15a). The timber elements did not present any local failure or damage. However, the connections between the rafters and the tie-beam were weakened, particularly the left connection, over the support with horizontal displacement. The depth of the step was insufficient and the timber in the notch front showed some fissures. Therefore, this part of the tie beam (beyond the step) was strengthened with screws (12 screws M6-200) in order to increase its shear resistance. Moreover, using the pre-existing holes, an internal bolt of 20 mm diameter was introduced at mid joint, normal to the rafter in each rafter-tie beam connection (Figure 15b). Similar bolts existed in those connections before the dismantling of the trusses.

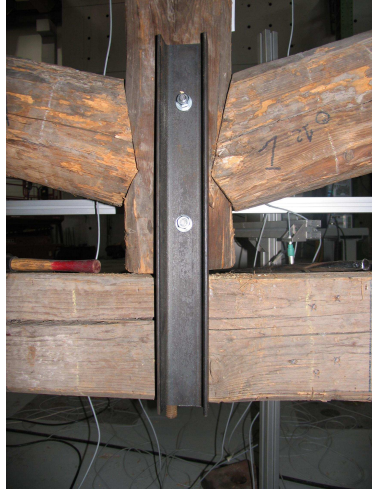
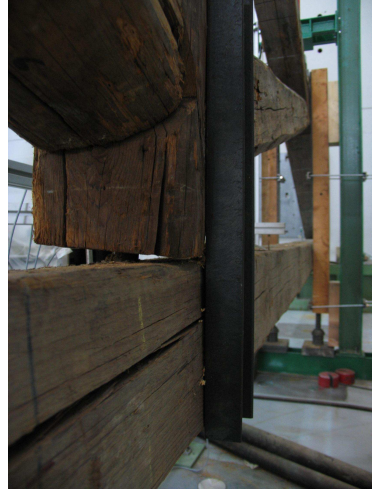
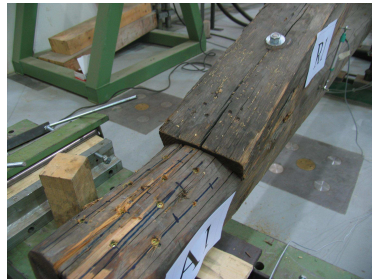
(a) UPN profile preventing the out-of-plane movements in the king post-tie beam connection

(b) Screws and internal bolt to strength the rafter-tie beam connections

Figure 15: Strengthening of *Truss 1*.

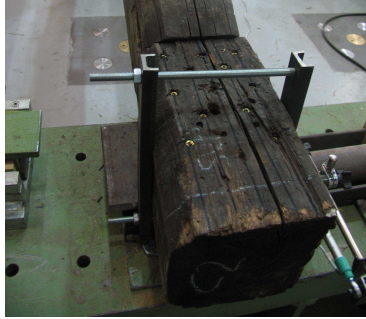
Figure 16: Strengthening of *Truss 2*. Screws and binding strip applied in the step front of the rafter-tie beam connection.

In the case of *Truss 2*, only the connections between the rafters and the tie beam were strengthened. The stiffness of the king post-tie beam connection proved adequate to prevent the instability of the truss. Rather, the timber beyond the step displayed some signs of deterioration and the depth of the steps in the rafters/tie beam connections appeared insufficient. The same strengthening technique used in *Truss 1* was applied: one internal bolt tightening the con-

nection and screws beyond the step to improve the shear resistance. However, and as an improvement based on the failure modes observed in *Truss 1* tests, a binding strip was used to confine the timber in the front notch (Figure 16).

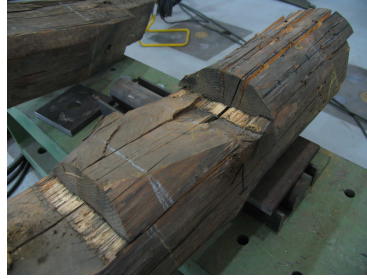
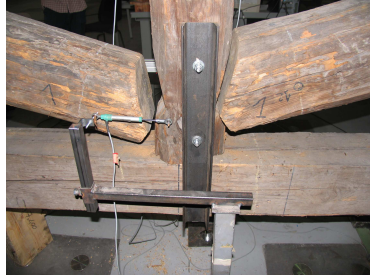
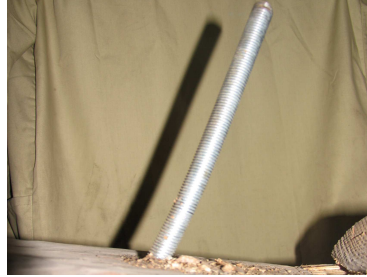
(a) Shear failure in the notch front

(b) Failure of the rear step

(c) Disassemble of king post-struts joint

(d) Bending of the internal bolt

Figure 17: Failure damages of *Truss 1*.

The load capacity of *Truss 1* was improved by the strengthening but only the symmetric test corresponding to the ULS was accomplished. At the end of this test, the local damages in the tie beam-rafter connections hampered the execution of the non-symmetric tests. In consequence, the decision was to proceed with a symmetric load test until failure. It is important to point out that the ultimate load achieved in the failure test was lower than the load level attained in the precedent ULS test. Despite the strengthening measures undertaken to improve it, the failure was caused by lack of shear resistance of the tie beam in the notch front. Theoretically, the presence of the screws should have increase the shear resistance but, because of the fissures already existing before placing the screws, the timber part in the notch front did not work as a rigid body. The screws expanded the fissures and the rigid body split in small pieces (Figure 17a). Moreover, the failure of this connection was caused by a previous shear failure of the rear step (Figure 17b). With the horizontal movement of the rafter in the connection tie beam-rafter, the joint king post-struts was dismantled (Figure 17c) and important bending stresses

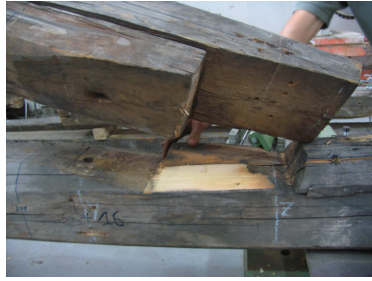
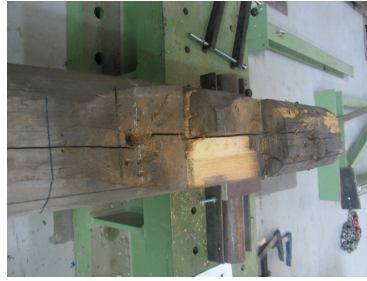
Figure 18: Shear failure of the tie beam-rafter connection for *Truss 2*.

In the case of *Truss 2*, it is difficult to conclude if the strengthening was efficient in the improvement of the truss load capacity, as no failure was obtained in the tests performed in unstrengthened conditions. The strengthened truss was subjected to the entire test history (SLS and ULS, under symmetric and non-symmetric loads). After that, a load procedure until failure followed. This procedure was similar to the previous but now, the load increment did not stop at the value of 80 kN (maximum point load corresponding to ULS). The maximum point load value achieved in the failure tests was 100 kN. Again, the failure of the truss was obtained by shear failure in the timber in front of the notch in the connection tie beam-rafter. First, the shear failure of the rear step happened and then the shear failure of the timber in the front part of the notch took place (Figure 18).

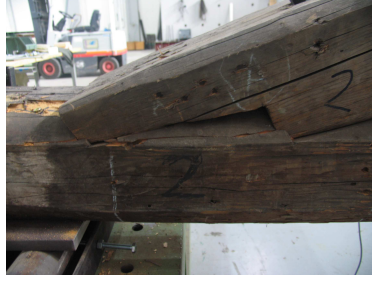
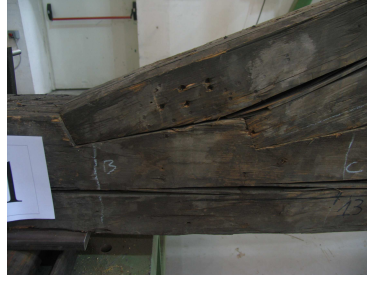
(a) Failed (right side)

(b) Safe (left side)

Figure 19: Double step connections between the rafters and the tie beam of *Truss 2*.

Failure was defined by the geometry of the tie beam-rafter connections (Figure 19) and happened in the double step connection in which the rear step presented a bad geometry (connection in the right side). The rear step must be deeper than the frontal one. If not, the surface resisting to shear stress is insufficient. The double step connections of the right side (over the fixed supports) failed as a consequence of a first shear failure in the rear step. Once the rear step failed, the stresses concentrated in the frontal step. As the frontal step geometry was not enough for the stresses level applied, the complete failure of the joint took place.

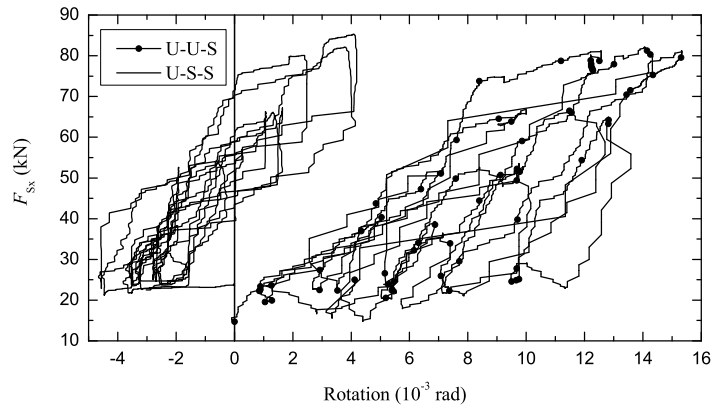
Figure 20: Moment-rotation response of the left rafter-tie beam connection of *Truss 2* under unstrengthened and strengthened conditions.

- Strengthening reduced the joints rotations, not by a significant increase in the stiffness value but, essentially, reducing the pinching effect observed in the unstrengthened conditions. In particular, in the first load cycle, the connections of the unstrengthened trusses presented significant pinching (Figure 20);
