Diagnosis and analysis of two king-post trusses

J.M. Branco & P.J.S. Cruz

ABSTRACT: An accurate geometric and mechanical evaluation of two king-post trusses, based in grading results with data gathered from NDT as well as from mechanical evaluation, followed by full-scale tests were performed. The trusses were reassembled in laboratory and submitted to a series of cyclic tests under symmetric and asymmetric loading. Strengthening techniques evaluated in precedents research steps were used in a second phase of the carrying tests.

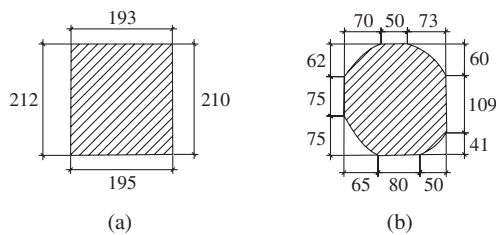
Figure 2. Comparison between the geometric properties of the cross-sections: (a) supposing rectangular and (b) with detailed measurements (dimensions in millimetres).

Each element, every 40 cm, was marked, named and the cross-section measured. Figure 2 presents the cross-section A of the tie beam of the Truss 1, as example of the difference that can be obtained if an inadequate measurement of the cross-section is done.

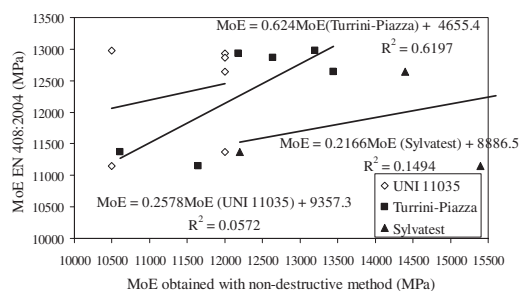
Figure 3. Correlation between MoE given by non-destructive test and MoE given by the mechanical evaluation.

During the visual inspection, significant variation in cross-section geometric properties was founded. Turrini-Piazza hardness test permits the correlation between the load force (R) required to embed a steel bit into the wood with MoE. However, the evaluation of a reduction factor dependent on the defectiveness of the element is required. This reduction factor was calibrate (with a value of 0.6) using near 1000 tests results and the MoE values obtained with the mechanical evaluation. Apart this capability of the test, it was tried to correlate the load force (R) with the density. The correlation obtained is poor ($r^2 = 0.35$) despite the significant values used. Others researchers have tried to correlate the Resistance Measure (RM), obtained with the resistograph test, with density. The same attempt was made but the correlation obtained is very poor ($r^2 = 0.02$). A correlation coefficient of 0.5 was obtained for the correlation between the depth of penetration measured with the Pilodyn and the density. In conclusion, and assuming as reference values for the MoE the results of the mechanical tests, a correlation between all non-destructive tests able to predict this property and that values were defined, and presented in Figure 3.

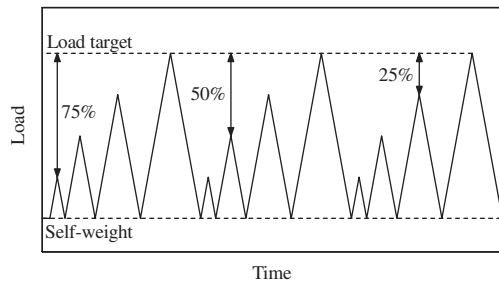
Figure 4. Load procedure applied in the carrying tests.

The timber trusses were tested under cyclic loading subjected to two point loads, each one directly applied over the joint strut-rafter. Symmetric and asymmetric tests were performed using two values of load, corresponding to Service and Ultimate Limit states (SLS and ULS, respectively). As loads, and in accordance with the Italian code D.M. 14/9/2005, it was considered the self-weight of the original timber roof and the snow load corresponding to the place where the trusses were recovered, Caldonazzo Lake (500 m of altitude). Before carrying the tests, and after the reconstruction of the disassembled trusses, trusses were subjected to a series of loading and unloading tests with the aim to adjust all trusses elements together reducing to the minimum the initial gaps between them. The first step of the tests was the application of the load corresponding to the self-weight of the timber roof (covering material and structure plus purlins). After that, the remaining load corresponding to each loading case was divided in four steps. Therefore, the load target was reached after 4 cycles of loading and unloading keeping constant the minimum load applied corresponding to the self-weight. For each test, three loading cycles were applied, Figure 4.

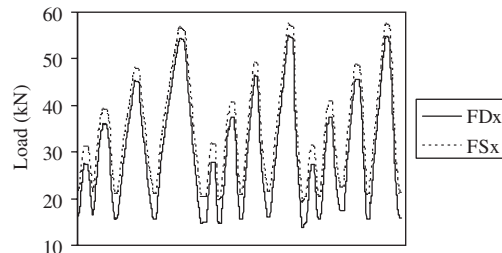
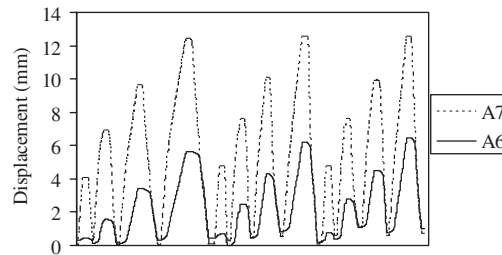
(a) Symmetric loading history

(b) Asymmetric response of channels A6 and A7

Figure 6. Asymmetric behavior of Truss 1 under symmetric loading condition (SLE).

The response of the timber trusses under the carrying tests performed is highly depending of the variability, previously detected and reported, along the truss members in terms of cross sections area and principal moments. Moreover, it is recognized the difficulty associated with tests over existing structures, in which the members can present residual deformations and signs of decay and/or the connections are not well tight. The tests results shows that even under symmetric loading conditions, the behavior of both trusses is asymmetric. This conclusion is more evident in the response of Truss 1 under symmetric loading corresponding to SLS, Figure 6.

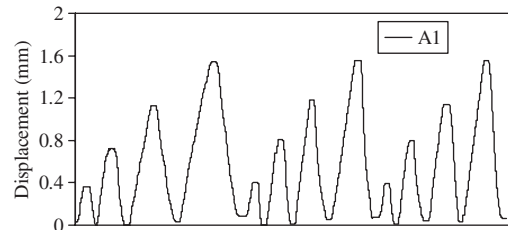
Figure 8. Horizontal displacement recorded in the support under symmetric loading.

As a consequence of the truss deformations under the vertical loads applied, horizontal displacement at the free support was recorded, Figure 8.

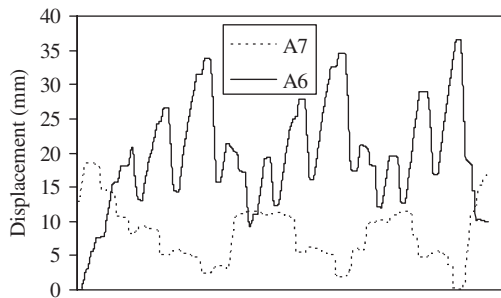
Figure 9. Asymmetric behavior emphasized under asymmetric loading (Truss 1 and SLE).

Under asymmetric loading conditions, the asymmetric behavior of the trusses, already pointed out, is emphasized. Channels A6 and A7 shows asymmetric displacement, Figure 9.

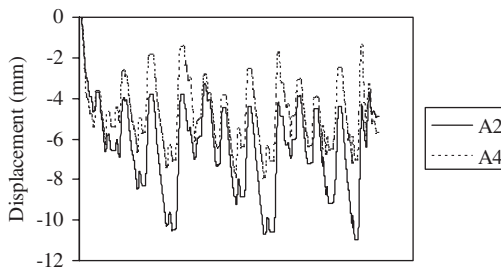
Figure 10. Distortion of the tie beam under asymmetric loading (Truss 1 and SLS).

beam connection, the asymmetric response of the overall truss causes distortion in the tie beam (Figure 10). This distortion induces important bending stresses in the bolt of that connection (Figure 11a).

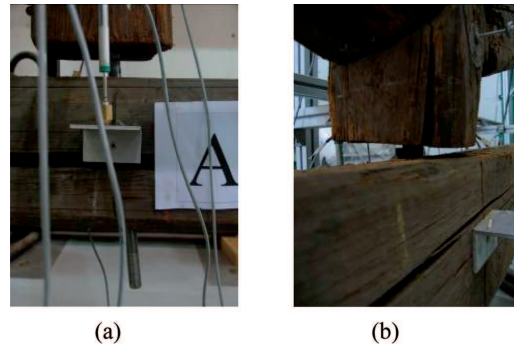
Figure 11. Behavior of the king-post/tie beam connection: (a) in plane bending of the bolt (b) out-of-plane movement prevented.

The connection between the king-post and the tie beam presents rotational stiffness in the plane of the truss and in the normal plane. Therefore, these connections prevent also the out-of-plane movement (Figure 11b) improving consequently the stability of the substructure composed by the rafters, the king-post and the struts.

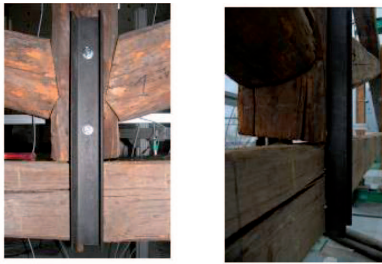
a) UPN profile preventing the out plane movements in the king-post/tie beam connection

b) Screws and internal bolt to strengthen the rafter/tie beam connection

Figure 13. Strengthening of Truss 1.

The next phase in the experimental program was to strengthen the trusses based in the response obtained in first phase and to repeat the tests. Strengthening of Truss 1 aimed essentially to repair the out plane movement observed and to prevent this instability making possible to perform the carrying tests corresponding to the ULS. The out plane deformations were removed and a UPN profile was bolted to the king-post. The objective was to prevent the out plane movements, increasing the stiffness of the connection in this direction, keeping the tie beam suspended to the king post,

Figure 11a. The timber elements did not present any local failure or damage however, the connections between the rafters and the tie beam were weakened. In particular, the left connection, over the support with horizontal displacement, the depth step was insufficient and the timber beyond the step was fissured. Then, it was decided to strengthen this part of the tie beam (beyond the step) with screws (12 screws M6-200) aiming to increase its shear resistance. Moreover, using the existing holes, an internal bolt of 20 mm diameter was introduced at midjoint and normal to the rafter in each rafter/tie beam connection, Figure 12b.

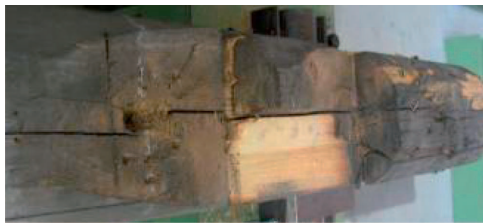
Figure 16. Shear failure of the rafter/tie beam connection for Truss 2.

Again, the failure of the truss was obtained by shear failure in the timber beyond the step in the connection rafter/tie-beam. First, the shear failure of the rear step happened and then the shear failure of the timber beyond the frontal step took place, Figure 15. The geometry decided which connections rafter/tie beam failed. The failure happens in the double step connection in which the rear step presented a faulty geometry. The rear step must be deeper than the frontal. If not,

the surface resisting to shear stresses is insufficient. The double step connections of the right side (over the fixed support) failed as a consequence of a first shear failure in the rear step.

Once the rear step fails, the stresses concentrated in the frontal step and the failure is reached, Figure 16.

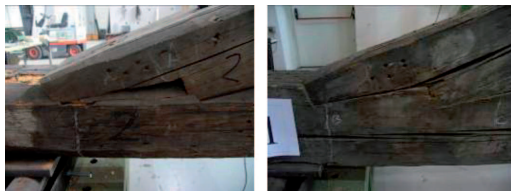
Figure 17. Double step connections between the rafters and the tie beam of Truss 2.
