New Low Level Waste Facilities

Quantification of coastal erosion at Dounreay using historical photogrammetry and remote sensing data

Reference number: NLLWF/3/REP/BGS/0291/A/01

Issue Date: 11th August 2010

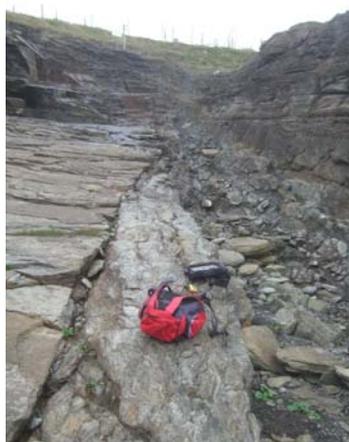
Figure 6. Foreshore close to Erosion Marker 14B

- 80 Of the 3 sets of markers considered in the Phase 1 study, all but one (14B) occur inland of the cliff line digitized from all of the OS surveys. The site of Marker 14B (Figure 6) now occurs on the foreshore, below the cliff, in the vicinity of [29913 96775]. It now lies immediately seaward of the cliff edge at the southern margin of Landfill 42, and represents a site showing probable minor landward recession of a cliff formed in tipped man-made materials.

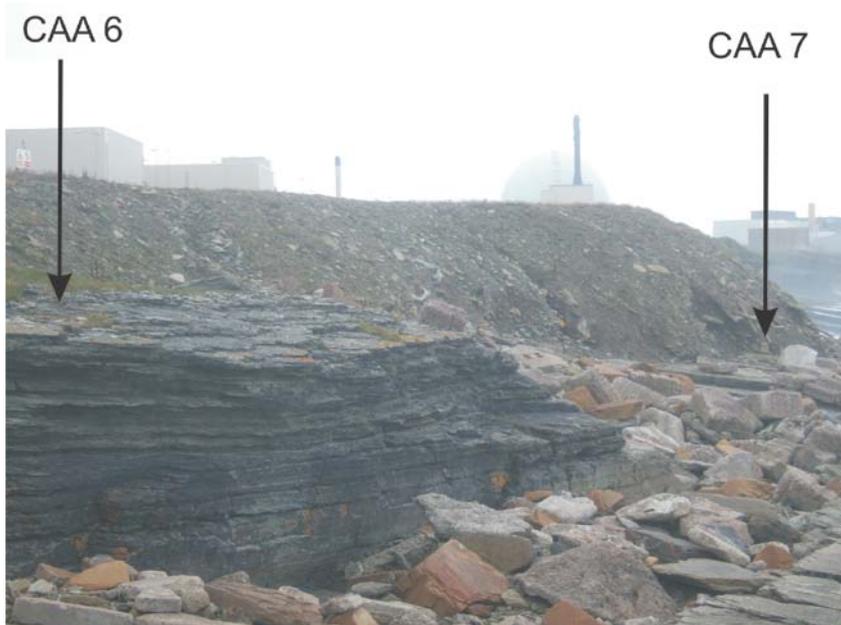
Figure 10. Cliff line at CAA_6 and _7 developed in made ground. Note blocks of concrete and orange sandstone, washed from of tipped material, lying on flagstone platform.

- 111 The present cliff top is developed in made ground at all of the FOP's between [²990 ⁹676] and [²985 ⁹672] (CAA_6 – _17) which are located along c.450 m of the cliff line seaward of the main part of the DNPE site. The lower parts of the cliff profile are developed in shallow dipping flagstone bedrock at CAA_6 (Figure 10) but the man-made material extends to the base of the cliff between CAA_7, _8 and _9.

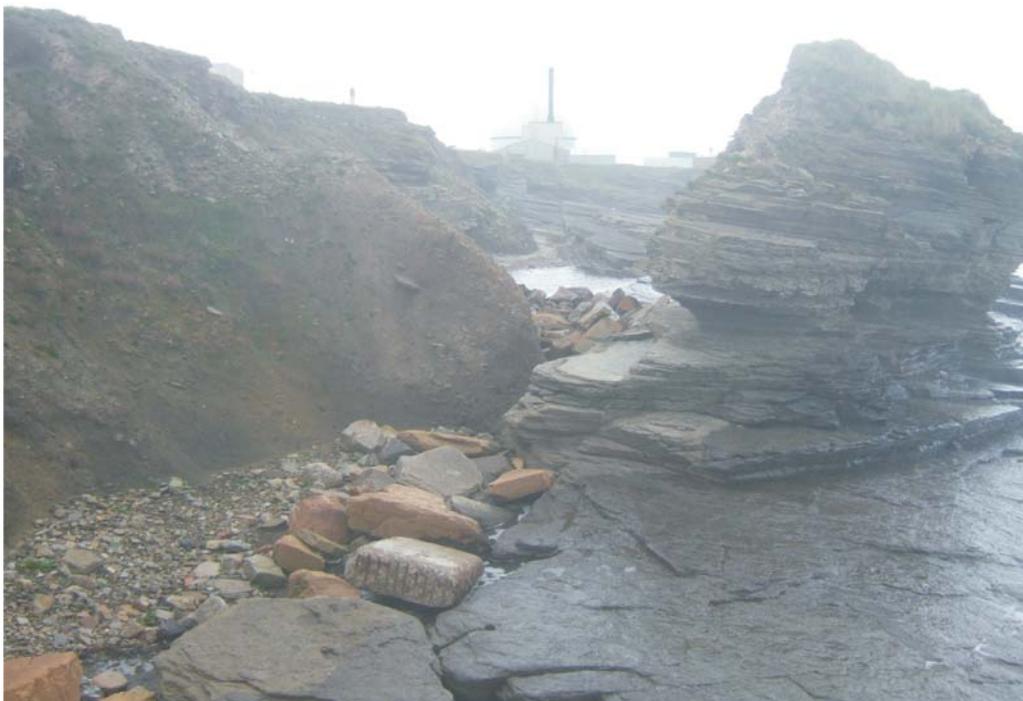
Figure 11. Convex profile in lower part of cliff in man-made deposits at CAA 8. Note: stack capped by a mixture of *in situ* Quaternary deposits and made ground.

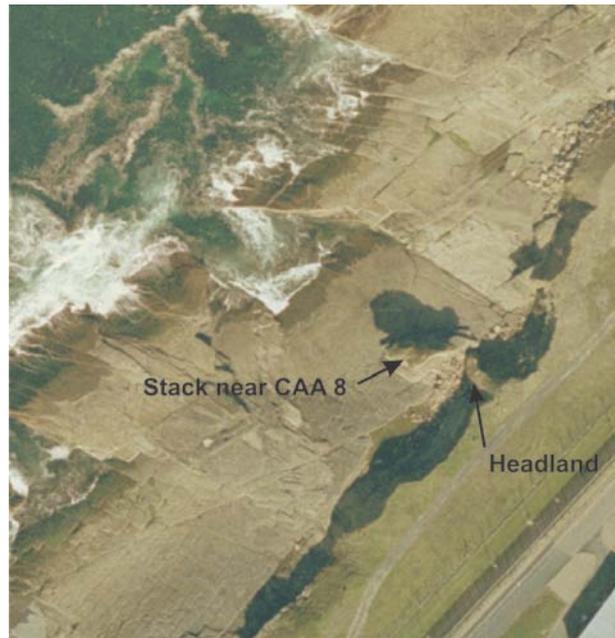
Figure 19. Stack near FOP CAA_8 and narrow headland extending from cliff line in 2004.

2. The stack appears to cover a slightly larger area on the 1951 imagery than on subsequent vintages of photography; the outline of its seaward edge appears to have changed very little on all of the later photographs.
3. Photogrammetric measurement of the position of the highest point on the stack, relative to the nearest point on the cliff edge (on the SocetSet models at c. 1: 500 scale), gave the following amounts of separation: 1951 - c. 18 m; 1965 – c. 9 m; 1988 – c. 6 m; 2004 – little measureable separation (see Figure 19).

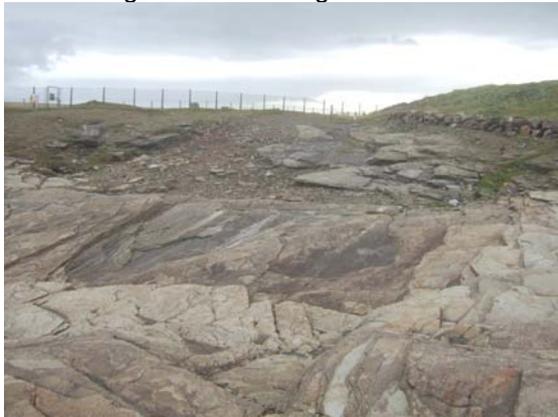
Photo Description: Eastern edge of Landfill 42. Looking inland from flagstone cliff.

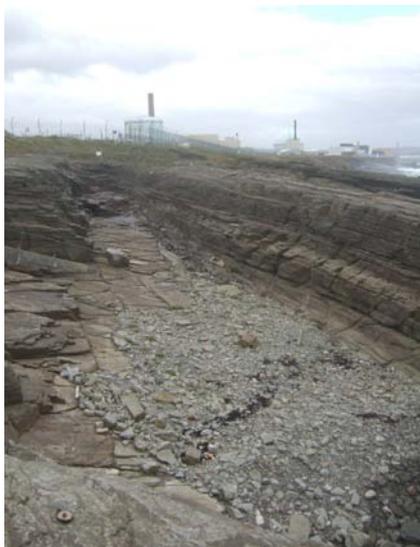
FIELD OBSERVATION POINT: CAA_2

Photo Description: Photo 2 Dog Track Fault looking SW

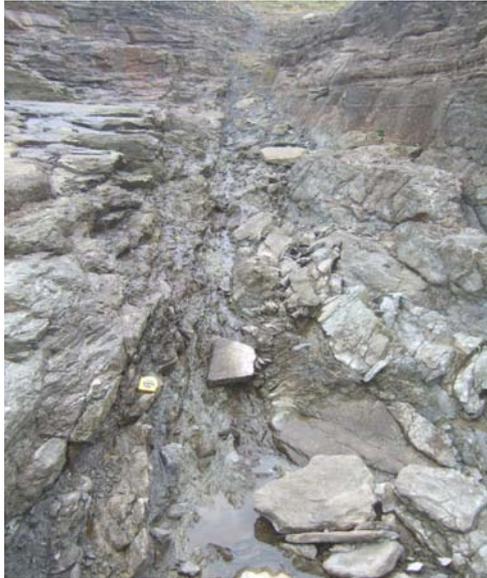
Photo Description: Close-up of same looking towards 200°

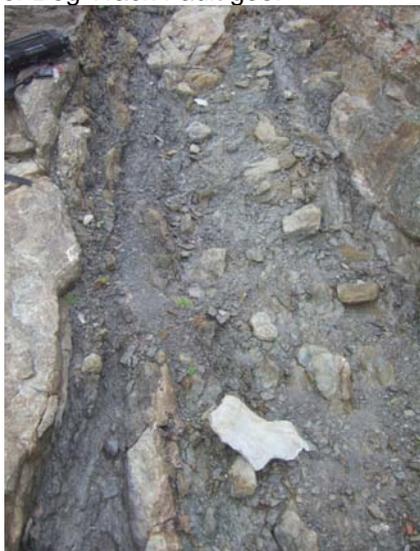
FIELD OBSERVATION POINT: CAA_5

Project: E3609R
Date Gathered: 21/09/2009 10:11:23
X: 299135.9748125
Y: 967724.16
Photo Description: Close up of clay gouge at head of Dog Track Fault geo.

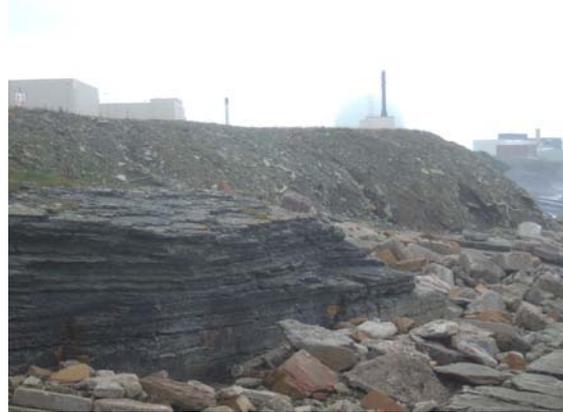
FIELD OBSERVATION POINT: CAA_6

Photo Description: Cliff being cut into Made Ground of LLWP. 50m SSW from photo shooting position.

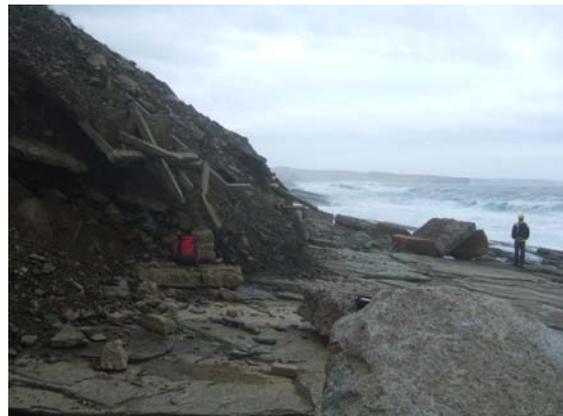
FIELD OBSERVATION POINT: CAA_7

Photo Description: Erosion of Made Ground at front of LLWP.

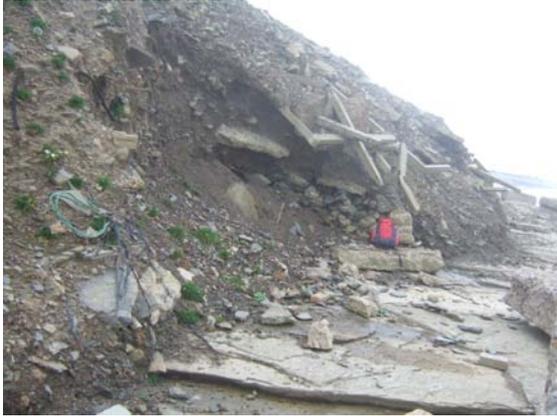
Photo Description: Erosion of Made Ground at front of LLWP (close up showing nature of material).

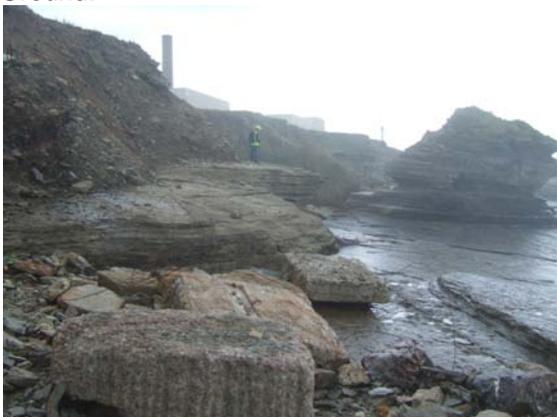
FIELD OBSERVATION POINT: CAA_8

Photo Description: Photograph of sea stack with cap of Quaternary sediments; against cliff cut in bulldozed glacial drift capped by Made Ground.

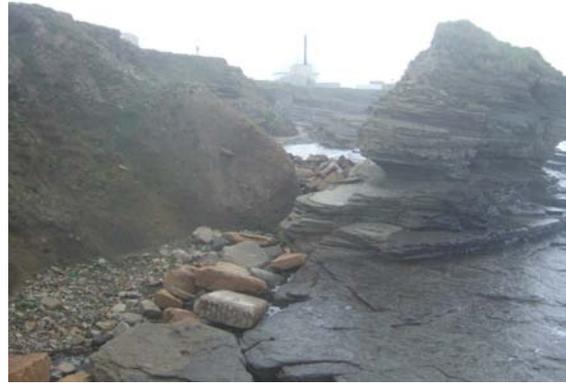
Photo Description: Photograph of sea stack with cap of Quaternary sediments; against cliff cut in bulldozed glacial drift capped by Made Ground. Note: made ground was noted during

the 1980's within the material capping the stack.

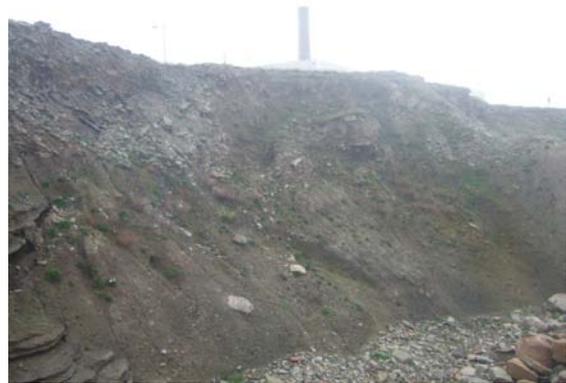
Photo Description: Close up of cliff cut in bulldozed glacial drift capped by Made Ground.

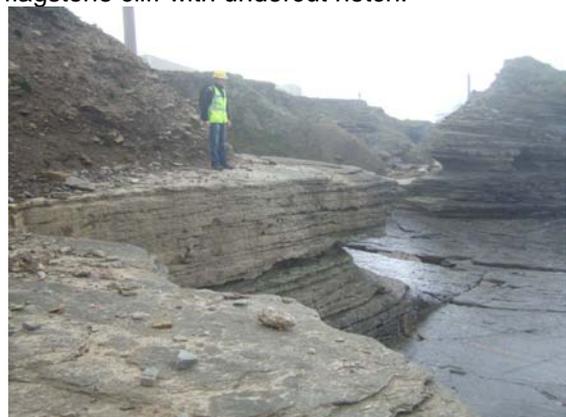
Photo Description: Bulldozed glacial drift capped by Made Ground resting on flat lying flagstone cliff with undercut notch.

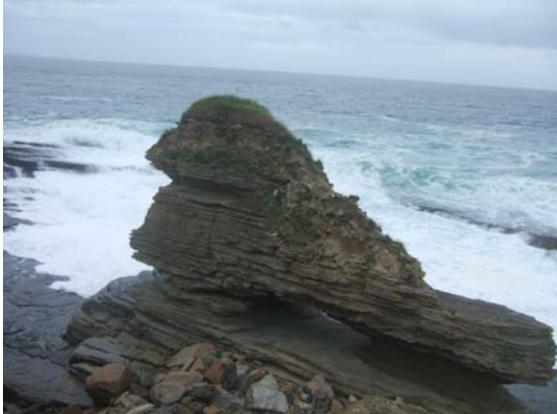
FIELD OBSERVATION POINT: CAA_9

Photo Description: View of sea stack capped with head; looking NNW from cliff top. Note undercutting and incipient arch formation.

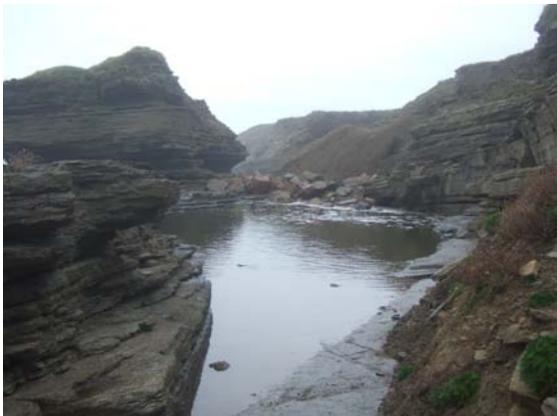
FIELD OBSERVATION POINT: CAA_10

Photo Description: Sea stack viewed from SSW looking NNE. Large granitic blocks on southern side of stack (possible sea defence or fallen from cliff top).

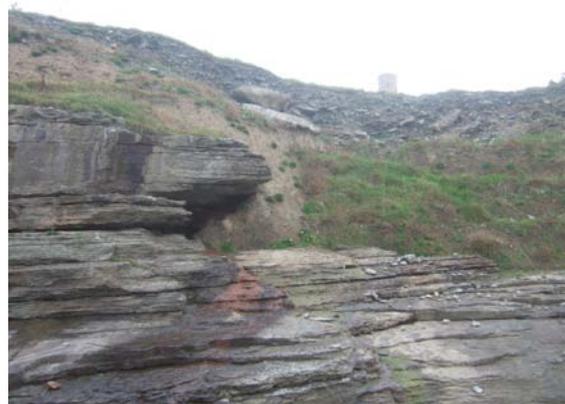
FIELD OBSERVATION POINT: CAA_11

Comment ID	Originated From	Comment
5	FOP	Moderate yellow brown diamicton is loose & slightly friable. Possibly disturbed during building of the site. It has certainly been

Photo Description: Made Ground about 1.5m thick on bulldozed glacial drift infilling narrow hollow in cliff top. Glacial material c 2.5m thick.

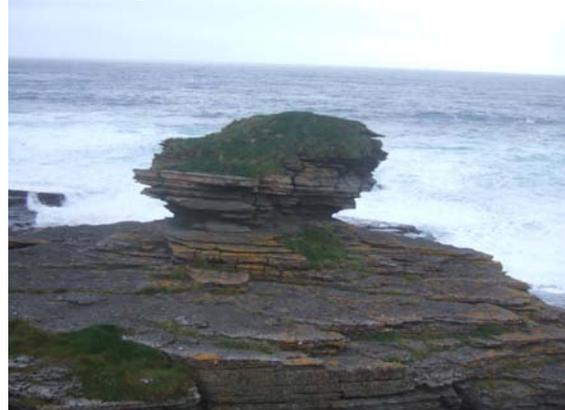
FIELD OBSERVATION POINT: CAA_14

Photo Description: Small stack with thin cap of soil and glacial deposits

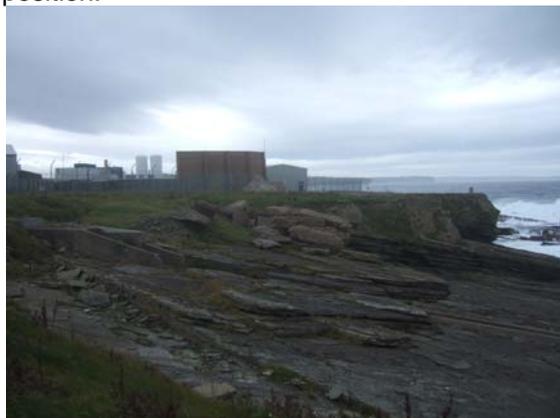
FIELD OBSERVATION POINT: CAA_16

Photo Description: View of coast in front of the DNPE looking NW. Large concrete blocks in foreground. Note possible *in situ* brown till in background about 100 m NW of photo position.

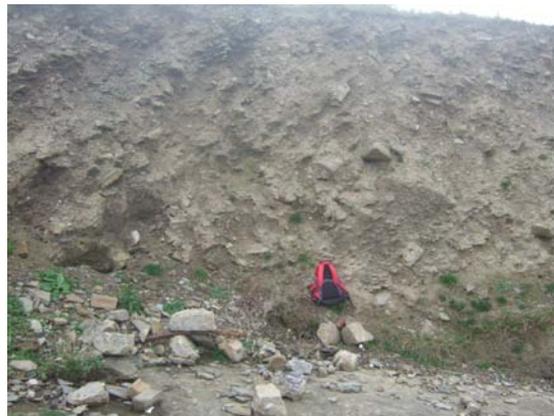
FIELD OBSERVATION POINT: CAA_17

all reworked. Note: steep stratification sloping onshore.

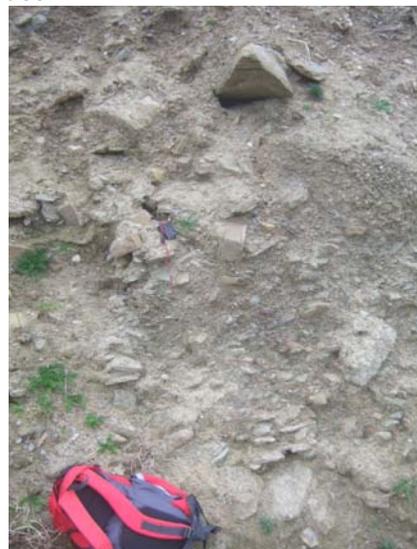
Photo Description: Close up of bouldery material with clasts up to 35cm in diameter; layer of interstratified bricks beneath compass.

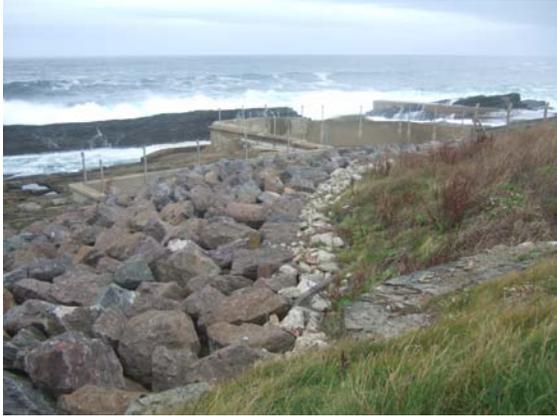
FIELD OBSERVATION POINT: CAA_18

Photo Description: Former pump house site; now demolished. Sea defence infilled with 3m x 3m diameter boulders from Reay Diorite quarry. Note remnants of concrete jetties etc.

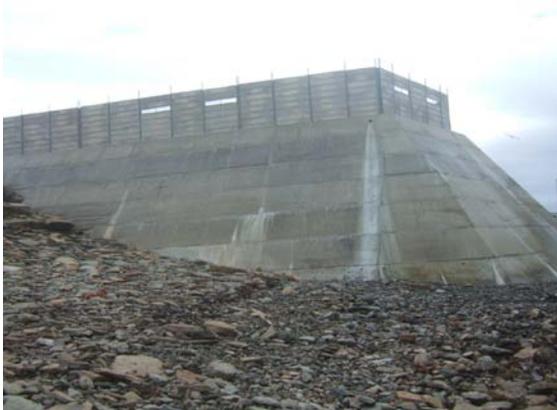
FIELD OBSERVATION POINT: CAA_19

Photo Description: Shaft Isolation Project Raised Working Platform looking SW.

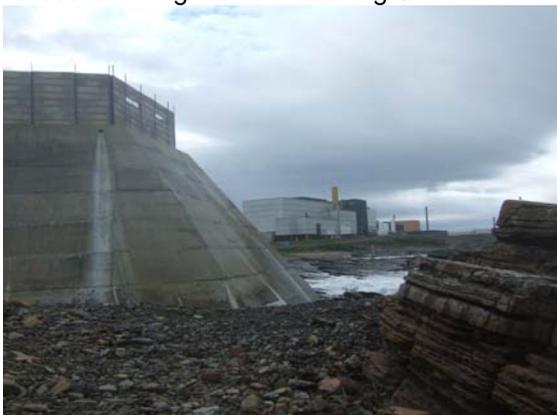
Photo Description: Shaft Isolation Project Raised Working Platform looking SW.

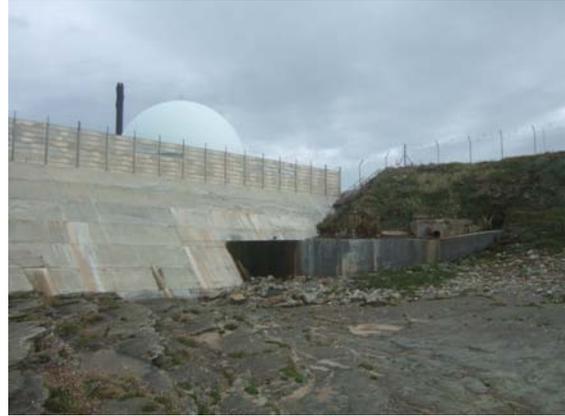
Photo Description: Shaft Isolation Project Raised Working Platform looking NE.

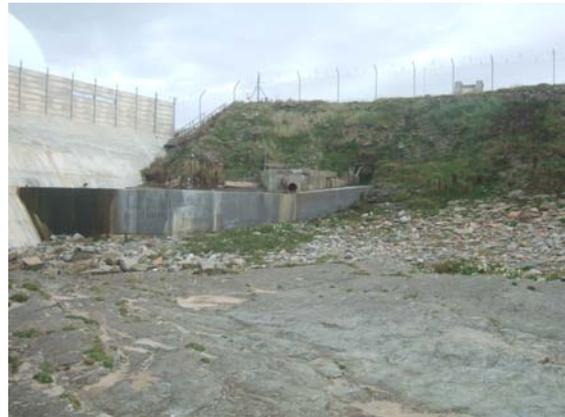
Photo Description: Made ground of reworked till about 5m thick on low flagstone ridge SW of Shaft Isolation Project Raised Working Platform. Note: gentle sloping beach on rock platform.

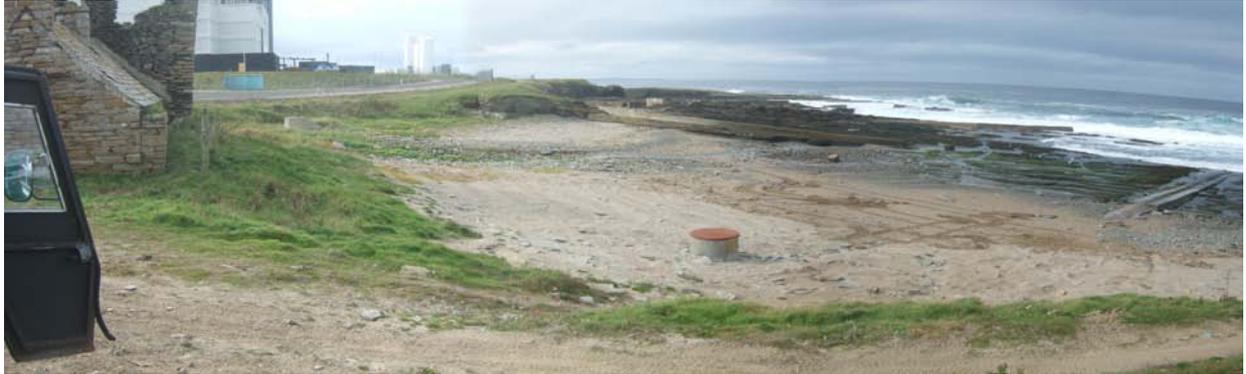
FIELD OBSERVATION POINT: CAA_20

Photo Description: Foreshore formed by Quaternary infill of channel by Dounreay Castle. Note: Drop in rock head (3 photograph panorama).

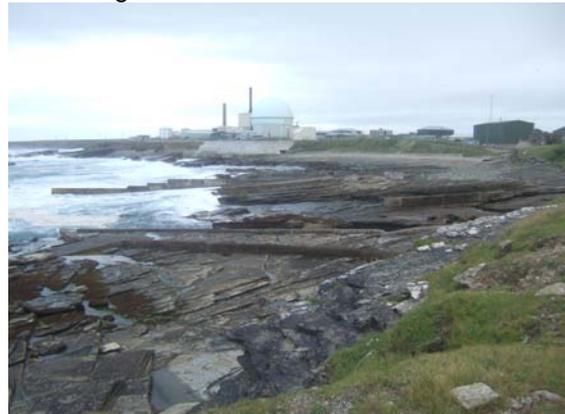
Description: View looking NE from close to Gate 29.

Photo Description: Dounreay Castle Bay viewed looking NE from close to Gate 29. Note concrete groines.

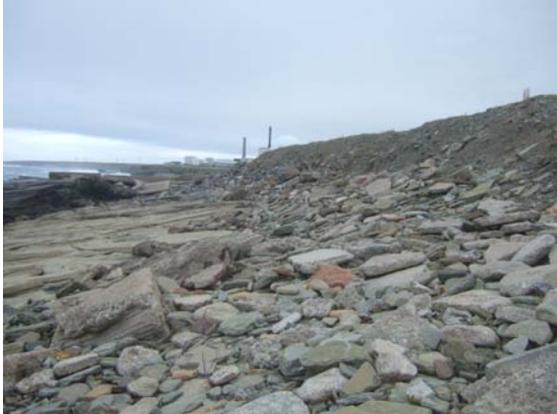
Photo Description: Made Ground looking NE. boulders, debris and concrete blocks, up to 5m

diameter on low wave cut platform in
flagstones

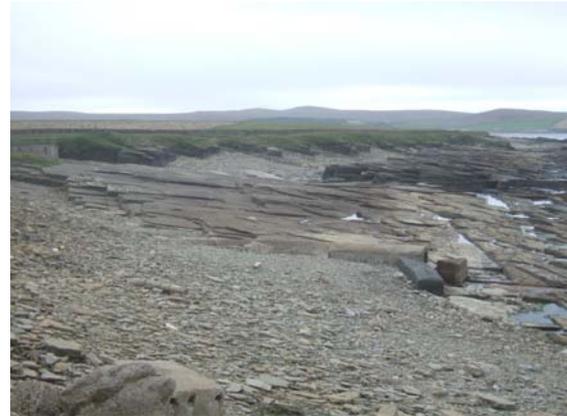
Photo Description: Made Ground looking
SSW boulders, debris and concrete blocks, up
to 5m diameter on low wave cut platform in
flagstones

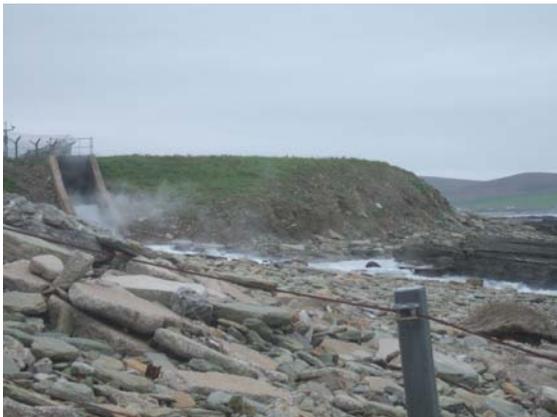
Photo Description: Deep water-filled geo with
vertical sides. Possibly modified by man. Note:
wide spaced vertical tabular jointing of
flagstones looking south.

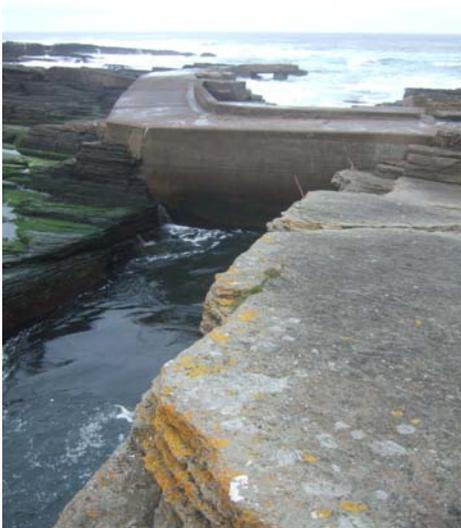
Photo Description: Mouth of geo with concrete jetty.
