# Landslide nature and distribution on the Market Rasen 1:50k geological sheet

Internal Report OR/10/013

This report is the published product of the British Geological Survey's Land Use and Development Programme's Landslide Hazards and Research Project, part of the Shallow Geohazards team. The report describes the landslides that have affected the Lincolnshire Escarpment in the Market Rasen 1:50 000 map sheet area.

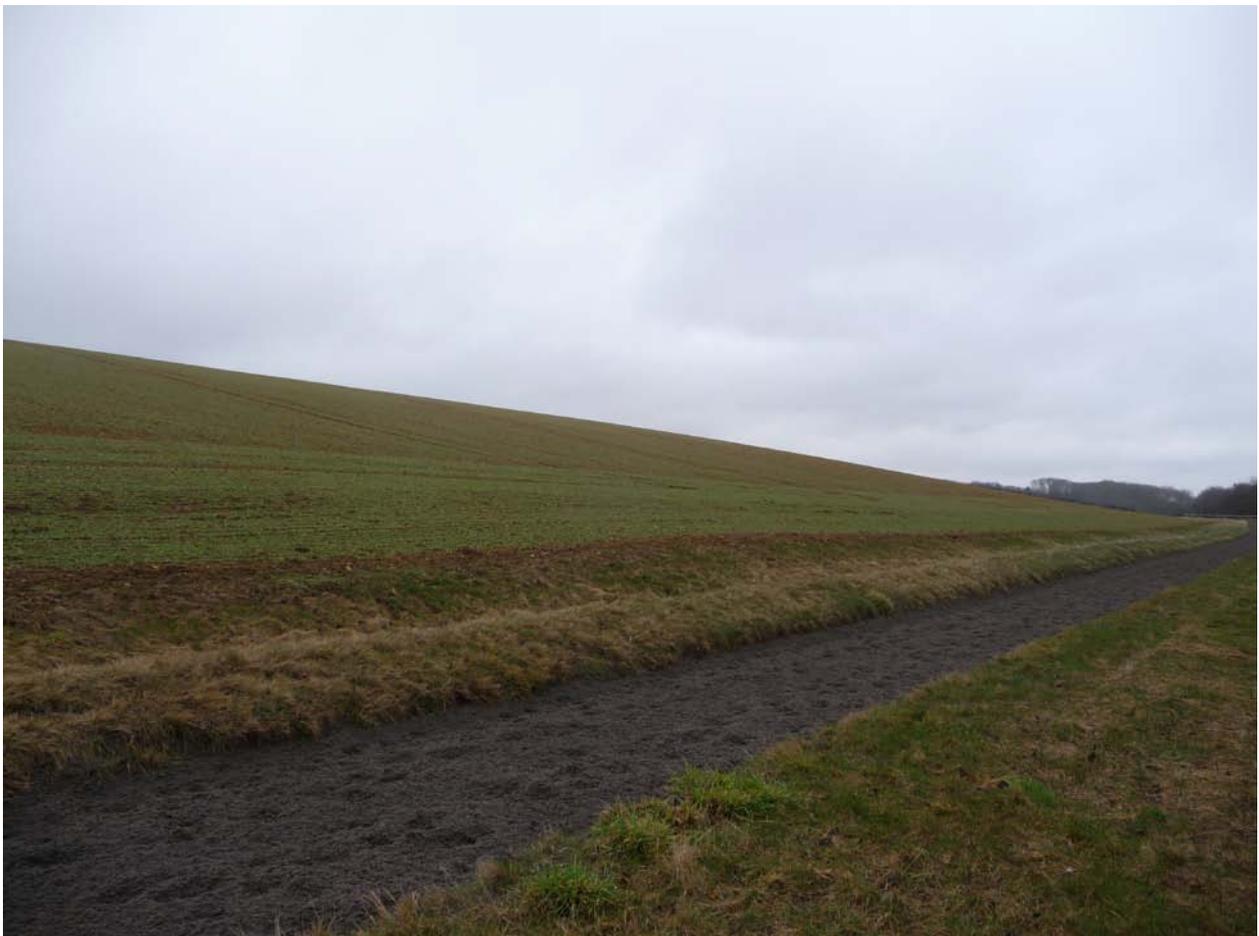
It has already been noted that the Lincolnshire Escarpment lowers and broadens towards the north away from the city of Lincoln. This decrease in slope height appears to facilitate more widespread arable land use, with a gentler, lower slope allowing regular ploughing. Several areas were identified along the escarpment from NextMap™ digital surface model slope data as having slope angles at or close to the angle of stability (between 3.8° and 12.5° with a median

value of 6.3°, Forster, 1992) for the Whitby Mudstone Formation. However, observation of the slope during the field survey revealed at best only very subtle lobate features which could not be confidently classified or mapped as landslides. Examples of this include the slope to the east of the village of Ingham [495450 383130] where a landslide was initially mapped from aerial photograph interpretation, but during the survey revealed only very subtle features within a ploughed field, and the slope to the south of Willoughton where NextMap™ digital surface model slope data suggested areas susceptible to landsliding (Figure 4). There is good reason to suspect that landsliding may well have occurred in areas such as this, and it is likely that shear surfaces would be evident in trial pits. However, due to repeated ploughing, coupled with natural processes of degradation such as hill wash and soil creep, any landslide features have subsequently been erased and overprinted. Therefore it is possible that landslides are more widespread than those mapped during this survey.

Figure 4. Typical ploughed slope profile in an area of suspected landsliding south of Willoughton. Photograph taken from NGR 493180 392143, orientation 135°.

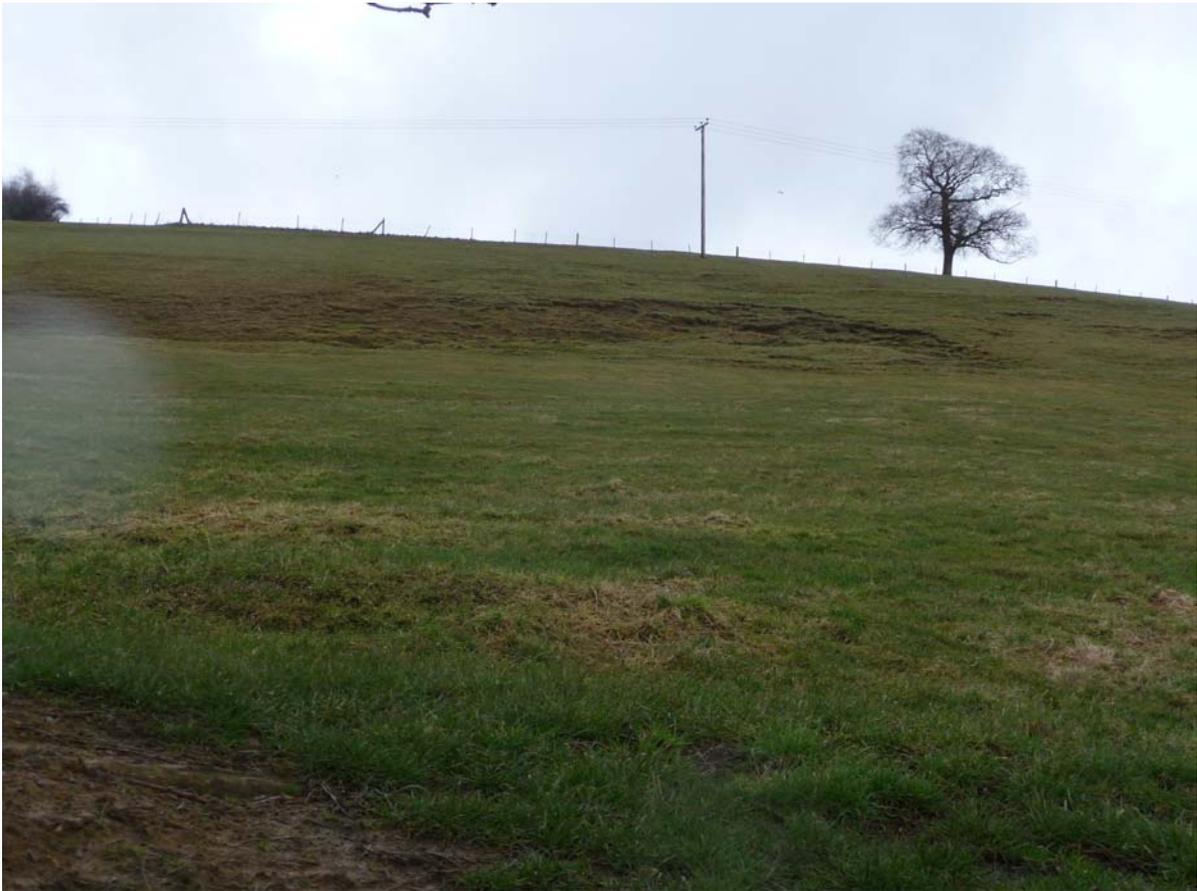
Landslides in the Market Rasen sheet area are interpreted to be between 100 and 1 000 years in age. The Ermine, Mill House (Figure 5), South Carlton (Figure 6) and South Carlton 2 (Figures 7 & 8) landslides all showed signs of recent activity. Cracks were also observed in the road between the South Carlton and South Carlton 2 landslides [495539 376298]. But the large scale movement responsible for the overall morphology of the slides is estimated to have occurred between 100 and 1000 years ago. The Burton Park, Glentworth and Hemswell landslides were all highly degraded, showing no signs of recent activity, and these too are interpreted to have formed between 100 and 1000 years ago.

**Figure 5. Fresh scarp features within the Mill House landslide. Photograph taken from NGR 495797 375113, orientation 090°.**

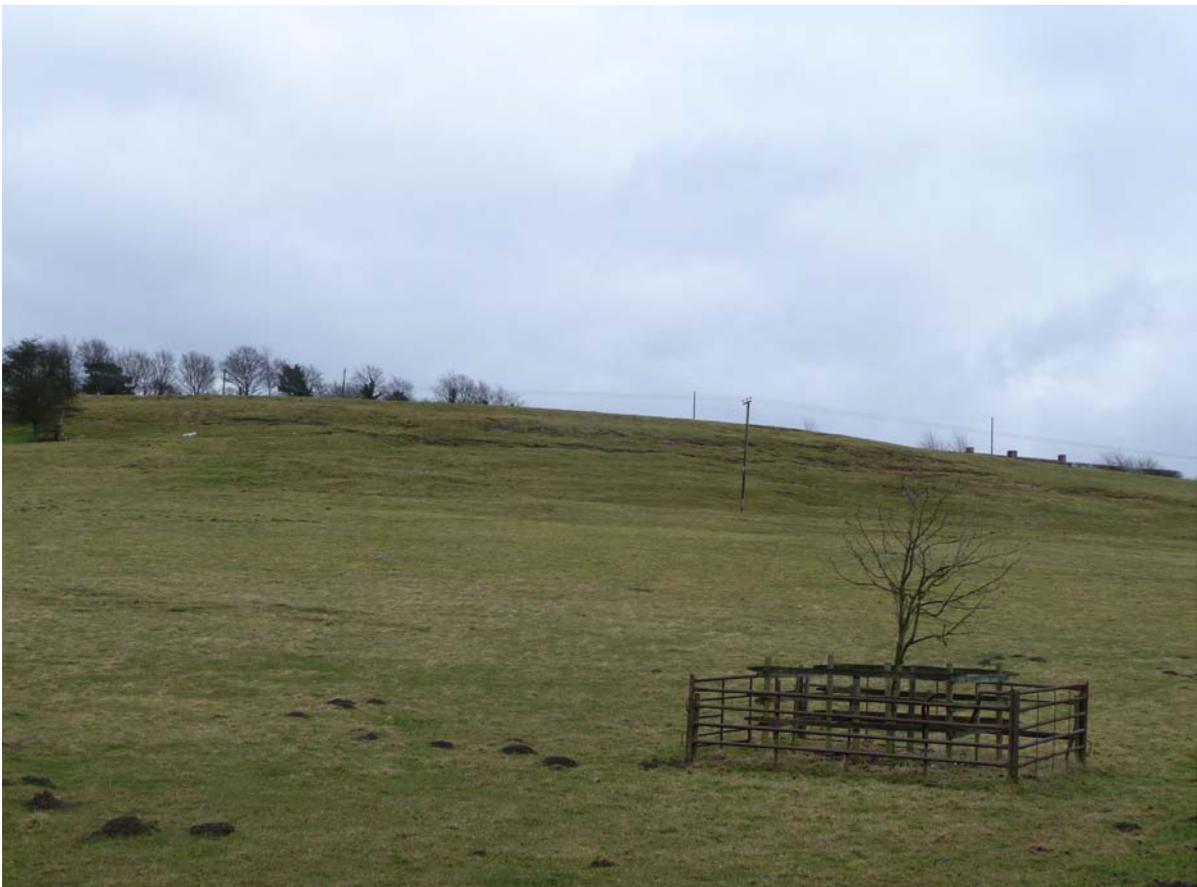
**Figure 6. South Carlton landslide. Photograph taken from 495366 376396, orientation 090°.**

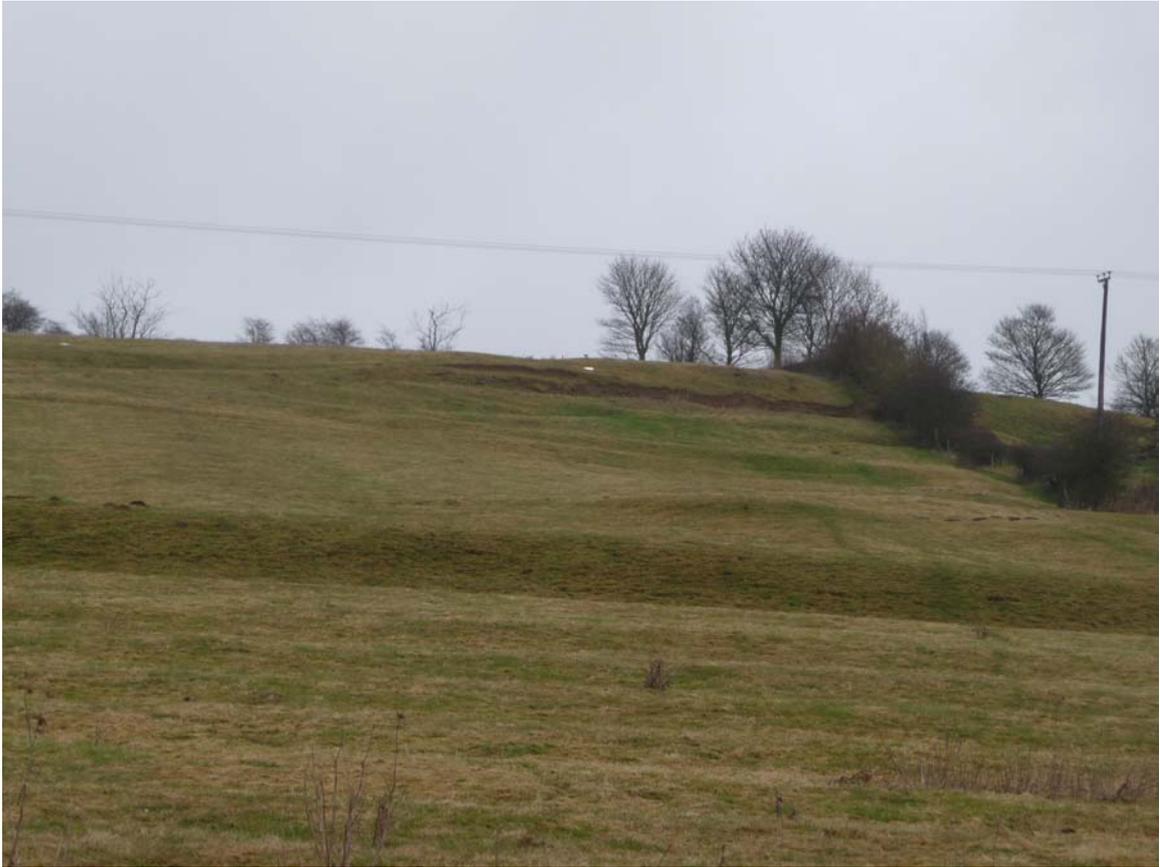
**Figure 7. Fresh backscar feature at southern end of South Carlton 2 landslide. Photograph taken from 495604 375502, orientation 090°.**

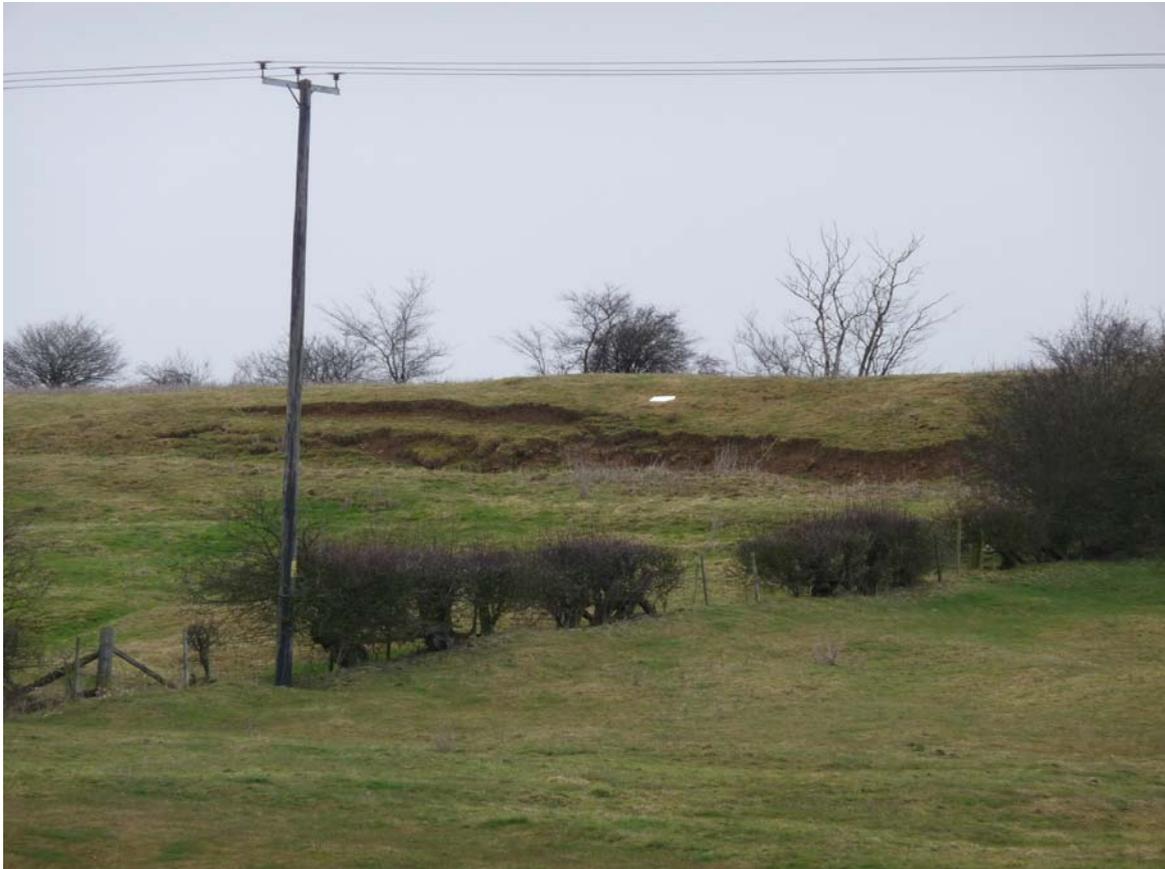
**Figure 8. Close up of backscar at southern end of South Carlton 2 landslide. Photograph taken from 495759 375212, orientation 040°.**
