# **Vegetation damage and synchronous tephra-fall influence sediment-charged flash floods**

Jan Alexander<sup>1\*</sup>, Jenni Barclay<sup>1</sup>, Janez Sušnik<sup>1</sup>, Sue C. Loughlin<sup>2</sup>, Richard A. Herd<sup>1</sup>, Amii Darnell<sup>1</sup> and Sian Crowweller<sup>1</sup>

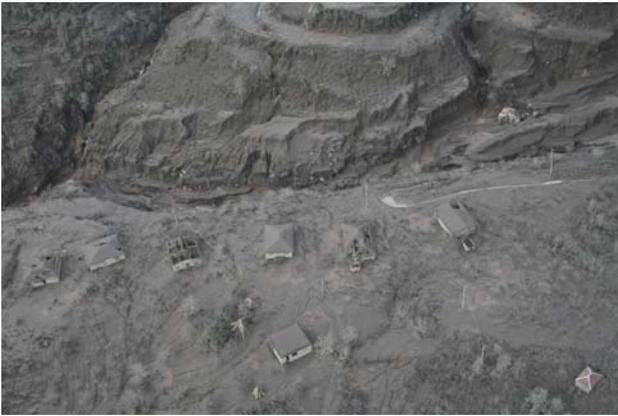
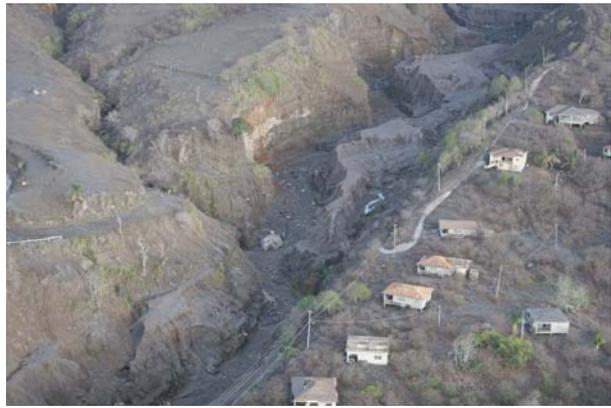
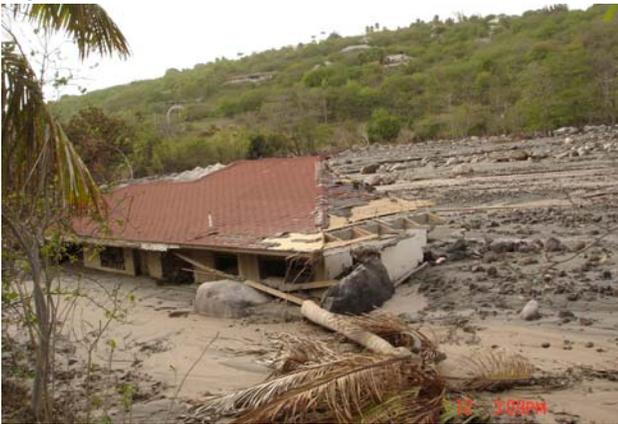
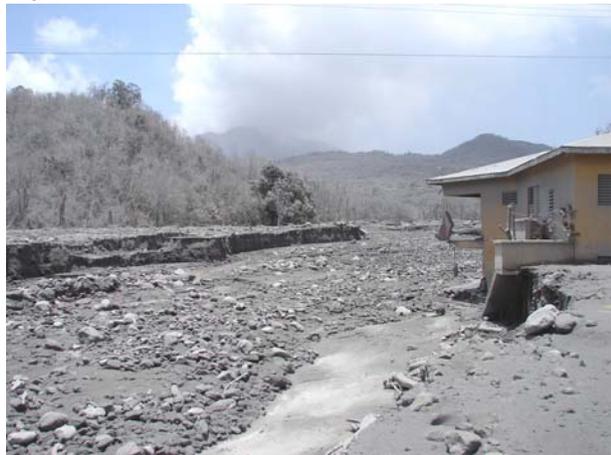
**Fig. 2.** Photographs of the Belham Valley; **A.** and **B.** are aerial views of the same reach of the upper valley at Dyer's (E on Fig. 1A) taken on the evening of the 20<sup>th</sup> May 2006 (MVO photograph; copyright NERC) and in November 2006 (photographer RH) showing the extent of tephra deposition and its later partial removal from *e.g.* roofs. The vegetation damage in May was extreme and by November significant re-growth was evident. **C.** A small house towards the lower end of the Belham Valley (A on Fig.1A) on 12<sup>th</sup> June 2006 (photographer Tina Bretton). Notice particularly the >2 m boulders against the walls that were deposited in May 2006 and the extent of vegetation damage still evident on the far valley side. **D.** View upstream at D on Fig. 1A on 23<sup>rd</sup> May 2006, (photographer SL; copyright NERC) shows the extent of vegetation damage on the hills and the channel incision into the 20<sup>th</sup> May and older deposits. The house was well above the valley floor in 1995.

The volcanic-dome collapse on 20<sup>th</sup> May 2006 was the second largest in the 12-year eruptive history and *c.*  $115 \times 10^6 \text{ m}^3$  was removed from the edifice in less than three hours with most activity taking place within 35 minutes (3; [www.mvo.ms](http://www.mvo.ms)). The associated lahar activity caused more geomorphic change in the Belham Valley (Fig. 1) than observed on any other individual day since 1995. In two days (20<sup>th</sup> and 21<sup>st</sup> May) more change occurred within the valley than the cumulative total of the preceding five years (Fig. 2).

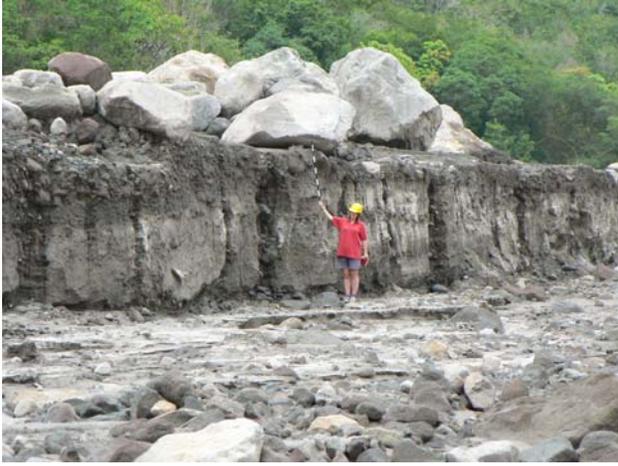
Alexander et al  
Figure 5

**Fig. 5.** Photograph of the Belham valley floor above old bridge site, showing large boulders transported by the May 20<sup>th</sup> flood and the side of the narrower channel cut after that event.

Rain fell over the whole catchment. Tephra were added to the flow by direct fallout and by entrainment in the rapid runoff. This with bed and suspended load added to the bulk discharge. The flow transported large volumes of sediment including boulders throughout the system. Sedimentary mapping indicated that the flow “bulked up” with coarse sediment in the mid-reaches by eroding up to 3 m of post-1995 deposits from the valley floor (e.g. seen at the Sappit confluence, Fig. 1). Although there was net valley floor lowering upstream of the bridge site on the 20<sup>th</sup> May, a sandy-gravel or gravelly-sand bed up to a few 100 mm thick, with isolated and clusters of boulders (diameter to >1.5 m) was deposited on scour surfaces (Fig. 5).
