**Acoustic Measurements of
Flocculating Sediments in the
Tamar estuary: A record of the
POL data collection during the
FLOCSAM fieldwork**

**Benjamin D. Moate
Richard D. Cooke
and Peter D. Thorne**

October 2009

This document provides details of the POL contribution to the FLOCSAM fieldwork carried out in the Tamar estuary, June 2009. The aim is to provide a record of instrument settings, calibration coefficients and deployment details to aid in the future analysis of the data obtained. A preliminary analysis of the POL data is also presented to aid the focus of further analysis.

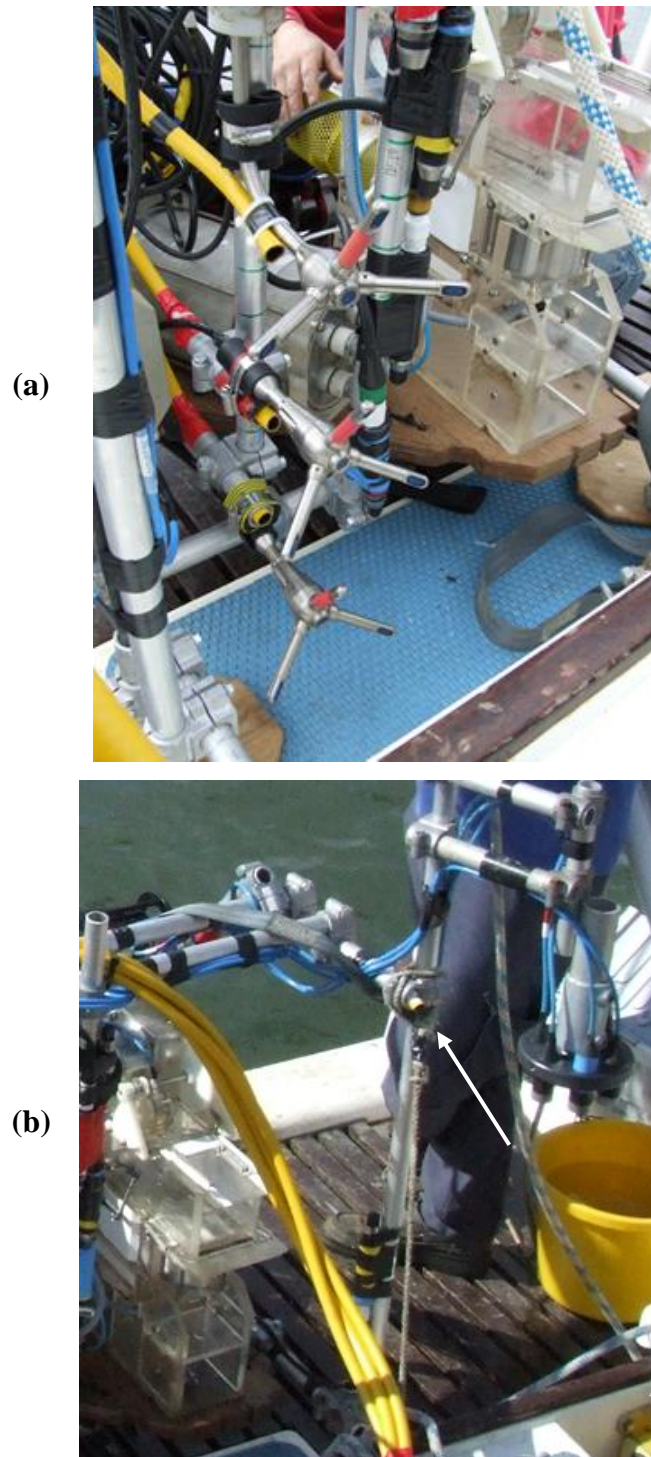
Figure 3 – Photos showing locations of the pump sample inlets on the instrument frame, with (a) three inlets, one positioned behind each ADV, and (b) one inlet located 7 cm above and 20 cm behind the ABS transducers.

Pump samples hoses were attached to the frame at four locations, shown in Figure 1, with photos provided in Figure 3. Three pump sample inlets were located on the ADV support leg, one inlet immediately behind each ADV (see Figure 3a), whilst the fourth inlet was located 7 cm above and 20 cm behind the ABS transducers (see Figure 3b).

10:40 – Pump samples mounted at same heights and side of frame as ADVs. One pump sample mounted on ABS side of frame (white tape), ~ 7 cm above ABS and 20 cm horizontally behind.
