# ADAPTATIONS AND COUNTERMEASURES FOR MITIGATING IMPACTS DUE TO GLOBAL WARMING IN GEOTECHNICAL AND GEOENVIRONMENTAL ENGINEERING

**Hideo Komine**

Department of Urban and Civil Engineering, Ibaraki University, 4-12-1 Nakanarusawa, Hitachi, Ibaraki, 316-8511, Japan.

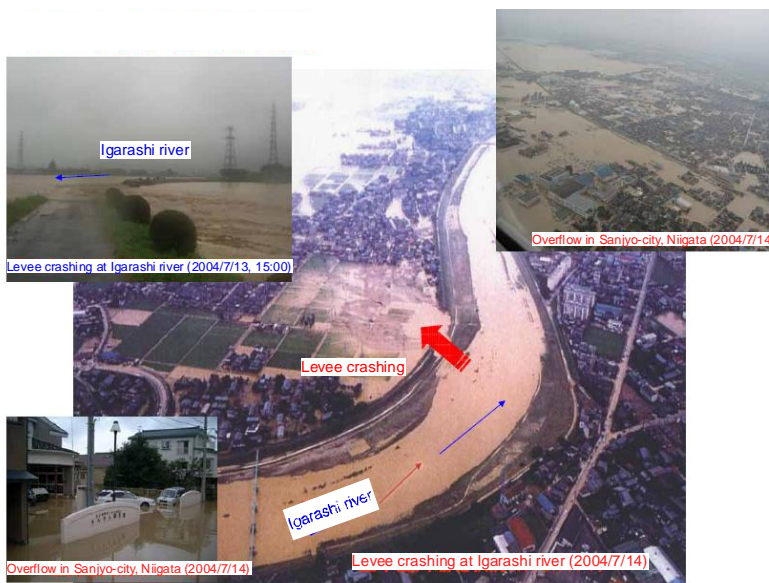
In fact, there are some disasters caused by torrential rainfall in Japan. Figure 2 shows the disaster of levee

crashing by the 2004 year Niigata torrential rainfall at Igarashi river, July 2004. A lot of amounts of water run out from the point of levee crashing at Igarashi river. Consequently, Sanjyo-city had large disasters by overflowing from the Igarashi river.

Figure 2 Levee crashing by 2004 Niigata torrential rainfall at Igarashi river, July 2004 (Photos is from the Hokuriku Regional Bureau, Ministry of Land, Infrastructure and Transport in Japan).

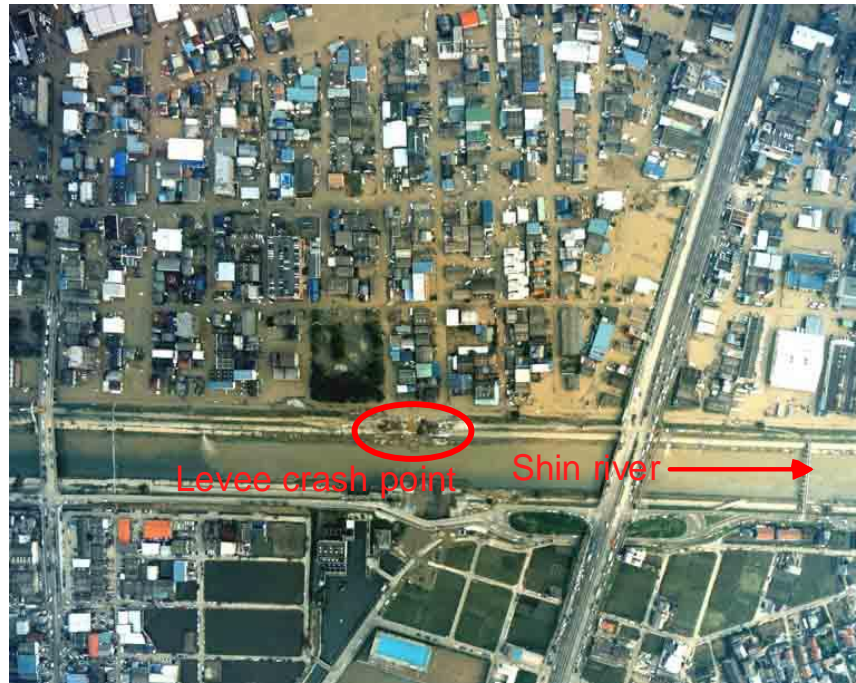
Figure 3 is the situation of levee crashing by 2000 Tokai torrential rainfall at Shin river, September 2000. As

Figure 3 Levee crashing by 2000 Tokai torrential rainfall at Shi n river, September 2000 (Photo is quoted from the website of Kokusai Kougyo Co. Ltd.).

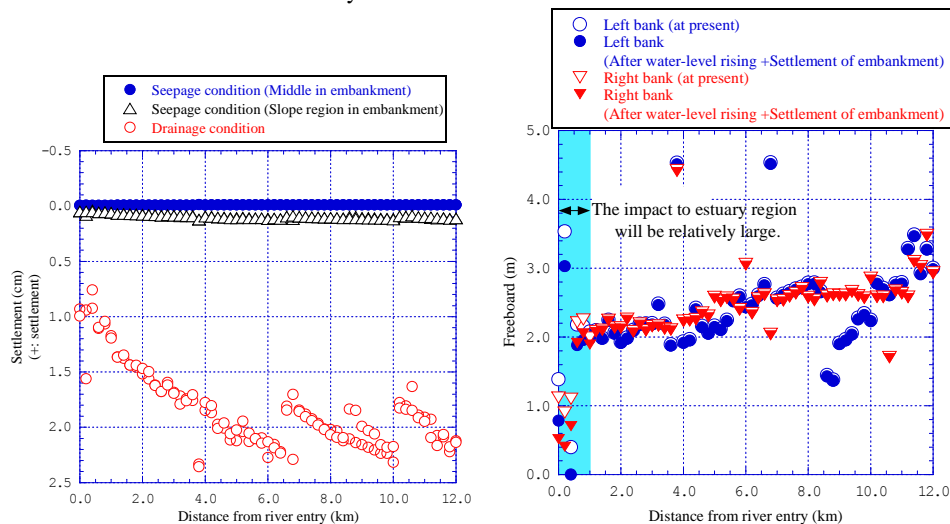
b) This study predicted the maximum settlement of the actual river levee named the Kimotsuki river by the water

retention characteristics and the volume change characteristics. From the calculated results, the predicted maximum settlement of concentrated heavy rains may become 2.48cm in Kimotsuki river.

c) This study proposed the vulnerability evaluation of river levees and banks using freeboard of embankment. The proposed evaluation can compare the effect of water level rise with the settlements and the standard values of freeboard.

Figure 5 The predicted settlement (left) and the predicted freeboard (right) of embankment by raining in the Kimotsuki-river.

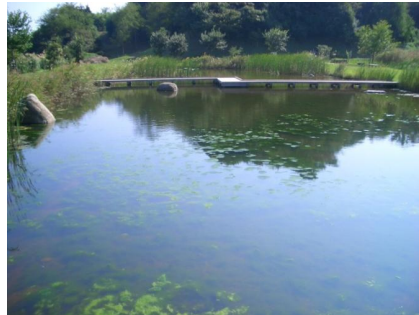
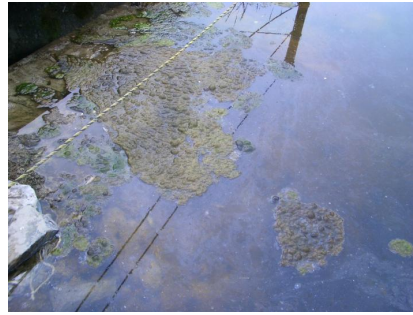
Figure 6 Actual situation of closed water environment named as Akabane -Ryokuchi park in Ibaraki

It is anticipated that temperature rising due to global warming will derive deterioration of water chemistries in closed water environments such as lakes/marshes. Figure 6 shows the actual situation of closed water environment named as Akabane-Ryokuchi park at Ibaraki. As in Fig. 6, the marsh is eutrophied and a lot of water-bloom is growing so the quality of water is so bad. If the

(a) Cover shot : The marsh is eutrophied and a lot of water-bloom is growing

(b) Side of the marsh : Eutrophicating marsh is marked and methane gas from marsh deposit can be observed.

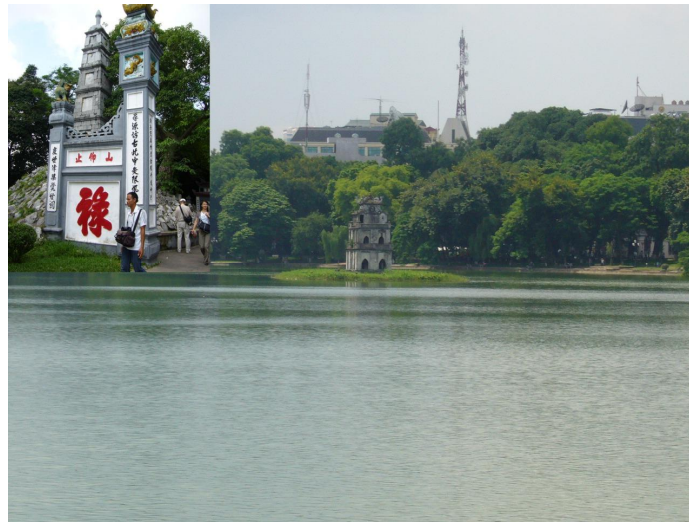
Figure 7 Actual situation of closed water environment in the park in Hanoi, Vietnam.

temperature of marsh water will be increasing by global warming, it is thinkable that the quality of water will be worse than now. In Vietnam, there is the same situation (see Fig. 7) as the above so Vietnam has also the same problem due to global warming. Therefore, our group are now developing the new technology using combustion waste such as coal fly ash and/or melted slag for mitigating water pollution in closed water environments. The detail of the above new technology is referred by Kigata et al. (2008).

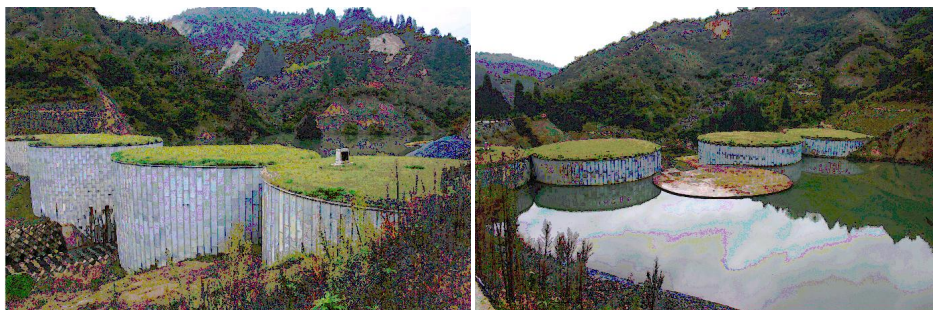
Figure 11 shows an example of utilization of disaster wastes. The structure shown in Fig. 11 is the debris barriers made by disaster wastes which were generated by the 2004 year Niigata Chuetsu earthquake. The author believes that the example in Fig. 11 is one of exemplary aftercare as adaptations and countermeasures.

Figure 11 Debris barriers made by disaster wastes which were generated by 2004 year Niigata Chuetsu earthquake.
